#### DAY-LIGHTING OF A CULVERTED CHANNEL IN DYCE, ABERDEEN

River Restoration Centre Conference, University of Nottingham, 19<sup>th</sup> April, 2012

Dr. Hamish Moir, Dr. Chris Bowles, Mr. Sam Diaz

### Case study of 'constrained process restoration'

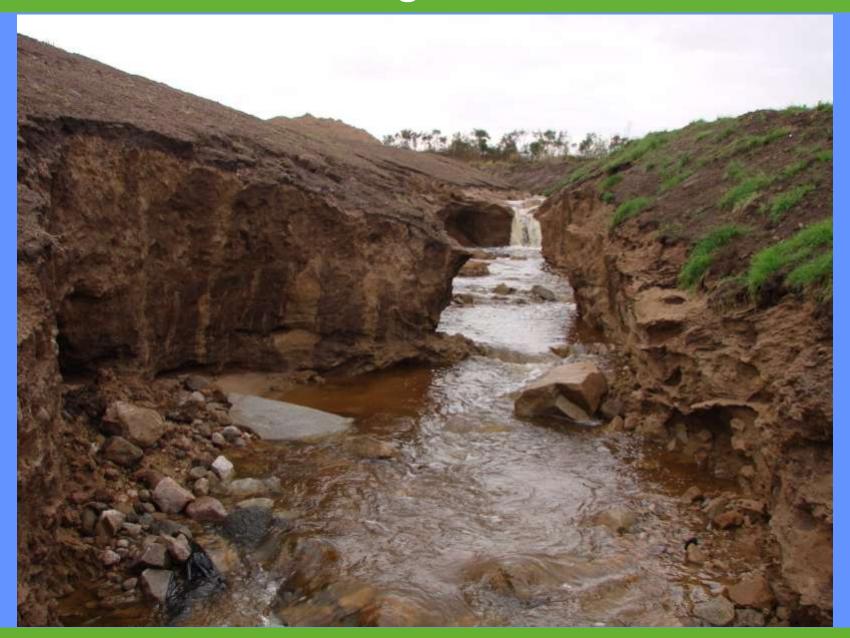
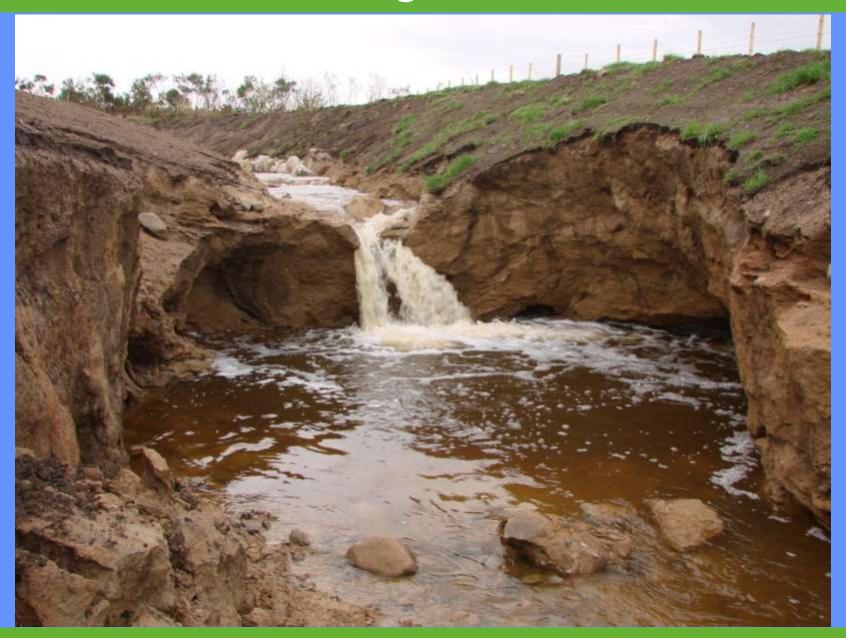
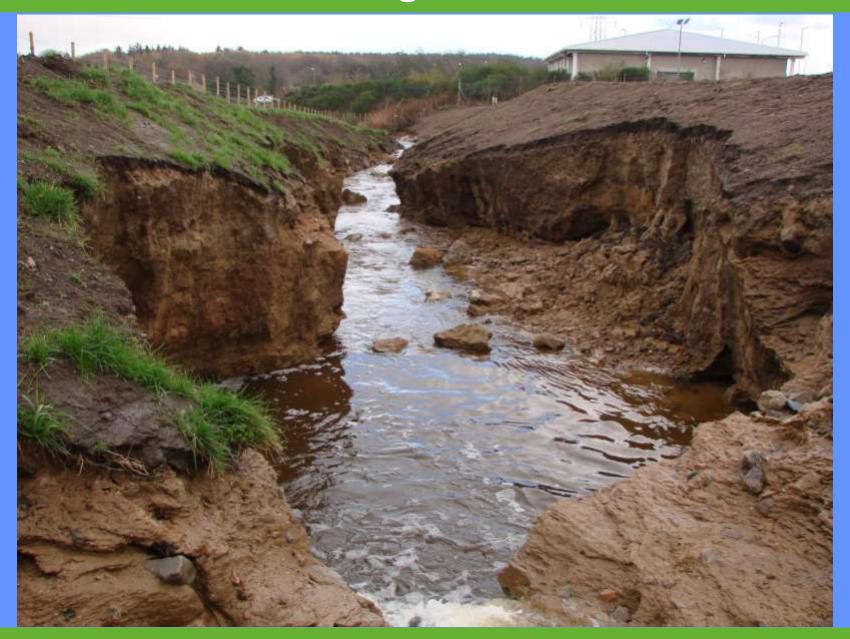
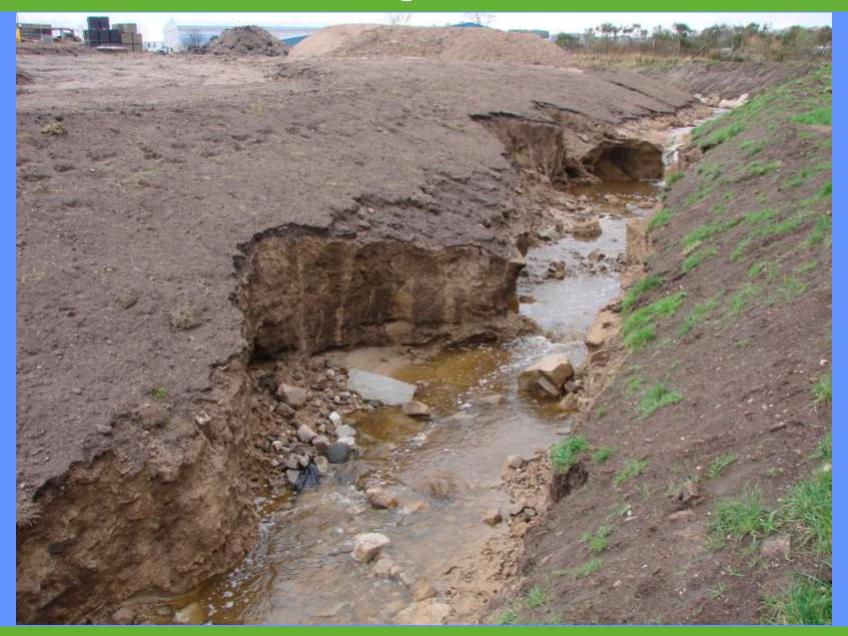
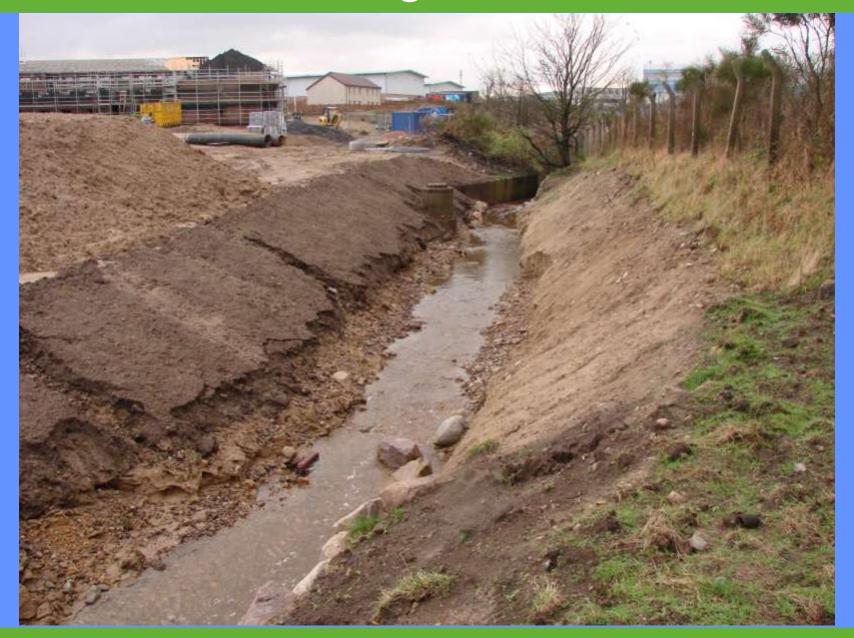
### High flow events prior to further analysis

Two flood events occurred on 31<sup>st</sup> Oct and 5<sup>th</sup> Nov 2009

Nearby gauge on mainstem River Don indicated magnitudes of ~10 year return interval

Site estimate indicated discharge of 2.0 – 2.5 m<sup>3</sup>s<sup>-1</sup> (i.e., design Q<sub>50</sub> underestimated)

- Incision of the channel bed of up to 2.7 m
- Upstream head-cut migration of 7.5 m due to 05/11/09 event
- Total cut of 539 m<sup>3</sup> of material

- New design concept produced based on reproducing natural fluvial process and form given imposed conditions
- Main aspects of design to reduce forces applied to the channel bed:
  - step-pool design where basal bed slope > 3%
  - inset 'benches' adjacent to the channel (where site allowed)
  - appropriately sized bed material introduced
- Step-pool design based on established procedures reviewed by Chin, et al (2009):
