Restoring Meanders to Straightened Rivers

1.9 Reconnecting a remnant meander

RIVER ROTHER

LOCATION - PETWORTH, WEST SUSSEX FROM SU98051906

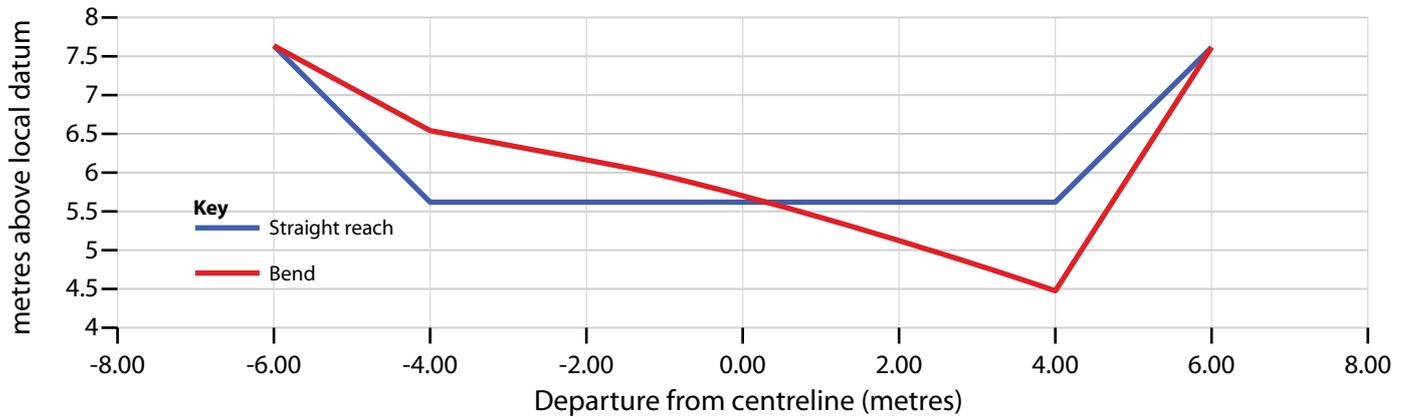
Figure 1.9.2

DESIGN CROSS-SECTIONS FOR STRAIGHT REACH AND BEND APEX

Expert judgement and field observation was supported by a model to inform the more detailed channel design. However it was impractical to excavate the complex shapes optimised by this model. Therefore the loop was excavated to one of two basic cross-section designs, namely bend apices and straight reaches, while points on the transition between them were interpolated (see Figure 1.9.2). The bed level was set to reflect existing conditions in the River Rother at each end of the loop and to improve connectivity with the floodplain during high flow events. A large scrape was excavated to create wading bird habitat and to provide clay for construction of the bund.
