Revetting and Supporting River Banks

4.7 Bank revetment using low steel sheet piling and coir rolls

RIVER THAMES

Location - Clifton Lock Cut, Oxfordshire SU 544944 Date of construction - September 1996 Length – 140m Cost – £45,000

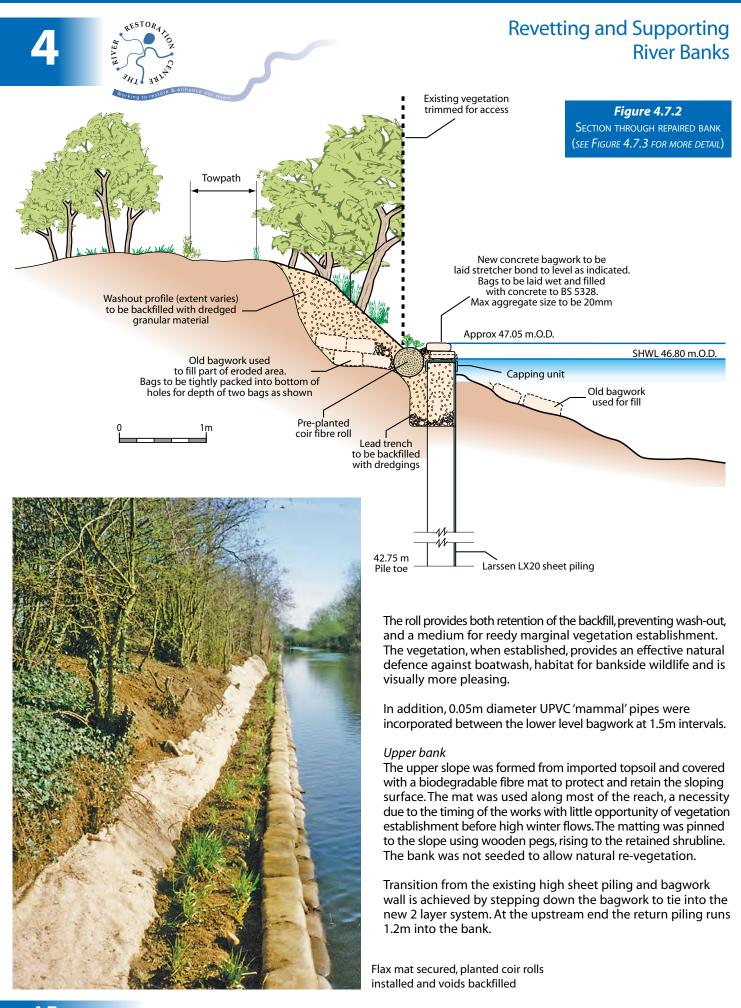
2 layer capping bagwork and tie-in to existing sheet piling

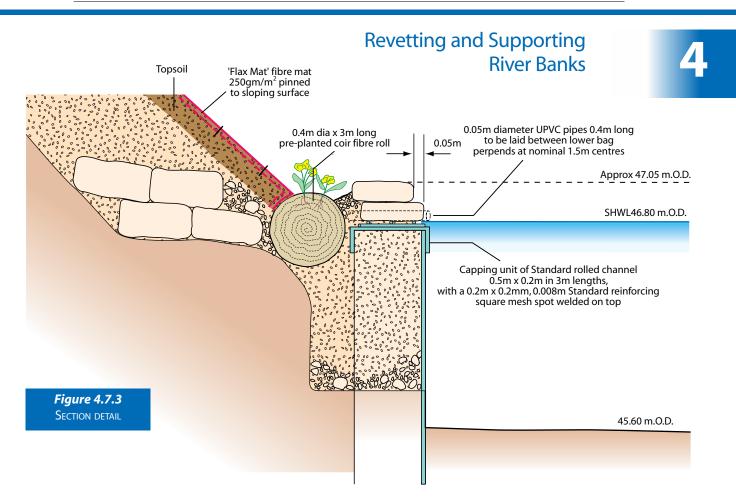
The introduced bagwork has settled (soil and silt has solidified) and is standing up well to wash caused by passing boats. Where there is sufficient light there is good vegetation growth and numerous plant species have successfully established. However, in some areas lack of maintenance means riparian vegetation has overgrown, restricting some views of the river from the towpath. The minor tree work carried out along the towpath has since ceased and it is suggested that the scheme may have benefited from a tailored tree maintenance schedule.
