Controlling River Bed Levels, Water Levels and Flows

5.3 River Ogwen 2013 Update

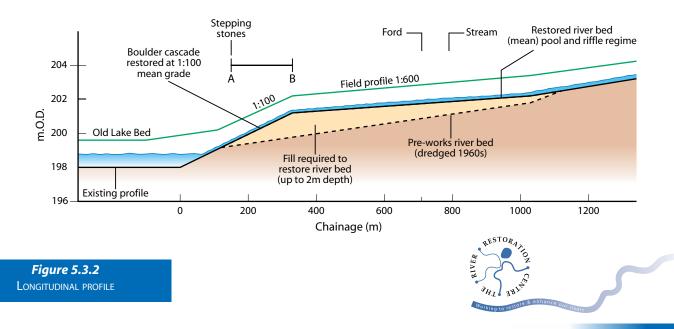
Restored bed levels and bank profile

A boulder cascade (**A** to **B**) was designed comprising four drops of around 0.4m over a reach of 100m, giving an average gradient of 1 in 100 to parallel the natural field gradients alongside.

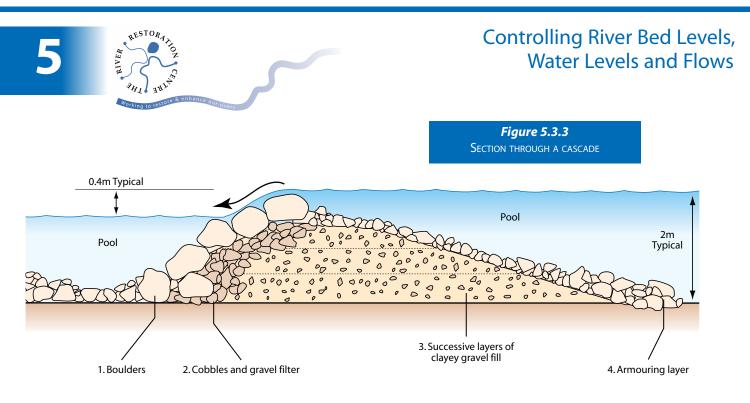
Old maps were studied to determine the planform, which included the secondary channel that formed the island. Trial digs were undertaken to determine the historic bed elevations and thus the crest level of the upper cascade. It was concluded that river flow around the island was probably a seasonal feature so the bed elevation here was kept marginally above restored river water levels consistent with site investigations. The design for each of the four elements of the cascade is detailed in Figure 5.3.3. Boulders face-up more general fill in a structured way. Construction comprised a series of 'lifts' undertaken whilst the river was flowing over the works. Each lift comprises a line of selected boulders that are backed up by a layer of mixed cobbles and gravels that are sufficiently large not to eventually wash out through the interstices between boulders. Behind this 'filter' layer a further layer of more clayey gravel fill was placed. The structure was built up in successive lifts to achieve a 'wedge' shaped profile that is sufficiently stable to impound water upstream. An armouring layer of rocks was finally dropped over the general fill. All material was carefully sorted from the original dredgings.

Restoration of boulder cascade, stepping stones and braided channel

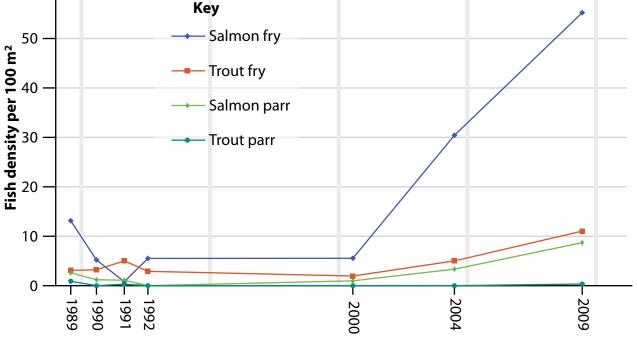
Fisheries monitoring has demonstrated an improvement in salmonid recruitment. In particular a significant increase in the density of Atlantic salmon fry has been recorded (*see Figure 5.3.5*). Whilst continued monitoring of fish has been undertaken, no other ecological data has been surveyed in relation to this scheme. Fencing has been installed on the right bank and this has now vegetated up as a result.

Some adaptive management was required around five years after completion. The boulder cascades settled more than was anticipated such that the 'island' feature was rarely an island. Additional boulders were installed to raise the cascade levels

closer to the original design levels. The degree to which slumping and settlement of placed bed material (even boulders) neds to be carefully considered when attempting to restore bed levels. The remediation works cost approximately £10,000.
