### 8.4 Restoring a ford as a stock and vehicular crossing point

#### RIVER OGWEN

LOCATION - 5KM SOUTH OF BETHESDA, GWYNEDD SH641615

## 8.4 River Ogwen 2013 Update

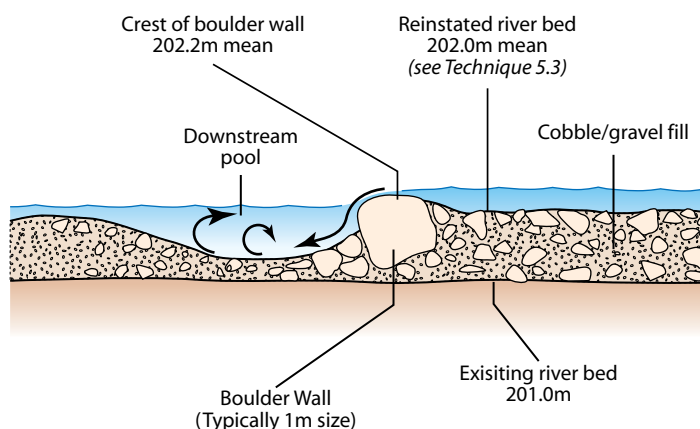
The restored ford, shoals and riverbed

The ford remains in good condition with minimal disturbance to river morphology and has not required any repairs to date (March 2013). The ford is used occasionally by the tenant farmer who crosses the river in this location with his tractor.
