JBA
consulting

River Blythe Restoration Plan

Draft for comment

May 2017

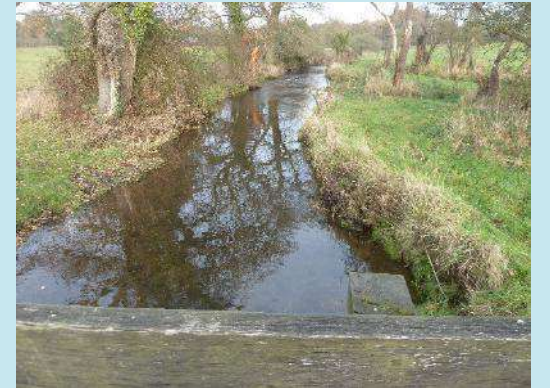
Although considered passive meandering, there are relatively straight sections characterised by gliding flows.
