Test & Itchen River Restoration Strategy - Appendix B Progress Report

River (& local name)	Reach Code	SSSI Units	Management Option
River Test – Southington House, Overton	T009 and T010	84	Rehabilitate N.B I think this should be a red restore due to large impounding structure.
<p>SU 50953 49769 Restoration Potential- Issues to address in Appendix B of the strategy: T009 -This reach is modified through Overton Town and impounded upstream of a sluice for around 75m. In this section the left bank is Overton sports ground and the right bank is garden. The bank is mown along both banks downstream. Channel is heavily modified through over-deepened and over-widening. It is a major silt trap with little flow diversity. A major sluice exists in the river creating a flow split by the sports ground. Previous attempts have been made to narrow the channel which have been unsuccessful due to the depth of the channel.</p> <p>T010 – Channel through Overton golf course starts at upstream end as a hatch take off from the main ponded area. Flow has been increased through the reach. The upstream end is gravel and chalk gravel but the downstream end is silted through the private grounds joining the mai

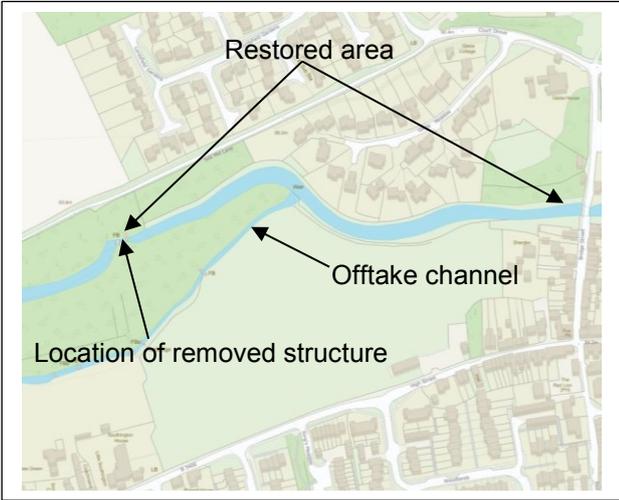
<p>The map shows a plan view of the river channel. A blue line represents the river. A section of the river is highlighted in a darker blue and labeled 'Restored area'. An arrow points to a specific location on the river labeled 'Location of removed structure'. Another arrow points to a side channel labeled 'Offtake channel'.</p>
