Restoring Meanders to Straightened Rivers

1.4 New meanders to one side of existing channel

RIVER SKERNE

LOCATION - DARLINGTON, Co DURHAM, NZ301160

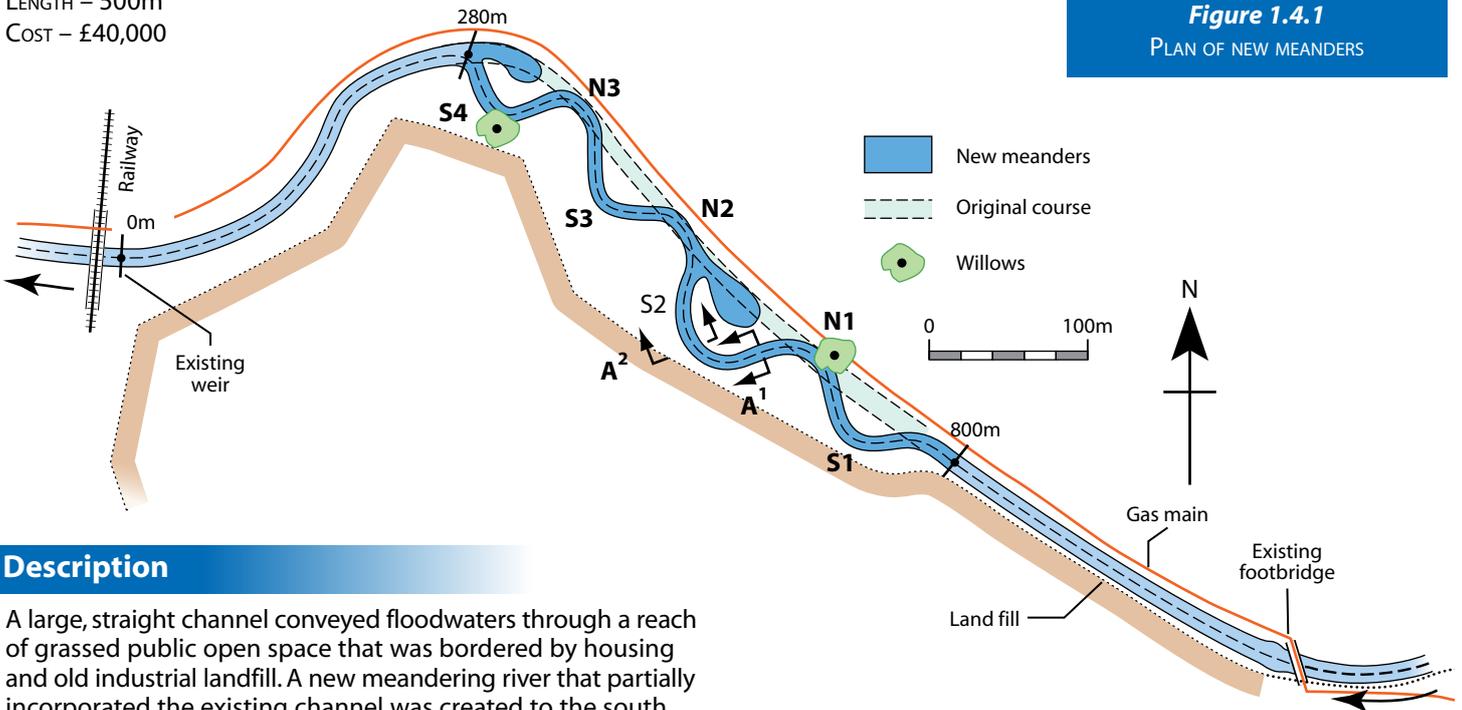
Figure 1.4.1
PLAN OF NEW MEANDERS

A large, straight channel conveyed floodwaters through a reach of grassed public open space that was bordered by housing and old industrial landfill. A new meandering river that partially incorporated the existing channel was created to the south side. The risk of flooding, affecting people and property, was safeguarded.

Alignment of channel (Figure 1.4.1)

The lateral extent of meandering is constrained between a gas main, running closely alongside the north bank of the old course, and landfill tipped to within 10 to 50m of the south straits precluded any possibility of 'mirroring' historic mean

bank. Bends **S4** and **N1** were located to retain two mature willows on the banks. The remaining meanders are set out between and checked against geomorphological criteria to finalise the layout. High flows in this channel and other constraints precluded any possibility of 'mirroring' historic meander patterns that were sustained by entirely different hydraulic criteria.

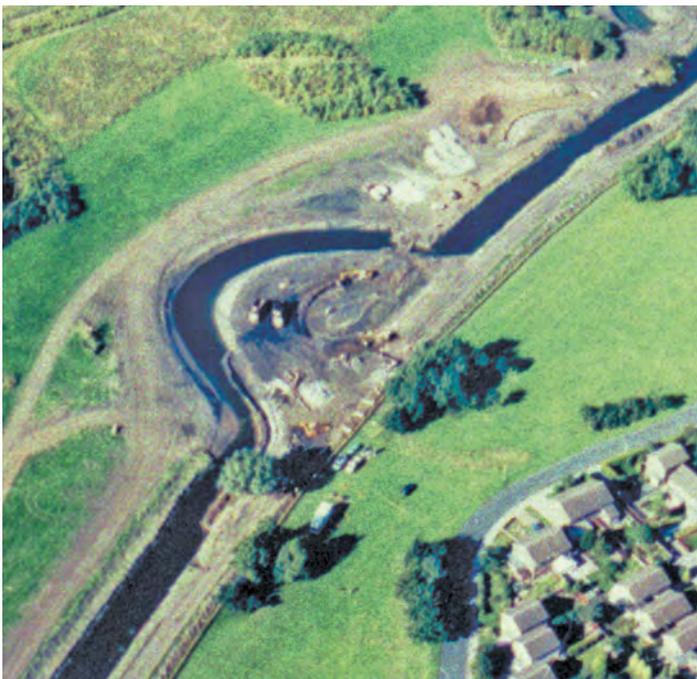
Meander excavation
- Autumn 1995

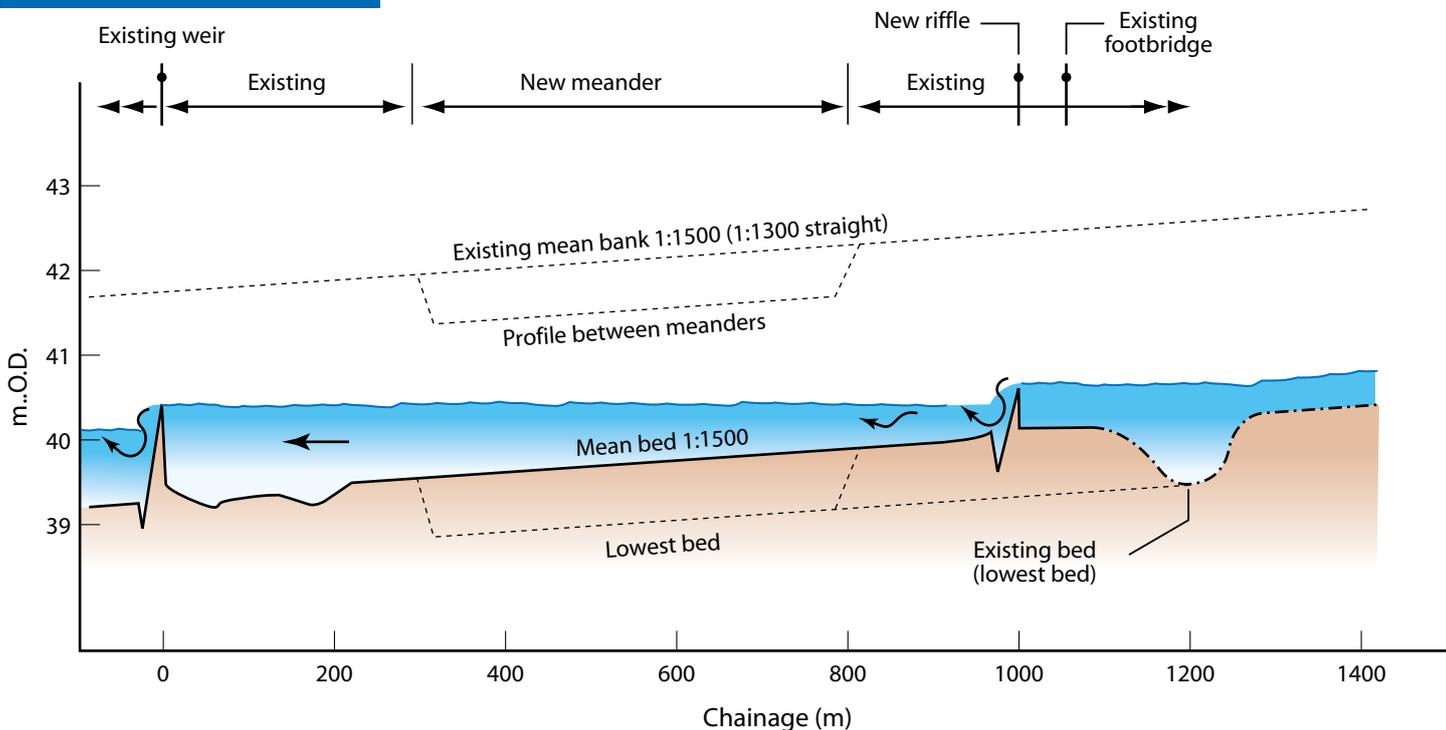
Figure 1.4.2
LONGITUDINAL PROFILE

The original mean bed gradient of 1:1300 paralleled the mean bank gradient at a depth of c.2.4m. The new mean bed gradient and level matches the existing but flattens to 1:1500 because of the increased length created. meander was expected to reach c.1m depth as observed at an existing bend at ch. 1200m. This is shown as 'lowest bed' on the long section 1m below mean bed. Conveyance of floodwaters across the new meanders was facilitated by a general lowering of inter-meander land levels by c.0.6m. This also enhanced water storage aspects of the 1 in 100 year flood hydrograph, attenuating the peak flow downstream.

Normal water levels in the reach are controlled by an existing weir at ch. 0m, but the effect of this diminished at ch. 900m where the original straight channel was retained and enhanced. Enhancements included an artificial rock/gravel riffle at ch. 1050m shown on the long section (see Part 3).

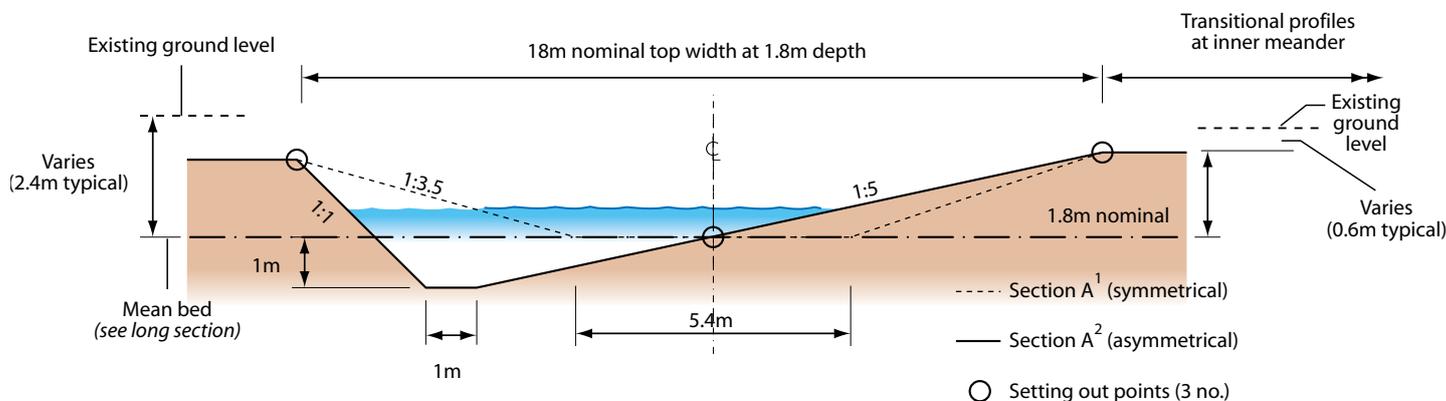
Figure 1.4.3
SECTION THROUGH NEW MEANDERS

Because of continuously varying vertical depths described for the longitudinal profile, the design needed to be simplified. Two sections (symmetrical and asymmetrical) were developed based on mean depth (1.8m) and mean top width (18m). These applied to two points only on each meander - intermediate

profiles required a continuous transition between them. The asymmetrical section allows for 1m of scour at each bend described above.

A variation of the pair of sections shown was developed for bends **S1** and **S4**. A horizontal ledge at normal water level was incorporated around the inside of each to simulate the effects of natural shoaling.

Cross-sections (Figure 1.4.3)

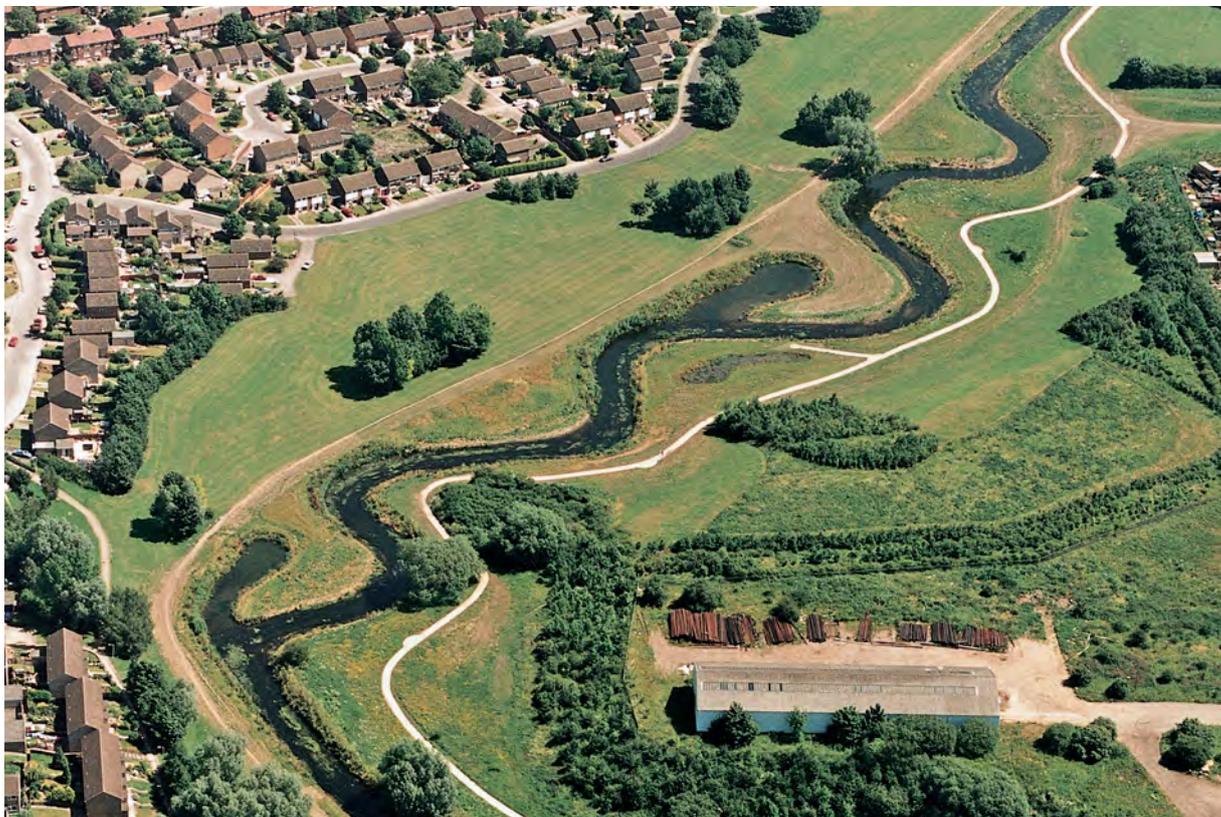
Completed meanders
– Summer 1997

the indigenous clays have resisted erosion. Sands, silts and mud have deposited as shoals where eddy currents arise around the inner margins of bends and the deeper pools created around the outside appear self-sustaining. Diverse flora and fauna have rapidly colonised the many different features of the new course and local people enjoy relatively safe access to the waters edge.

The newly meandered channel has proved to be stable under frequently occurring flood conditions. The most vulnerable banks, located where bends are incorporated into the backfilled course, are supported by revetments (see Part 4), but elsewhere

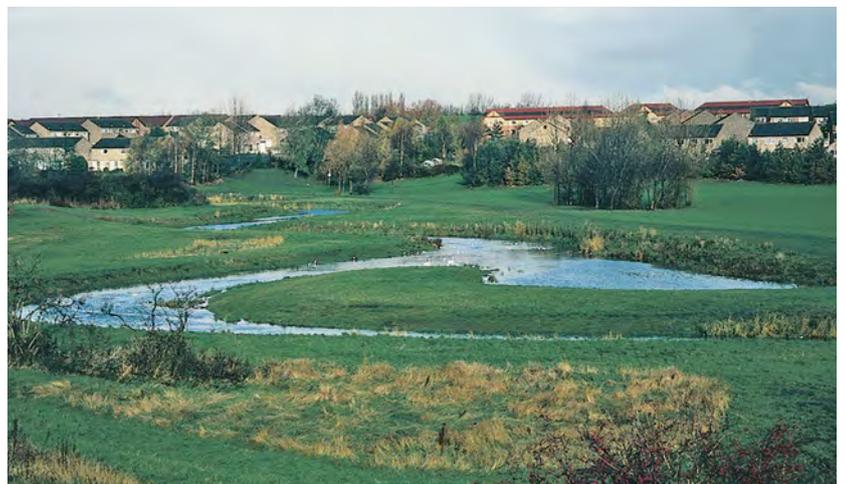
Looking downstream
towards large backwater
– February 1997
