9.2 Reedbed at Raglan Stream

RIVER COLE

LOCATION – COLESHILL, OXON/WILTS BORDER, SU234935

Enhancing Outfalls to Rivers

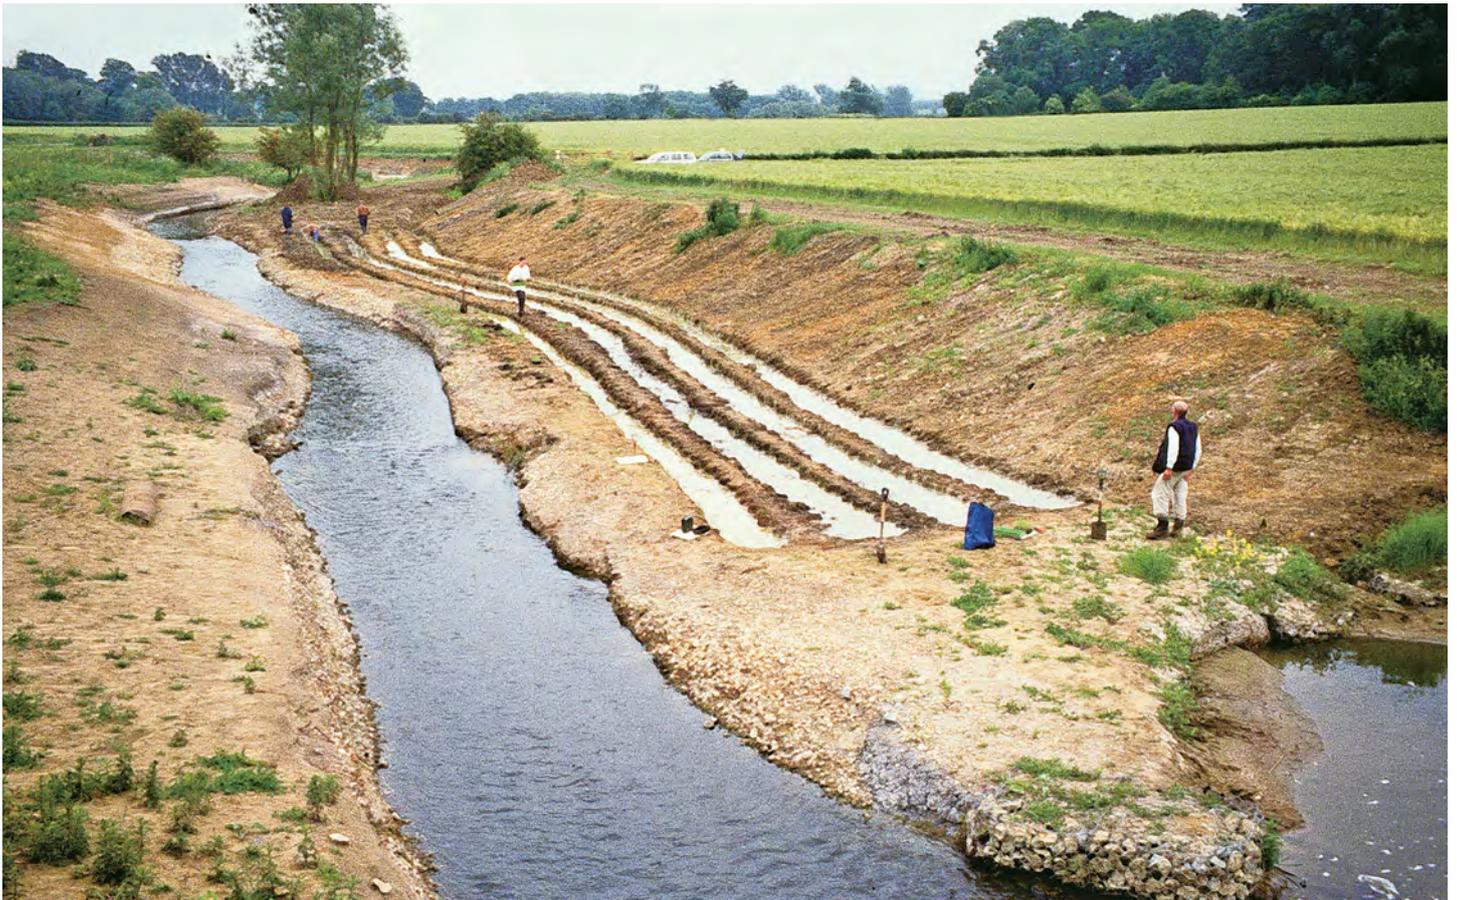
Planting reedbed – Spring 1996

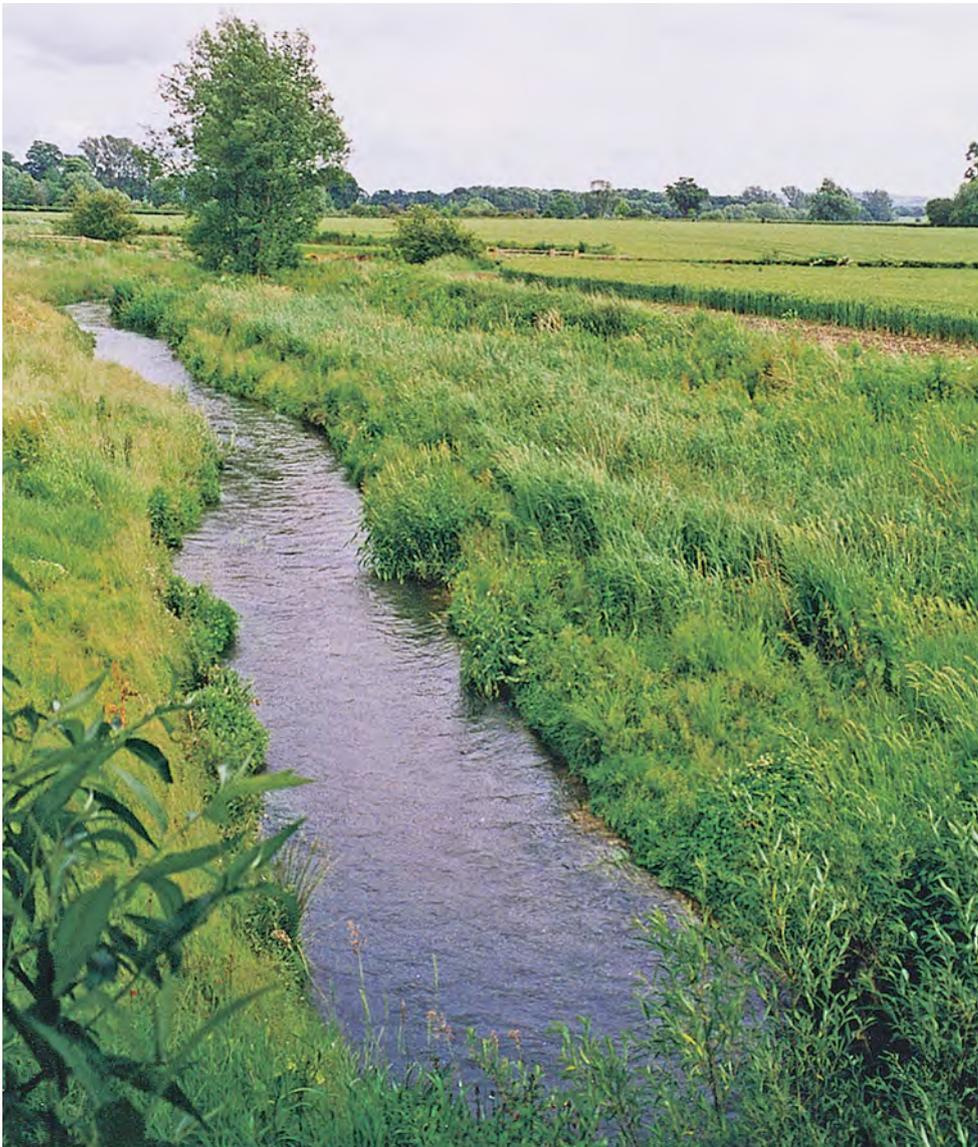
Reedbed established – Summer 1998

The reedbed established exceptionally well with 93% of seedlings surviving to maturity, although seed germination was perhaps only 50%, but still sufficient to achieve full colonisation within two growing seasons. Other aquatic species colonised the area naturally, including greater water plantain and soft rush. Concerns that the River Cole might damage the reedbed when in flood proved unfounded because the overall size of the new river and adjacent reedbed is much greater than the existing cross-section downstream so flood flow velocities are low.
