Restoring Meanders to Straightened Rivers

1.5 New meandering channel replacing concrete weirs

RIVER MARDEN

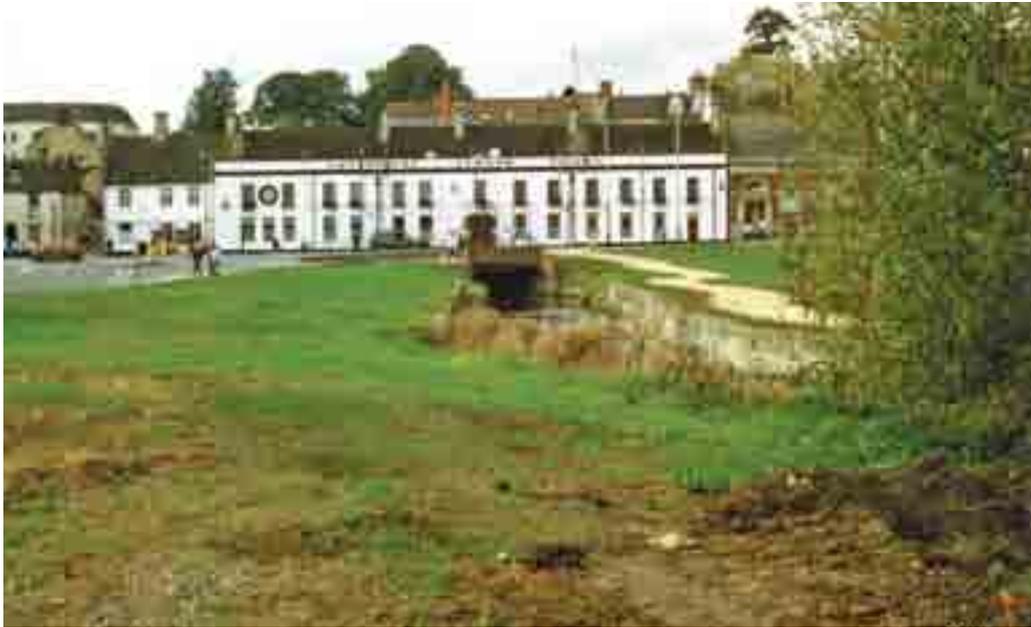
Before:
View downstream towards culvert

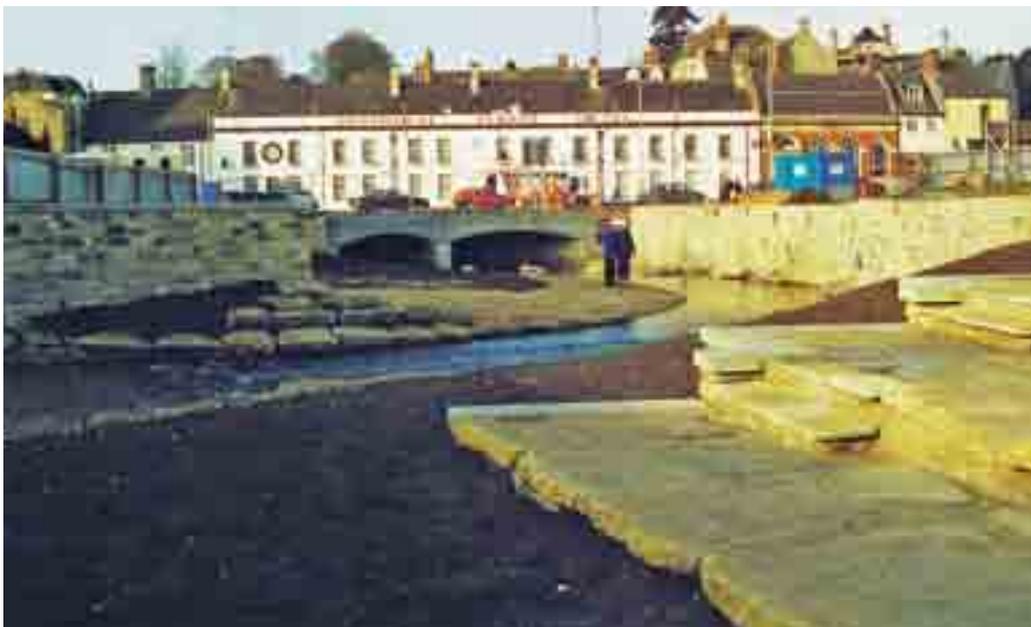
Completion:
View of the new river course

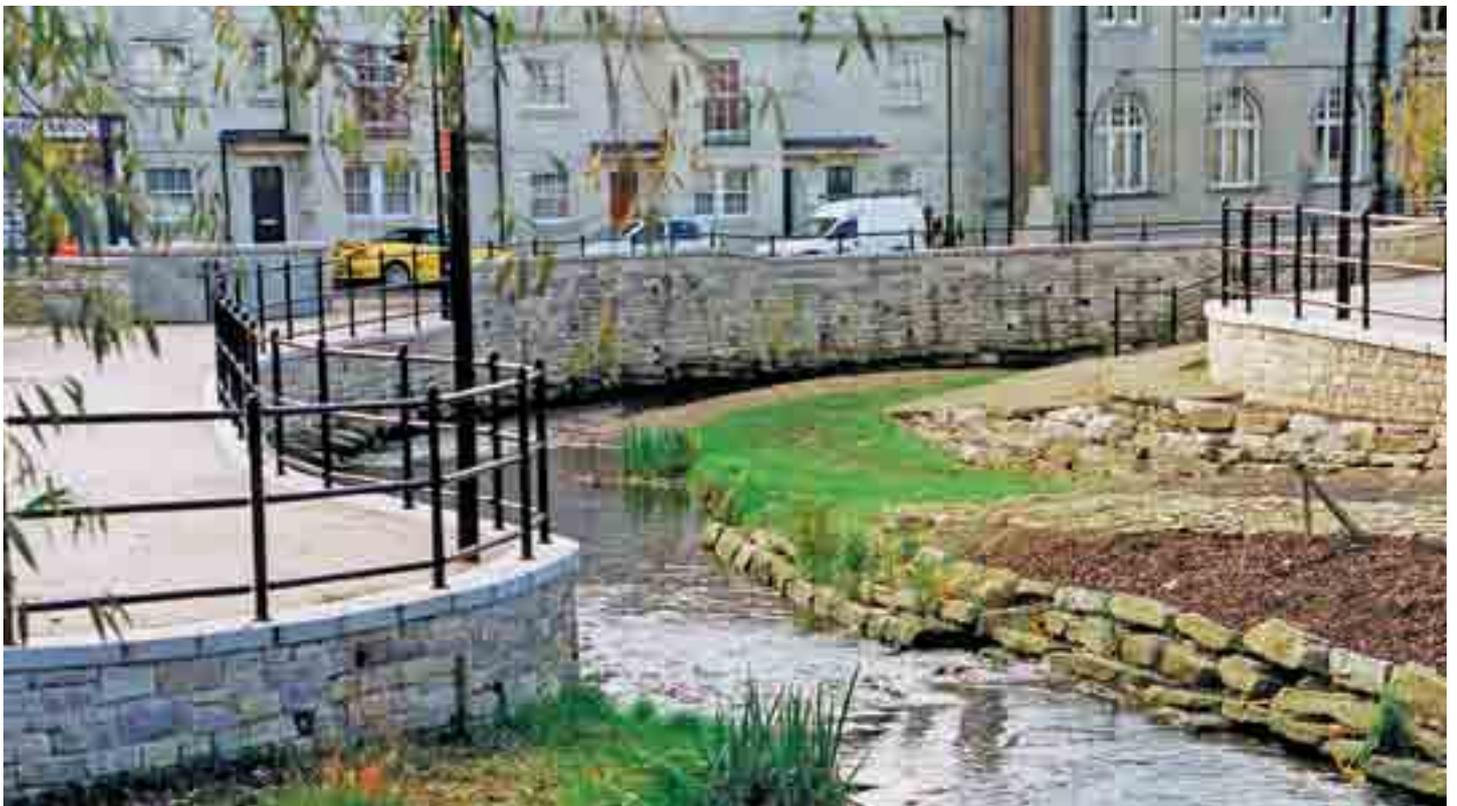
View of Section A in November 2001

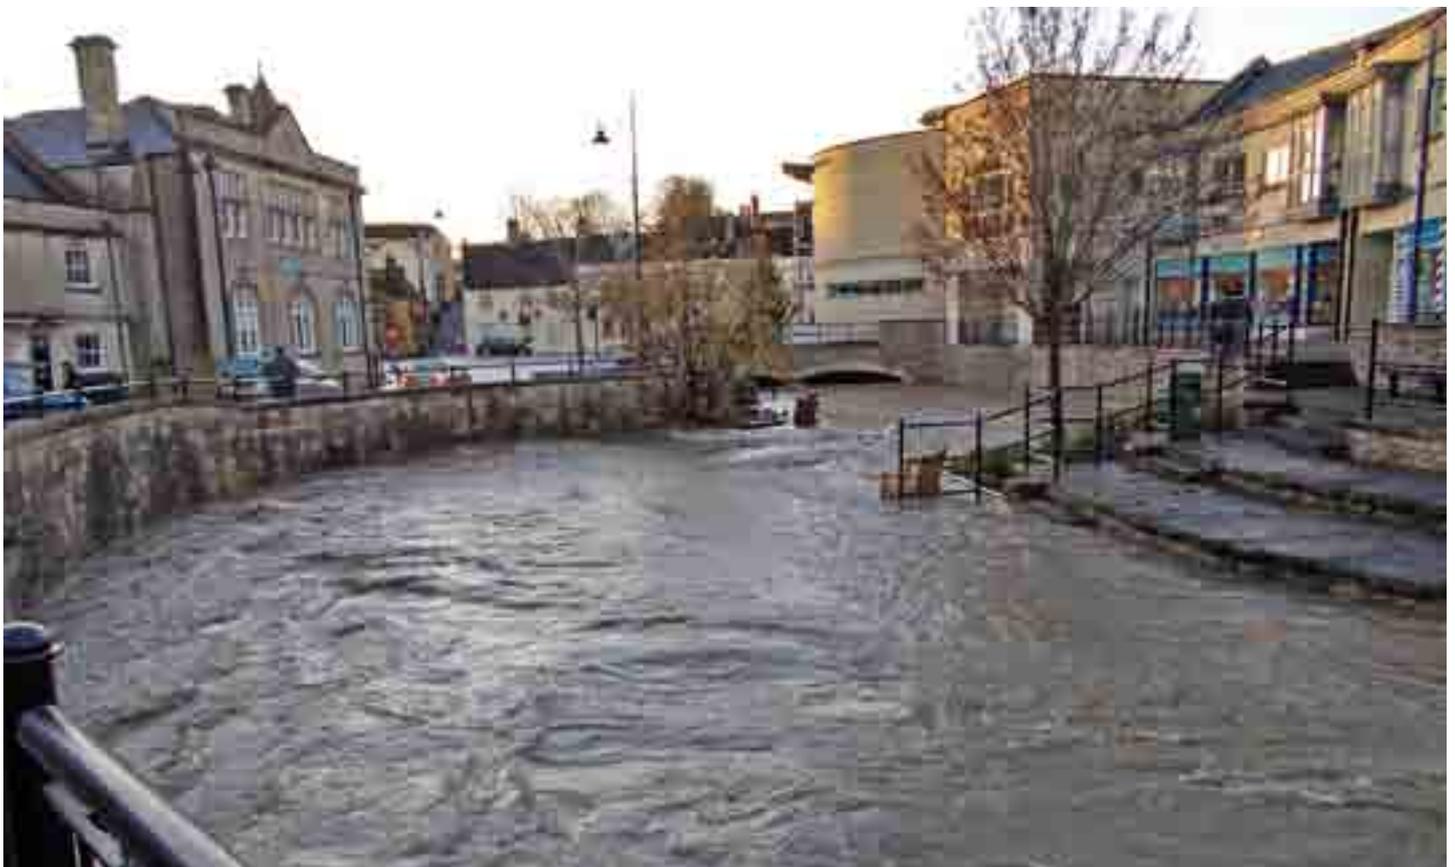
The river in flood – the flood gates are closed and the much increased capacity protects the town centre – November 2012

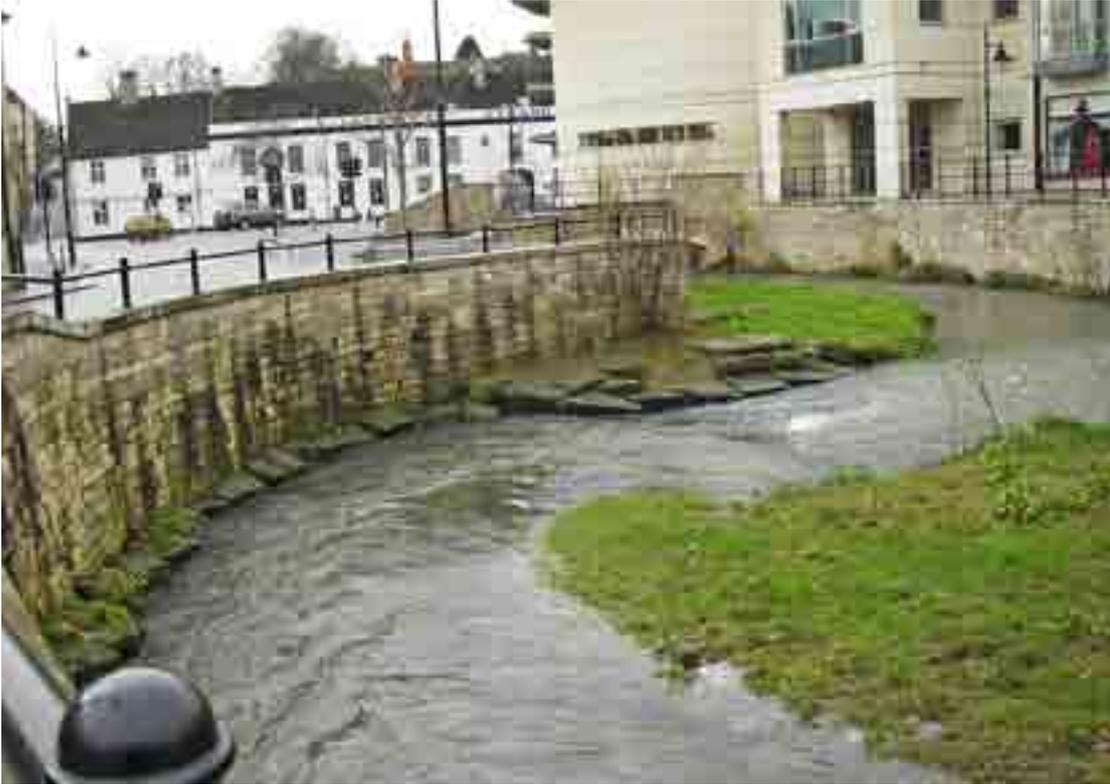
The designed channel and shallow grassed slopes hold up well over the winter period – early 2006

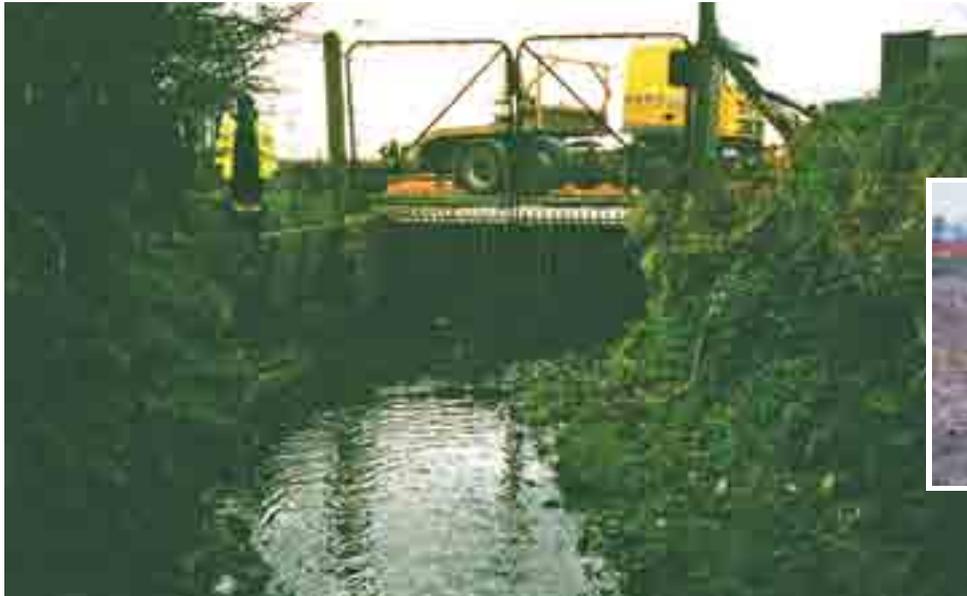
View of headscreen prior to removal

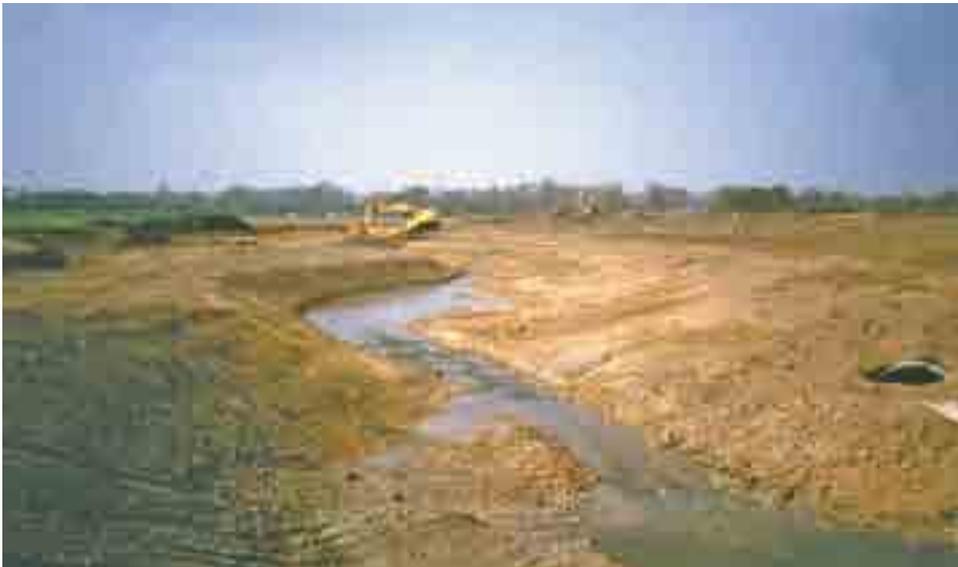
Looking downstream at the shallow bank slopes. The severed culvert still visible

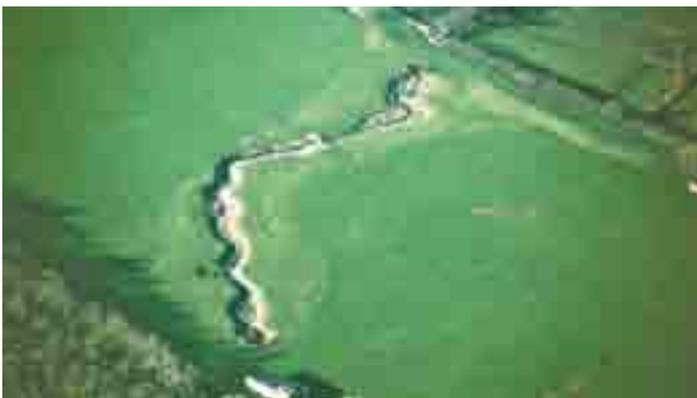
The new sinuous course and extent of wildflower seeding

The new course is 12.5% longer than the culvert, sinuous, with varying bed and top-of-bank widths. A shallow (1:8 batter) 'beach' area, as a result of an exposed gravel lens, and new meanders (1:5 inside batters) form the focal points for access to the stream.

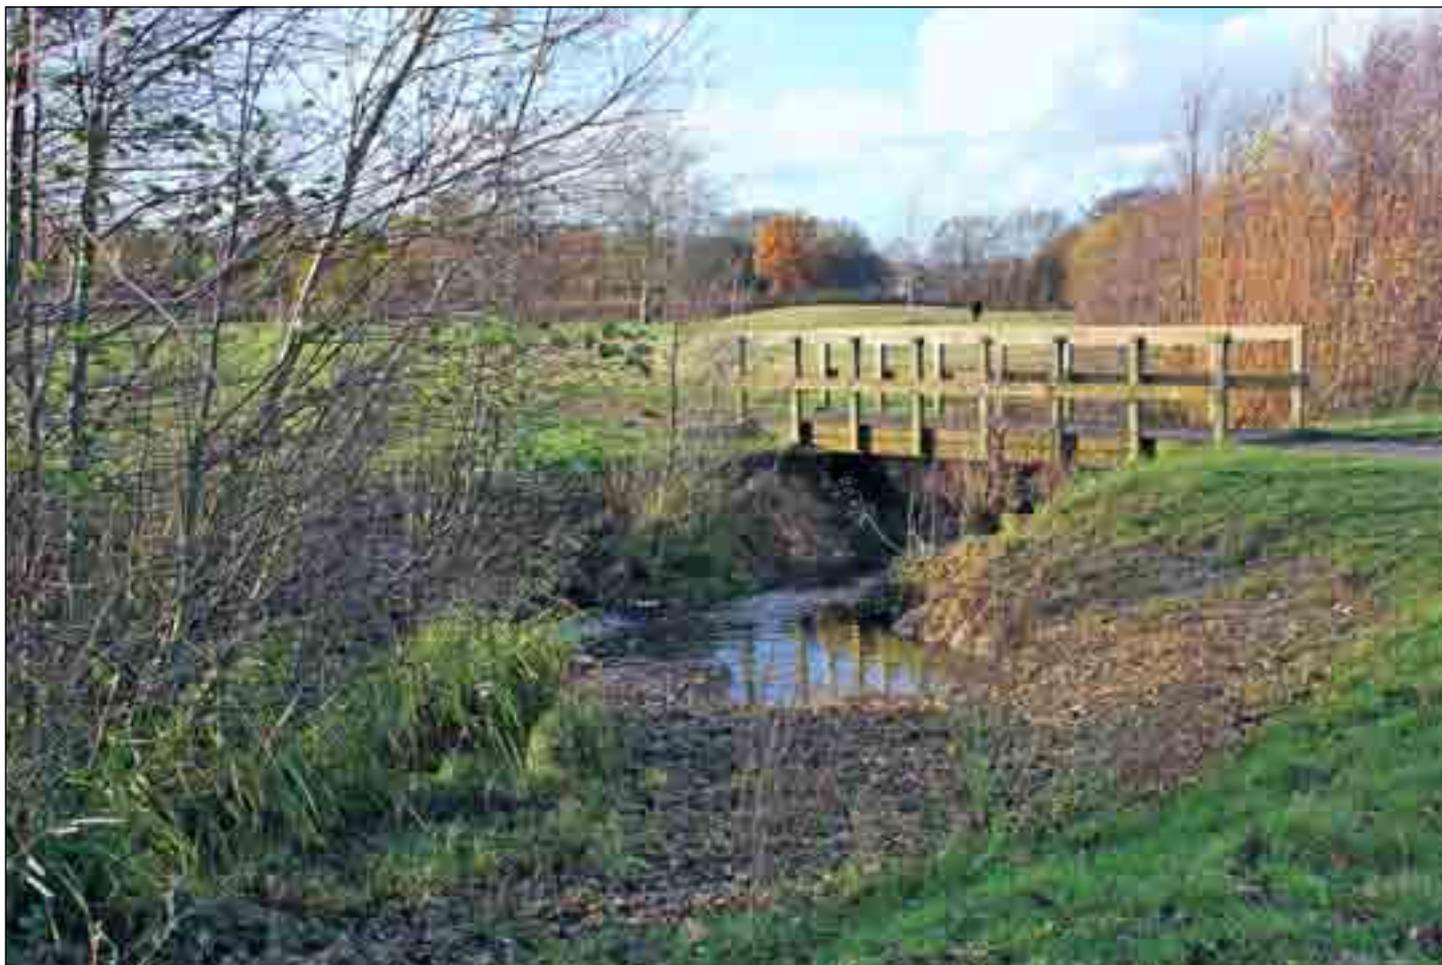
Effective narrowing of the channel, and asymmetric shallowing of the bed has occurred following restoration – 2012

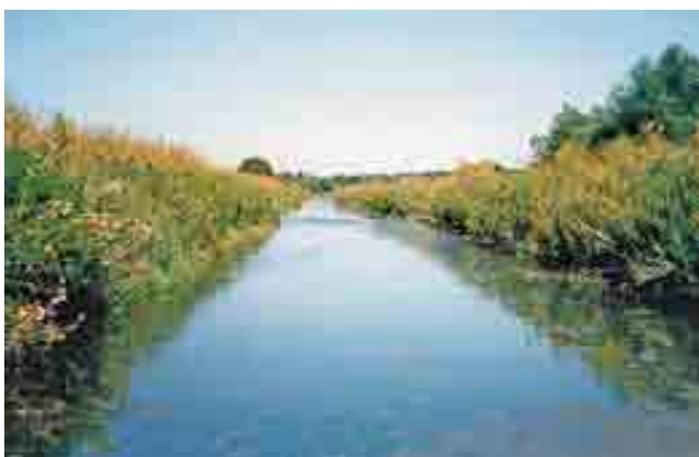
Canalised course of the Little Ouse

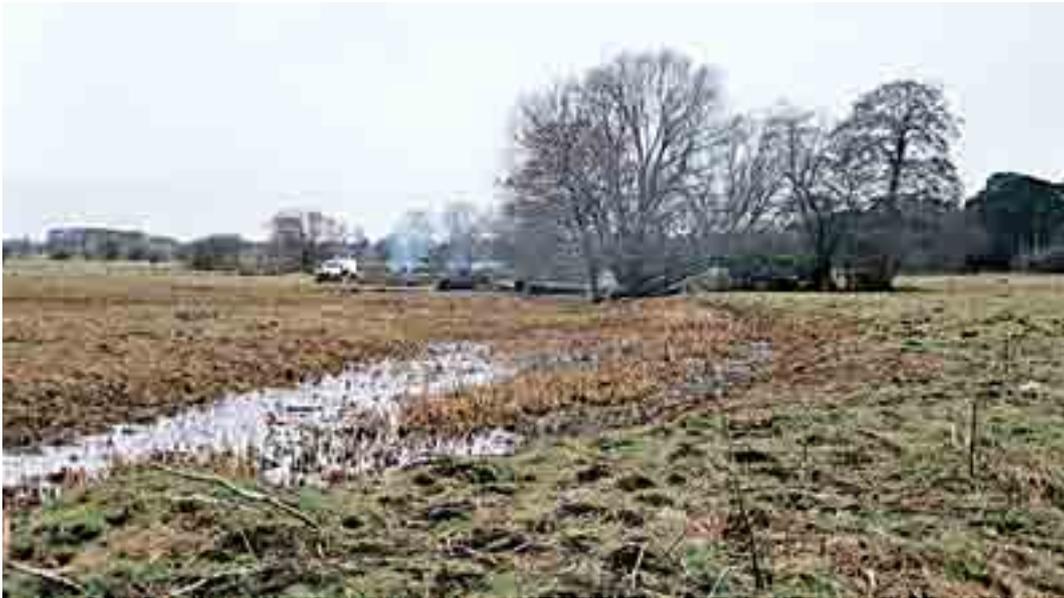
Looking downstream along the old meanders

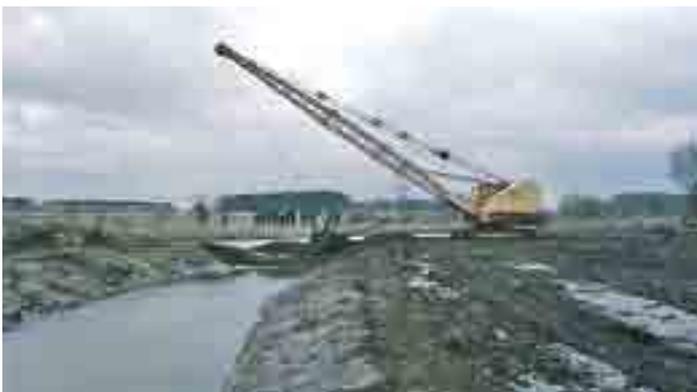
The structure, 6m wide by 10m long by 2m high, was constructed using 1.5m by 1m prefabricated concrete blocks below a 0.75m depth of boulder sized limestone, surfaced with 0.25m of cobble sized limestone. The 'weir' was designed to be permeable to provide a sweetening flow to the canalised channel. Flows, where levels exceed the 2m crest, will overtop and discharge through the retained canalised 'flood relief' backwater channel.

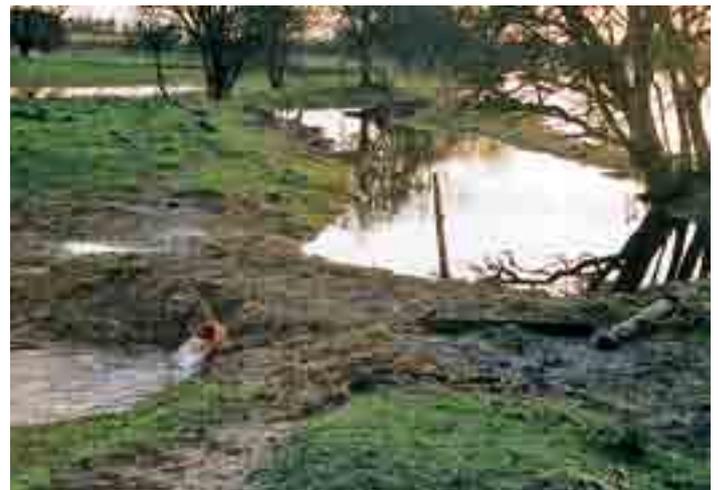
In the middle of the meandering reach a marshy backwater section was isolated with a bund and a sluice at the upstream end to protect the habitat from high velocity flood flows.

Sluice, bund and upstream flooding area

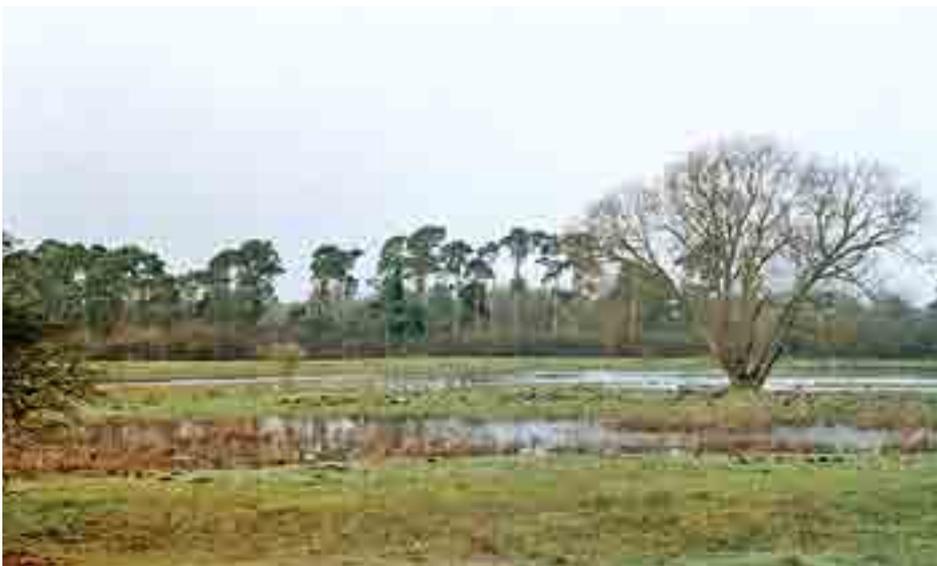
Flooding along meanders – Spring 1999

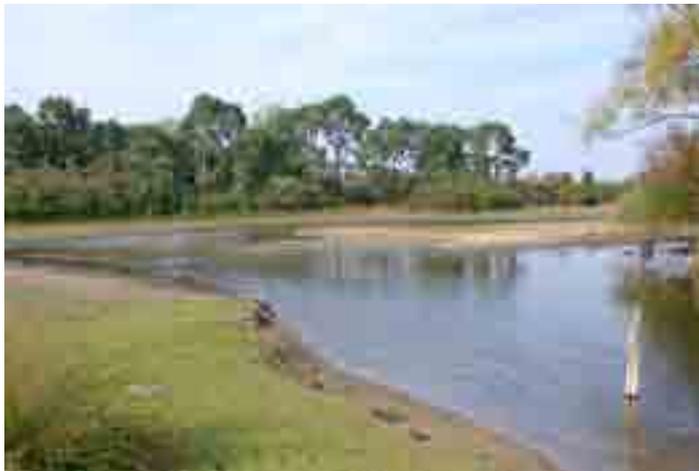
© BTO Main breach along the meanders – 2002

High river levels resulted in scour of the more vulnerable sections of meanders causing breaches in the banks. These were repaired using clay in 2002, but subsequently failed and further breaches occurred. These were exacerbated by a fallen willow (*Salix spp.*) branch that deflected the flow.

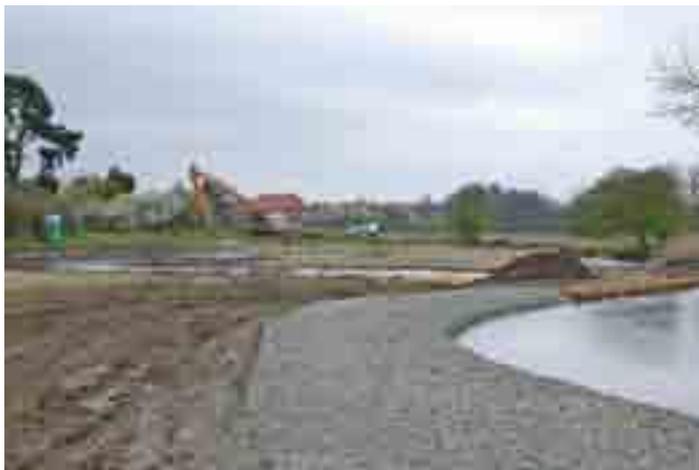
© BTO Same bank reinforced using blue clay – October 2003

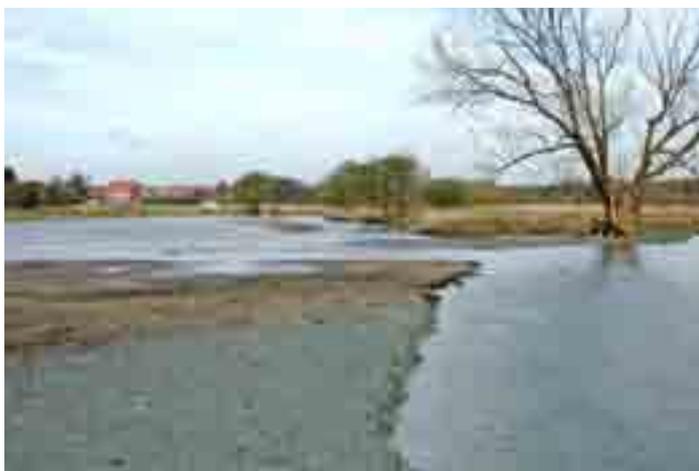
© BTO Breach of the reinforced clay bank – March 2004

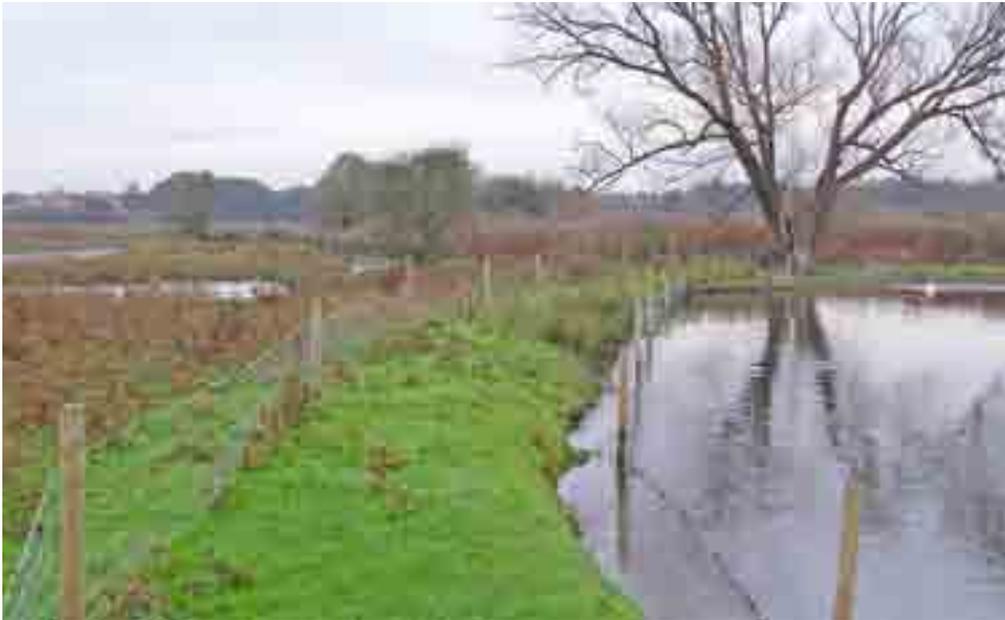
Initial vegetation growth on pre-seeded coir matting – December 2005

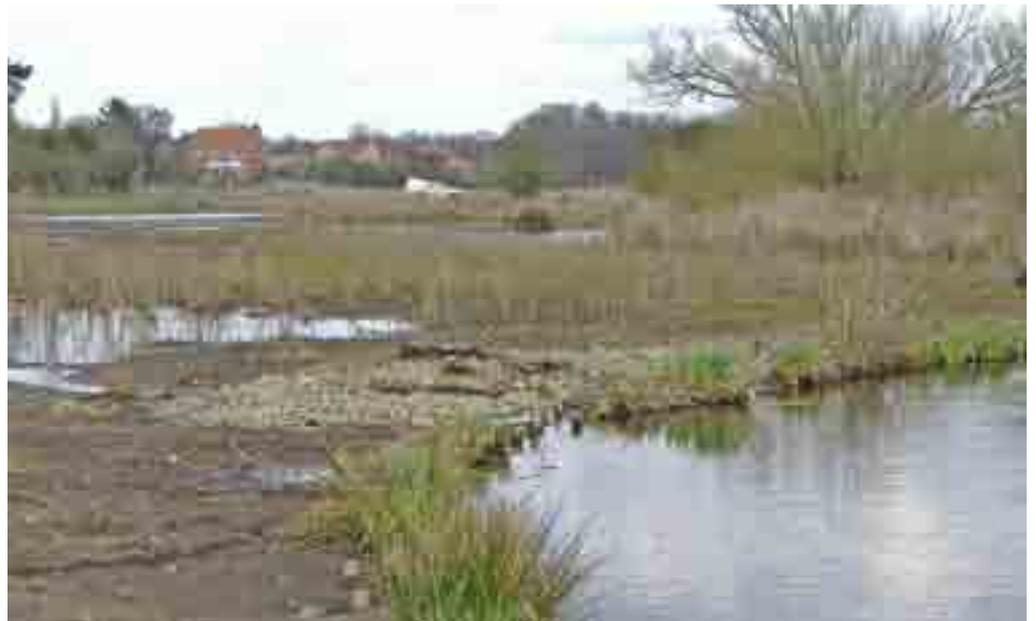
Erosion of the coir matting – April 2008

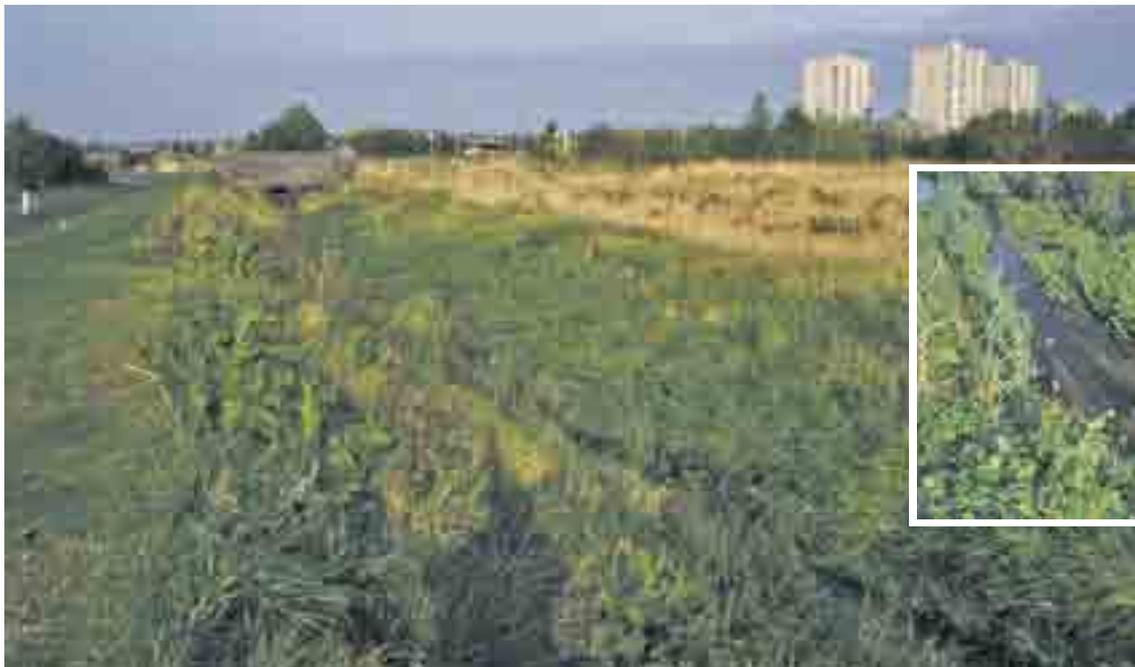
Before:
The Alt, straight
and steep sided

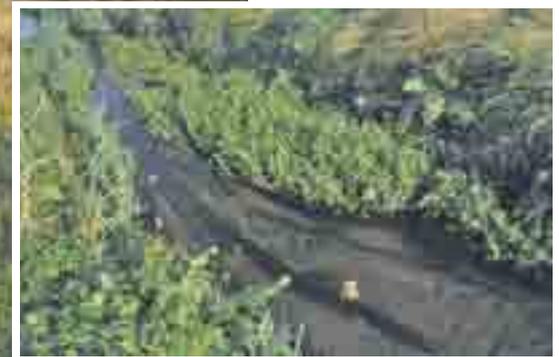
Bed dominated
by silt

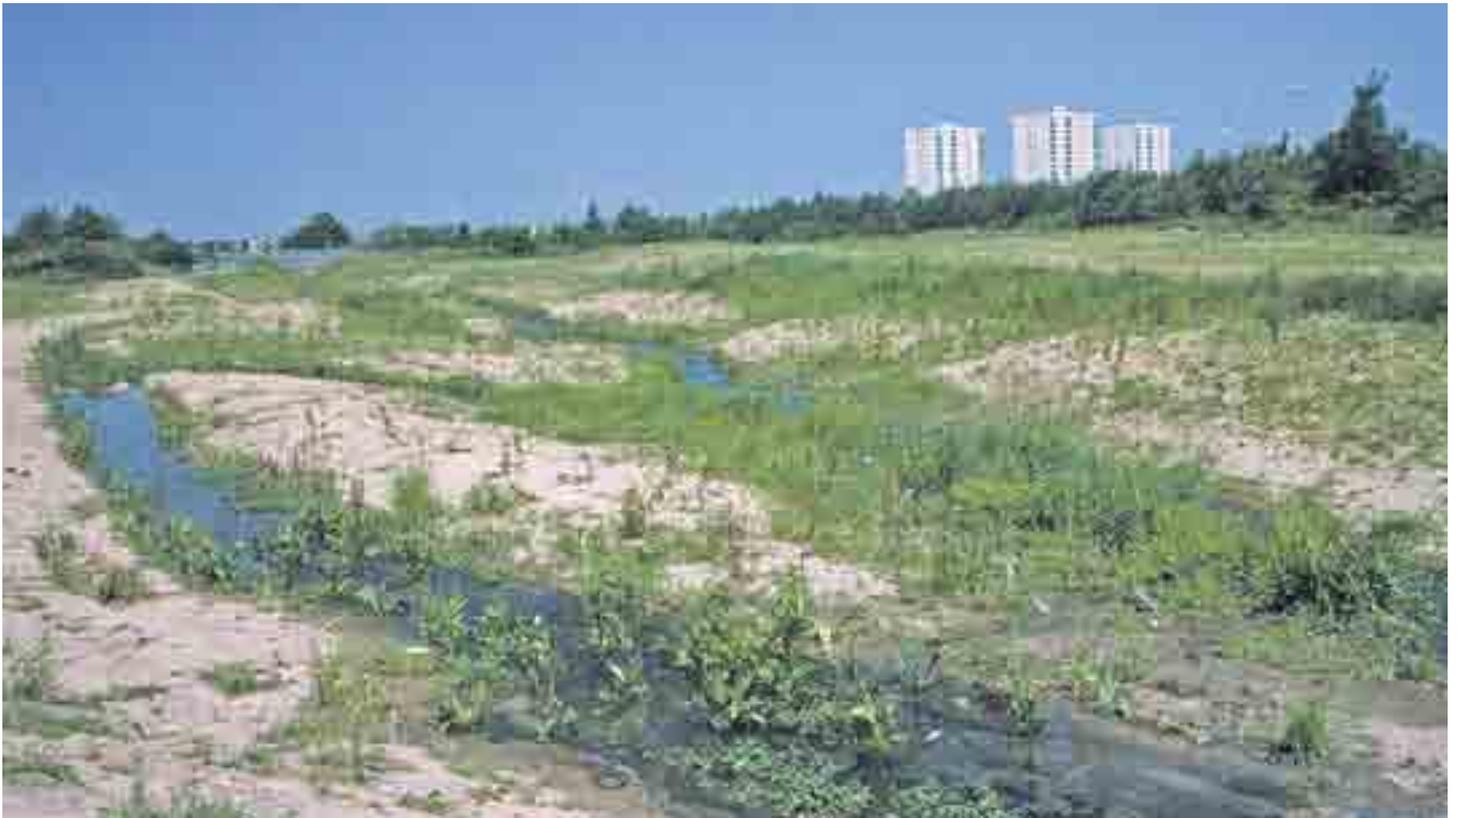
The excavated 'floodplain' area

The 1.5 metre 30 degree banks were excavated back on either side of the existing course, creating up to a 30m width of 'floodplain'. This work was carried out over 140m. The 'floodplain' comprises a 'main' channel and several braided channels separated by marginal berms. In order to achieve a matrix of channels, standing water and damp areas, interspersed by trees and shrubs, ground levels needed to vary. Due to the uncertainties of ground condition and in order to work with the natural conditions as much as possible, this was supervised on-site to avoid over-specification on the design drawings, and to allow for adjustments as necessary.

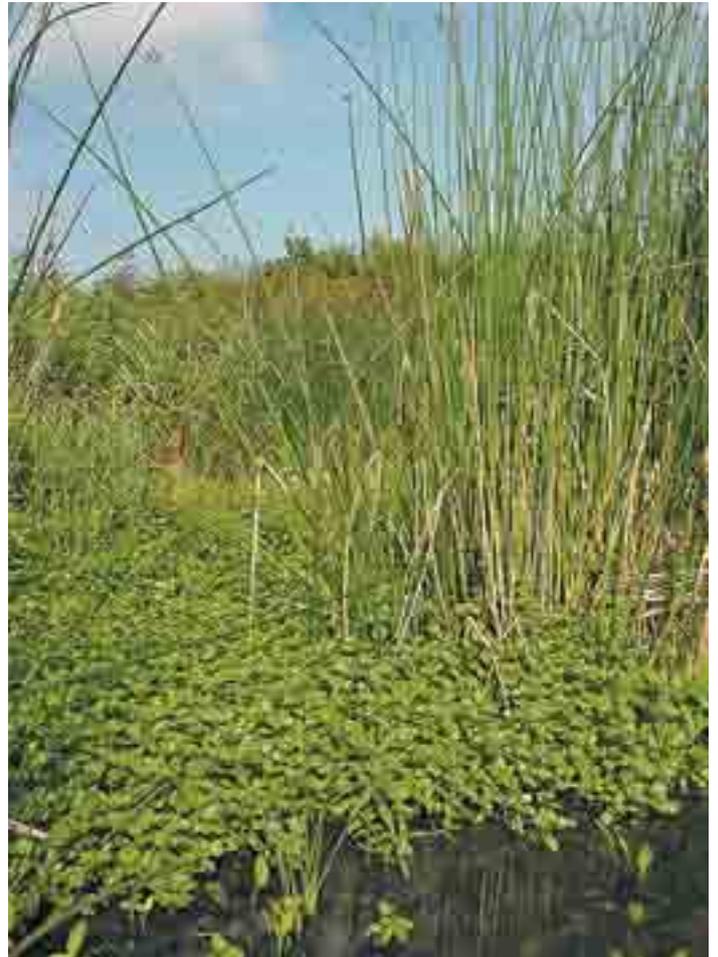
A good diverse vegetation structure has developed along and between the channel threads

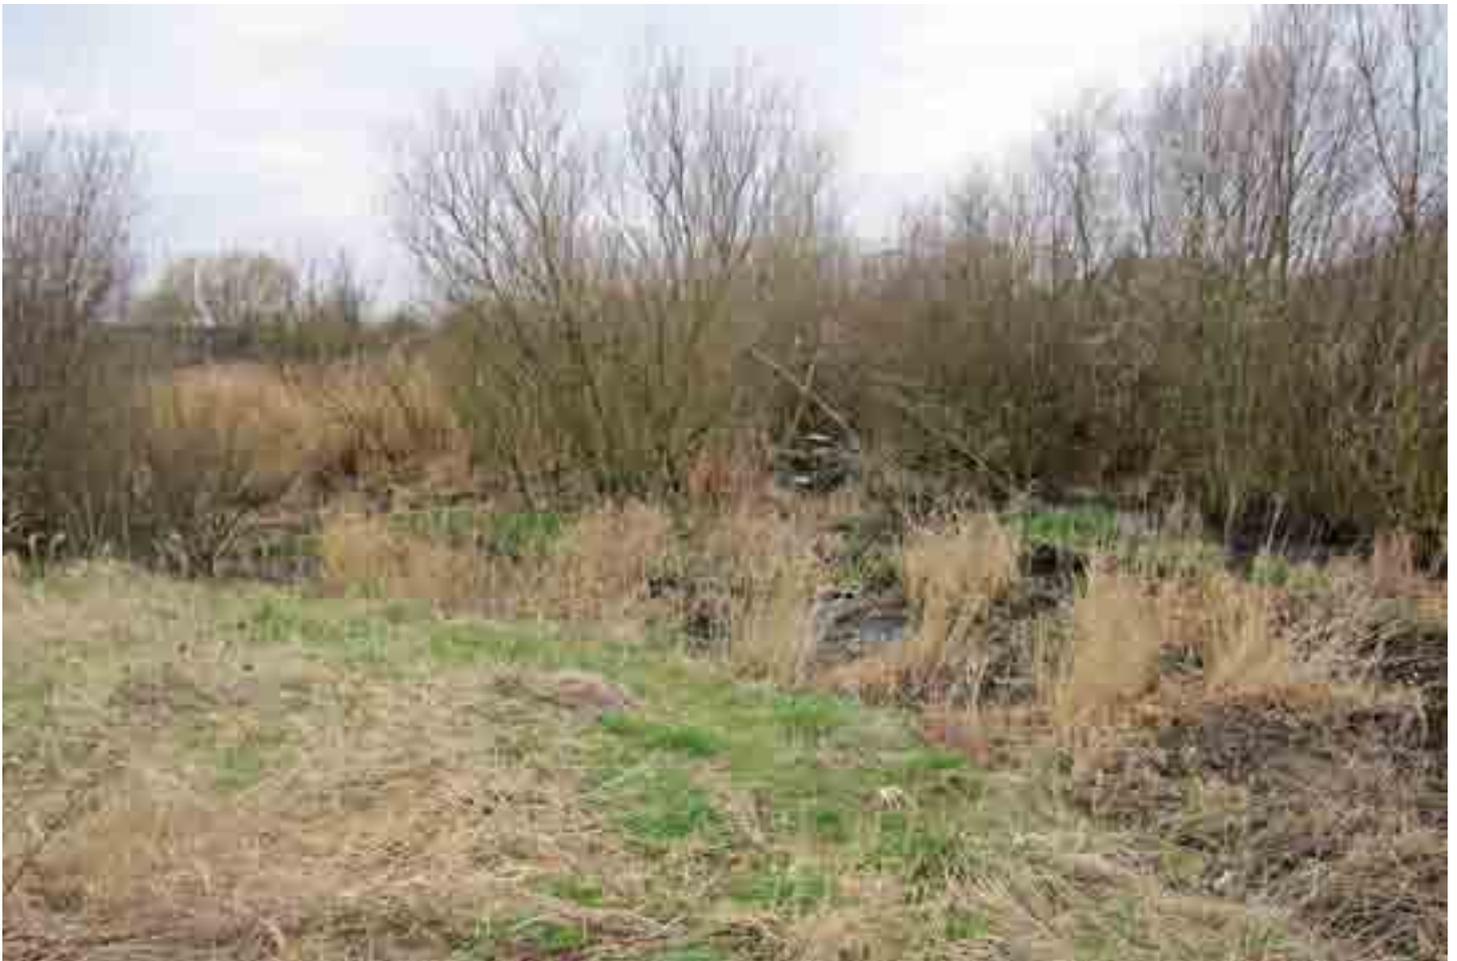
One of the choked braided side channels – March 2012

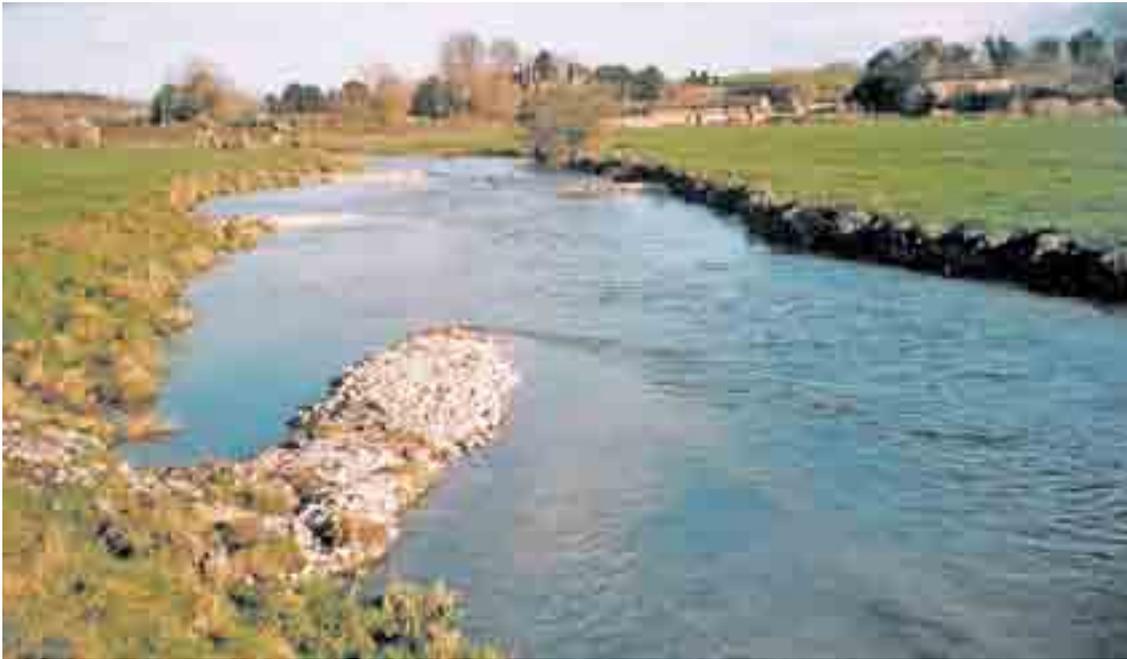
Completed chalk groynes

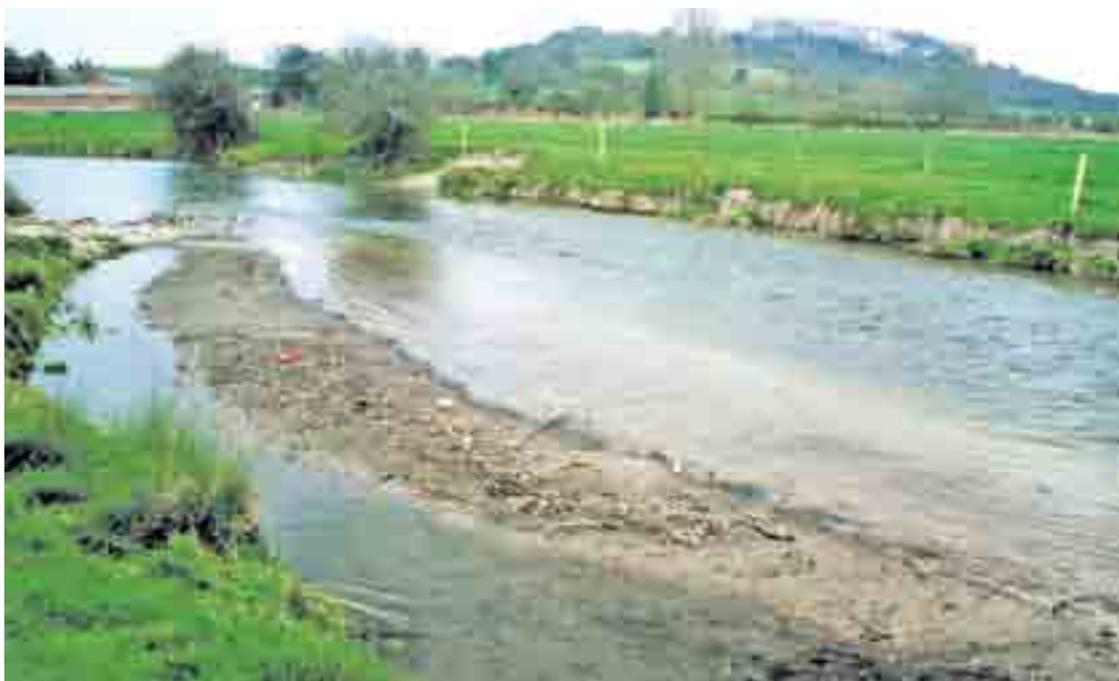
Type B deflector before planting

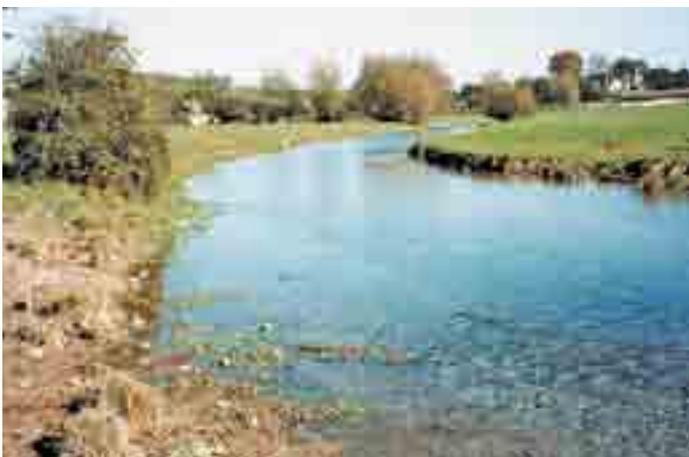
Cattle poached, wide and shallow

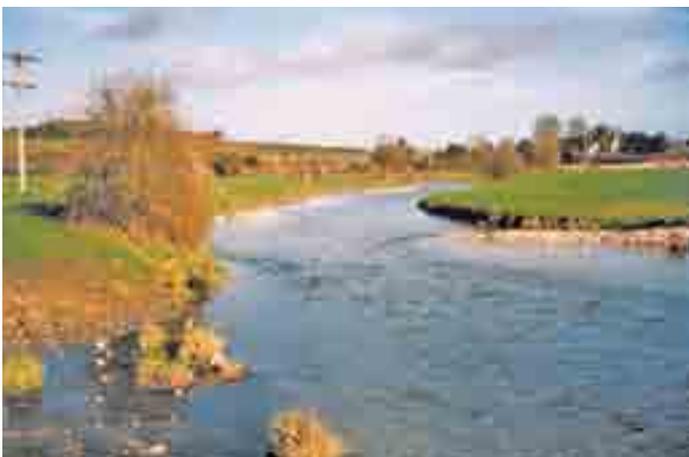
Groynes in place already increasing flow diversity

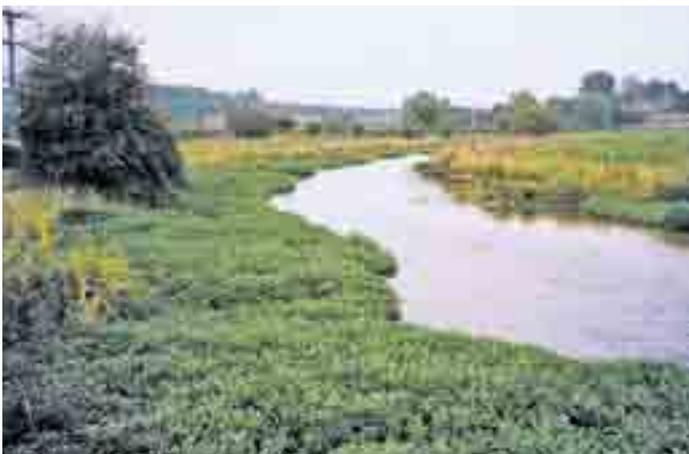
Silt deposits were quickly colonised and the river narrowed

Following the works rapid siltation occurred, resulting in channel narrowing. In the 2007 survey an approximately 30% reduction in channel width was observed compared to pre works. The variations in flow characteristics observed in 2002 remain the same.

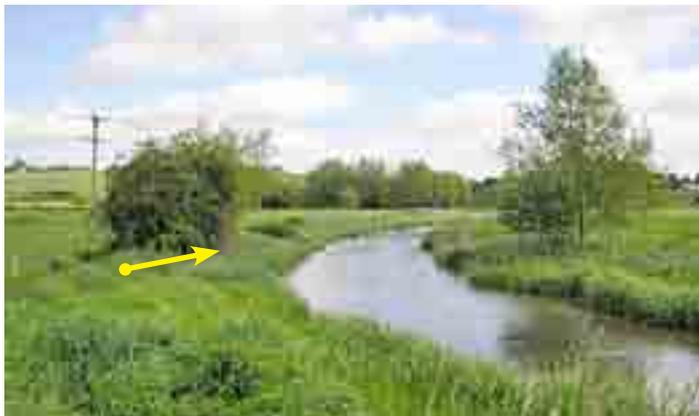
The narrowed channel – May 2007
(Arrow indicates location of 2012 photograph)

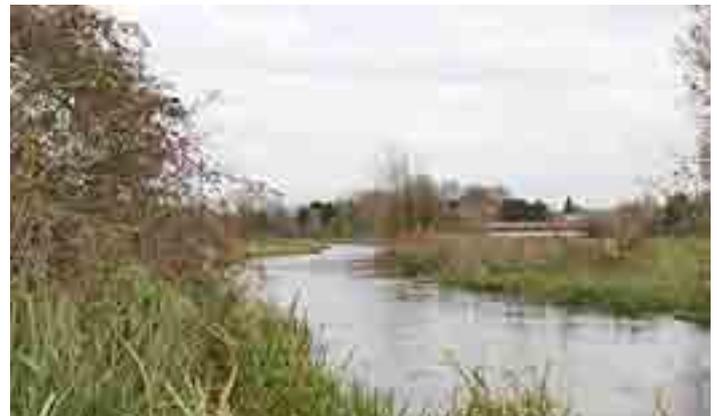
The site after 15 years showing the development of vegetation – November 2012

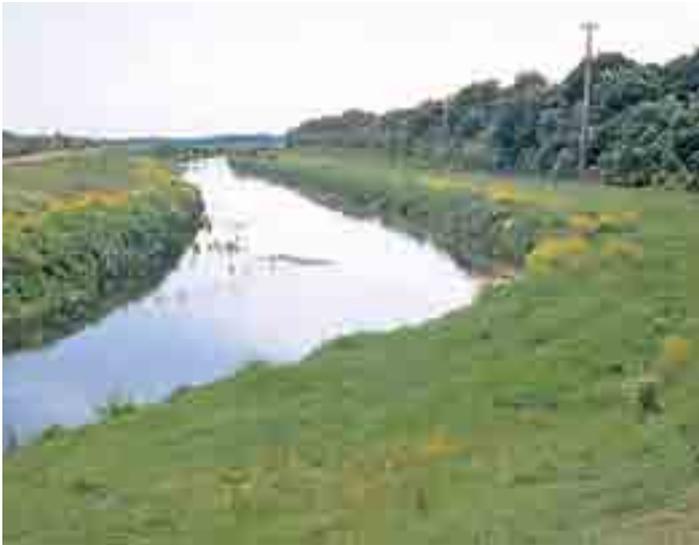
River Dearne. Wide and straight, choked in summer

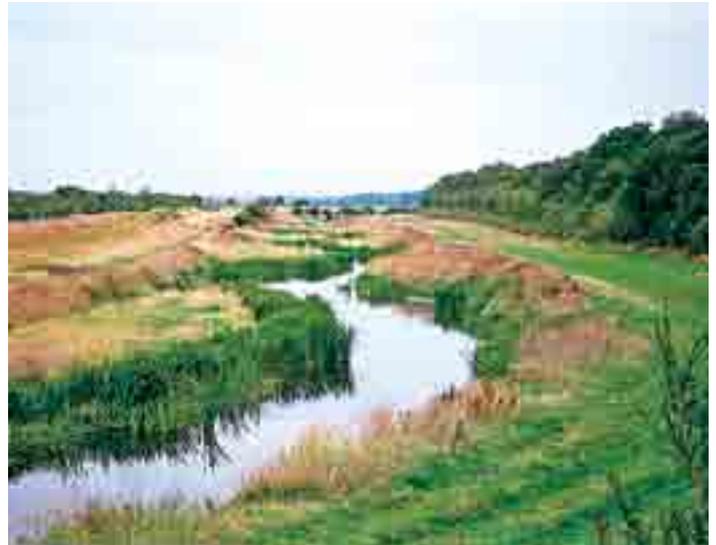
New sinuous reed-fringed course

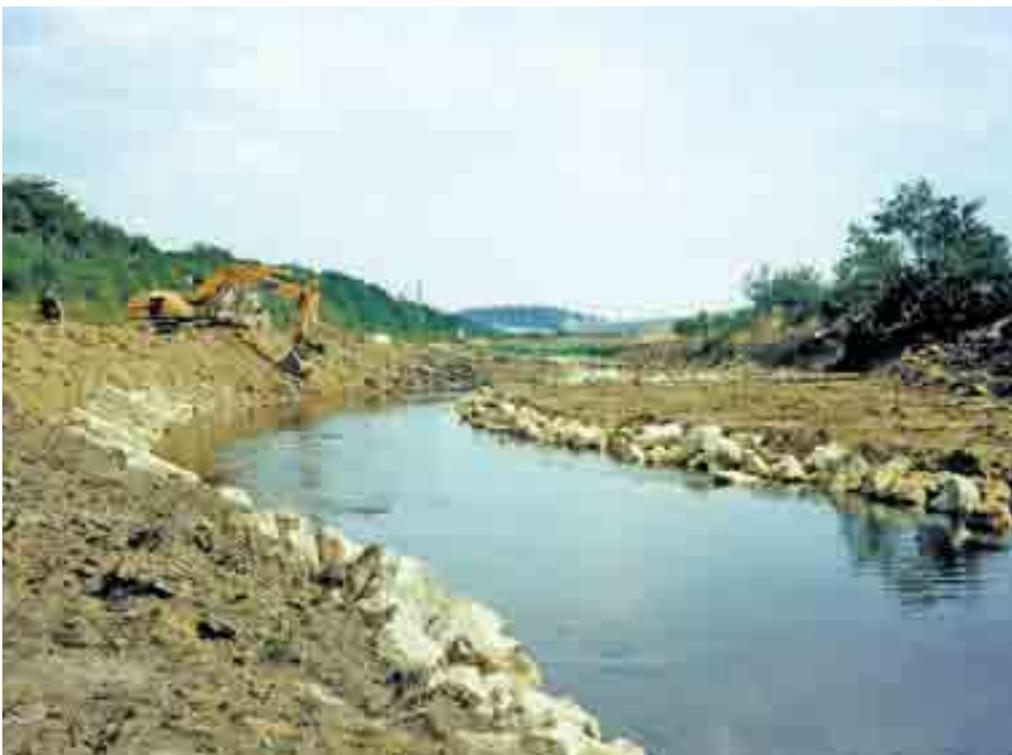
Placement of limestone boulders and berm back-filling

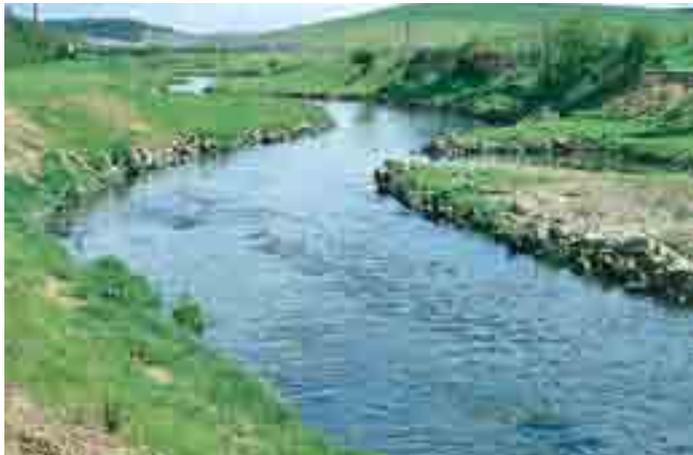
Narrowing increased velocities and created riffles used for fish spawning

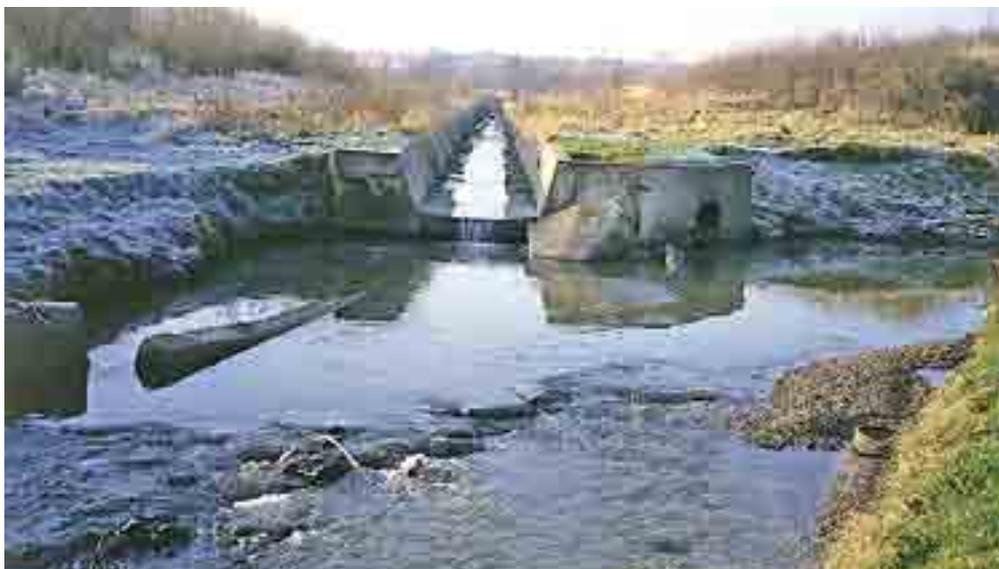
Yardley Brook entering the River Cole before works
