Restoring Meanders to Straightened Rivers

1.5 New meandering channel replacing concrete weirs

RIVER MARDEN

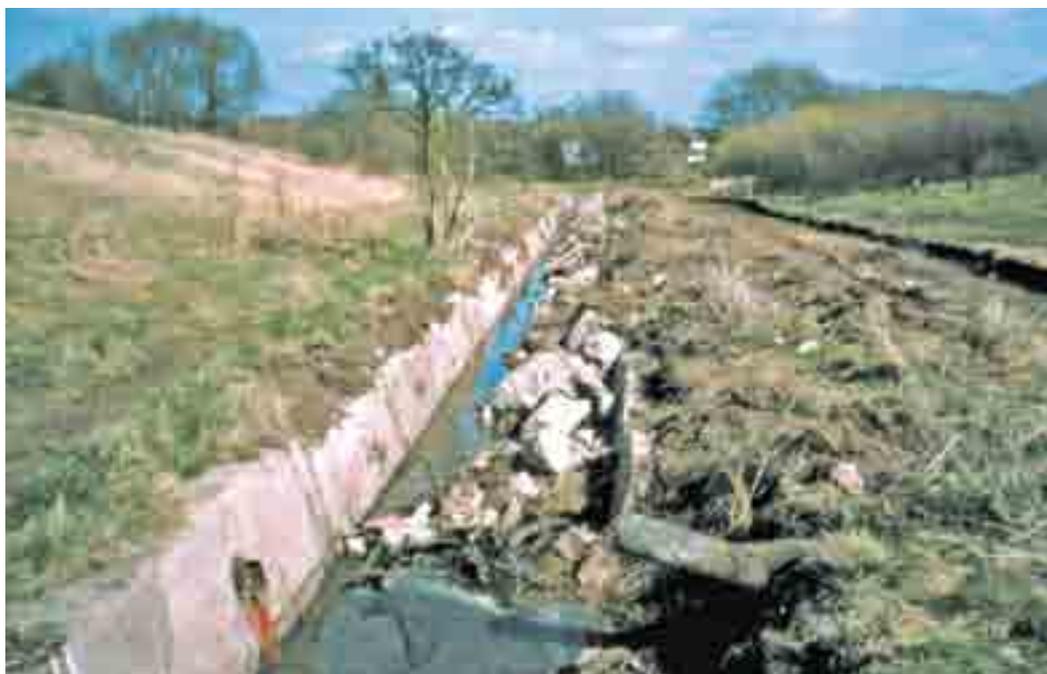
Concrete channel being broken up

The lip of the concrete channel was broken up using an excavator, to ensure that once buried the remnant channel would not protrude above ground level. The broken concrete was pushed into the barely flowing channel.

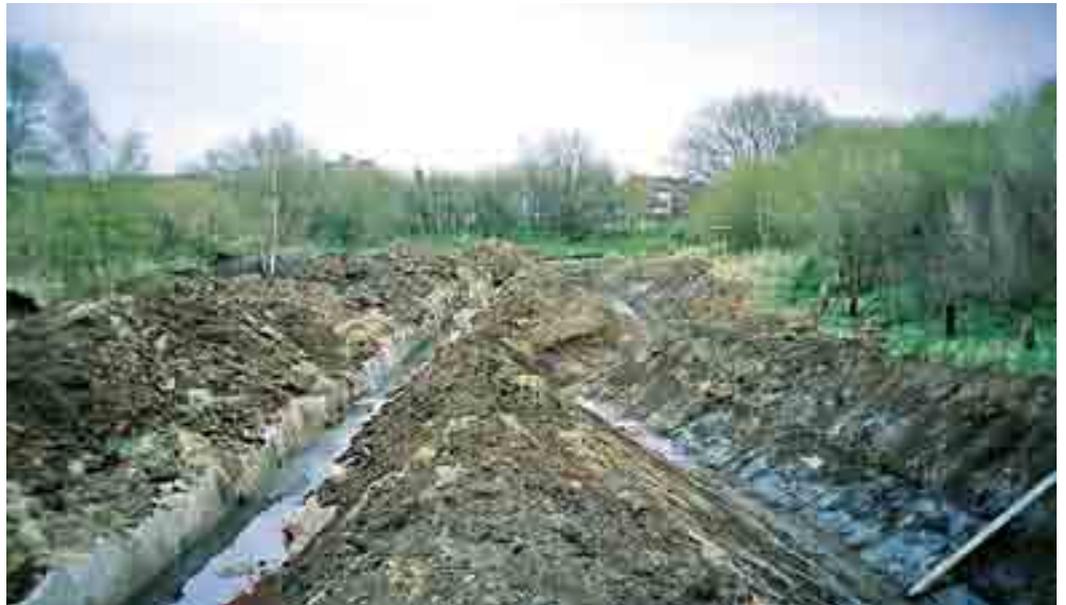
The 'new' brook being excavated adjacent to the old channel. Spoil stockpiled

All spoil was stock-piled between the new and the old channel, and where this became too narrow, on the opposite bank of the old channel. This maintained the flow through the old drain and allowed all work to be carried out in the dry. Once completed, flow was diverted through the new course, and the old channel was filled using the spoil from the new.

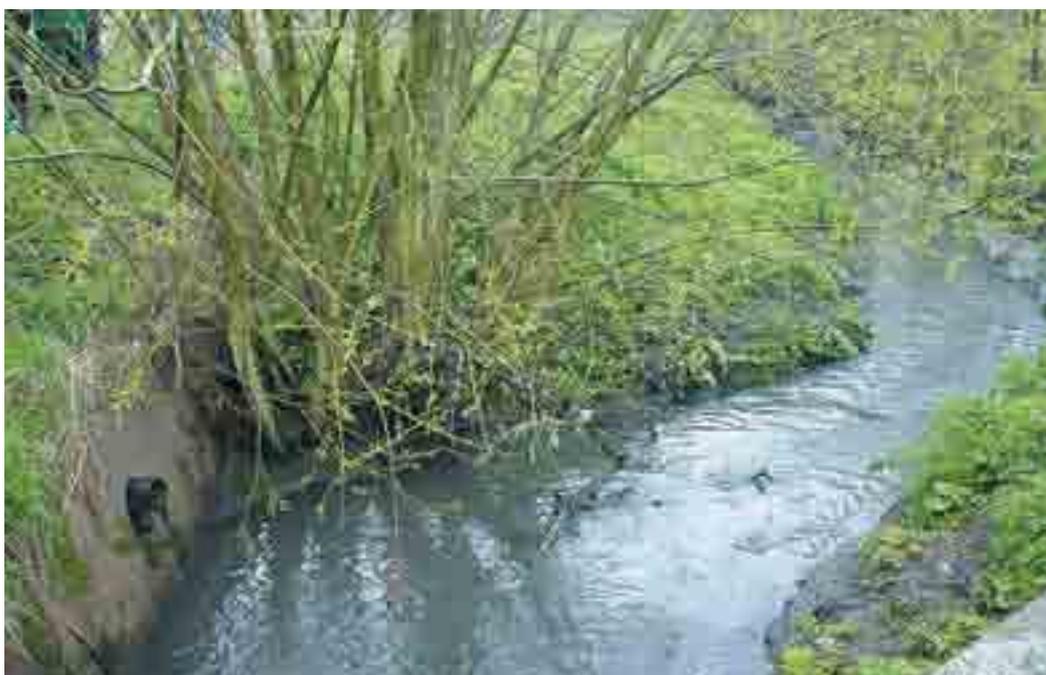
Live willow plug

At the upstream end of the 'new' brook the old course was blocked with rubble then plugged with live willows (*Salix spp.*) laid in during the in-filling process to form a growing plug.

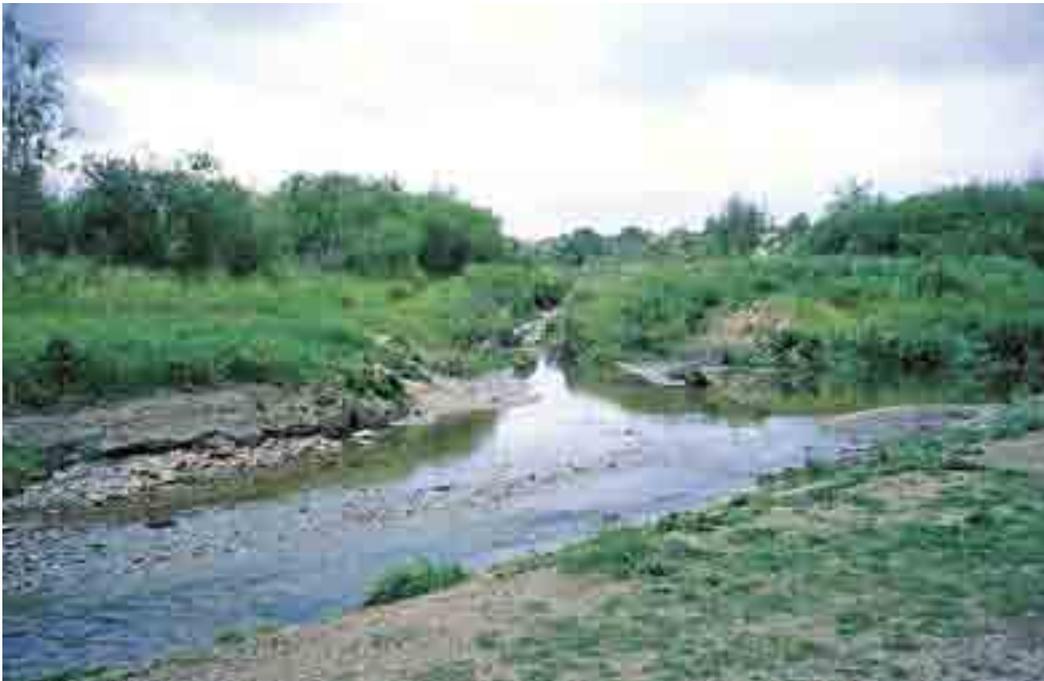
After – the new 'natural' Brook

After completion winter flows quickly began to 'develop' the kinds of natural channel features one would associate with a small brook. The 'V' shape quickly transformed through erosion of the loose fill material into a much more 'natural' channel 2-3m wide. This process has continued as the site matures.

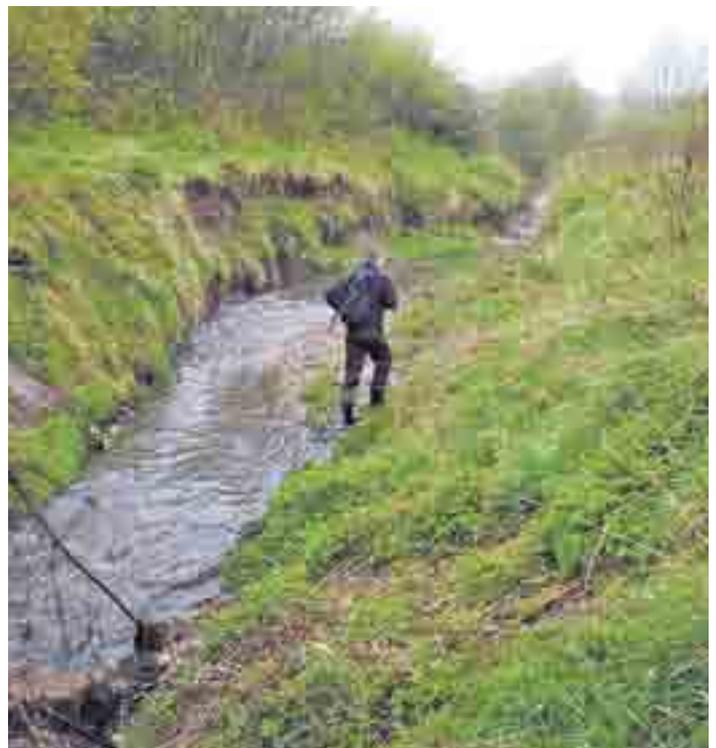
Six years on. Earth cliffs, gravel shoals and a diverse flow regime – April 2001

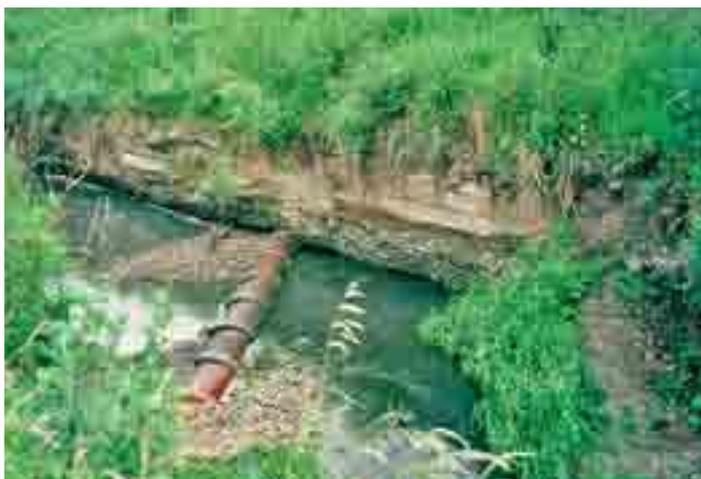
© Environment Agency Erosion exposing sewer pipe as nickpoint moves upstream

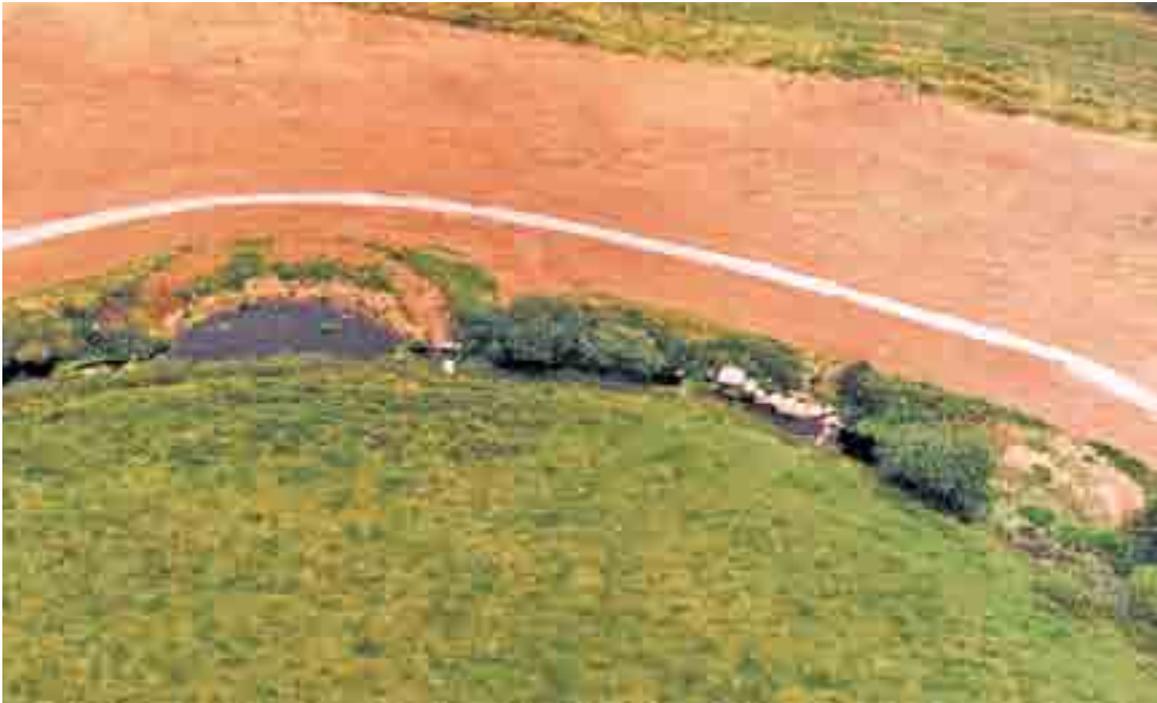
Downstream bays after less than a year.
Note: Bay 2 is already becoming choked with vegetation

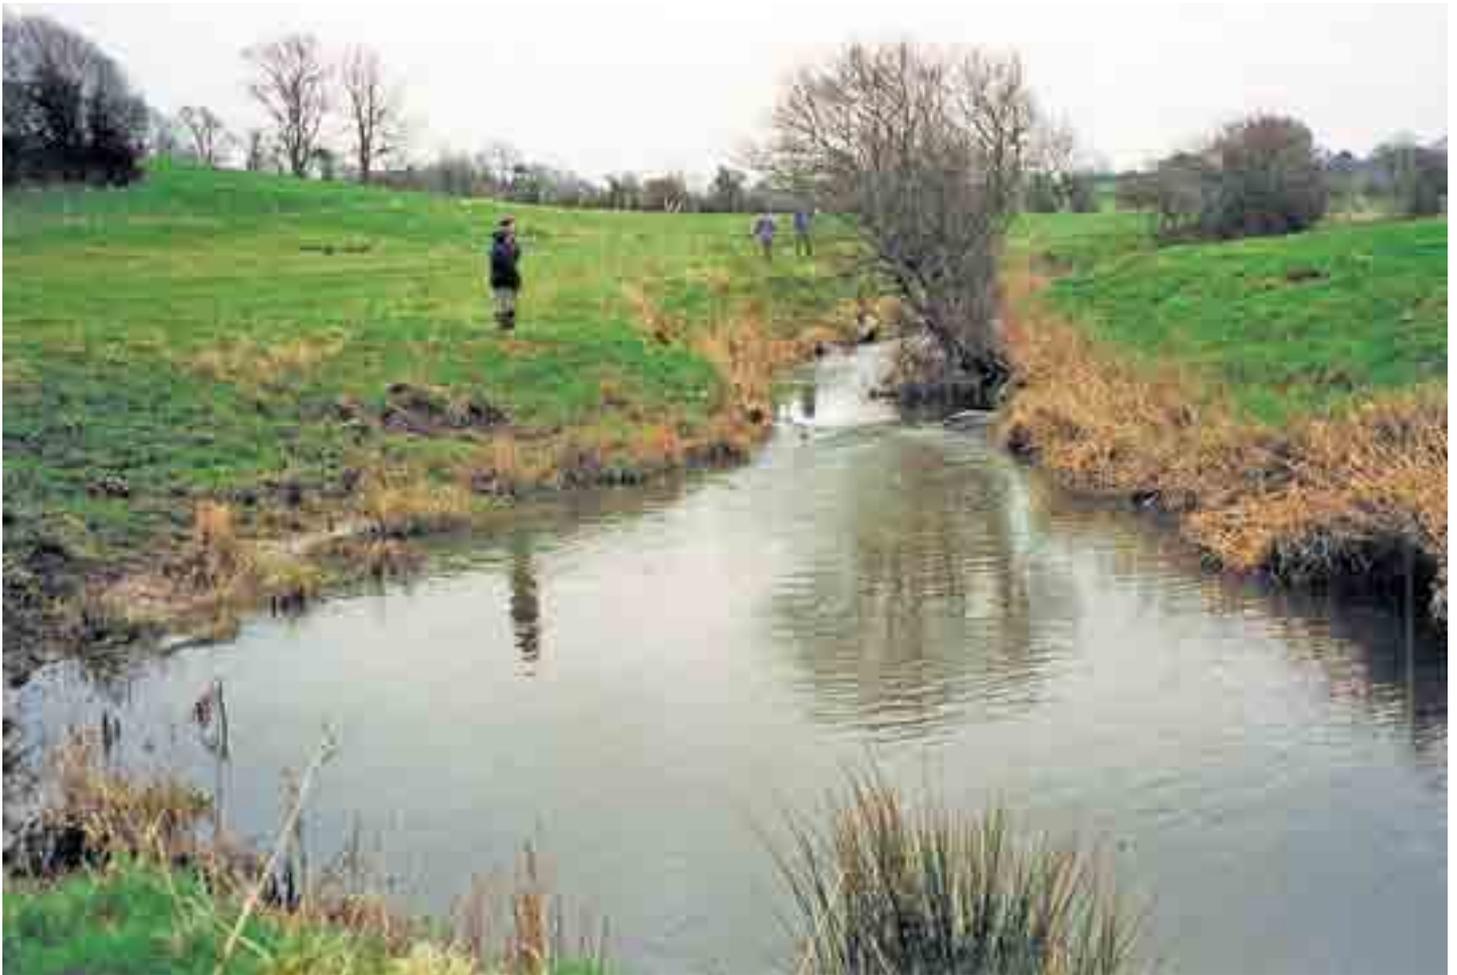
Bay 1 showing the angle of flow keeping the bay 'open'

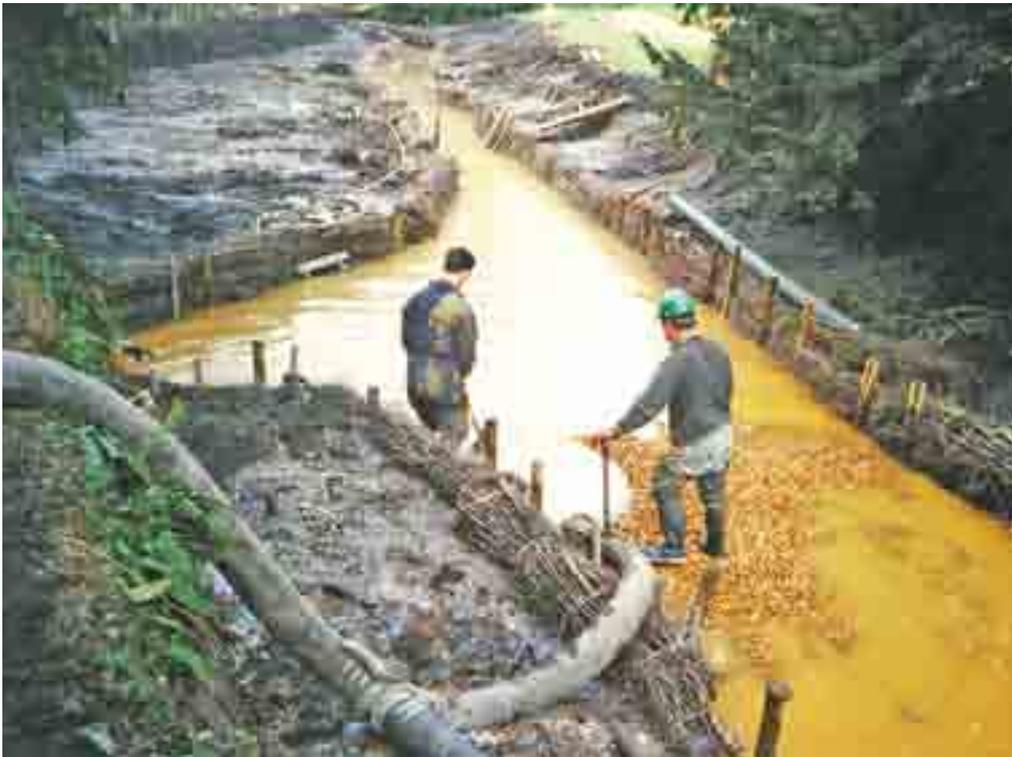
View of the wide dredged section, gravel being placed within the low-flow channel

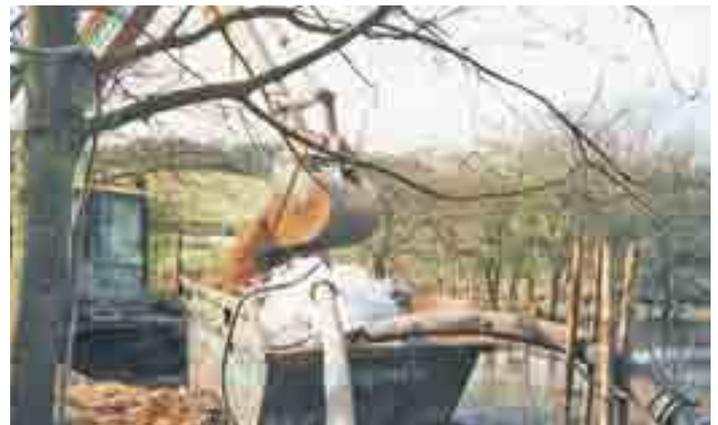
Pumping apparatus in operation

- At the site compound a submersible pump powered by a diesel generator was placed in a skip located near to the river.

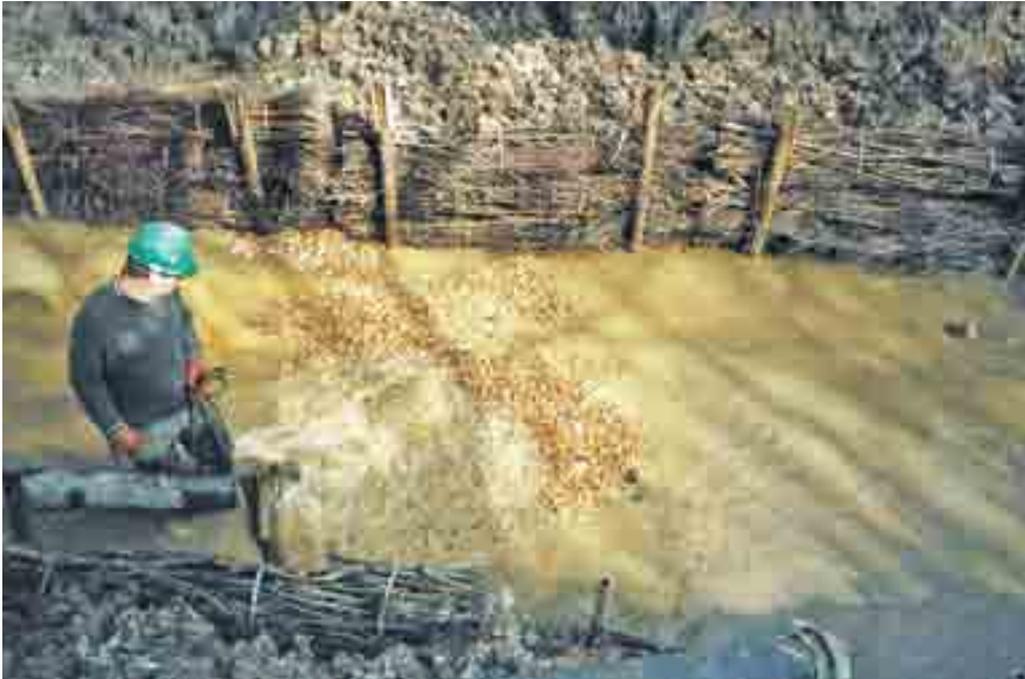
Gravel pumping in operation

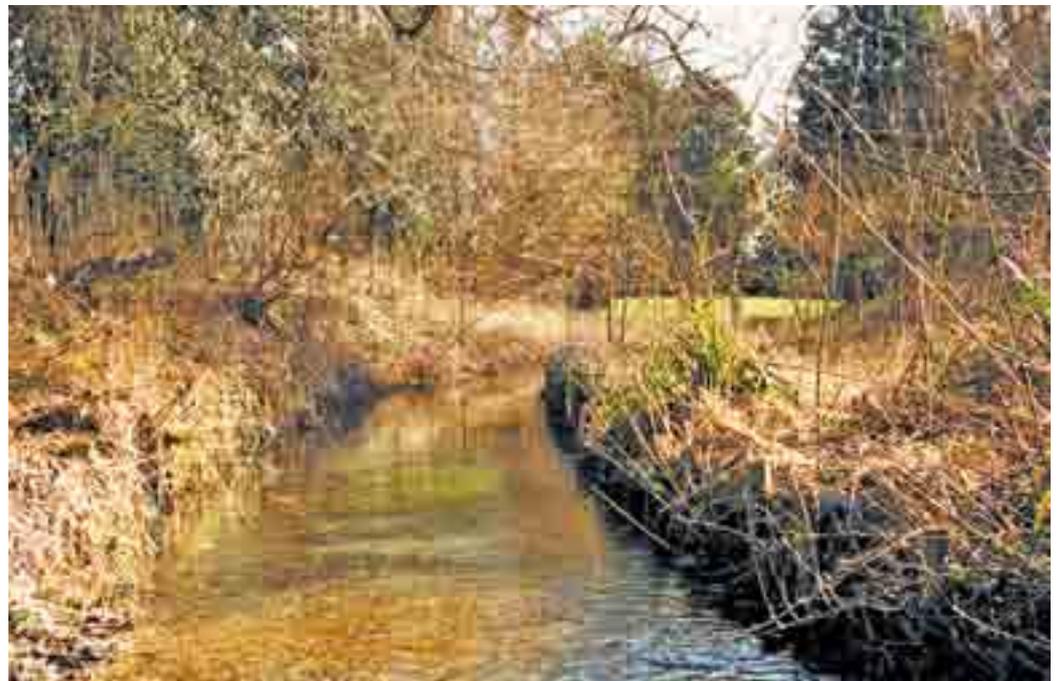
Four years on
– gravel shoals and deeper
hollows remain

Using this approach the contractor was able to place the gravels economically and without having to remove existing valuable trees and shrubs. By introducing the gravel it was possible to shape the bed, recreating pools on the bends and riffles on the straight sections (see *Technique 5.5* for more detail on bed raising).

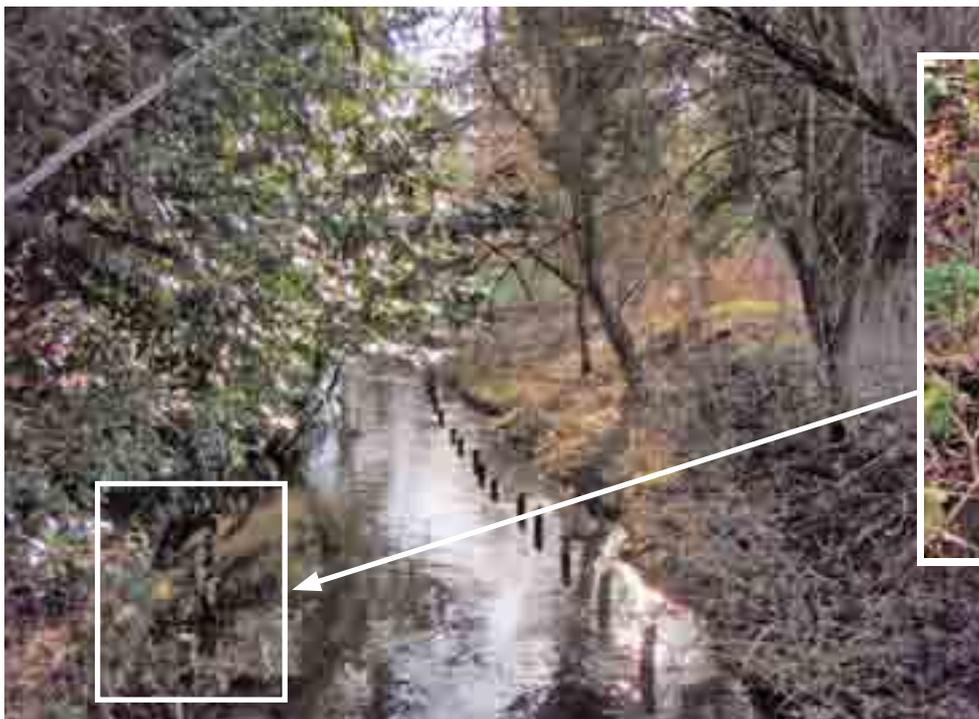
Looking downstream the lines of posts visible with no vegetation behind them – 2013

The works to the 300m dredged section was carried out sympathetically to minimise the need for disturbance to the woodland. However, by not having to carrying out any tree works to these densely shaded parts of the reach, the over-shading has restricted vegetation colonisation and stabilisation of the retained-silt edge. In these reaches the faggots have decayed and in some places the bank edge has eroded (highlighted by the remaining line of posts).

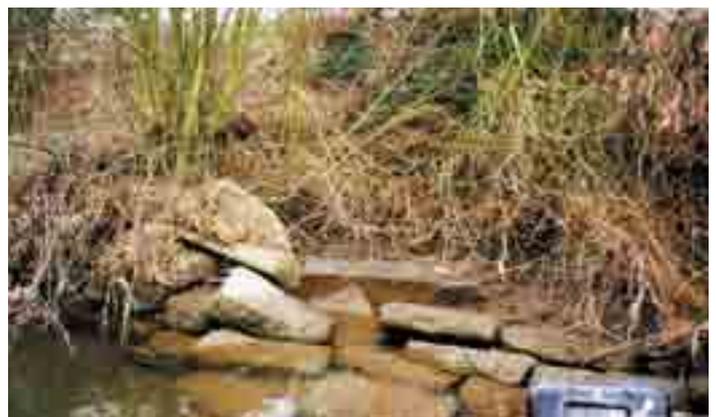
Failed section of bagwork at Clifton Lock Cut

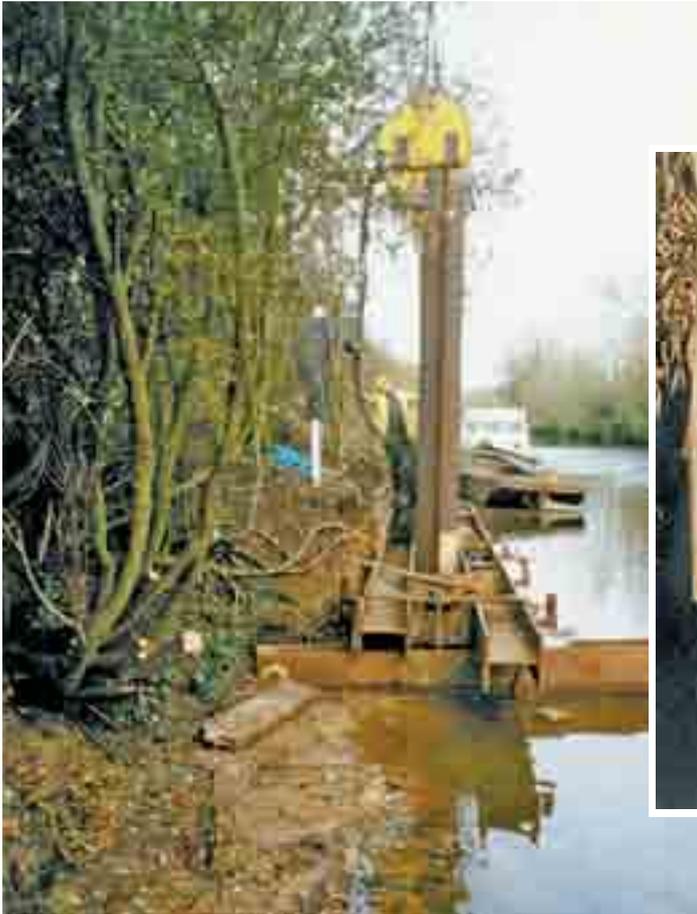
Initial sheet piling after bagwork removal, over existing trees

allow continued maintenance dredging) with an above-water 'soft' approach promoting vegetation growth. The sheet piling was carried out using a land based crane with floating pontoon to support the piling frame, thus reducing the degree of trimming and removal of existing bankside vegetation.

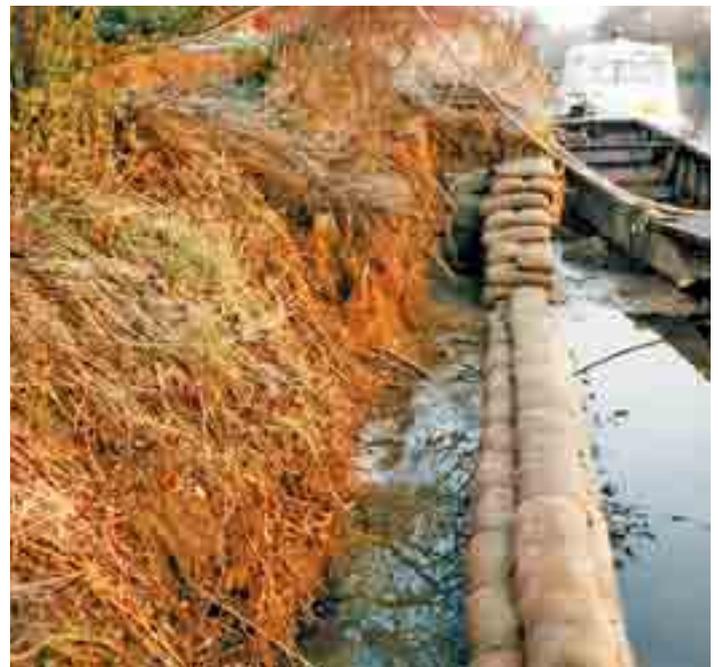
2 layer capping bagwork and tie-in to existing sheet piling

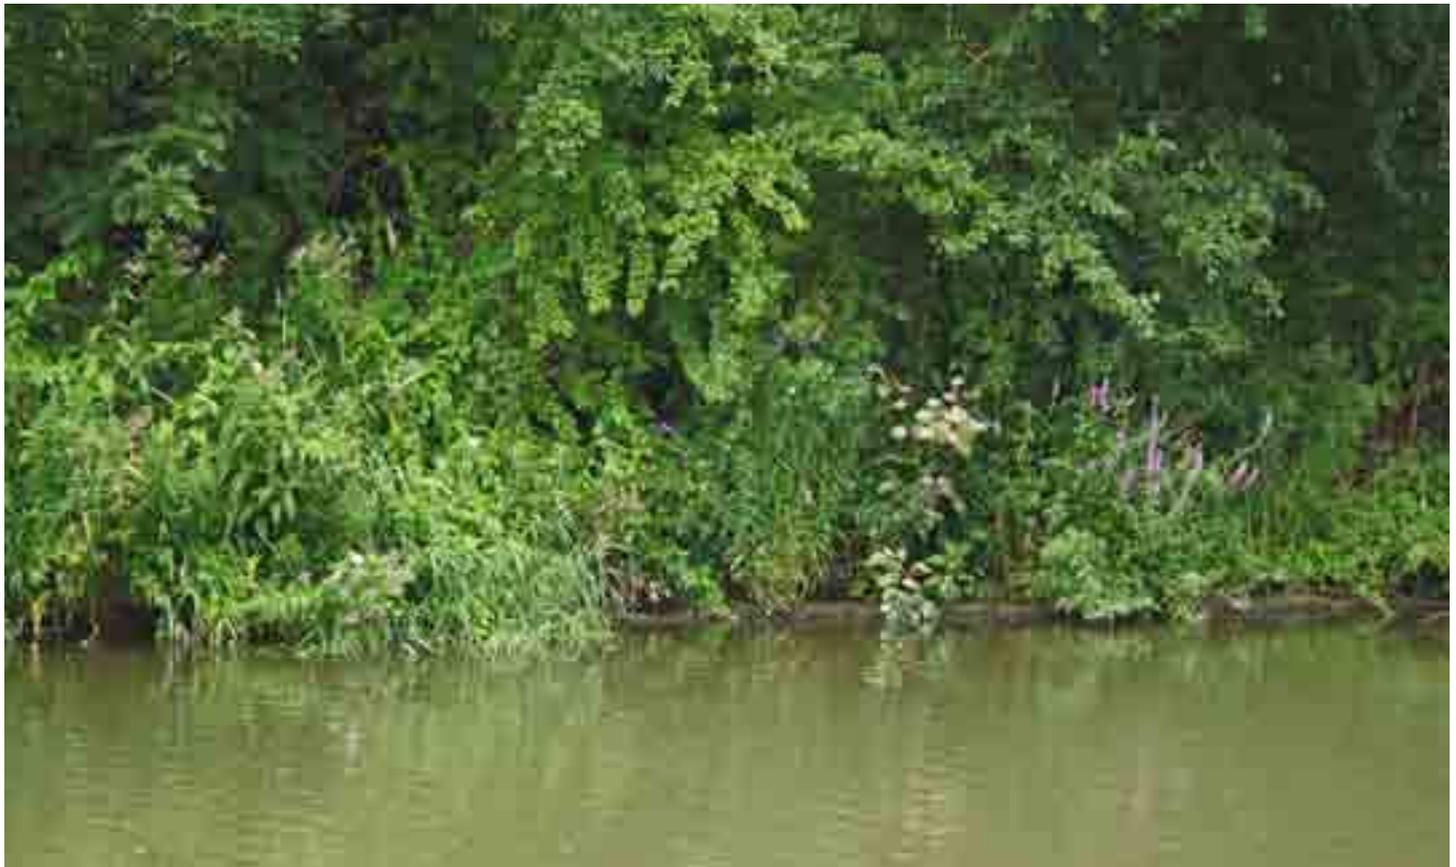
Vegetation growth has established and the bagwork has remained intact – August 2013

The introduced bagwork has settled (soil and silt has solidified) and is standing up well to wash caused by passing boats. Where there is sufficient light there is good vegetation growth and numerous plant species have successfully established. However, in some areas lack of maintenance means riparian vegetation has overgrown, restricting some views of the river from the towpath. The minor tree work carried out along the towpath has since ceased and it is suggested that the scheme may have benefited from a tailored tree maintenance schedule.

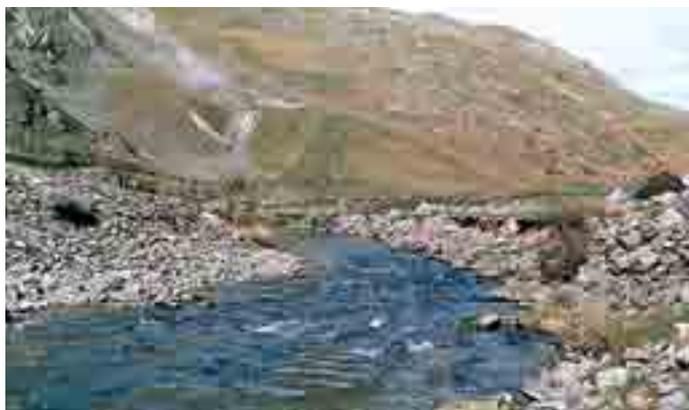
Deep channel and dredgings on bank at Blaen-y-Nant confluence

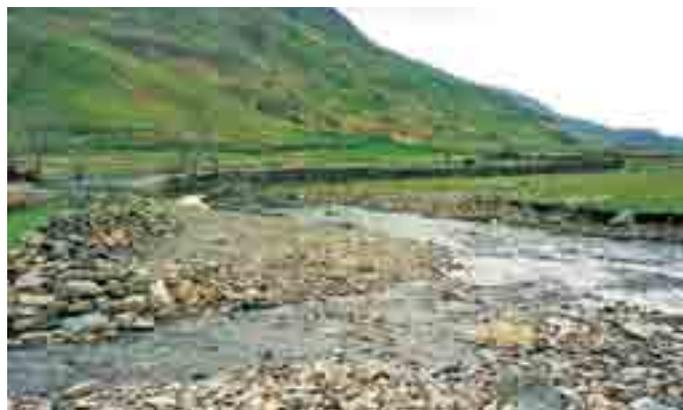
Restored bed levels and bank profile

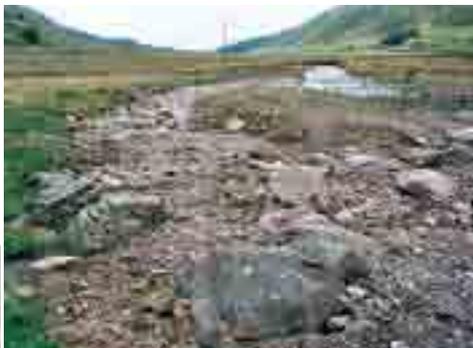
Restored island

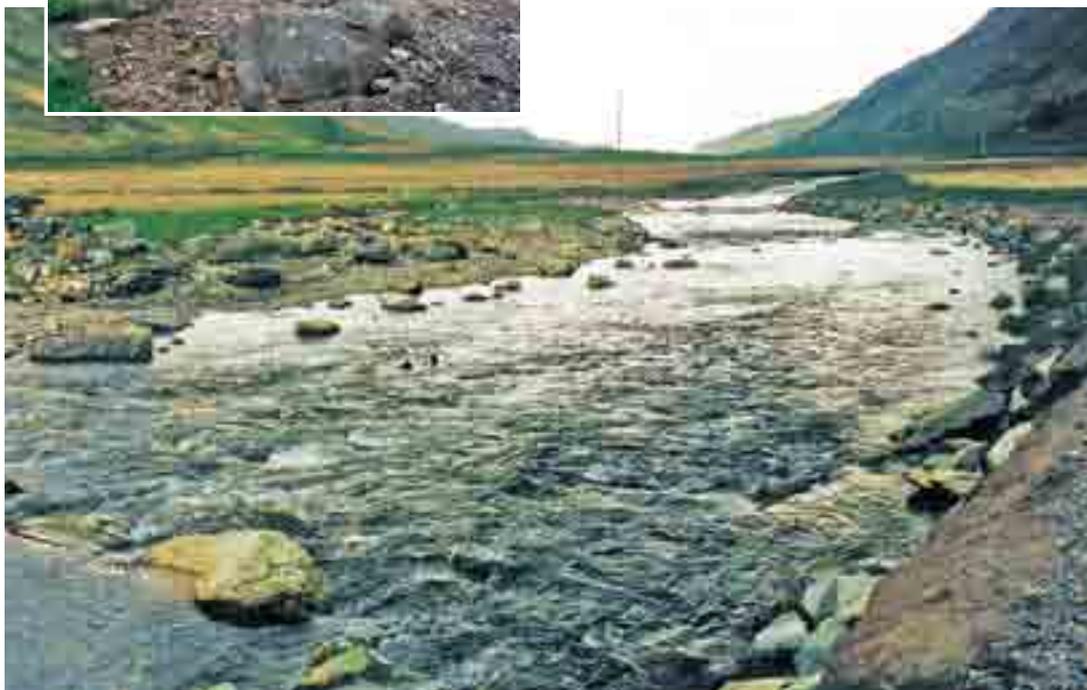
Restoration of boulder cascade, stepping stones and braided channel

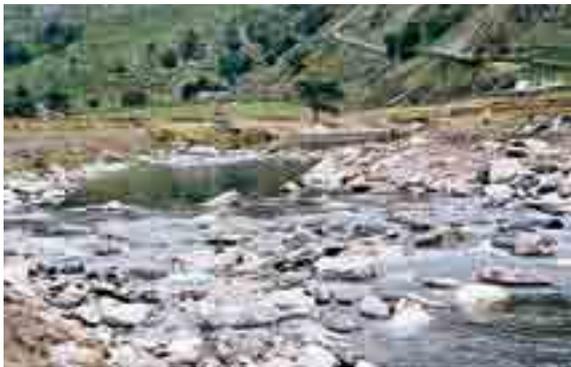
Lower 'stepping stone' cascade

The lower cascade was the smallest of the four so was readily adapted to restore a series of large stepping stones recorded on Ordnance Survey (OS) maps. The effect of restoring the cascade was to impound the upstream reach of river to a water depth of 2m. Ideally this upper reach would have been completely backfilled to the 1 in 600 gradient shown on Figure 5.3.2. but insufficient material was available for this because dredged gravels had been removed from site.

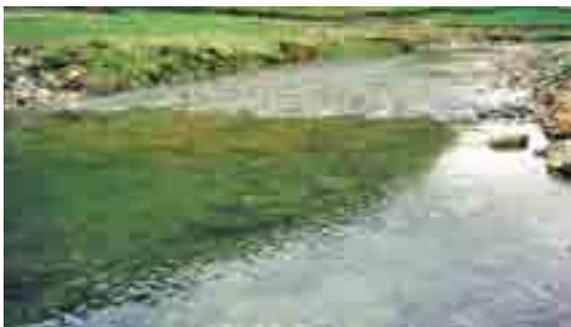
The practical alternative to full bed restoration was to concentrate the material available into a series of individual cascades along the upstream reach. These took a similar form to the main cascade but the downstream slopes were much flatter to simulate 'riffle' characteristics rather than true cascades. The upper of these 'riffles' at chainage 700m took the form of a long diagonal ford which restored a feature recorded on old OS maps – (see *Technique 8.4 for details of this ford*).

Flatter 'riffle' cascade with upstream pool

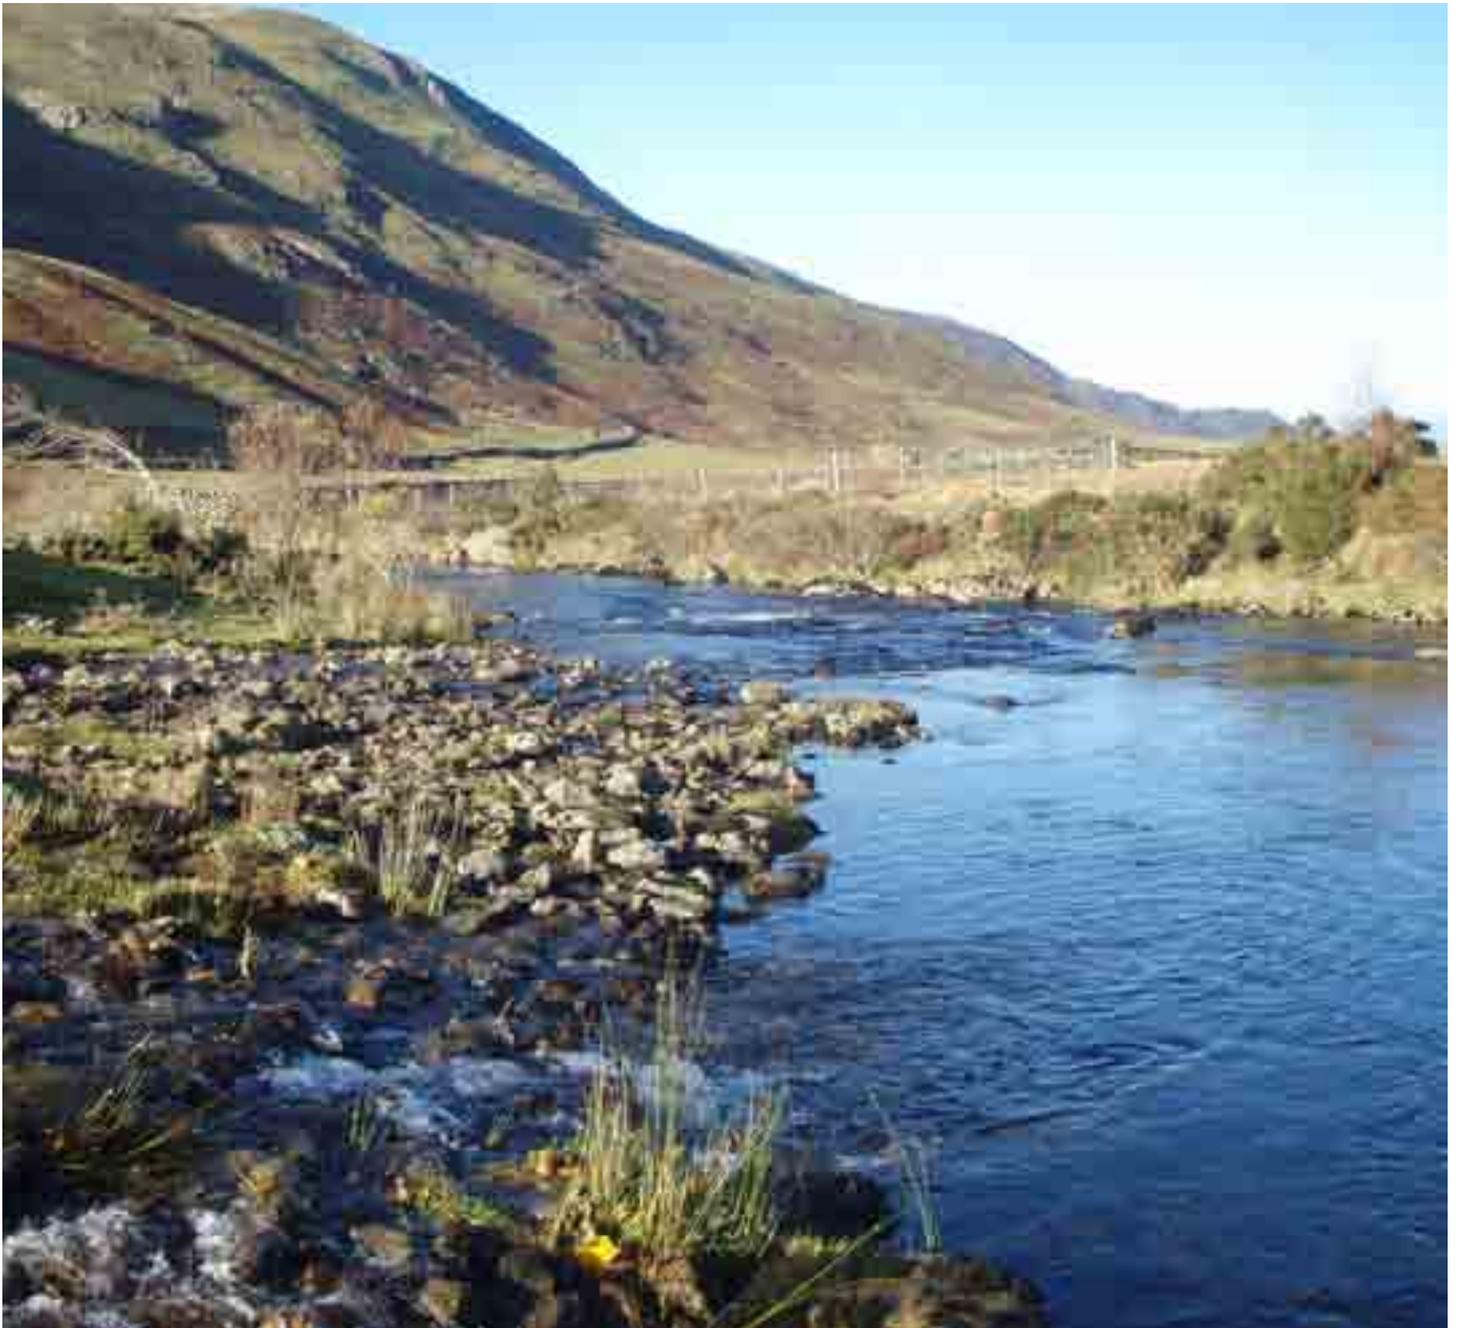
Restored bed levels and bank profile.
Right bank vegetated as a result of fencing.
November 2012.

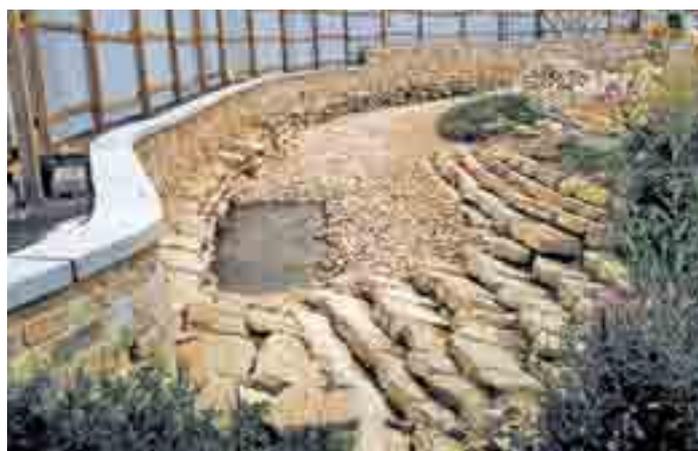
Simulated rock outcrop with downstream pool

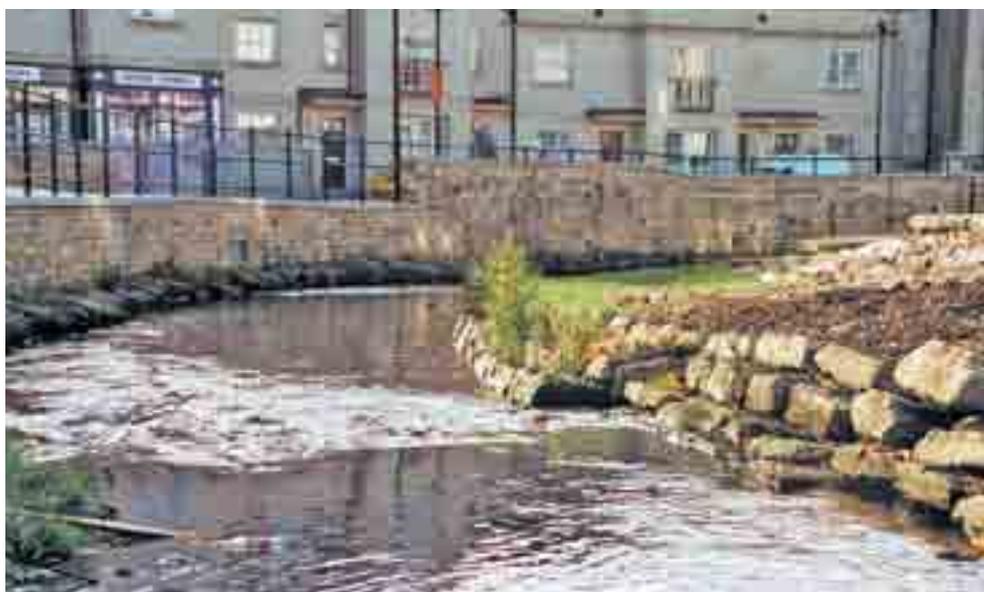
The outcrops provide stability to the bed and banks as well as aesthetic interest

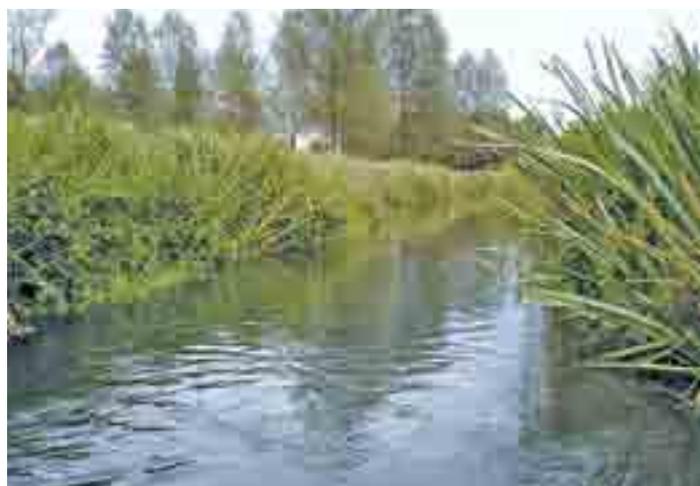
Before restoration – sluggish deep water with encroaching sedge

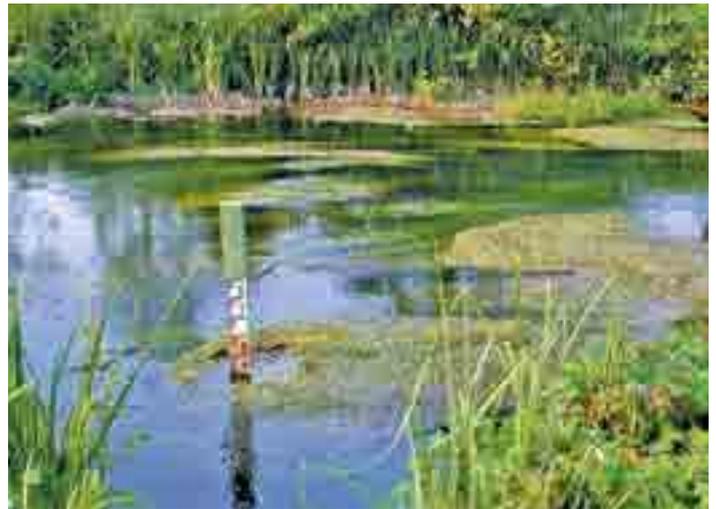
Gravel placement may influence or be influenced by fluctuating water levels

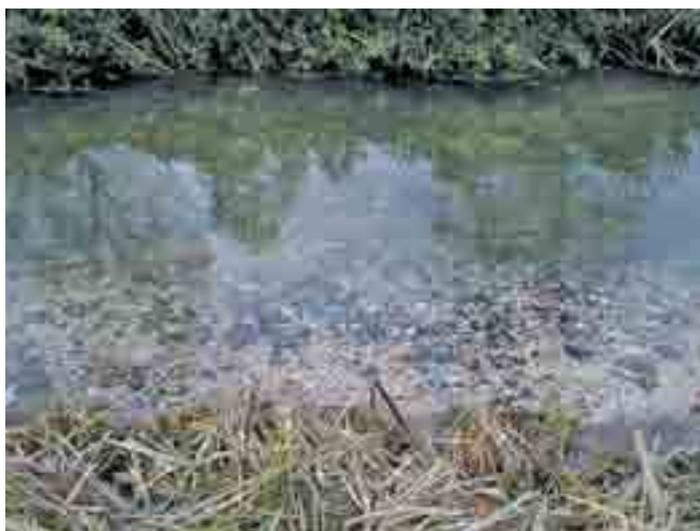
The material used to shallow the channel depth was chalky and gravel flints. Where possible it is advisable to use material from the immediate area to reflect the type of bed that would have been present under natural conditions. Here the gravel fill was excavated from the floodplain by the creation of an adjacent pond on the right bank. The suitability of the material was checked beforehand by the inspection of machine excavated trial pits. Infill material was predominantly a mixture of gravels and flints varying in size from 0.02m to 0.01m, with <5% coarse sand and minimal silt. A few larger flints were also present.

Flinty gravel used to narrow and raise the river bed

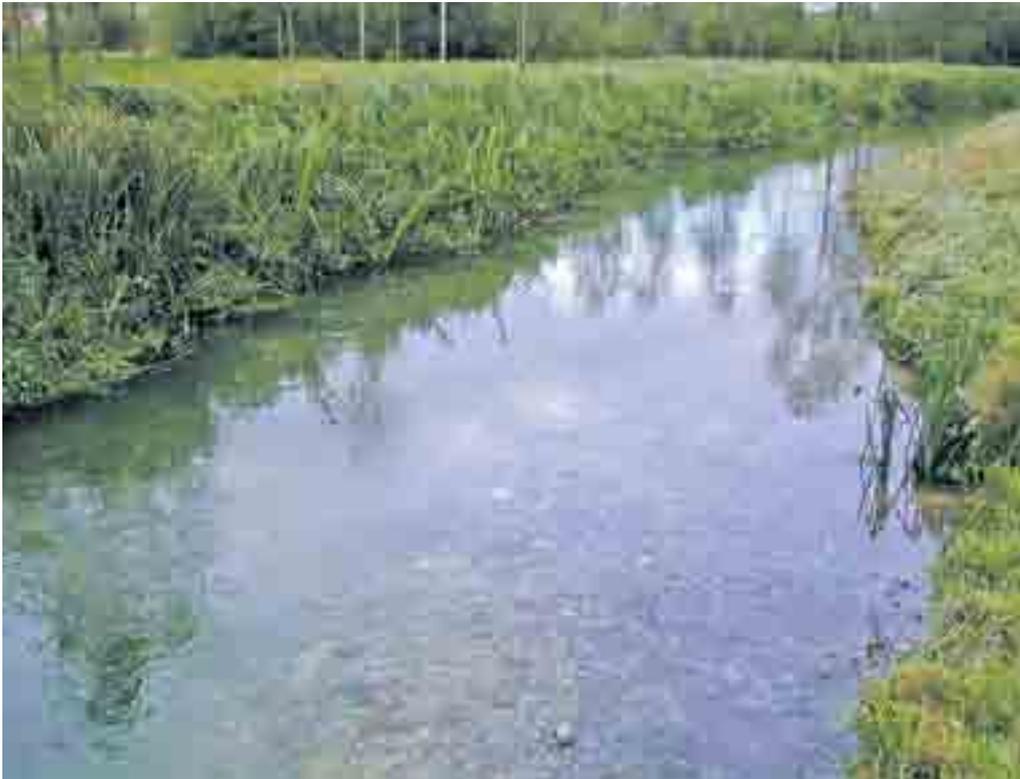
A few months after completion, the raised bed evident

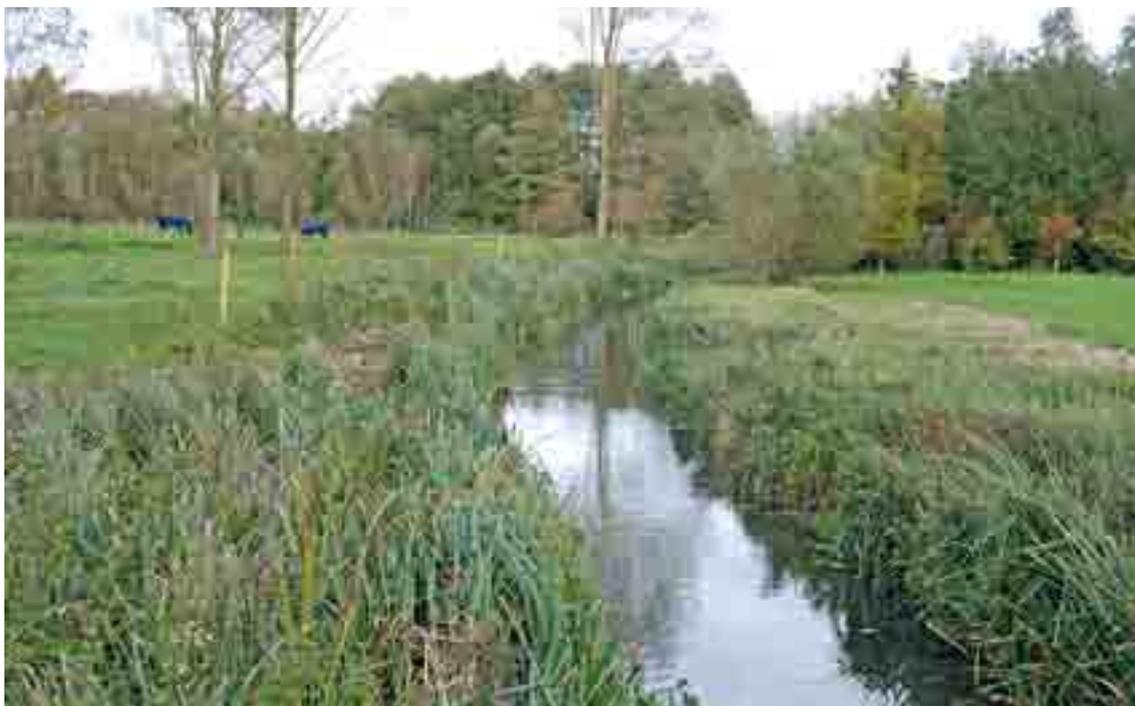
Effective narrowing of the channel and asymmetric shallowing of the bed has occurred following restoration – 2011

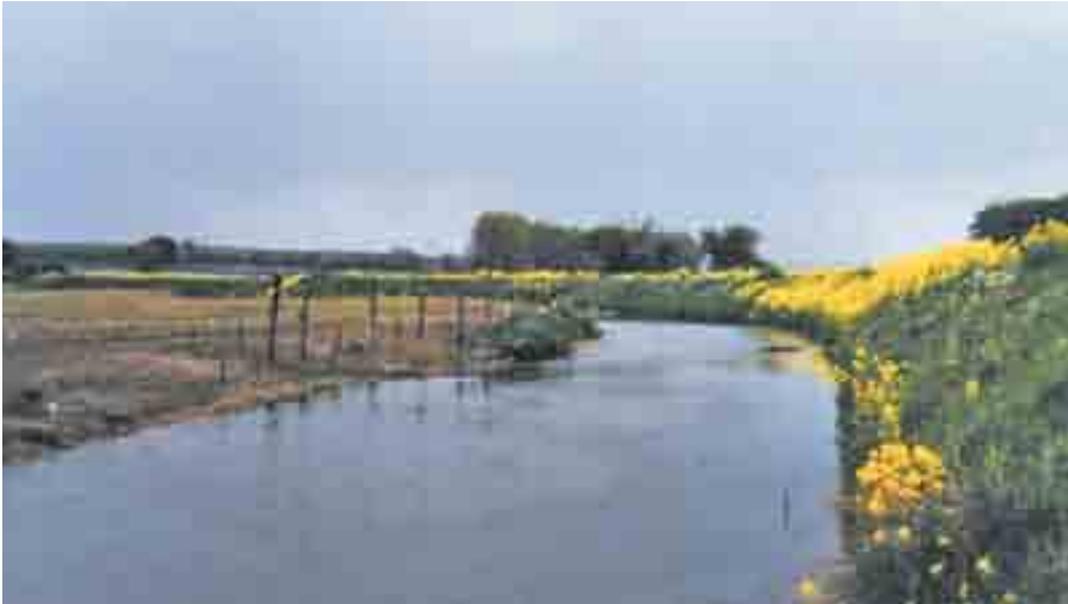
Removal of the left floodbank and marginal berm creation on the Great Eau at Withern

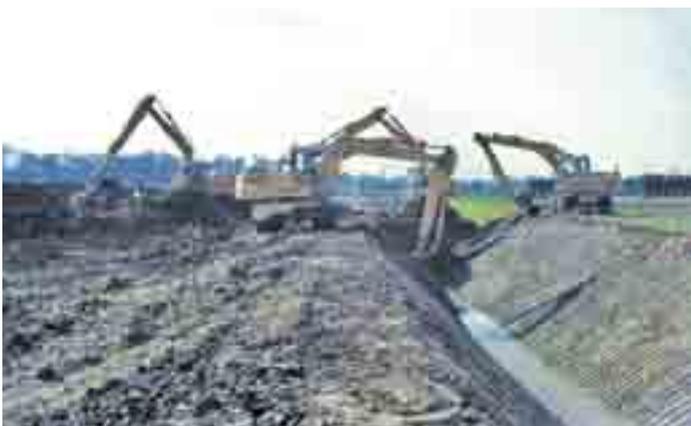
Relocating the IDB drain and set-back floodbank

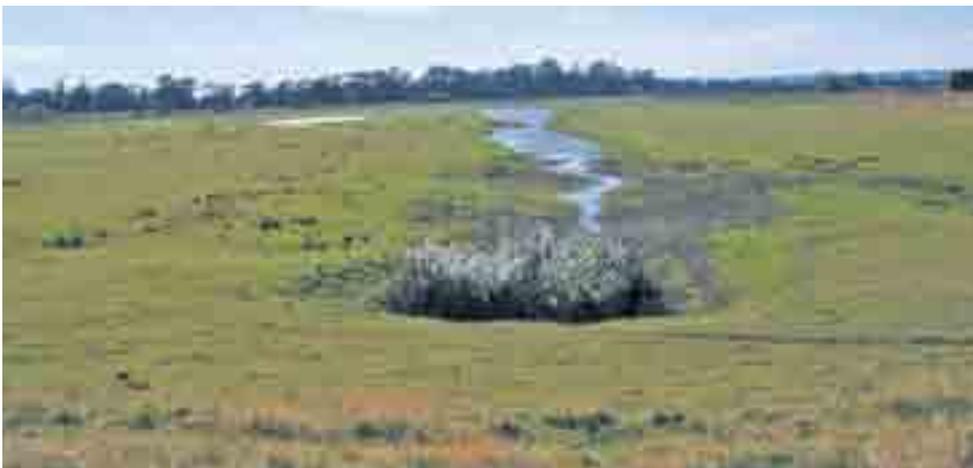
Water is designed to spill onto the 16ha site from the Long Eau when levels reach 2.6m above OD, just 0.3m over their normal retained level. This floods progressively outwards from the old course of the IDB drain, which represents the lowest levels within the area. This low spot remains damp for much of the year, the downstream end forming a permanent wet scrape/shallow pool.

Floodplain, penstock and permanent wetland area – October 2001
