Restoring Meanders to Straightened Rivers

1.5 New meandering channel replacing concrete weirs

RIVER MARDEN

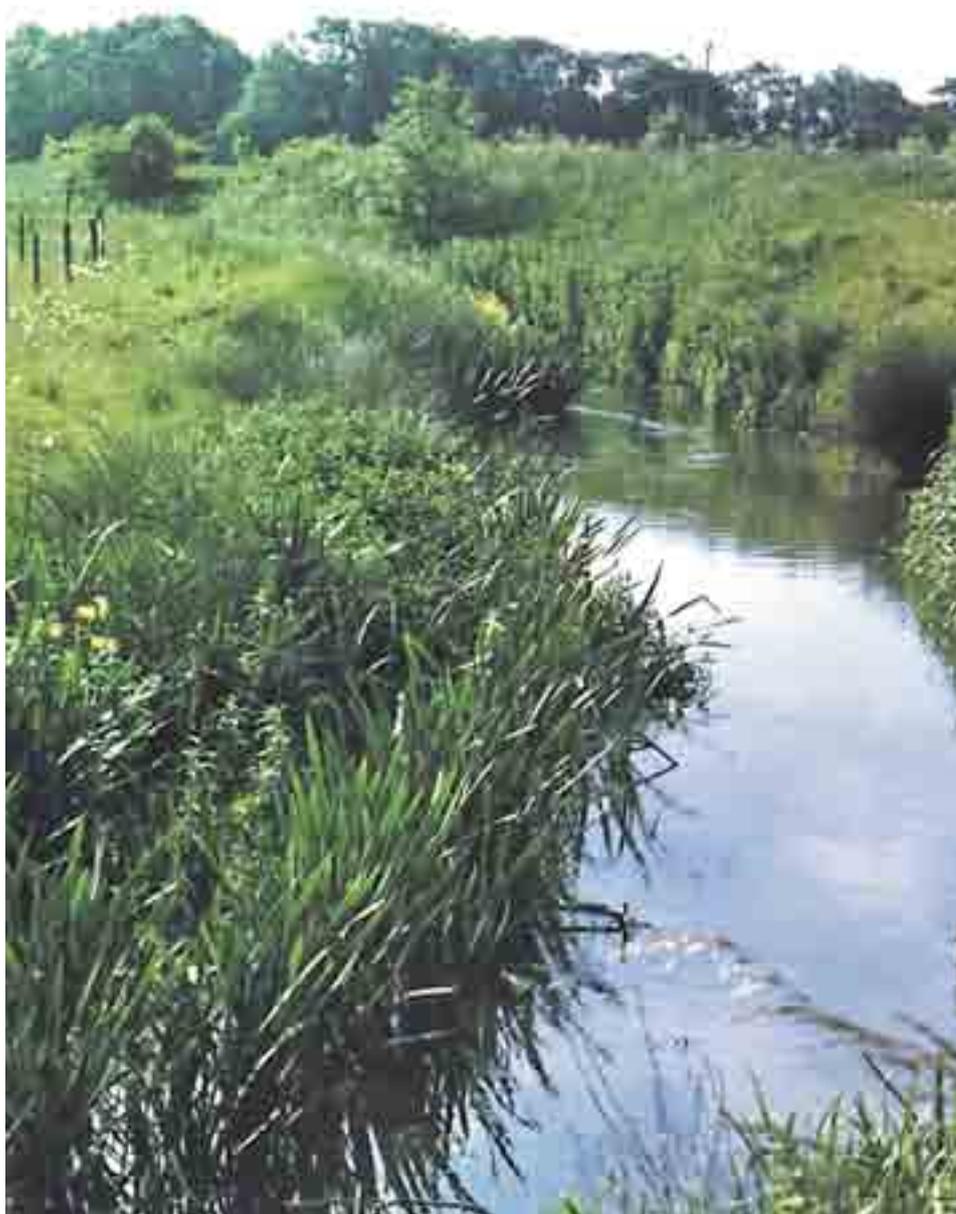
Berm at section A after 4 years

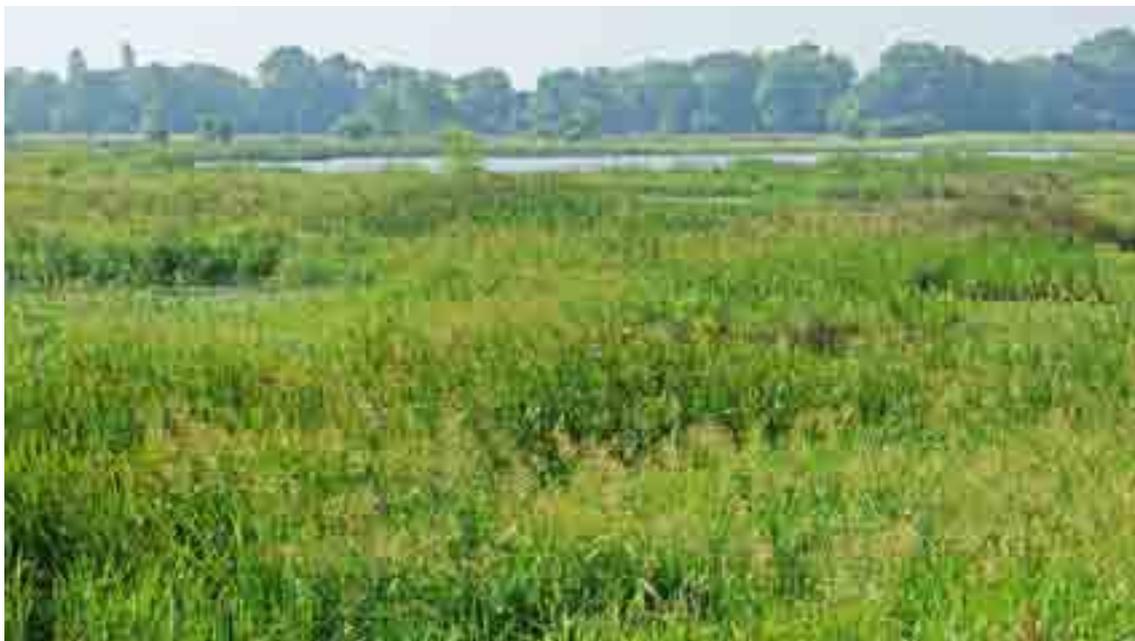
Floodplain, penstock and permanent wetland area 11 years on – August 2012

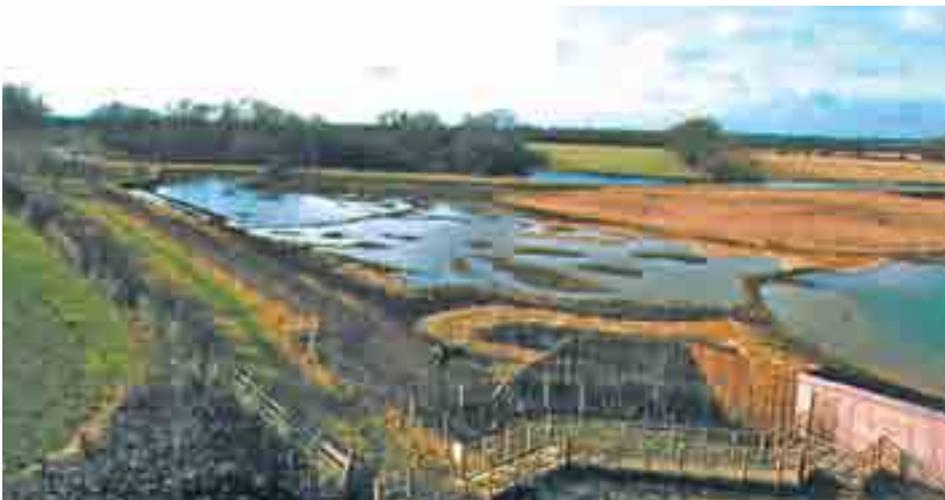
Wader scrapes
– February 1992

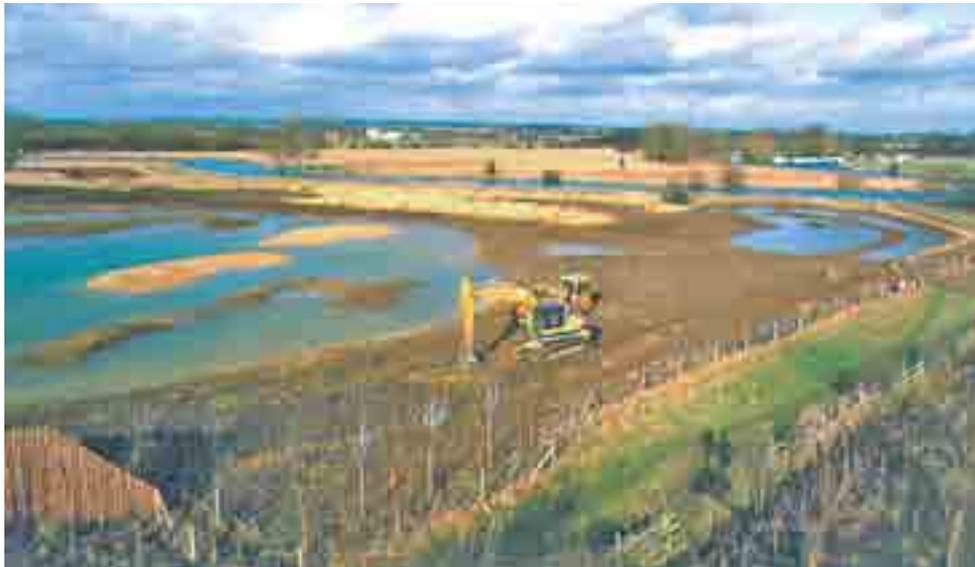
Main pond, pool and reedbed creation
– February 1992

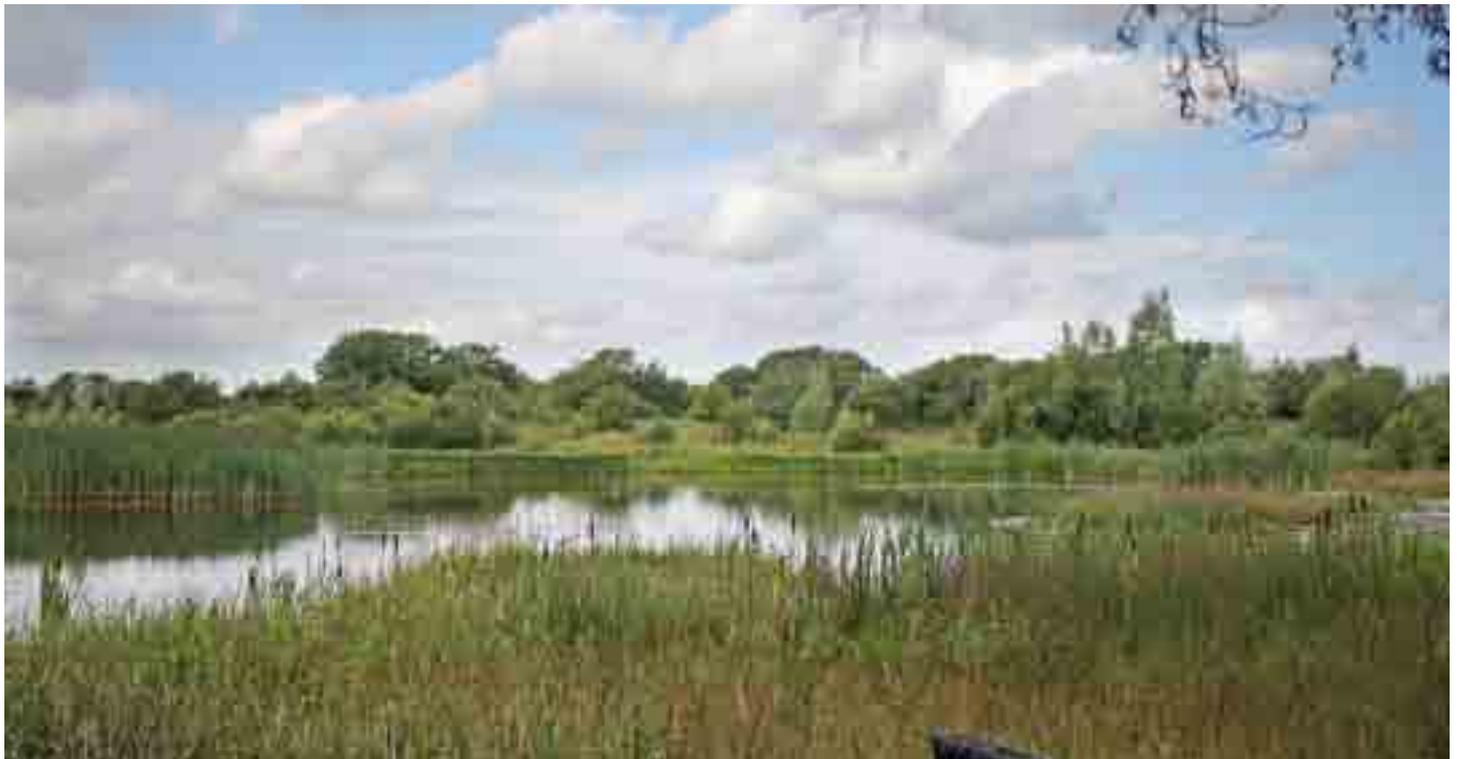
Main pond and gravel island continue to provide favourable habitat for wetland species – August 2013

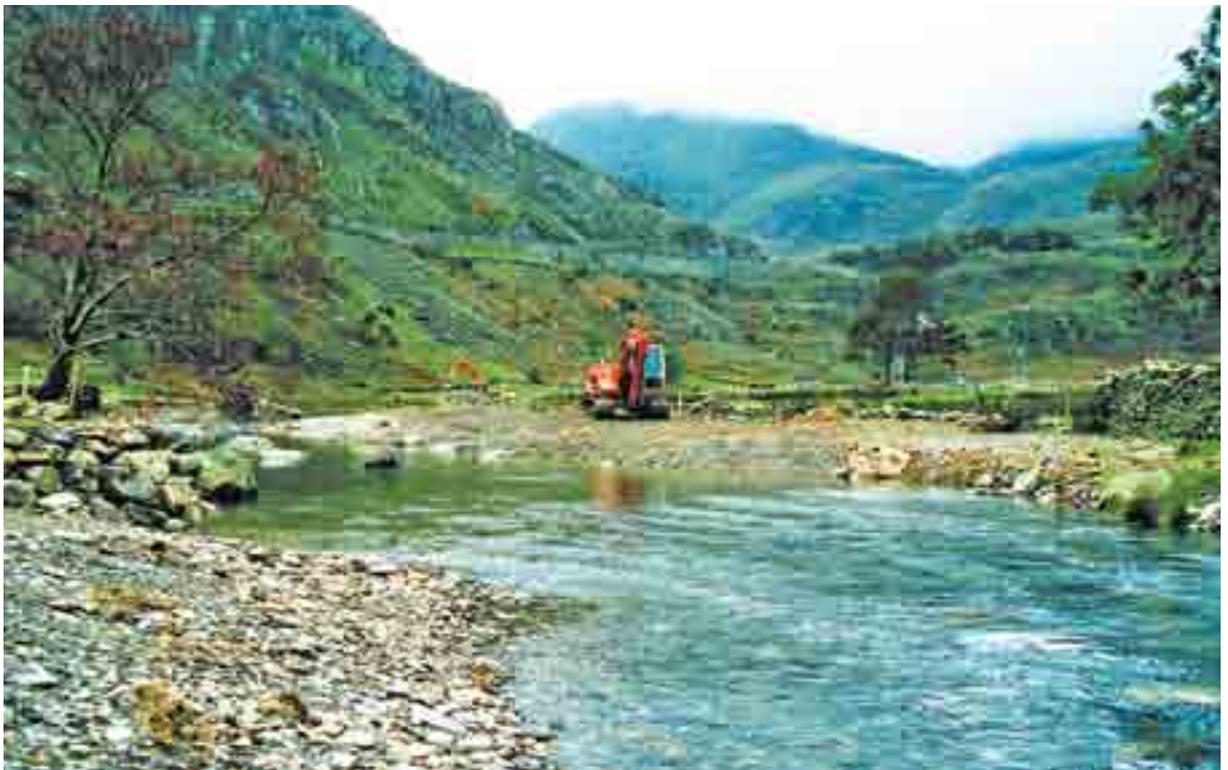
The restored ford, shoals and riverbed

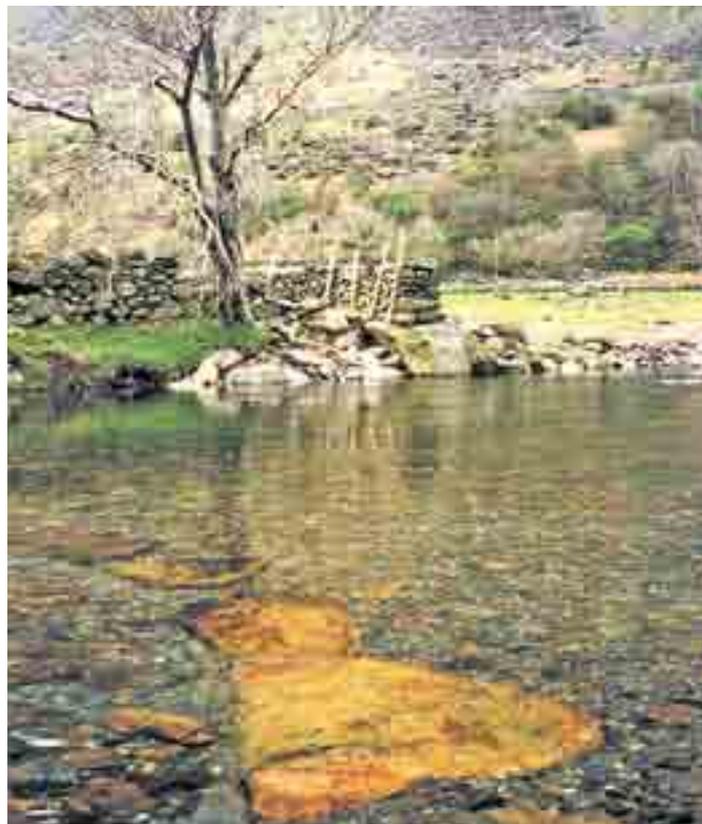
Downstream crest defined by boulders

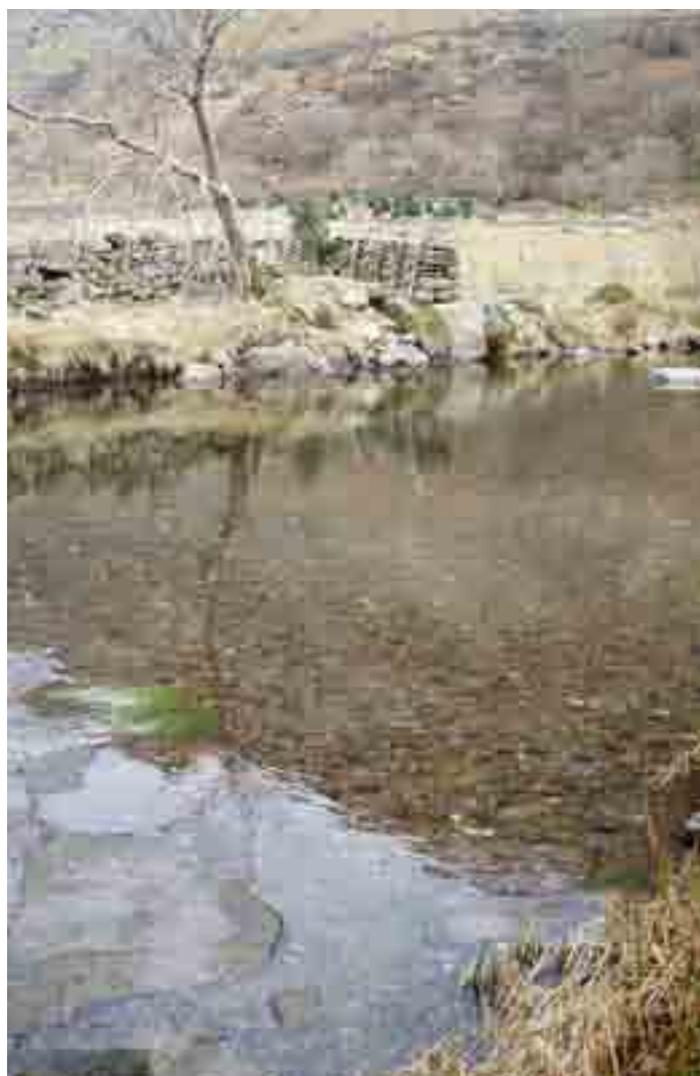
The ford remains stable with the boulders used for the downstream crest remaining in position – February 2013

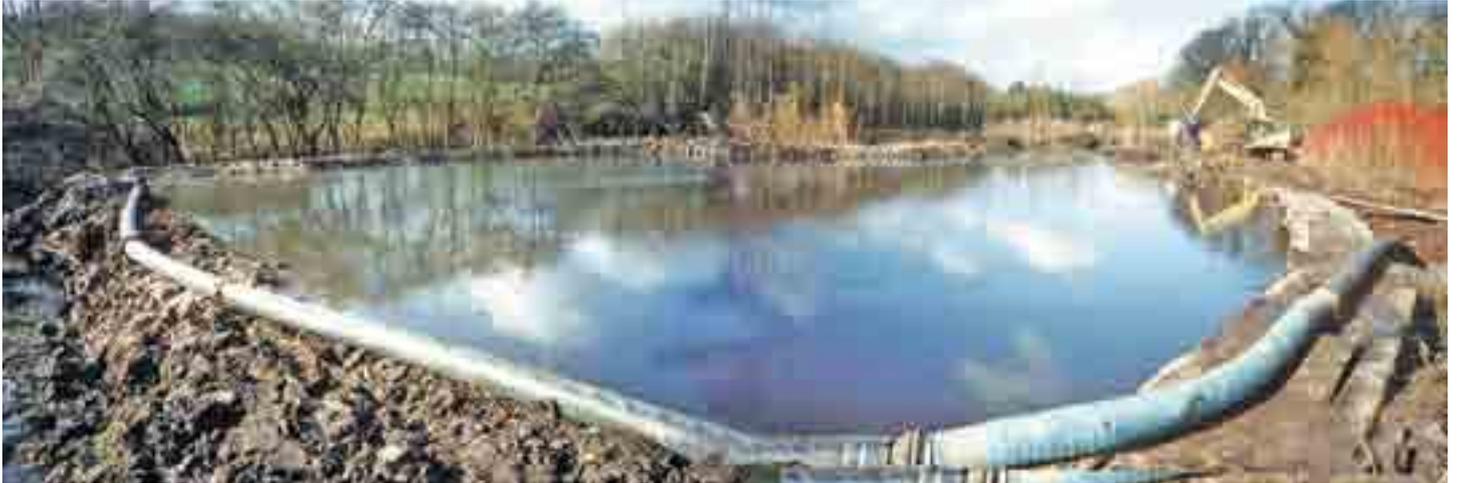
Lagoons and stilling basin – February 1995

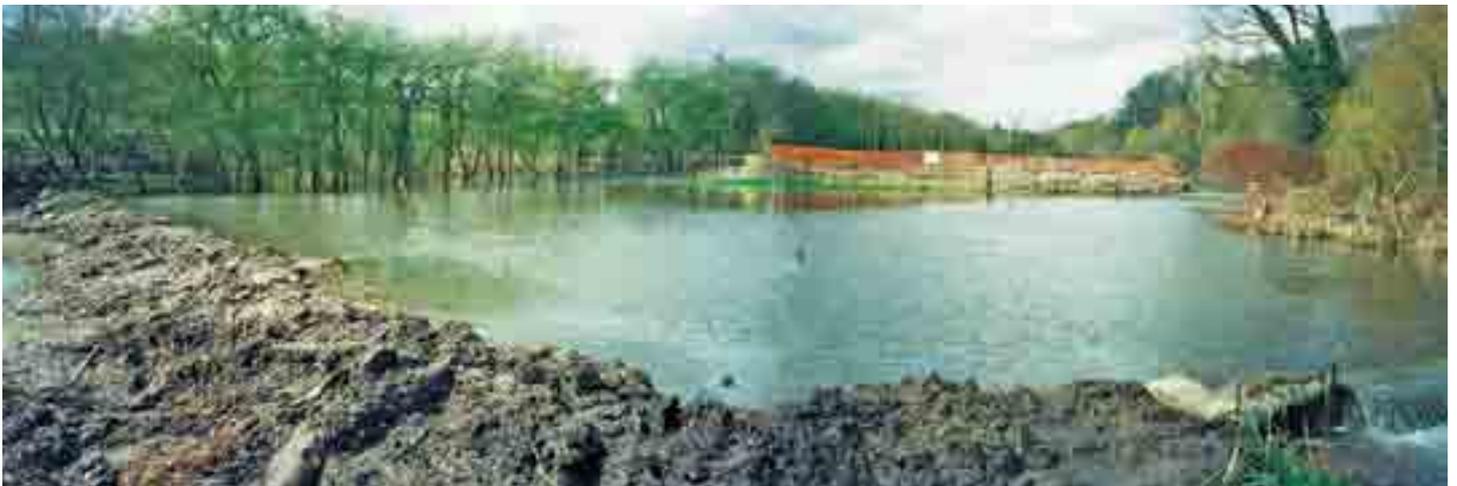
Lagoons, stilling basin and overspill – March 1995

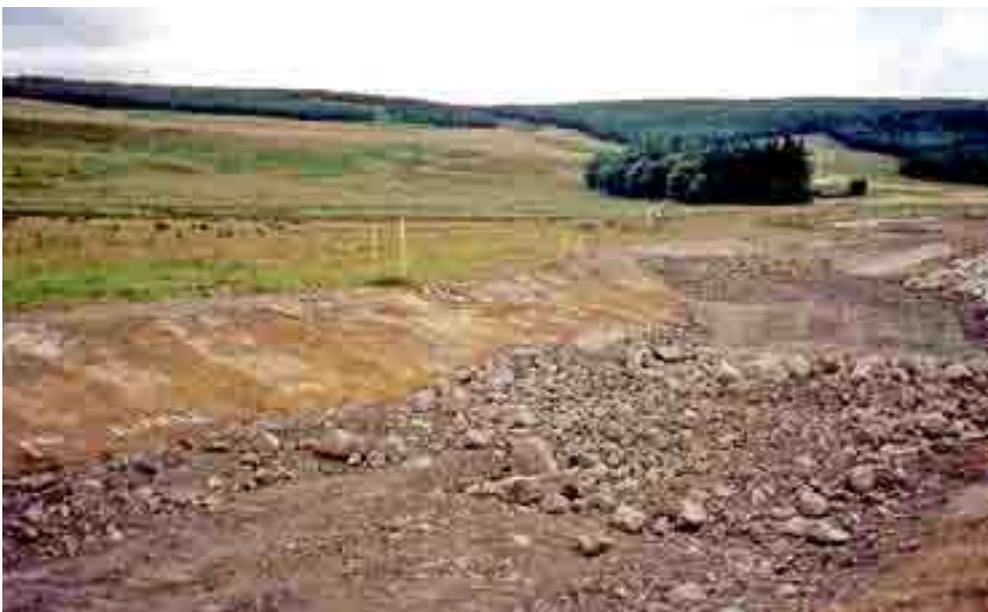
Shaping the new channel within the clay lining

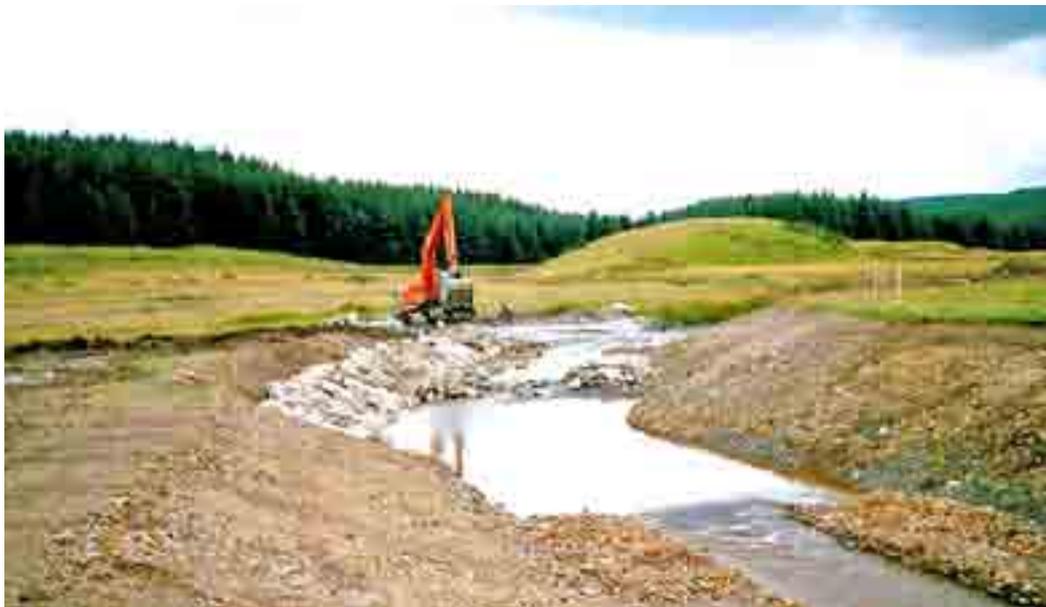
The 'constructed' run-pool-riffle sequence

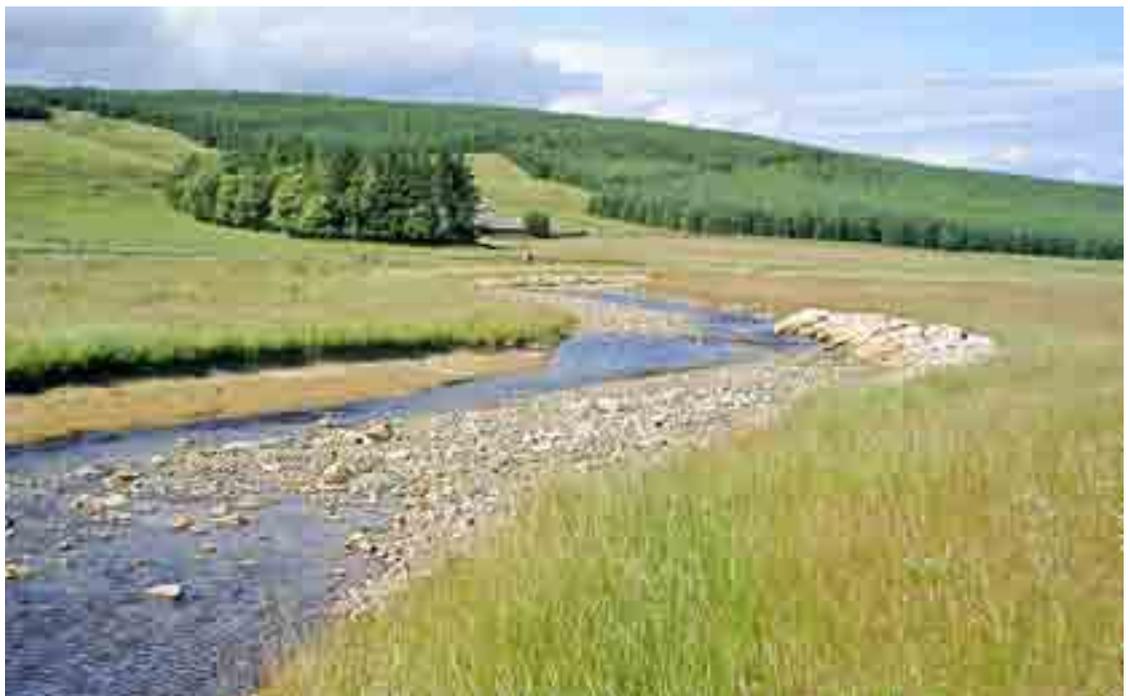
One year on and natural redistribution of in-channel sediments is helping to 'soften' the engineered channel

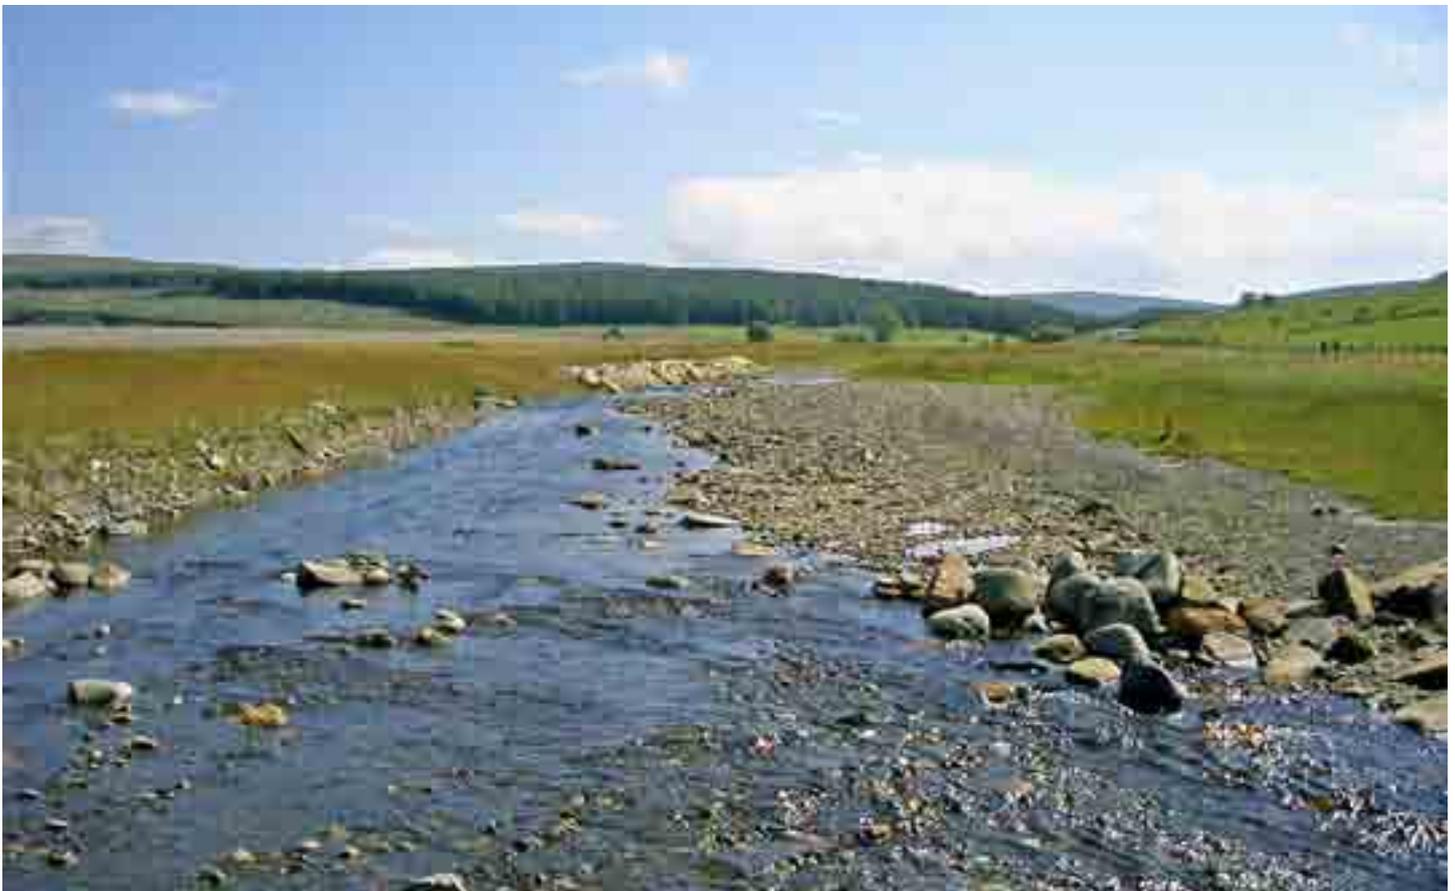
The overwide channel and plentiful bedload gives the river scope to shape its bed

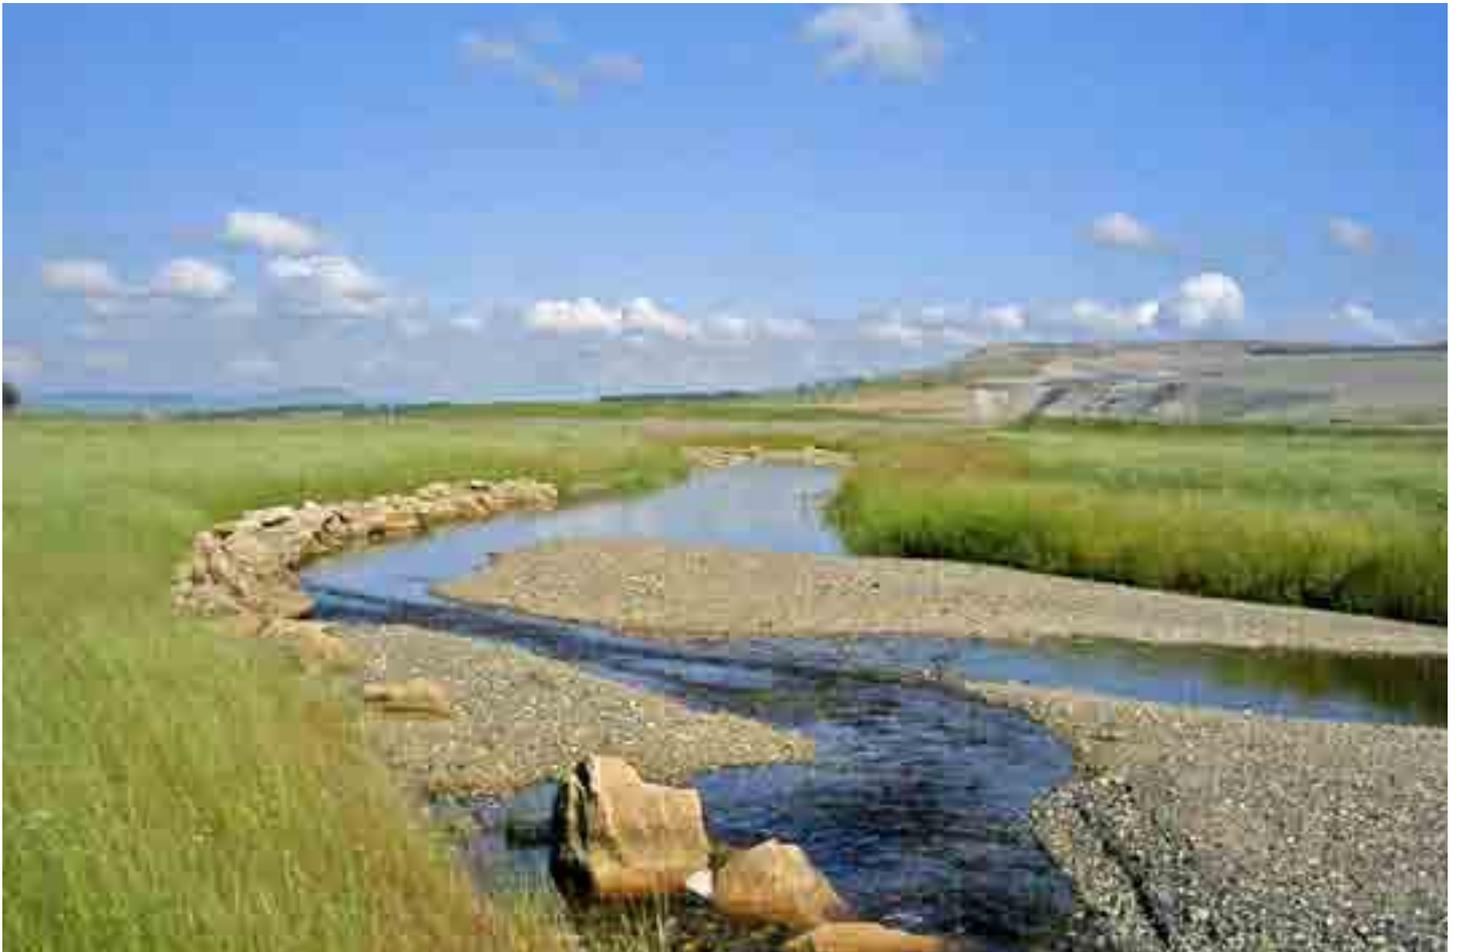
The rip-rap is still very evident but the in-river form is developing well

During a 1 in 10 year flood event the channel planform remained stable with only minor bank erosion. Channel change was most apparent near tributary junctions; dynamic reaches in natural rivers. The bed material was mobilised, as it was in natural reaches up and downstream, and as a result the constructed low-flow channel was replaced by a natural thalweg. The movement of the bed material resulted in some reaches becoming shallower, and the creation of point bars not in the design, increasing diversity of water depths and velocities.

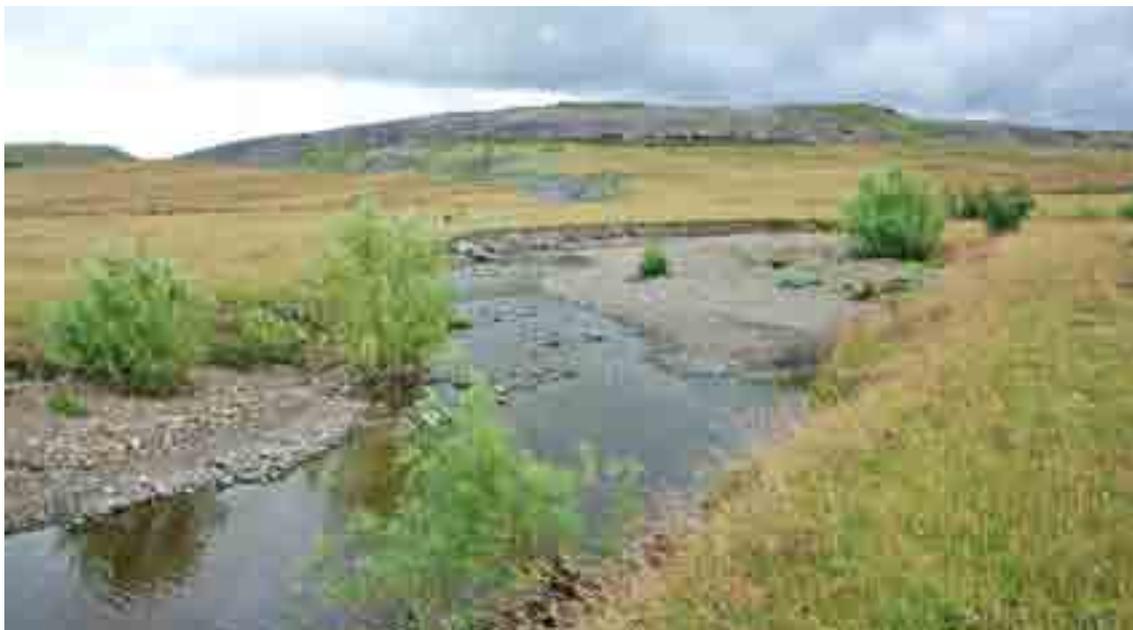
The channel realigned in 2004 after 7 years. Marginal vegetation has established and natural morphological processes are taking place – August 2011

In 2004 the channel was moved again, roughly along the course of the original, because of a commercial decision to extend coal mining activities. This allowed the channel design to incorporate lessons from the former project's successes and limitations.
