RIVER DIVERSIONS

11.2 Clay Lined River

RIVER NITH

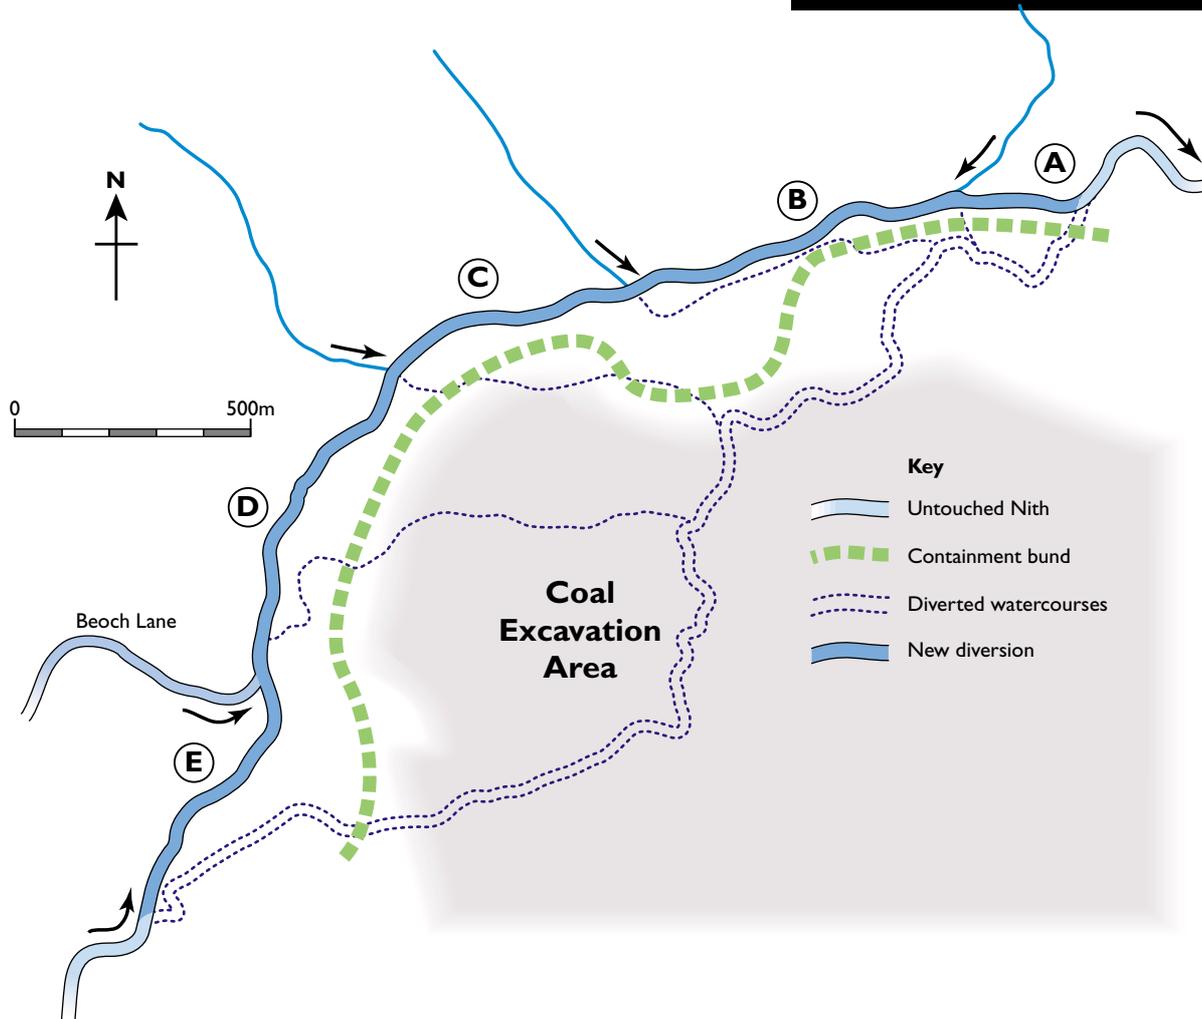
Figure 11.2.1
PLAN OF KEY FEATURES AND SEQUENCES (A – E)

Figure 11.2.1 shows the diversion channel to the north of the floodplain, with the containment bund protecting the opencast area. Works progressed from A to E upstream, enabling the tributaries and burn to be progressively captured by the new channel. These flows were used to wash silt from the new channel, then intercepted by temporary settlement lagoons at the confluence prior to controlled

discharge to the Nith. On completion, flow was intercepted above point E and allowed to flow through the new channel.

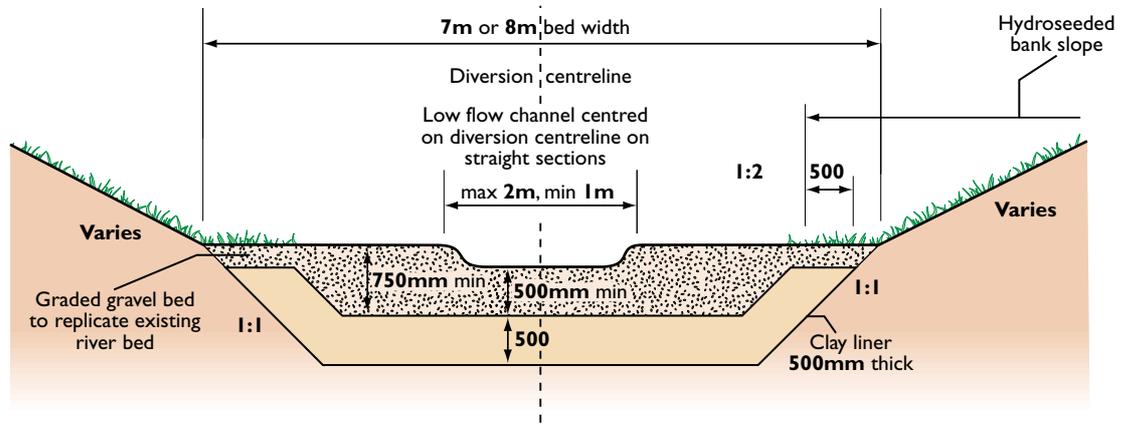
Figure 11.2.2
TYPICAL SYMMETRICAL CROSS-SECTION

A clay lined two-stage channel profile was adopted incorporating suitable run-pool-riffle sequences modelled on those in the existing river channel. Construction materials, including the 0.5-1m thick clay liner, river bed gravels and boulders, riffles and bund material, scour protection and in-stream features all came from the adjacent opencast excavations. It was anticipated that the new channel could match the length of the old one, but ultimately a reduction of 10% was necessary.

- a 1-2m wide depression was formed to create the low-flow channel, centrally on straight sections and towards the outside on bends (figs 11.2.2 and 11.2.3);
- precautionary stone rip-rap was placed on meander bends to maintain the designed plan-form;
- The bare banks were immediately seeded with a grass mix to reflect the grassy moorland surroundings to maximise vegetation cover before the onset of winter.

The key components of the design are shown in Figures 11.2.2 to 11.2.5 and include:

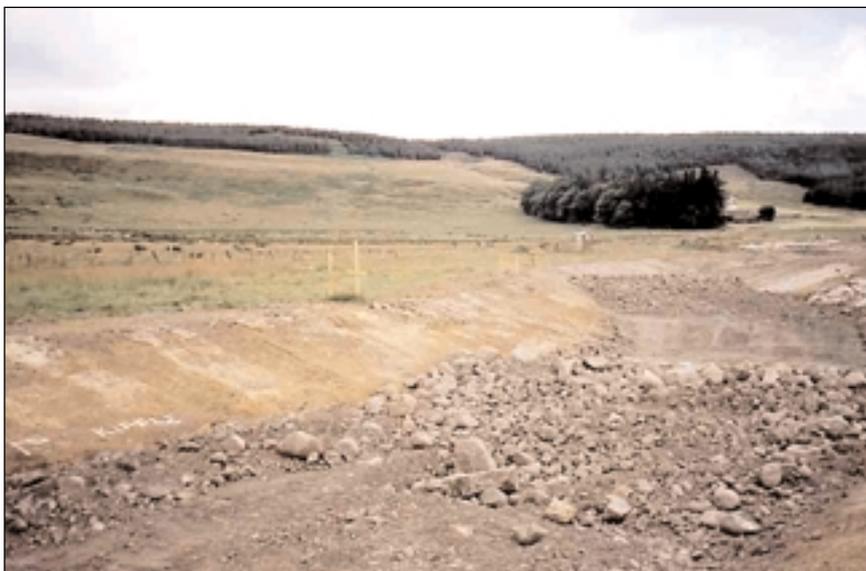
Shaping the new channel within the clay lining

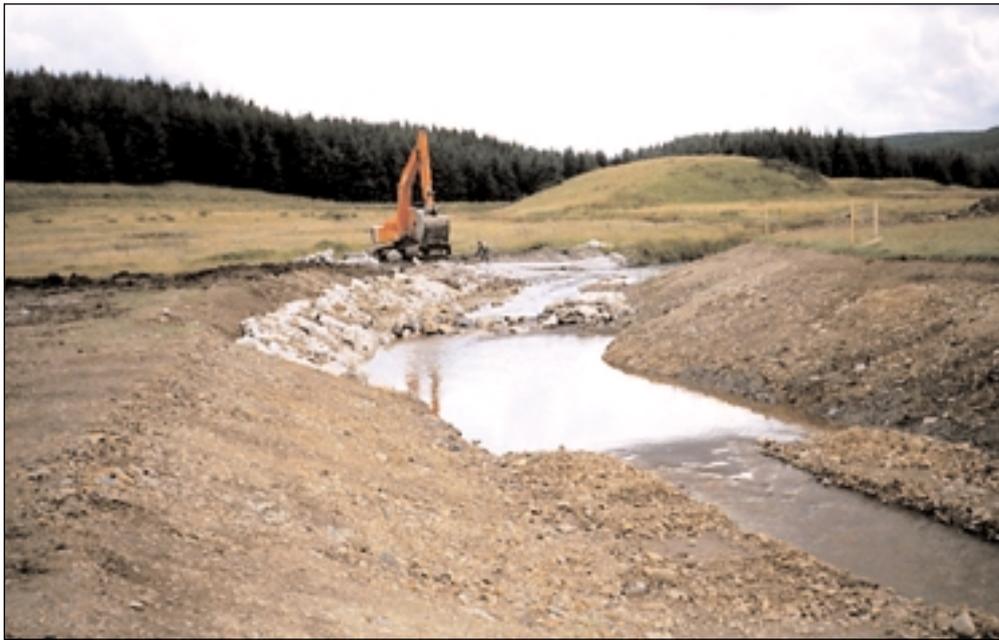
The 'constructed' run-pool-riffle sequence

Run-pool-riffle sequences were constructed by over-excavating the ground where the pools would be located. When forming the bed, cobbles and boulders

were pushed into the graded gravel upstream of the pool, forming a raised bed and a central faster 'run' of water entering the pool.

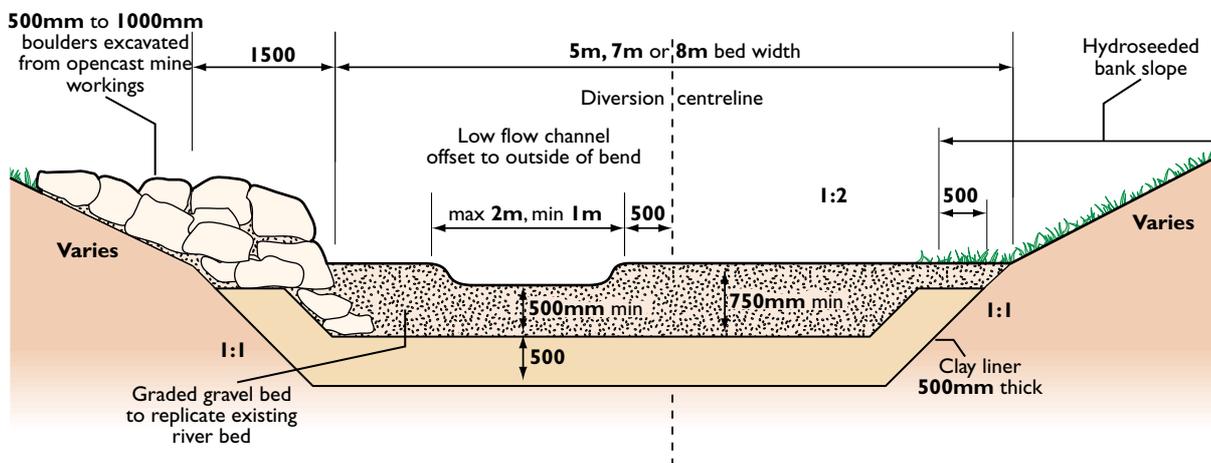
Figure 11.2.3

TYPICAL ASYMMETRICAL CROSS-SECTION

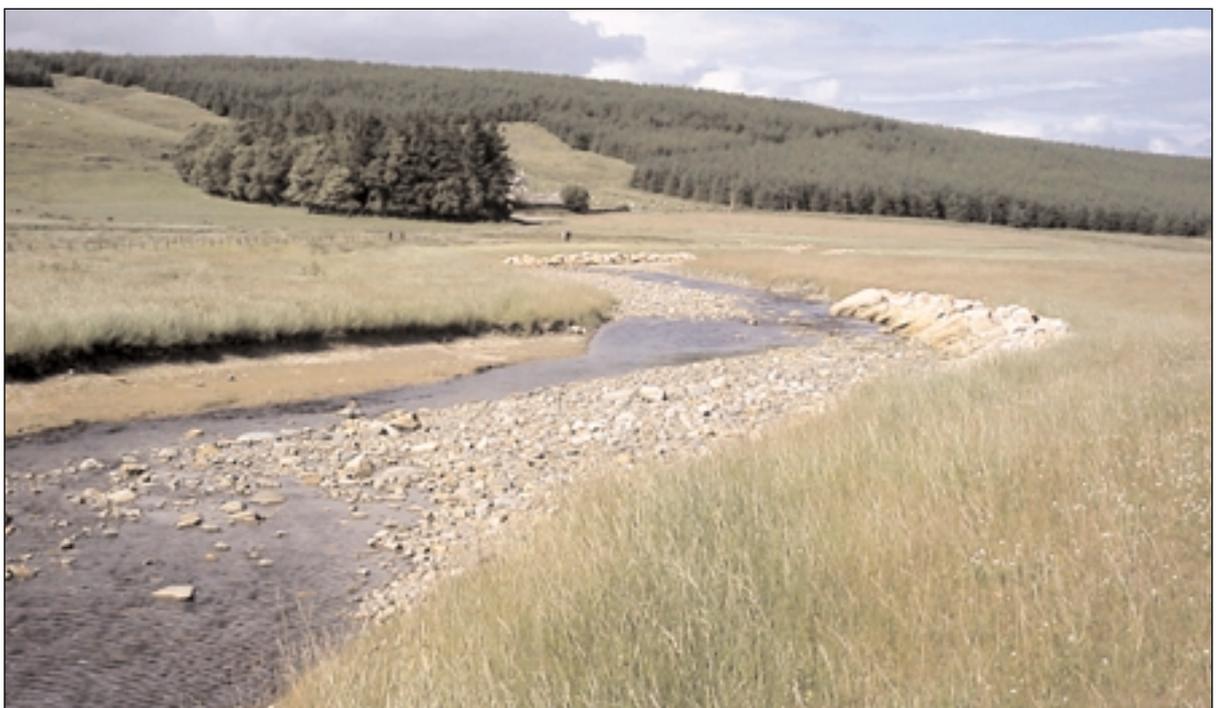
One year on and natural redistribution of in-channel sediments is helping to 'soften' the engineered channel

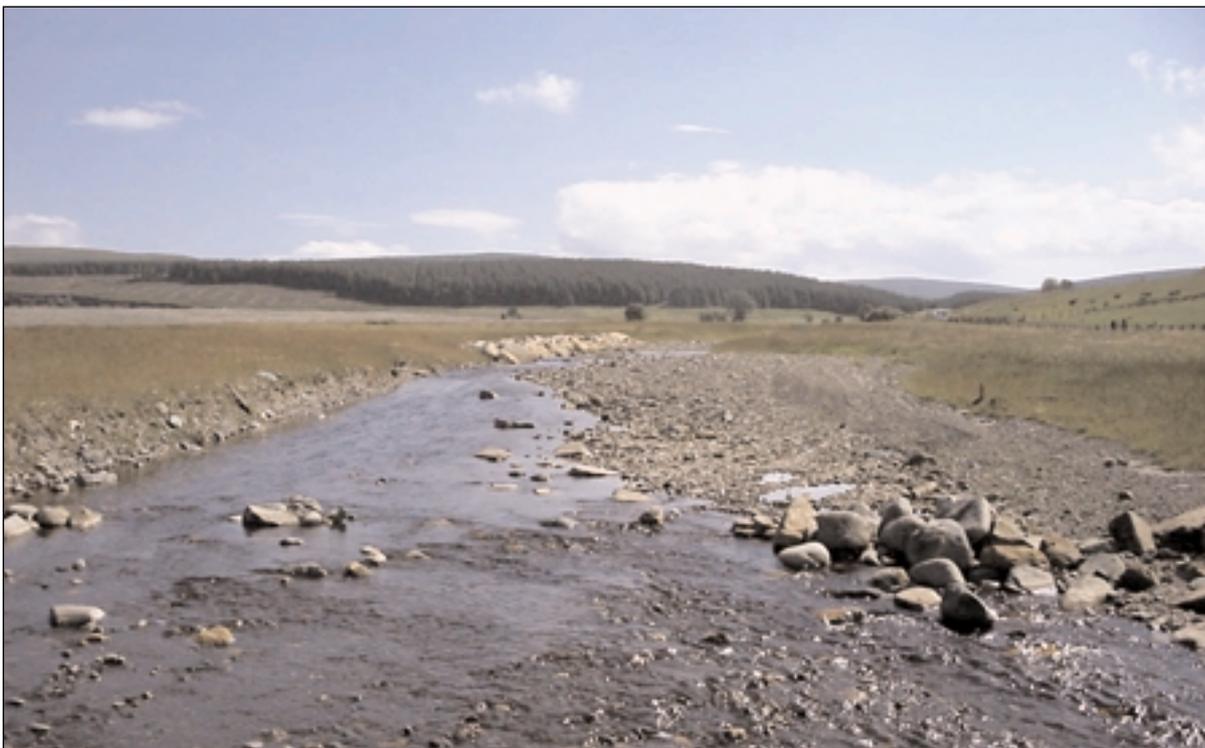
The overwide channel and plentiful bedload gives the river scope to shape its bed

tributary junctions; dynamic reaches in natural rivers. The bed material was mobilised, as it was in natural reaches up and downstream, and as a result the constructed low-flow channel was replaced by a natural thalweg. The movement of the bed material resulted in some reaches becoming shallower, and the creation of point bars not in the design, increasing diversity of water depths and velocities.

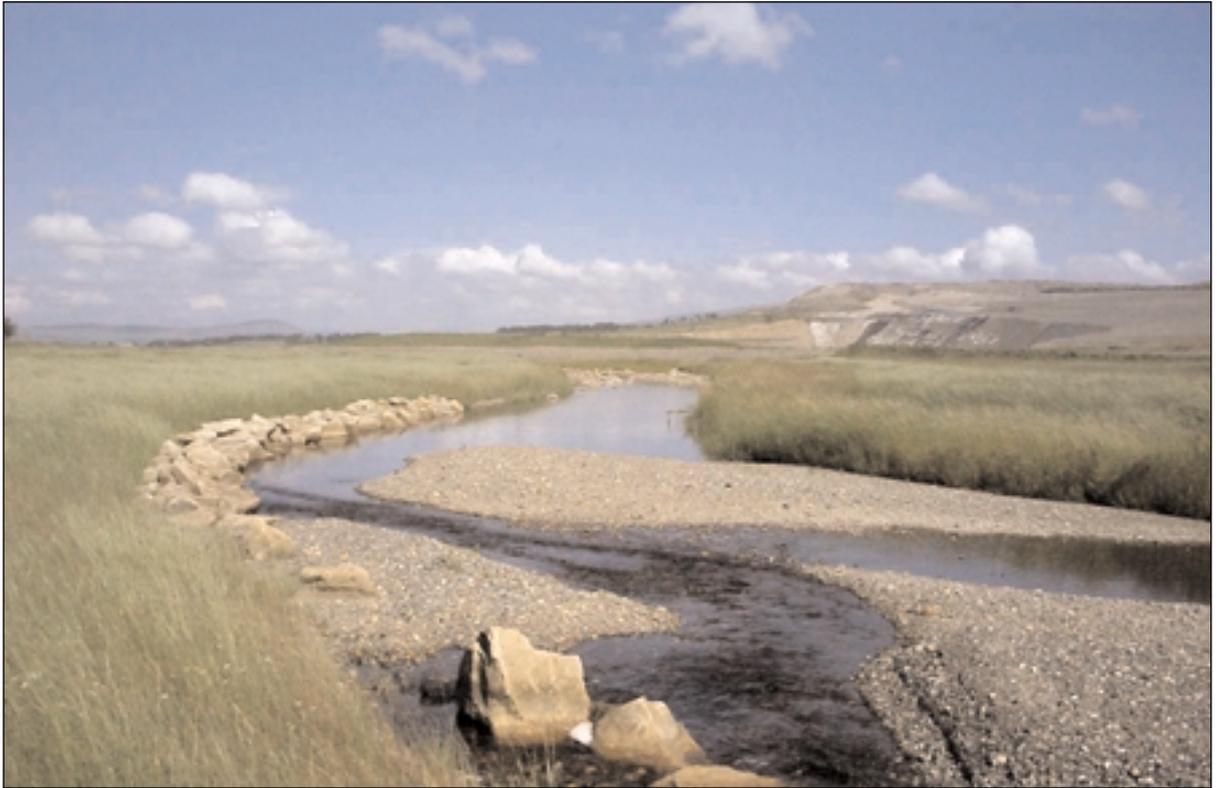
The rip-rap is still very evident but the in-river form is developing well
