# RESTORING MEANDERS TO STRAIGHTENED RIVERS

## 1.4 New meanders to one side of existing channel

### RIVER SKERNE

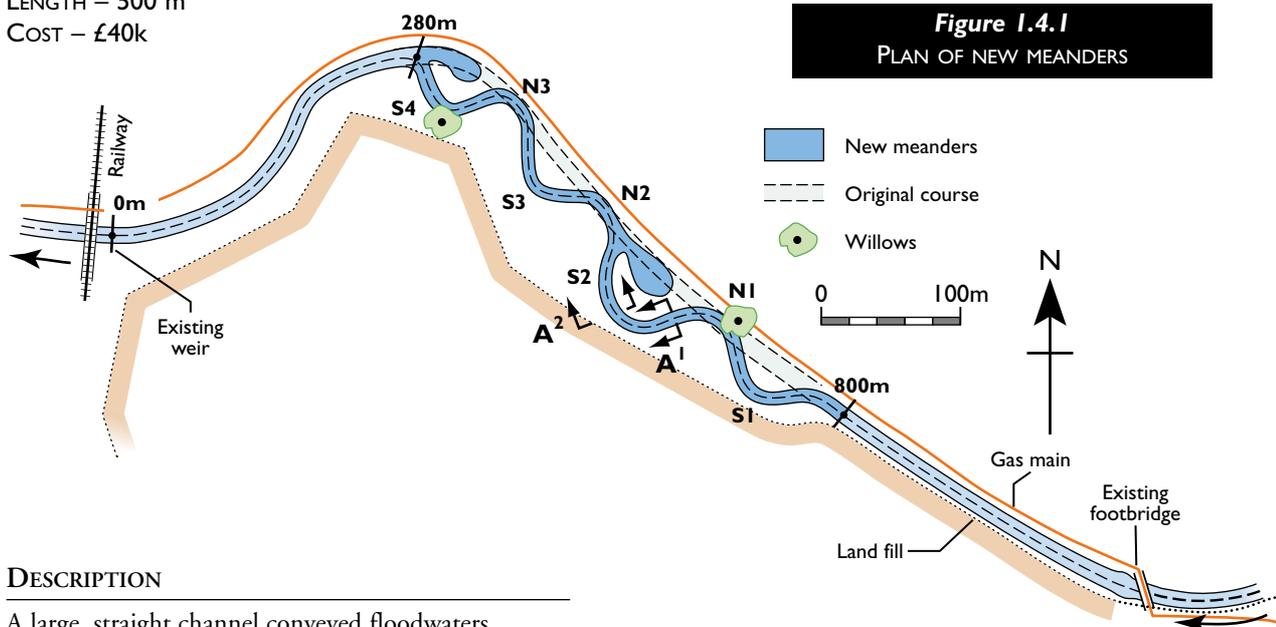
The lateral extent of meandering is constrained between a gas main, running closely alongside the north bank of the old course, and landfill tipped to within 10 to 50m of the south bank. Bends S4 and N1 were located to retain two mature willows on the banks. The remaining meanders are set out between and checked against geomorphological criteria to finalise the layout. High flows in this channel and

#### Alignment of channel (fig. 1.4.1)

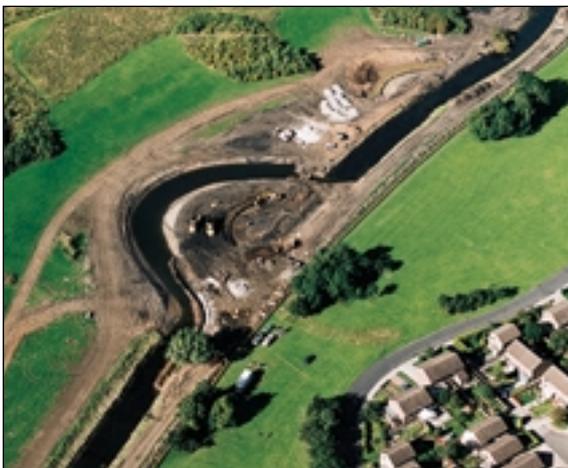
Meander excavation – Autumn 1995

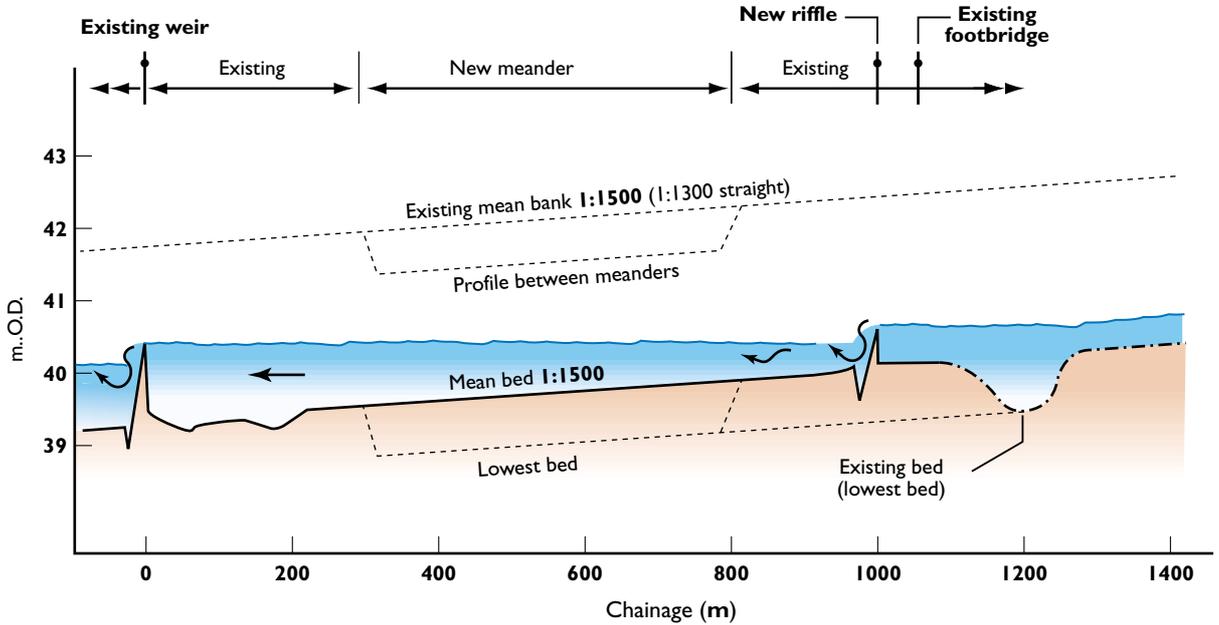
**Figure 1.4.2**  
LONGITUDINAL PROFILE

The original mean bed gradient of 1:1300 paralleled the mean bank gradient at a depth of c. 2.4m.

The new mean bed gradient and level matches the existing but flattens to 1:1500 because of the increased length created. Bed scour around each meander was expected to reach c.1m depth as observed at an existing bend at ch. 1200m. This is shown as 'lowest bed' on the long section 1m below mean bed. Conveyance of floodwaters across the new meanders was facilitated by a general lowering of inter-meander land levels by c. 0.6m. This also enhanced water storage aspects of the 1 in 100 year flood hydrograph, attenuating the peak flow downstream.

Normal water levels in the reach are controlled by an existing weir at ch. 0m, but the effect of this diminished at ch. 900m where the original straight channel was retained and enhanced. Enhancements included an artificial rock/gravel riffle at ch. 1050m shown on the long section (see Part 3).

#### Longitudinal profile (fig. 1.4.2)

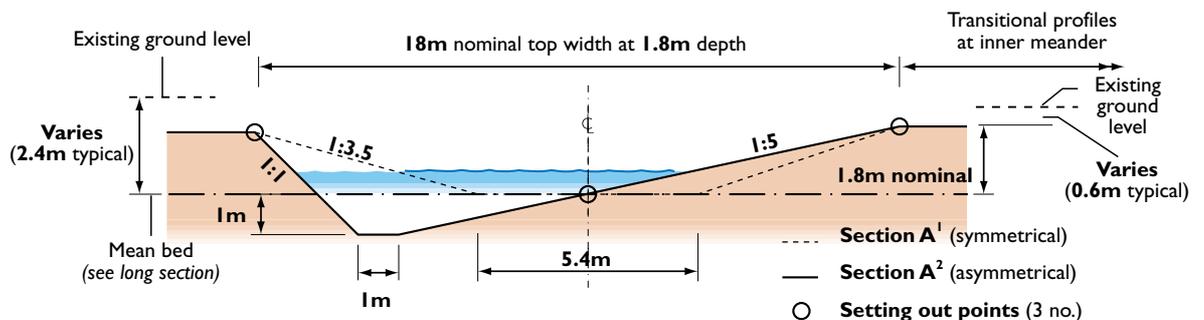
**Figure 1.4.3**  
SECTION THROUGH NEW MEANDERS

Because of continuously varying vertical depths described for the longitudinal profile, the design needed to be simplified. Two sections (symmetrical and asymmetrical) were developed based on mean depth (1.8m) and mean top width (18m). These applied to two points only on each meander - intermediate profiles required a continuous transition between them. The asymmetrical section allows for 1m of scour at each bend described above.

A variation of the pair of sections shown was developed for bends S1 and S4. A horizontal ledge at normal water level was incorporated around the inside of each to simulate the effects of natural shoaling.

*Cross-sections (fig. 1.4.3)*

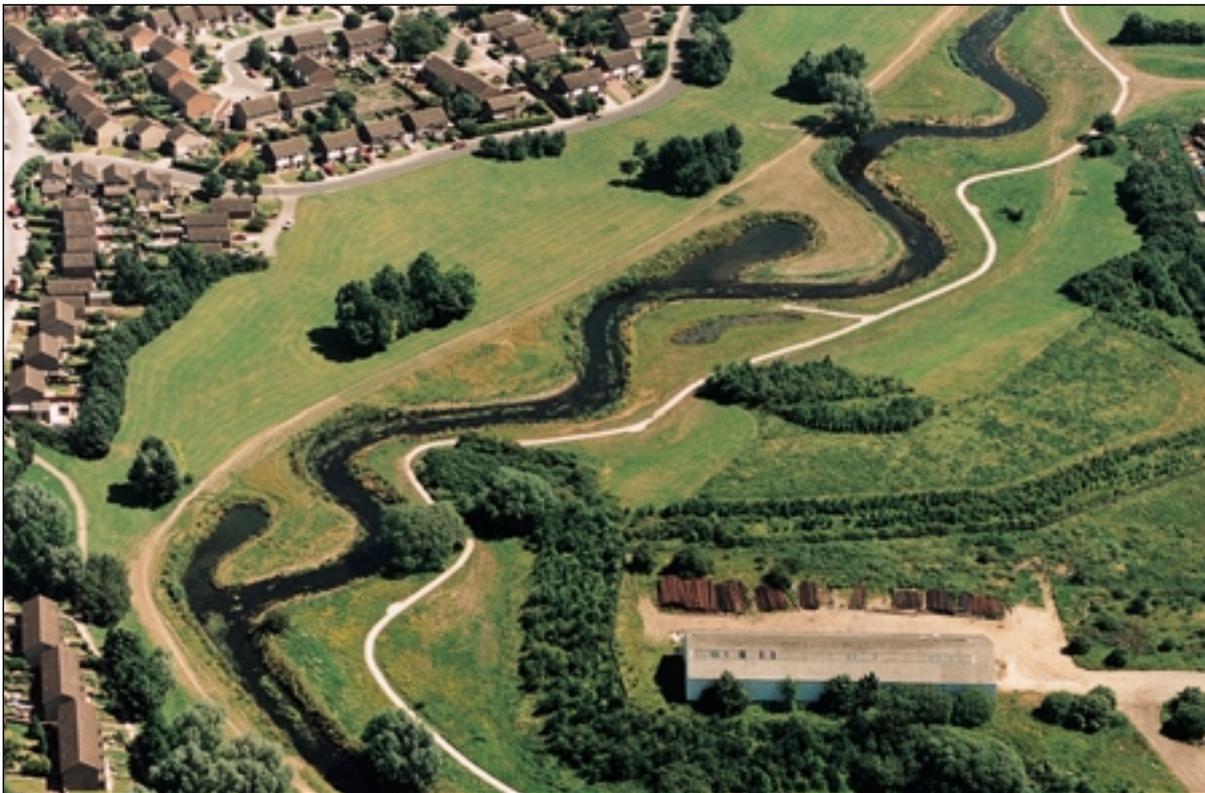
Completed meanders – Summer 1997

The newly meandered channel has proved to be stable under frequently occurring flood conditions. The most vulnerable banks, located where bends are incorporated into the backfilled course, are supported

by revetments (*see Part 4*), but elsewhere the indigenous clays have resisted erosion. Sands, silts and mud have deposited as shoals where eddy currents arise around the inner margins of bends and the deeper pools created around the outside appear self-sustaining. Diverse flora and fauna have rapidly colonised the many different features of the new course and local people enjoy relatively safe access to the waters edge.

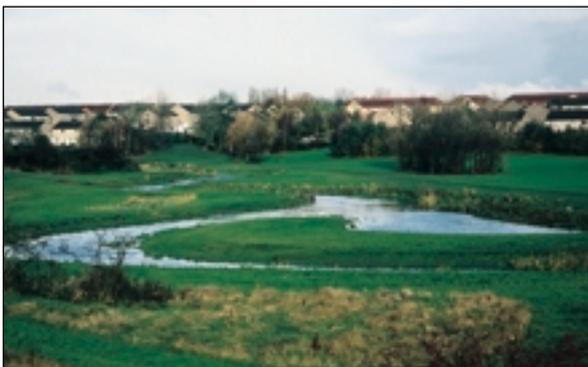
Looking downstream towards large backwater – February 1997
