RESTORING MEANDERS TO STRAIGHTENED RIVERS

1.7 Reconnecting remnant meanders

RIVER LITTLE OUSE

LOCATION - Thetford, Norfolk TL 870812 – TL 874816

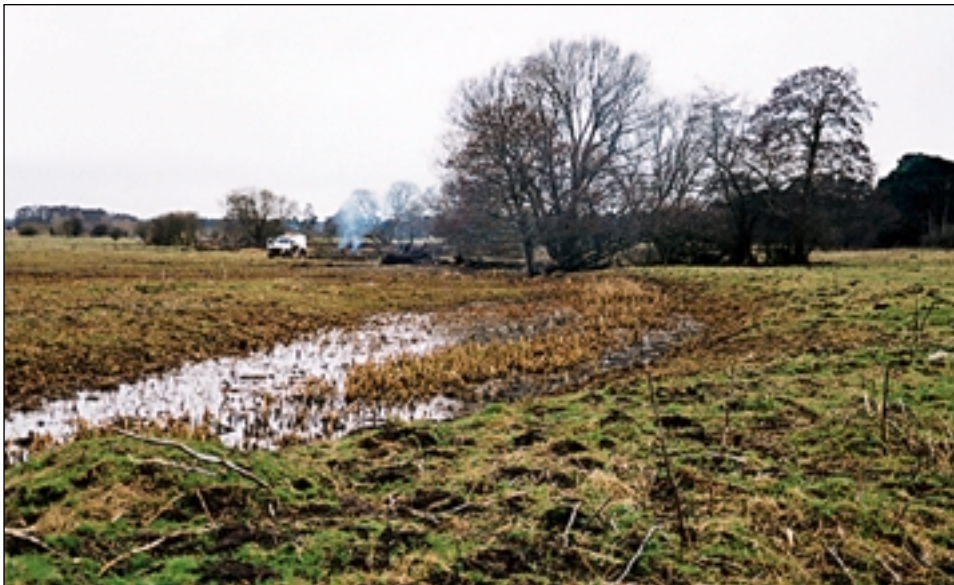
Looking downstream along the old meanders

The old meandering channel remained as a damp depression, merely infilled at each end during the excavation of the new cut. By restoring flows to the old channel 900m of diverse river habitat incorporating deep pools, runs and riffles would be regained, in contrast to the uniform, slack and deep water of the canalised section. Additionally, the landowner was keen to see the land adjacent to the meanders flood, restoring the lost hydrological connection between river and floodplain.

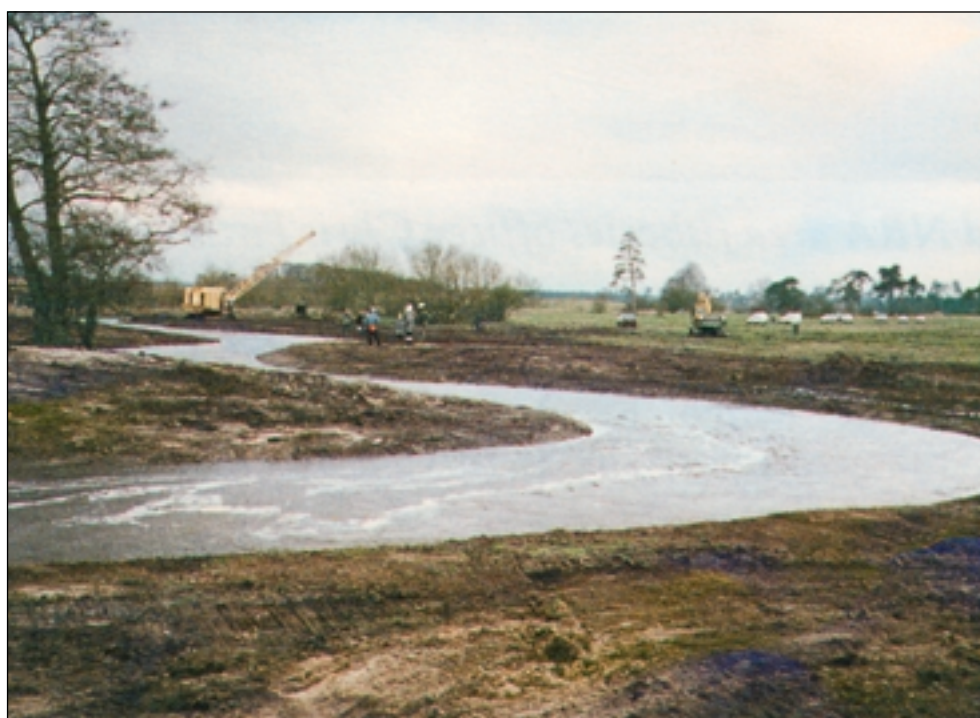
After reconnection
to the river

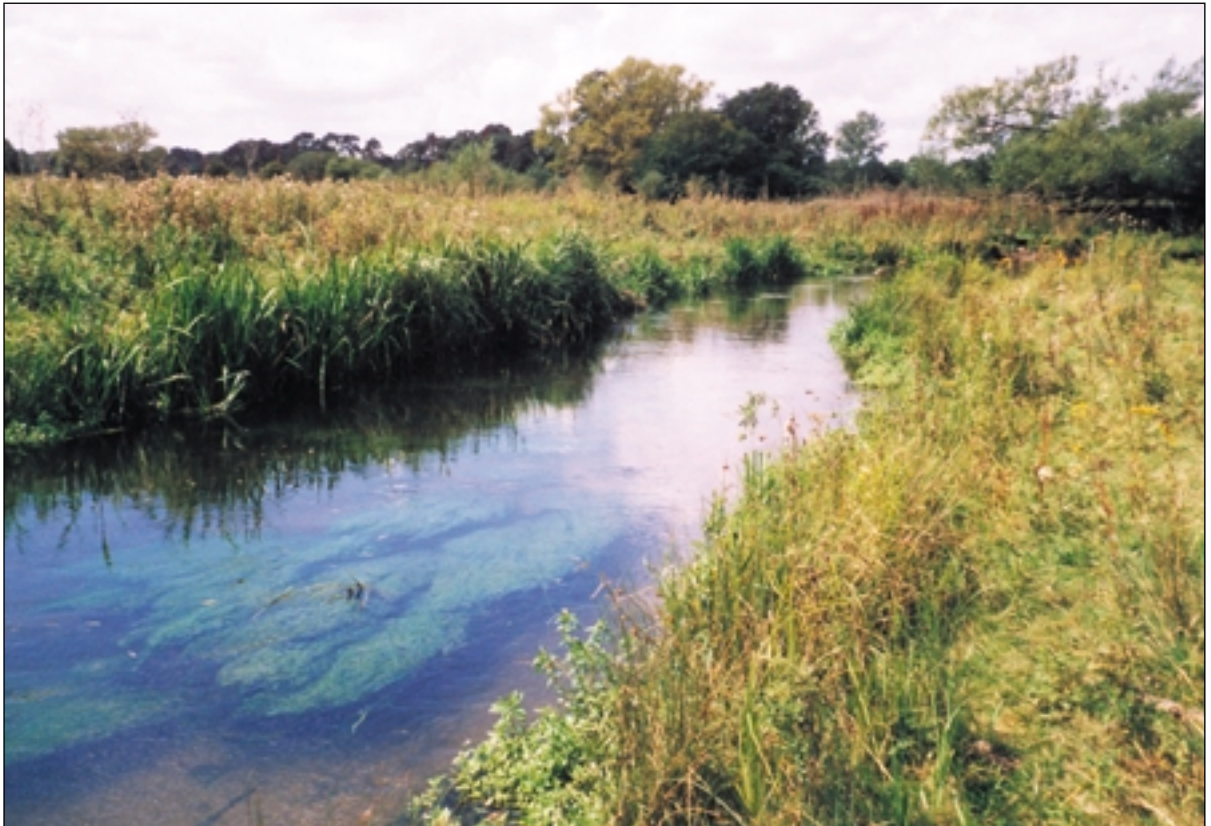
The restored Little Ouse

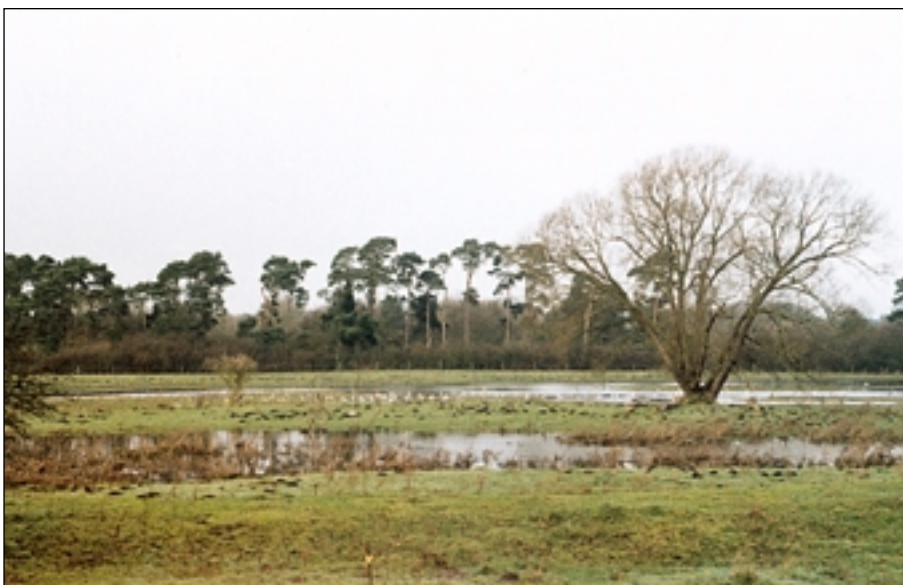
Flooding along meanders,
Spring 1999
