ENHANCING OUTFALLS TO RIVERS

9.2 Reedbed at Raglan Stream

RIVER COLE

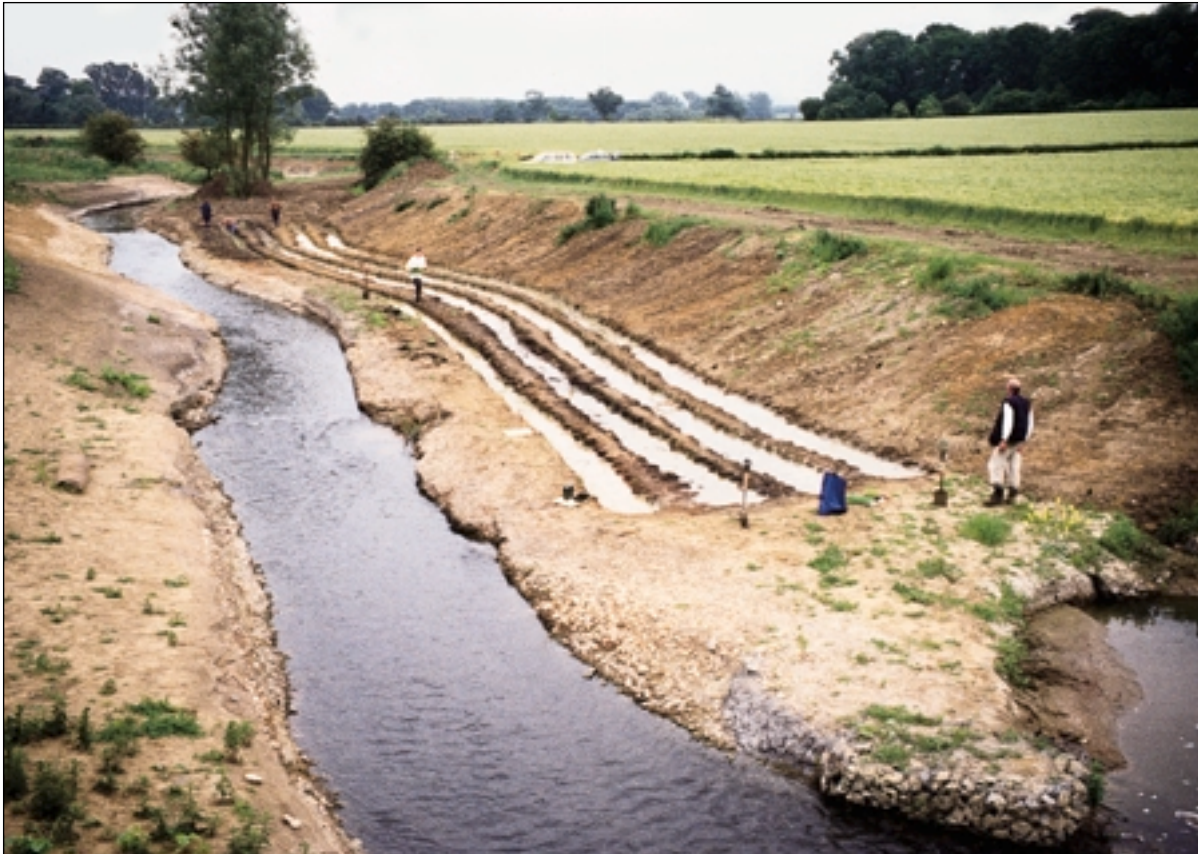
Planting reedbed – Spring 1996
