Case study 59. Hightown Sand Dune Restoration

Main driver: Improved defences

Project stage: Constructed 2011

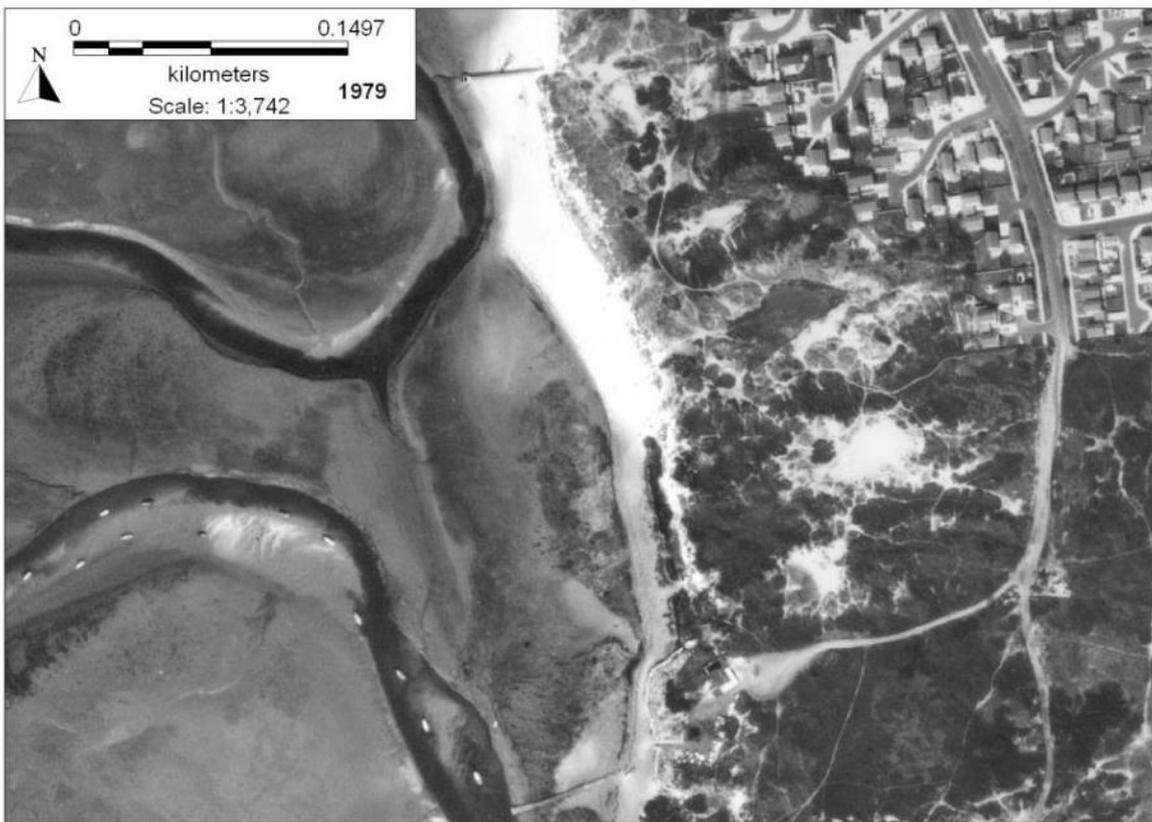
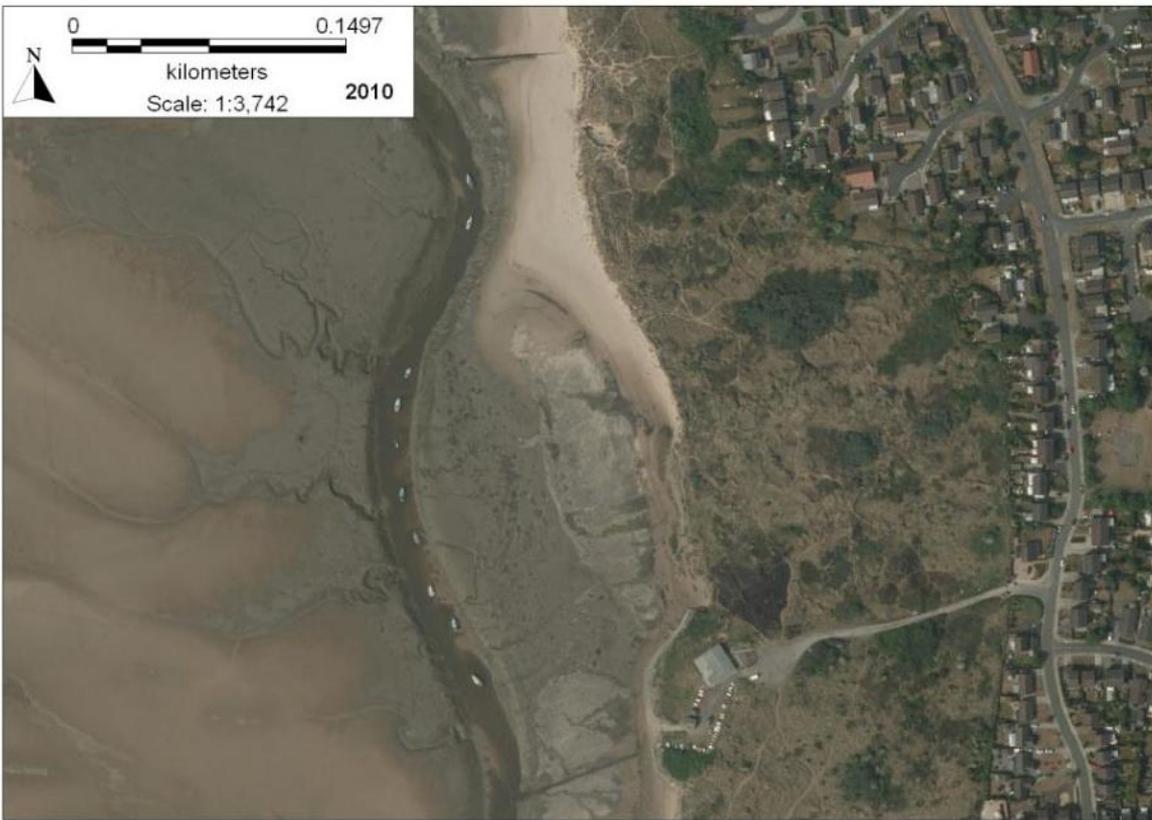
Photo 2: Changes in the dune extension between 1979 (top panel) and 2010 (bottom panel)

Photo 2 shows how the dunes have changed on this area of coast between 1979 and 2010, while Photo 3 shows the area of dune reinstatement.

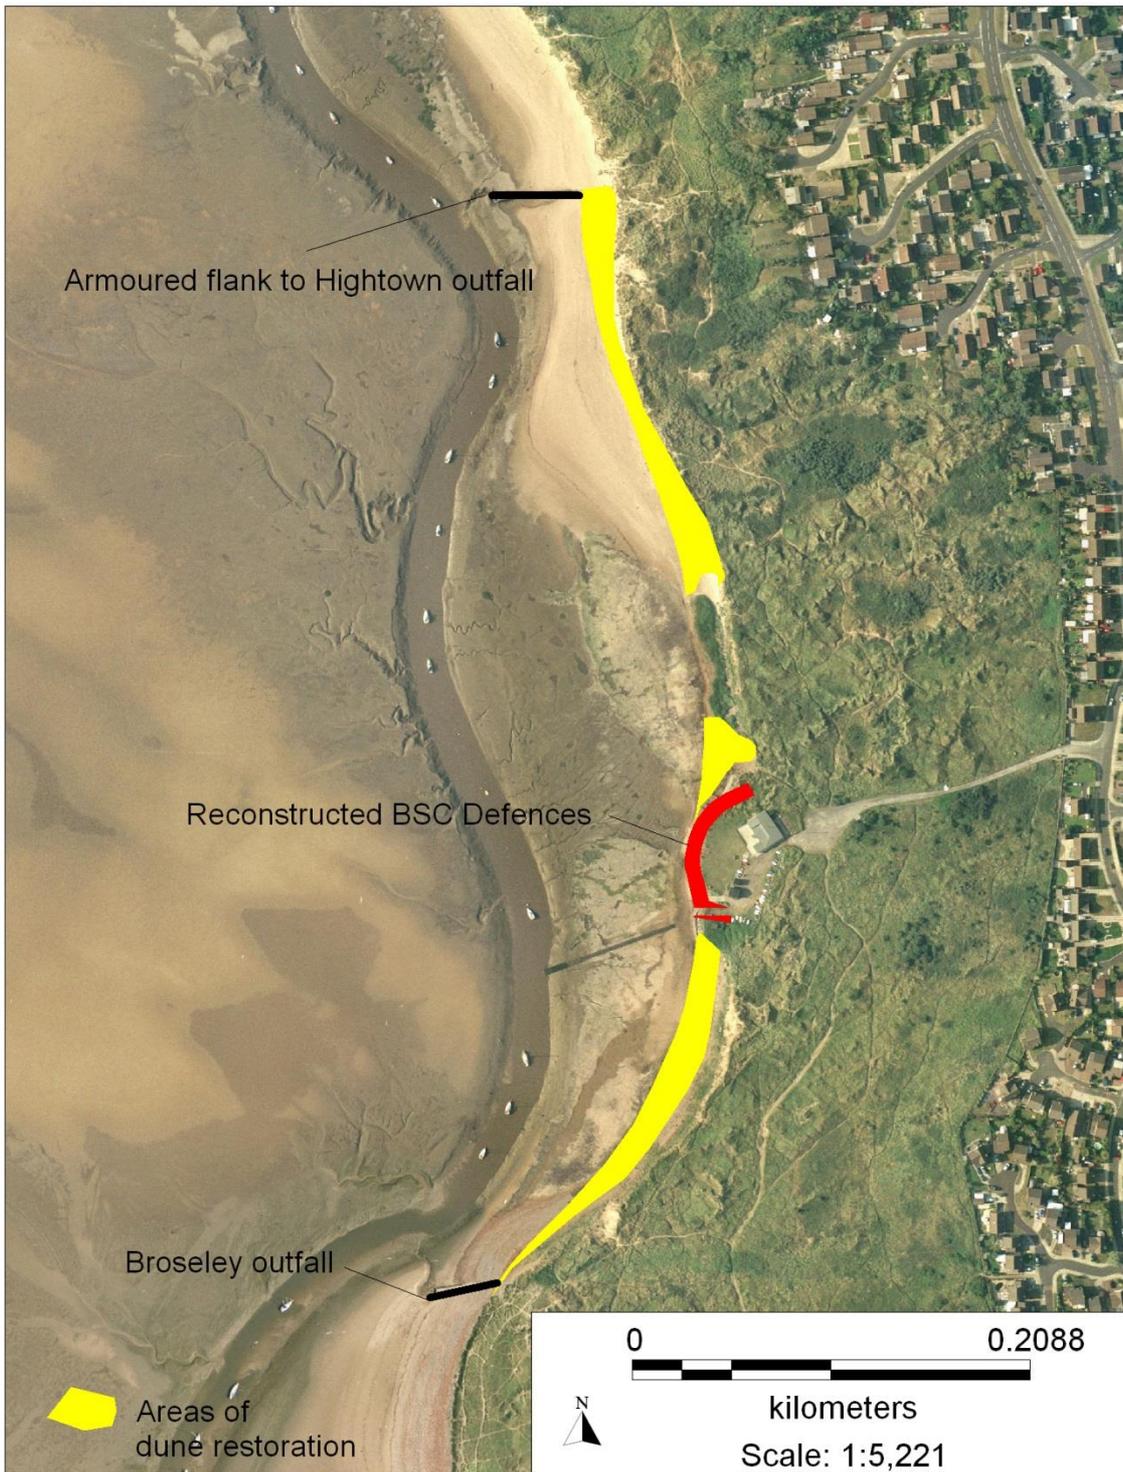
Photo 3: Area of dune reinstatement and where flood walls were repaired (source: Sefton Council)

BSC = Blundellsands Sailing Club

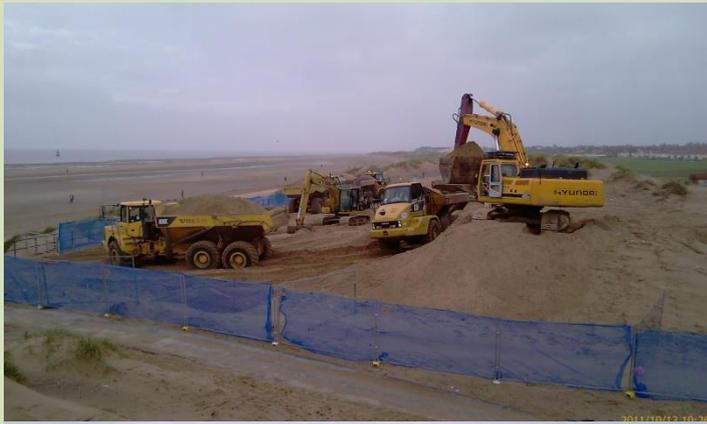
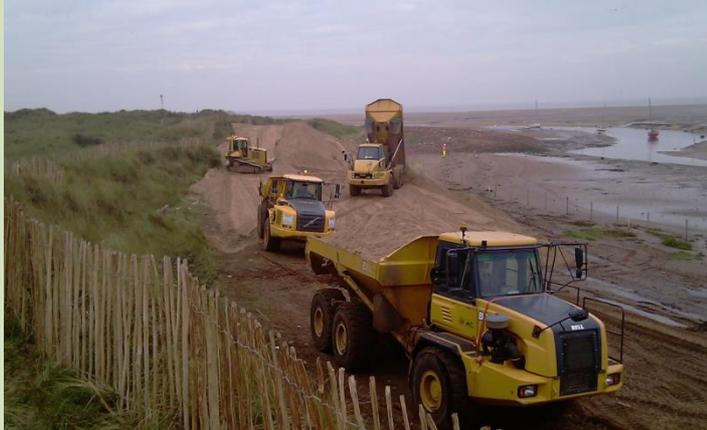
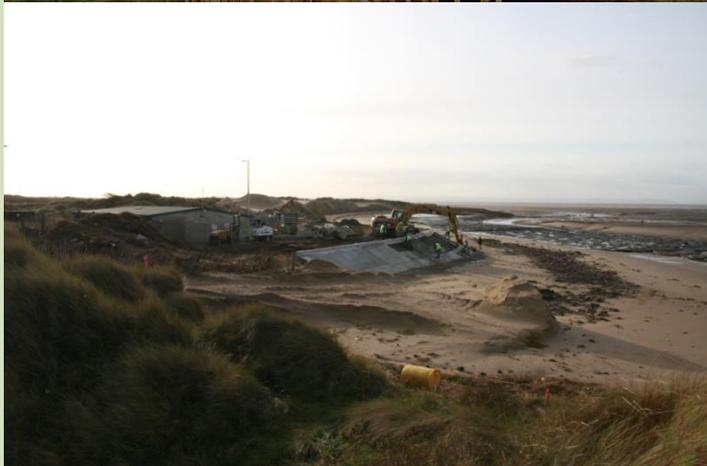
Photo 4: Sand being brought to the beach (source: Serton Council)

Sand was sourced from behind the promenade at Crosby from the Marine Lake up to Crosby Swimming Baths. A quantity of 28,000m³ was moved. The sand was transported by large off-road trucks that operated in a convoy. The route was along the beach to a point just north of the Coast Guard Station at Hall Road West, where it then ran above the beach and to the seaward side of the cycle track. Just past the point where the cycle track turns inland, the route would run through the dunes to a compound area near the sailing club. This route avoided the need to transport the sand by road.

Photo 4 shows sand being brought to the beach.

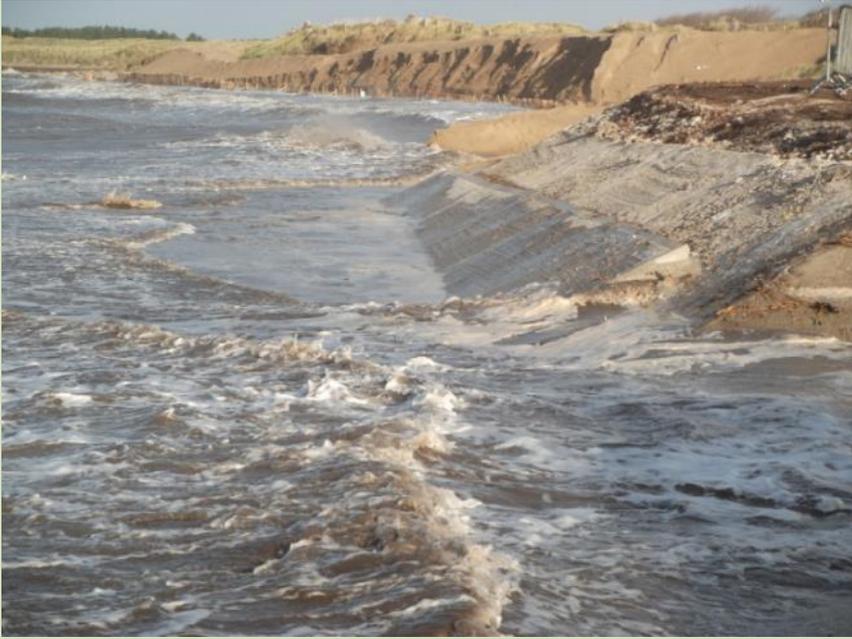
Photo 5: Dune erosion during a storm (source: Sefton Council)

Some large storms have eroded the dunes (Photo 5). Much of the sand had been redistributed on to the beach raising the beach levels; this is part of the natural system adjusting to the new position of the dunes.

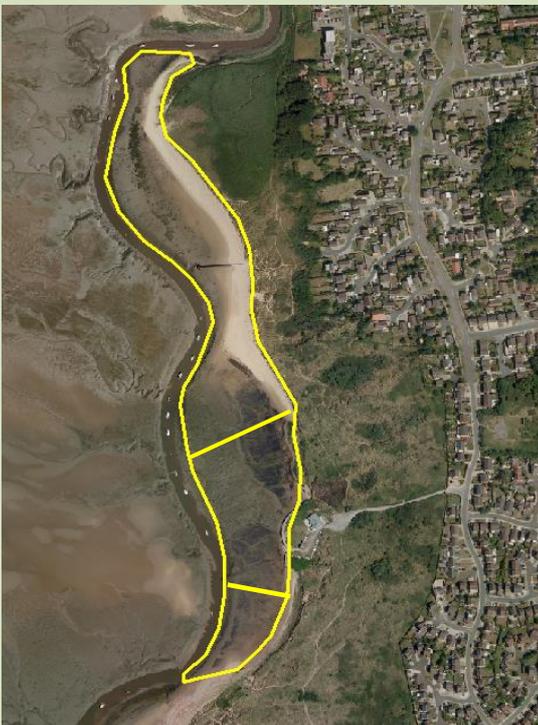
Photo 6: Area being monitored (source: Sefton Council)

Laser scanning and inspections have been undertaken. Beach topographic surveys were undertaken before and after the works to measure the height of the beach (Photo 6).

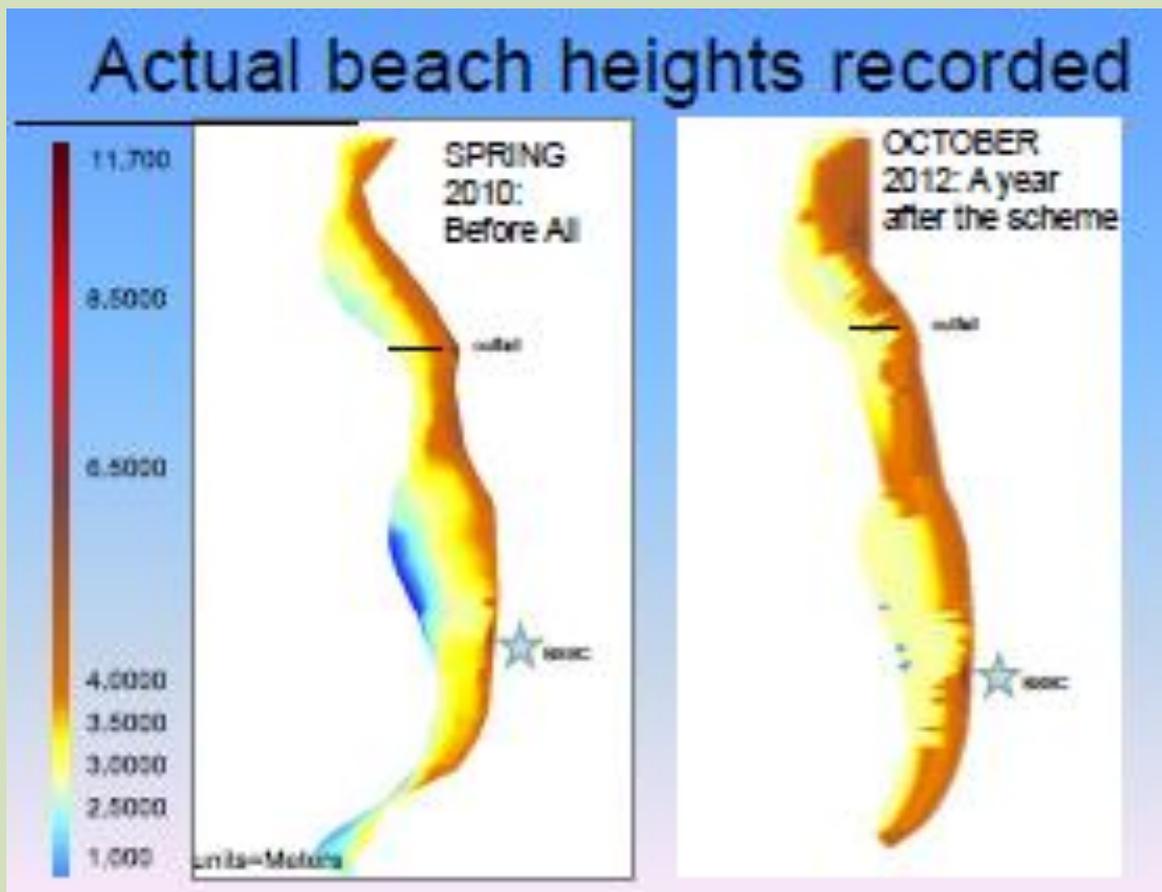
Figure 1: Recorded beach heights before and after construction work

Figure 1 shows the beach heights before and immediately after construction. Beach level comparisons are given in the appendix.
