Restoring Meanders to Straightened Rivers

1.6 Opening up a culverted stream

RIVER RAVENSBOURNE

LOCATION - NORMAN PARK, BROMLEY TQ412674

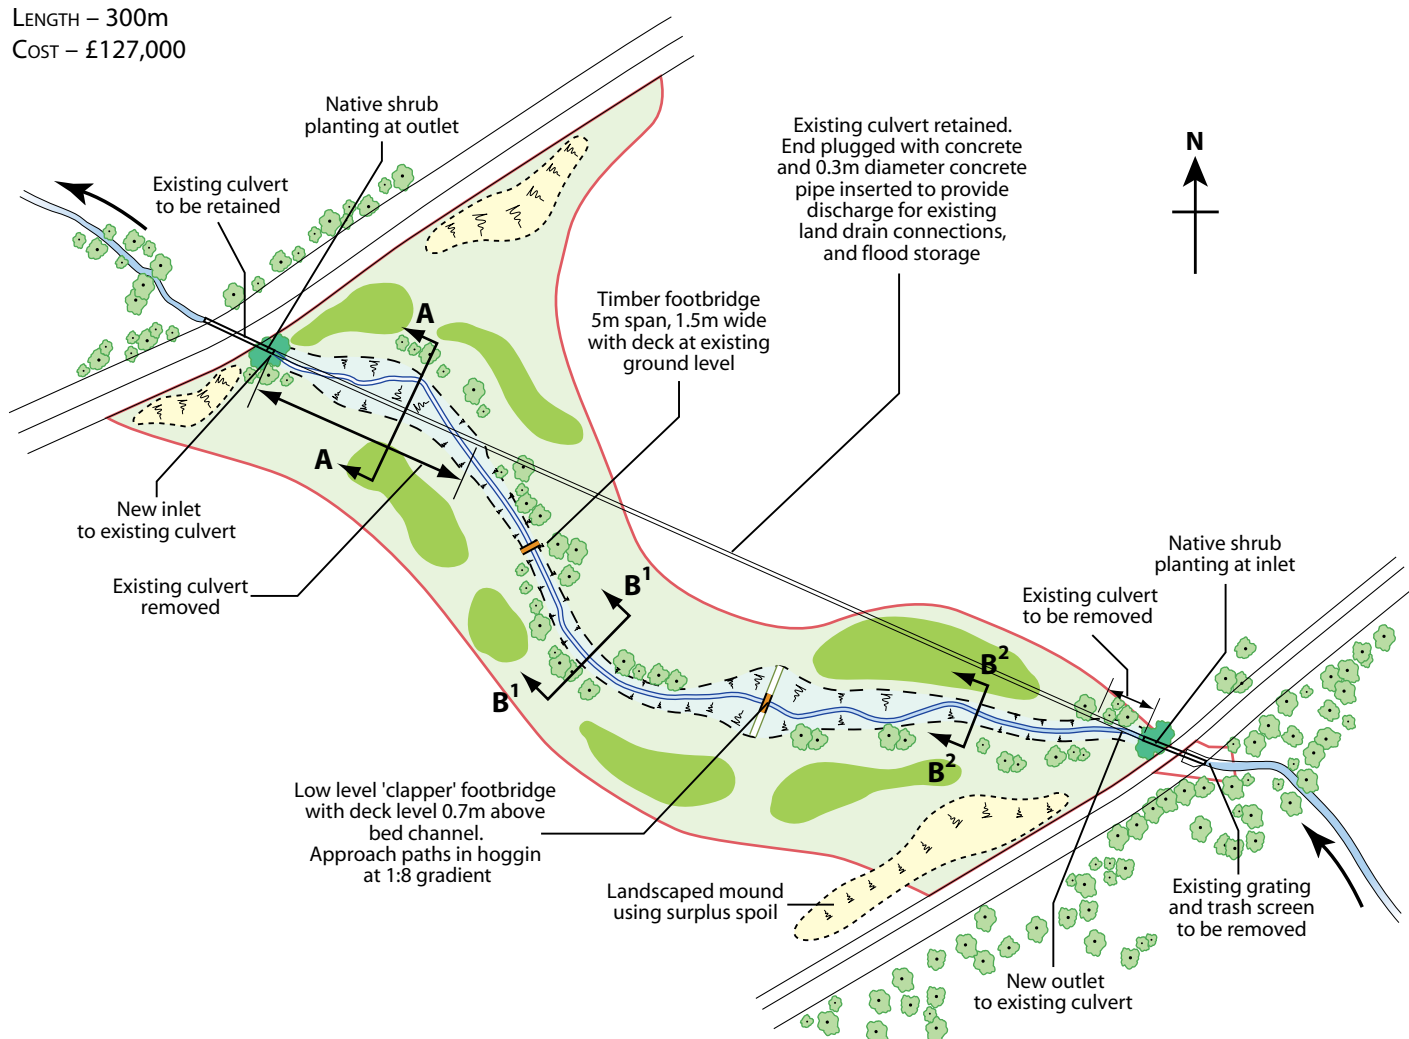
Figure 1.6.1

PLAN OF NEW CHANNEL

The design of the river channel was based on the historical layout, fluvio-geomorphology, flooding considerations and present day use of the park (cricket pitches). To avoid being overly prescriptive, the design drawings were kept relatively simple. The conditions encountered on site meant the final course is slightly different from the design plan (*Figure 1.6.1*). Indicative cross sections were provided at key locations with the main objective always a shallow, safe, accessible bank (*Figures 1.6.2 and 1.6.3*).

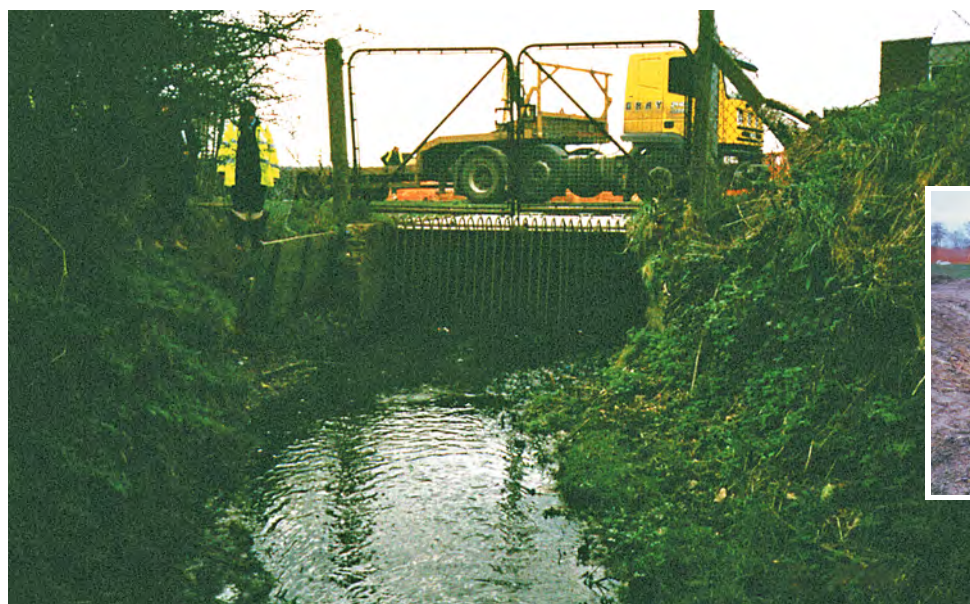
View of headscreen prior to removal

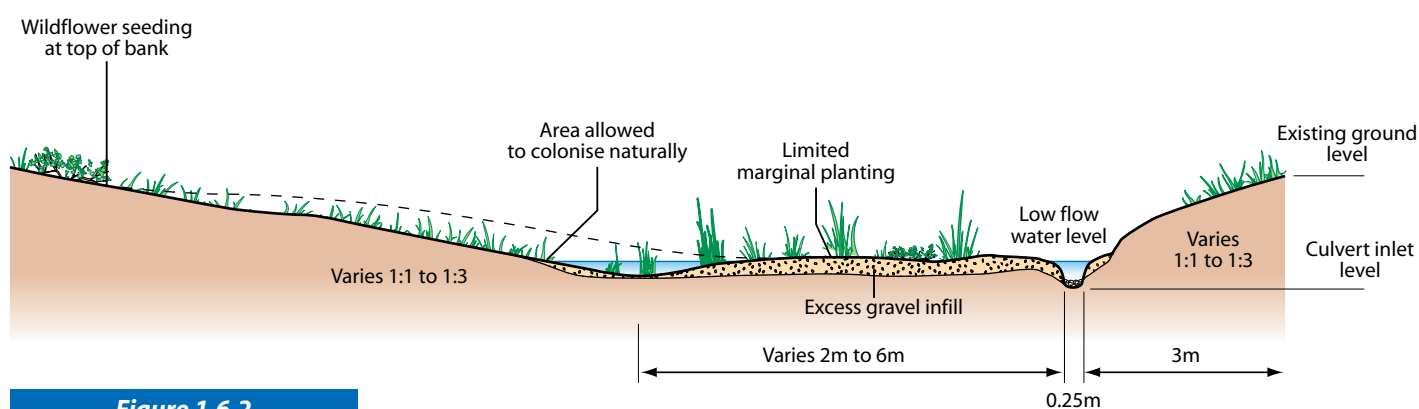
Figure 1.6.2

SECTION A THROUGH RAISED BED
AND MARGINAL SHOAL

The new channel varied in bank slope and bed width, but followed a smooth longitudinal bed profile. By then infilling with an excess of gravel, the stream was allowed to shape its new bed, rather than 'constructing' pools and riffles.

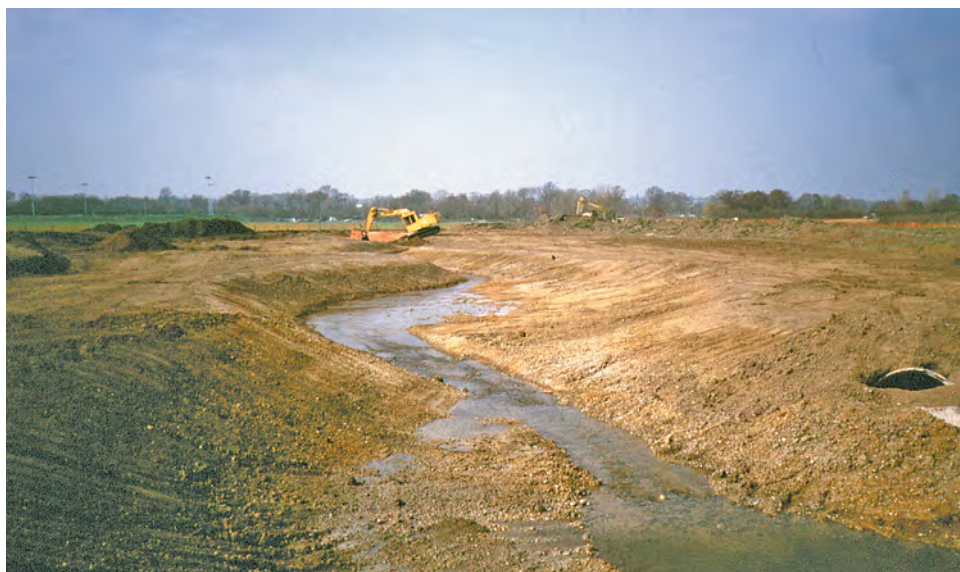
Looking downstream at the shallow bank slopes. The severed culvert still visible

The new course is 12.5% longer than the culvert, sinuous, with varying bed and top-of-bank widths. A shallow (1:8 batter) 'beach' area, as a result of an exposed gravel lens, and new meanders (1:5 inside batters) form the focal points for access to the stream.

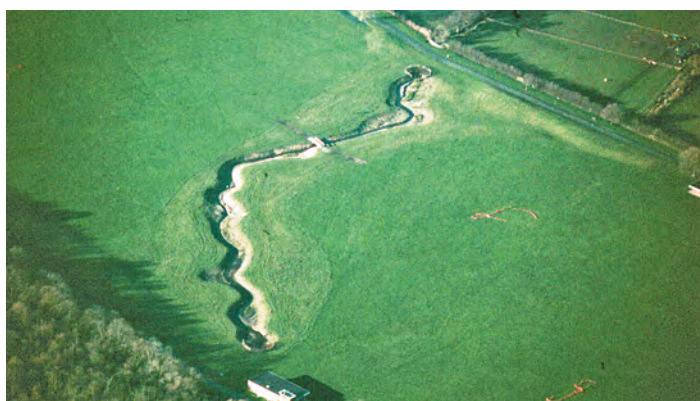
The new sinuous course and extent of wildflower seeding

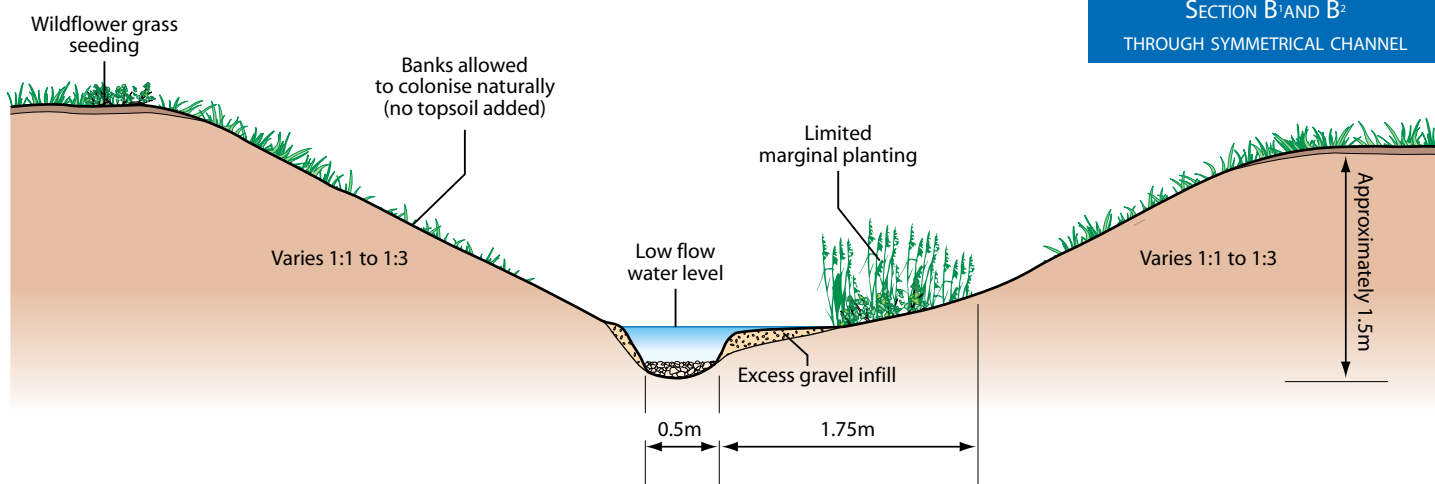
Figure 1.6.3

SECTION B' AND B"

THROUGH SYMMETRICAL CHANNEL

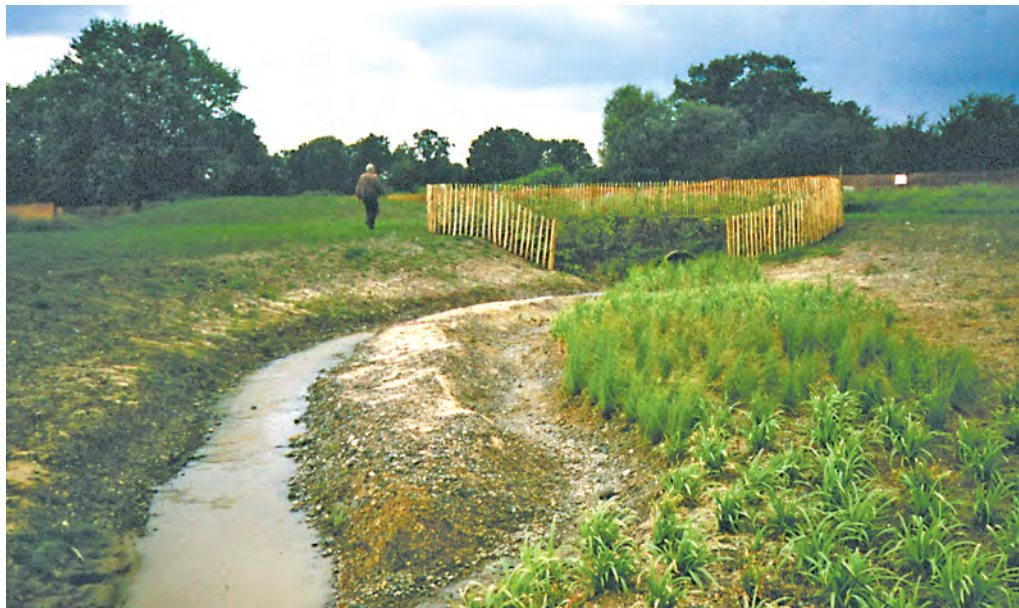
Planting up the 'wet berm' area
and shielding the culvert
entrance with shrub planting

Topsoil was not replaced on the riverbanks in order to attain a low fertility substrate suitable for the natural colonisation of wildflowers and plants from upstream. A 'buffer zone' between the amenity grassland and the top of the bank was seeded with a low-density wildflower mix from an approved source. This creates a visually pleasing edge to the playing fields and provides a suitable seed source for the banks. On the river's edge native provenance marginal plants were carefully sourced from a local nursery. School children were involved in some of the marginal planting. Wildflower plugs were also planted. The culvert entry and exit were both screened using a variety of native shrub species.

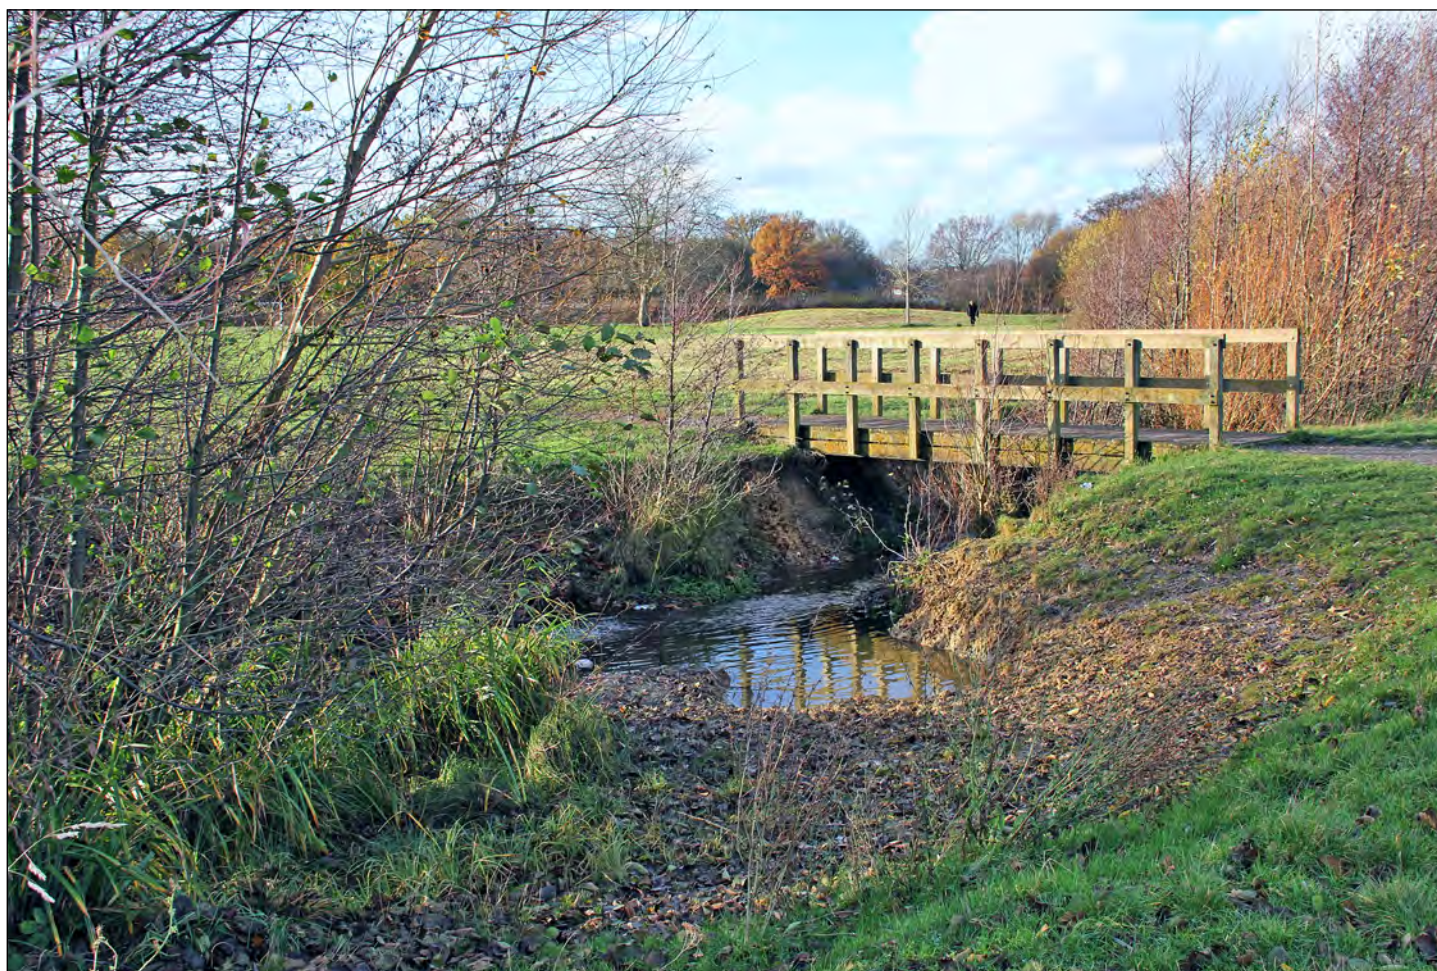
Effective narrowing of the channel, and asymmetric shallowing of the bed has occurred following restoration – 2012

Morphological processes are now able to take place on this de-culverted stretch of the Ravensbourne. Erosion and deposition is occurring within the new meandering channel and flow variability has developed. Areas of fast flow are evident in the shallower riffles and there is slower flowing water at the margins where the water level is deeper. Within a month of the works being completed the gravel had been redistributed as expected. The river had exposed the clay subsoil and has now created a stable channel.

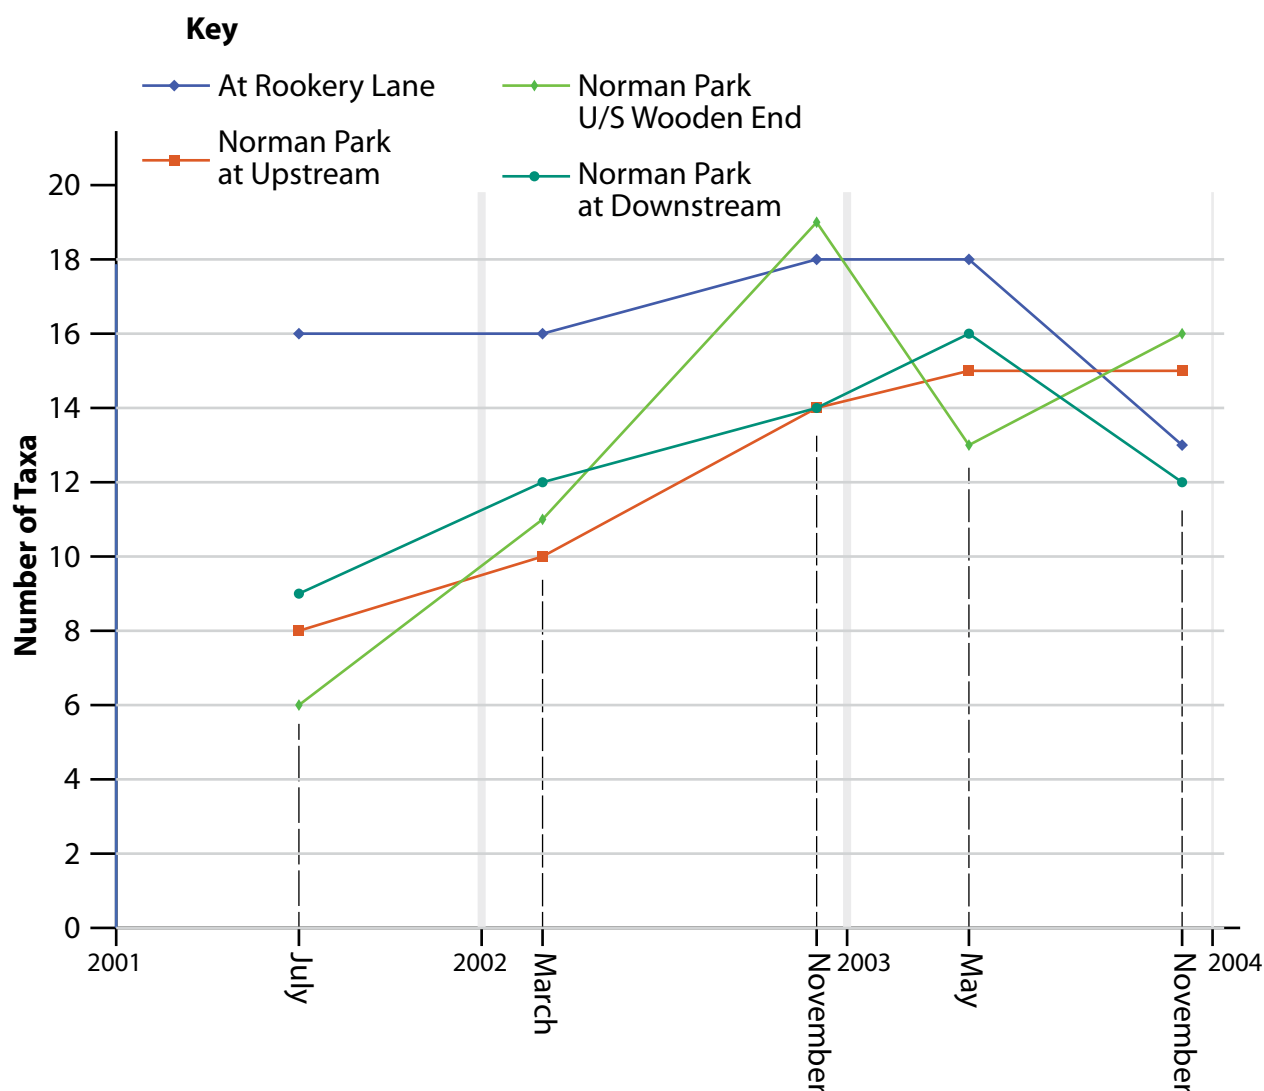
Changes in the number of invertebrates between 2001 and 2003.

By 2003 numbers for the control site (Rookery Lane) and the restored sites were similar demonstrating ecological improvement in the de-culverted stretch of the river.

Macroinvertebrate sampling was undertaken between 2001 and 2003 and this showed an increase in the number of taxa recorded following the works. Further sampling is planned for 2013 in order to compile a more complete dataset.
