# Revetting and Supporting River Banks

## 4.2 Willow mattress revetment

RIVER SKERNE

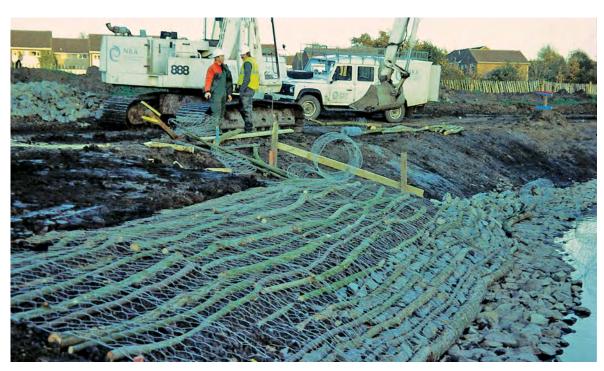
Mattress revetment under construction – October 1995 Note: Additional poles inserted to close up spacing after photo taken

This technique demonstrates revetment using willow branches that may be readily to hand in riverine situations through routine maintenance or pollarding of trees. They are laid along the reformed river bank and secured with sheep netting such that rapid growth of willow shoots will initiate a long term ecologically sustainable revetment.

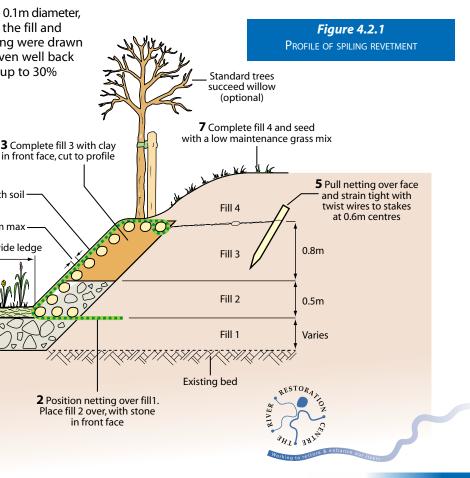
The revetment has remained stable, and dense willow growth up to 3m high covers the bank. Marginal sedge and iris complete what is a most desirable habitat niche favoured by water voles and birds.

Due to autumnal installation, no growth of willow occurred for the first 6 months, when winter floods washed out some soil. Since then the situation has reversed and silts are accumulating within the willow whilst roots extend into underlying soils and rock.
