Modifying River Bed Levels, Water Levels and Flows

5.10 Creating 'natural' features in a heavily engineered flood scheme

RIVER VALENCY

LOCATION - BOSCASTLE, CORNWALL SX10009123

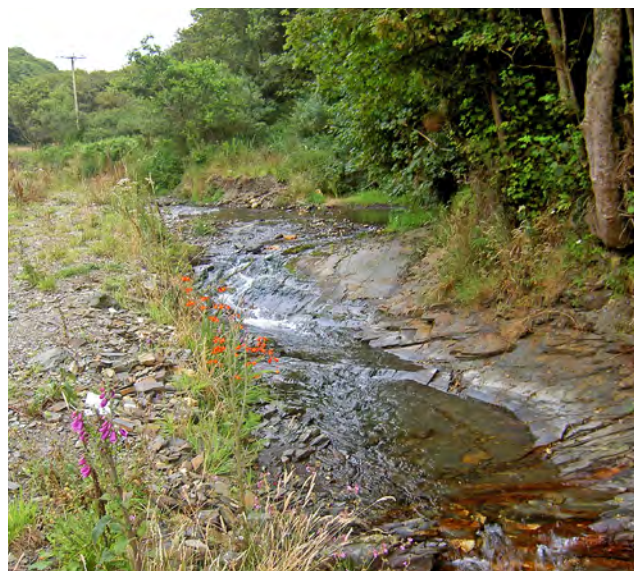
Natural cascade and pool upstream of Boscastle
- 2006

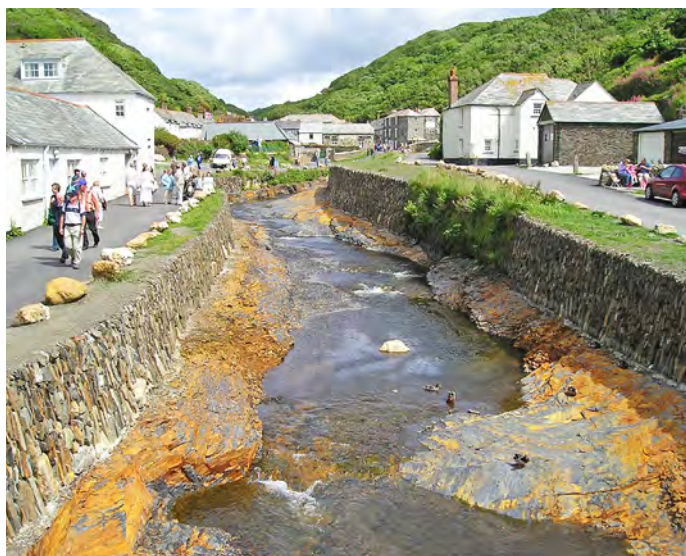
© Halcrow
The low flow course had to be entirely excavated to best mimic millennia of erosion of a hard rock bed.

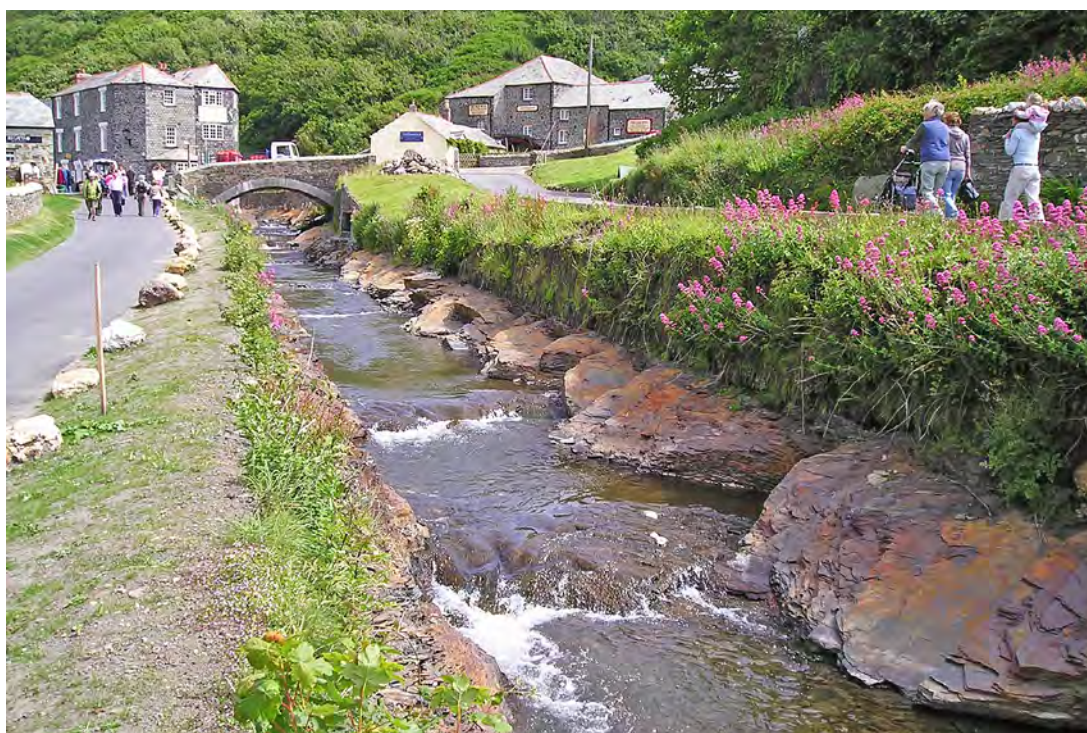
Deepened channel using natural fracture lines within the bedrock. Retaining walls becoming vegetated

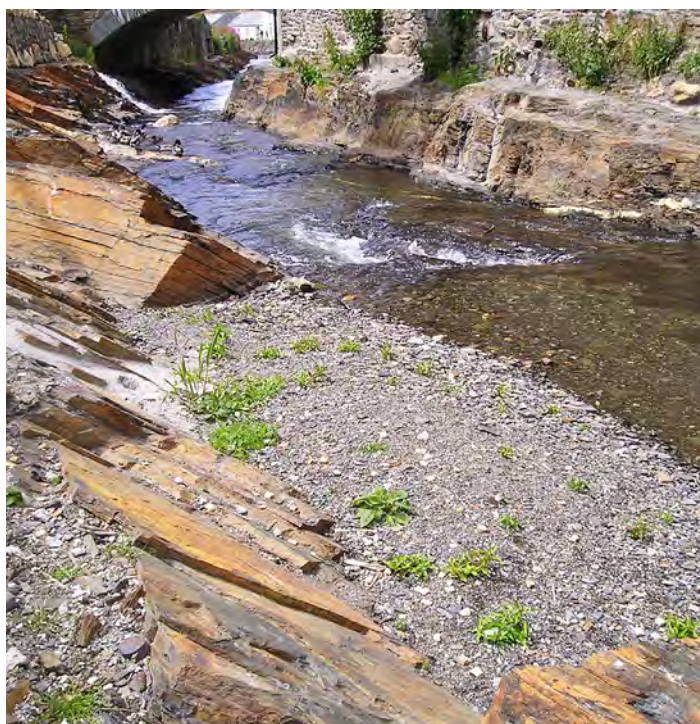
Gravel beaches have formed within the bedrock channel

The re-profiled river has performed well during the years since completion. The excavated profile has remained stable, as have the individually sculpted cascades, pools and embayments. Within the latter a good diversity of flow characteristics provides niche habitats, with some gravel in sheltered eddies as well as small beaches. It is also visually attractive, enhanced by the sound of the cascading water. This contrasts markedly with the flat, featureless river bed that existed before.

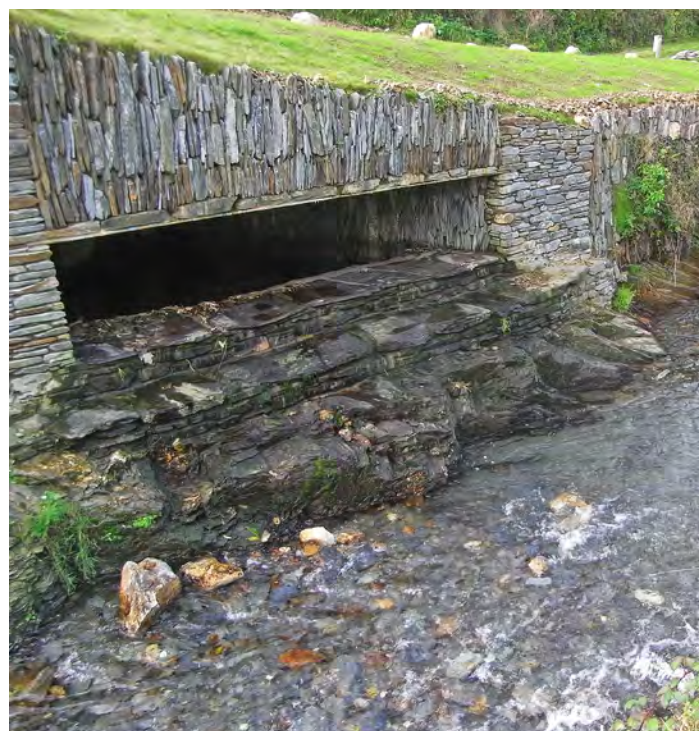
River Jordan outfall. The over-deepened pool has clearly filled with large stone sediment – October 2008

A single negative aspect has been the excessive deposition of stony sediment at one location. This is where the bed was significantly cut down below the optimum mean bed gradient of 1 in 45, to provide greater flow capacity where an overspill culvert of a tributary stream, the River Jordan, enters (See Figure 5.10.2). Bed material has simply filled this over-deepened pool to bring the bed back up to the 1 in 45 mean. Consequently there are no rock features in the bed here. This outcome was foreseen and this 'pool' had been designed such that the excess fine deposits would remobilise during flood flows, thus
