Restoring Meanders to Straightened Rivers

1.1 New meandering channel through open fields

RIVER COLE

LOCATION - COLESHILL, (OXON/WILTS BORDER) SU234935

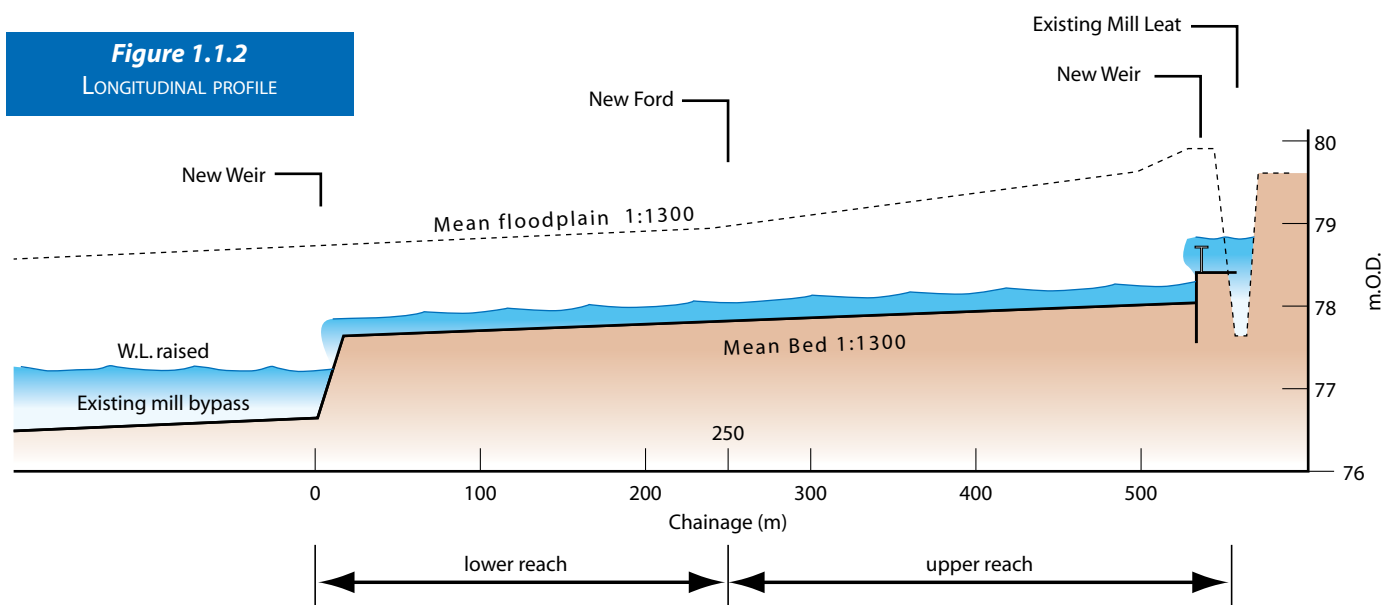
Figure 1.1.2
LONGITUDINAL PROFILE

**Design***Longitudinal profile (Figure 1.1.2)*

The new mean bed gradient was set at 1:1300 to match the mean floodplain gradient. The bed elevation was set to give the shallowest channel possible whilst having just sufficient depth to contain summer spates. The resultant channel bed is elevated higher than the old mill by-pass, but is lower than the retained water level in the mill leat which feeds it. Drop weirs were therefore required at each end (see *Techniques 5.1 and 5.2*).

Whilst weirs are generally undesirable, the alternative of deeper channels was more so at this site. The drop at the downstream end was reduced in height as a consequence of introducing new meanders downstream of the mill; these raised normal water level in the existing mill by-pass to historic levels (see *Technique 1.2*).

Section A shows a normal flow channel 2.6m wide by 0.8m deep - the geomorphology of the Cole indicates this to be the ideal size of channel. Because overall channel depth needed to exceed 0.8m (Figure 1.1.2). The upper banks were graded back as flat as practical.

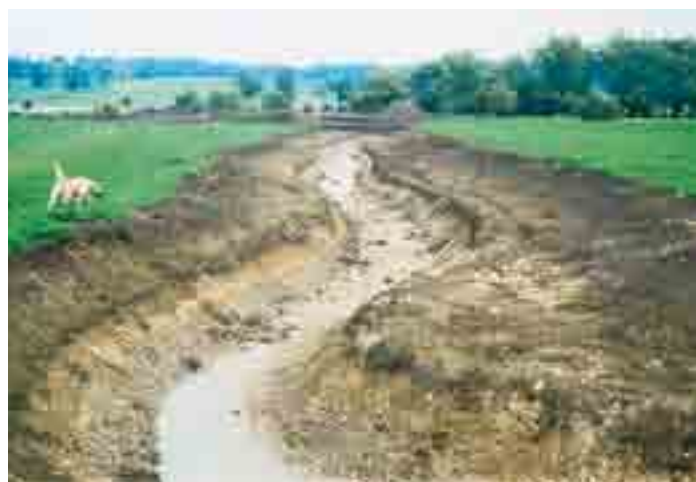
Upper reach at time of excavation – October 1995

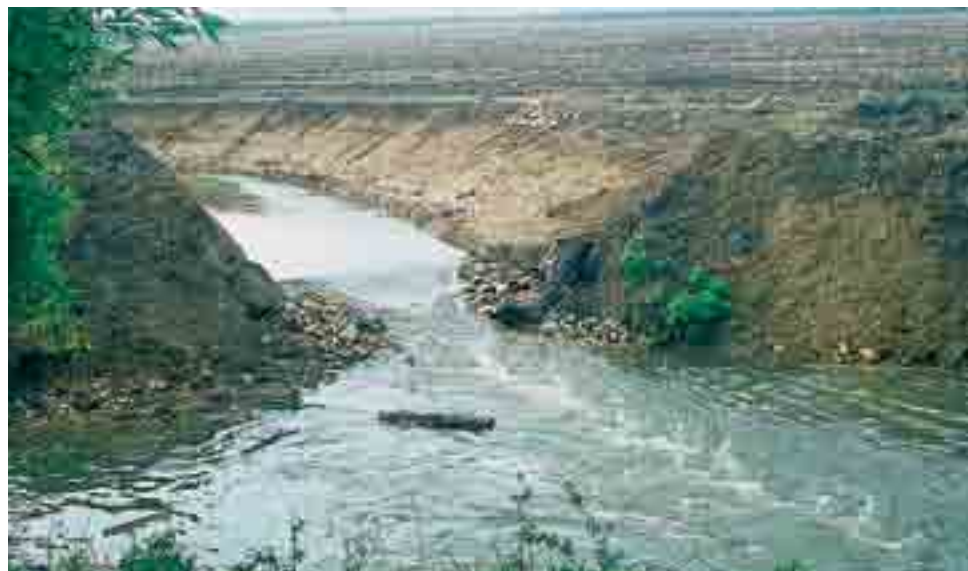
New channel flowing into existing channel during construction – September 1995

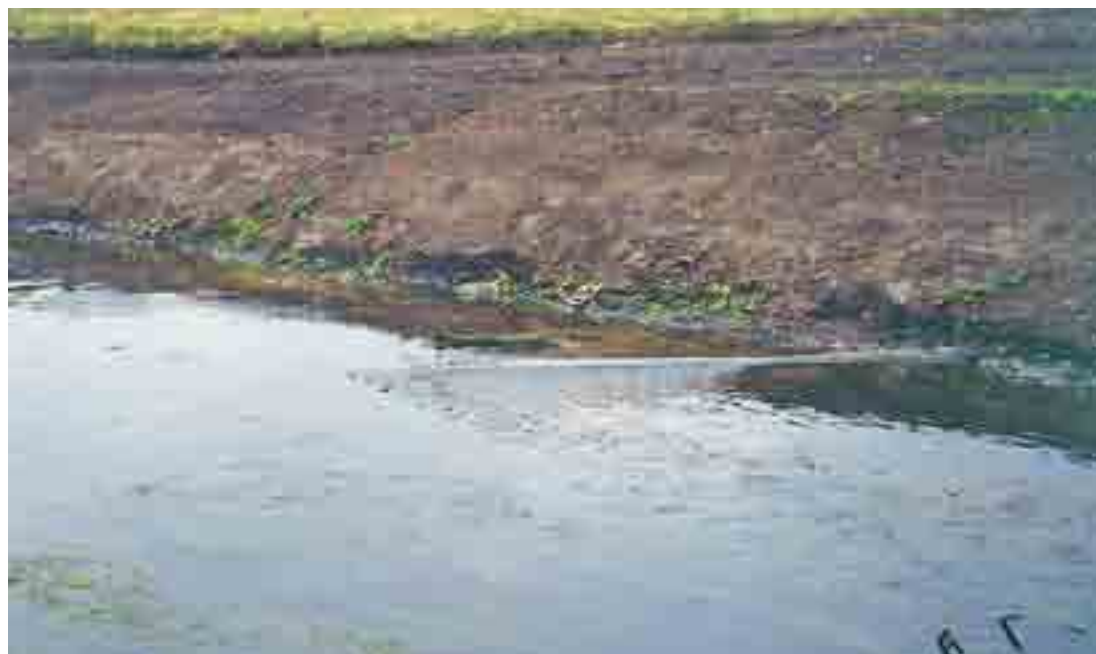
Type **A** deflector
– vegetation established

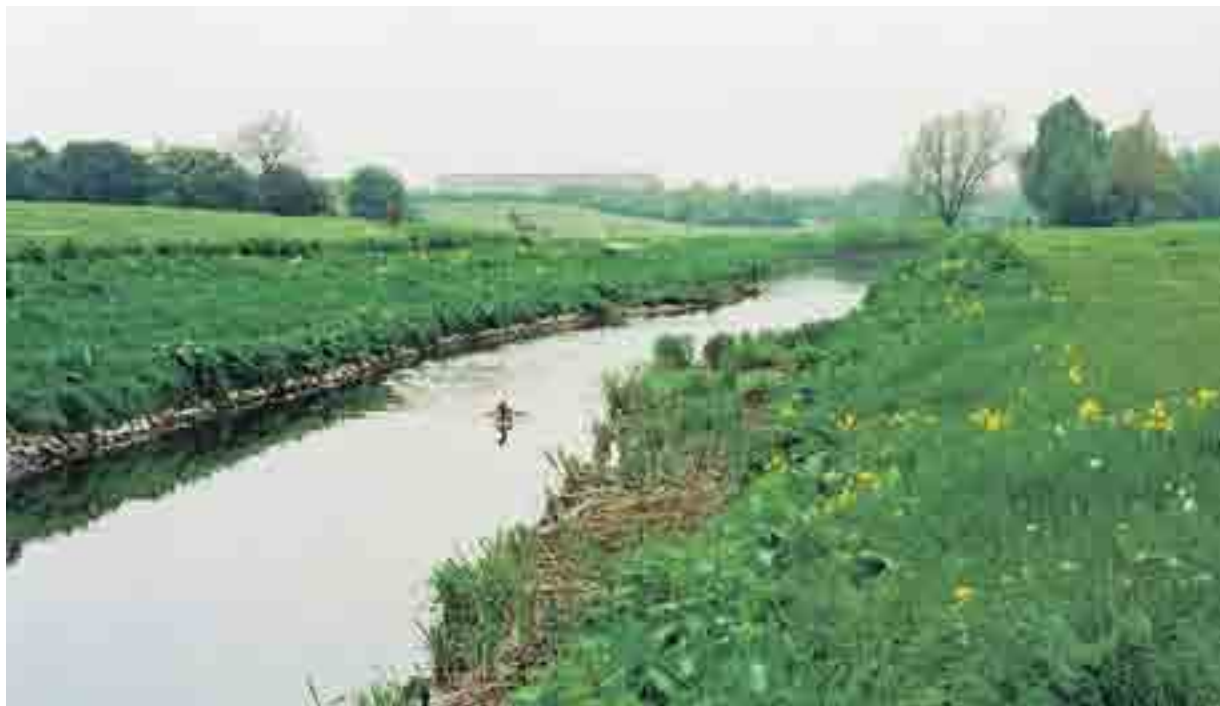
Type A Ledge
on the Skerne
– May 1998

Type A margins using plant pallets were installed downstream of the footbridge in the autumn of 1997 and overwintered satisfactorily in dormant conditions after several floods. Early summer 1998 growth was patchy with some silt banks smothering pallets. Growth was sufficient to ensure the spread of species to generate the dense cover required. Notable species that survived include occasional purple loosestrife and meadowsweet.

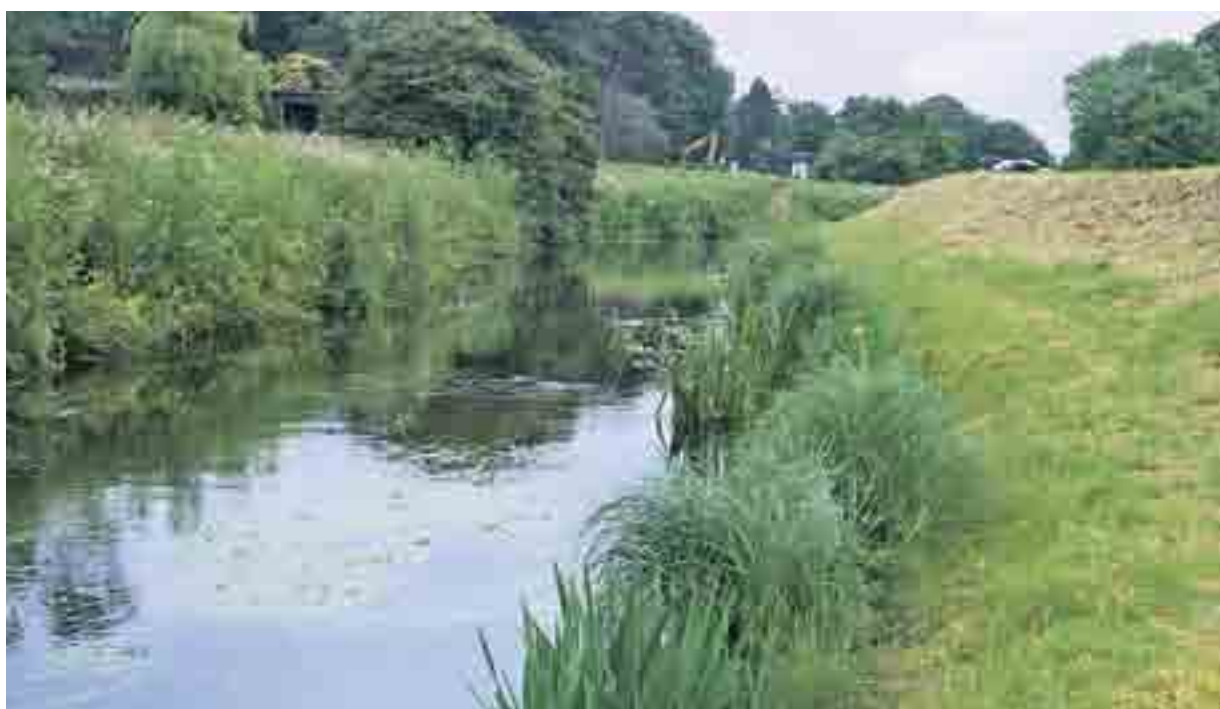
Type B Ledge
on the Skerne
after 2 years

Type B margins utilising plant rolls were installed upstream of the footbridge in August 1996. In 1998 they are attractive features much favoured by resident ducks that have created some bare patches between well established runs of lesser pond-sedge, yellow flag and reed canary-grass. The attraction of silt within the overwinter dormant vegetation along the ledges is significant; ledges have built up by as much as 300mm in places before being assimilated within new spring growth.

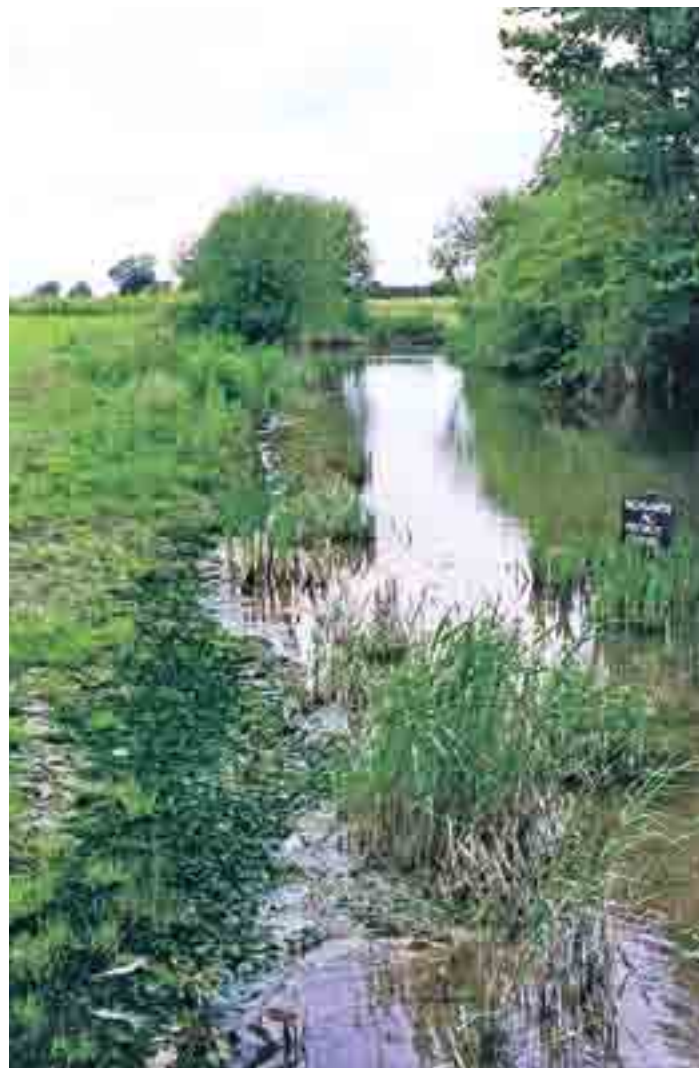
Type **A** and **B** ledges on the Cole after one winter

The ledges overwintered well in dormant conditions with no structural damage by floods although little more than 50% of the plants appeared to have survived to grow on during summer. The ledges are developing very well (1998) and creating both emergent vegetation habitat and landscape enhancement in the short stretch of river that previously had the least habitat and visual amenity value.

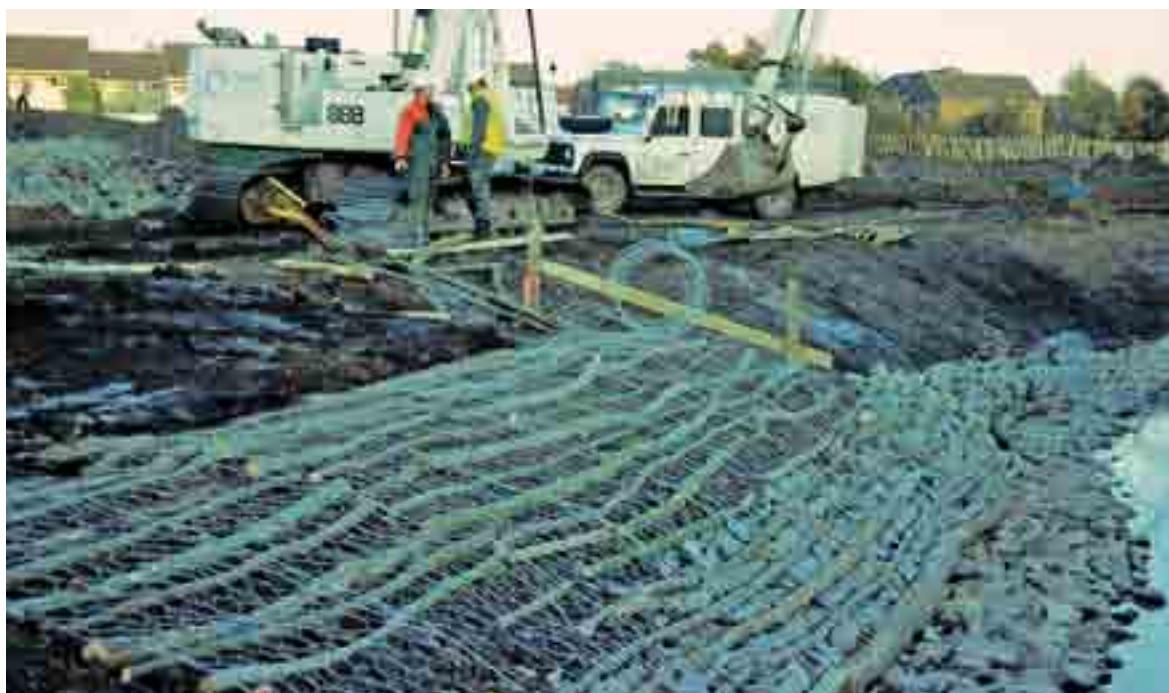
Mattress revetment under construction – October 1995

Note: Additional poles inserted to close up spacing after photo taken

Selected live crack and white willow poles, 0.05m – 0.1m diameter, were then laid horizontally all along the face of the fill and pressed into it. Finally the free ends of the netting were drawn tightly over the poles and secured to stakes driven well back in the fill. Due to the shortage of willow locally, up to 30% non-regenerative sycamore was incorporated intermittently. The netting was stapled to the poles to create a structurally integral unit.

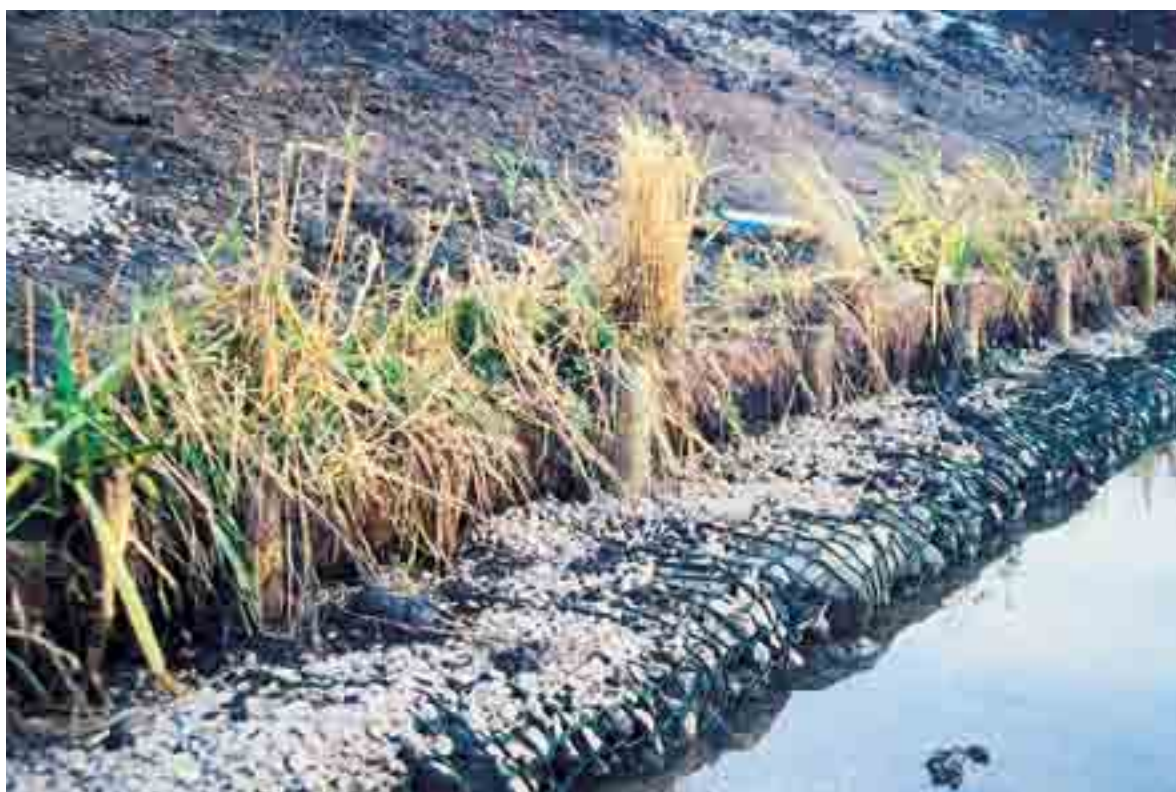
Transitional revetment at installation (water level artificially low in photo)

Rock rolls are flexible 'sausages' of crushed rock contained within nylon netting, whereas plant rolls are of dense coir within which selected marginal aquatic species can be pre-grown. Plant rolls fixed over rock rolls will become homogeneous as roots penetrate downwards into the rock and the adjacent soil. The design provides inbuilt flexibility whilst allowing the plants to develop in stable conditions.

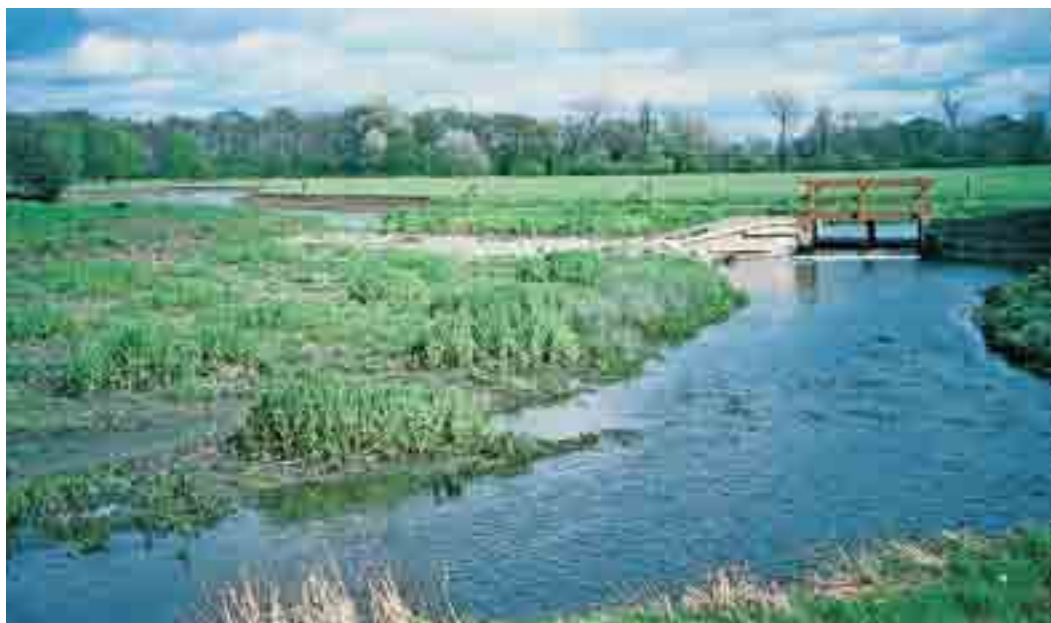
Spillway alongside bifurcation weir – April 1997

The hydraulic capacity of the flume is small (to suit base flows) so a 10m wide spillway is incorporated alongside to feed sufficient floodwater to fill the new channel. The crest level is only 0.1m above the normal water level in the leat so it operates frequently. Below the spillway, a large area of land is gently graded out towards the new channel which sustains marshy conditions around its inner margins. This low lying area is largely flooded before overspill occurs, ensuring a fairly smooth combining of floodwaters passing downstream. Water in the new channel rises quickly, ensuring the overspill is completely submerged (drowned) at an early stage of a rising flood, thereby further reducing scour potential.

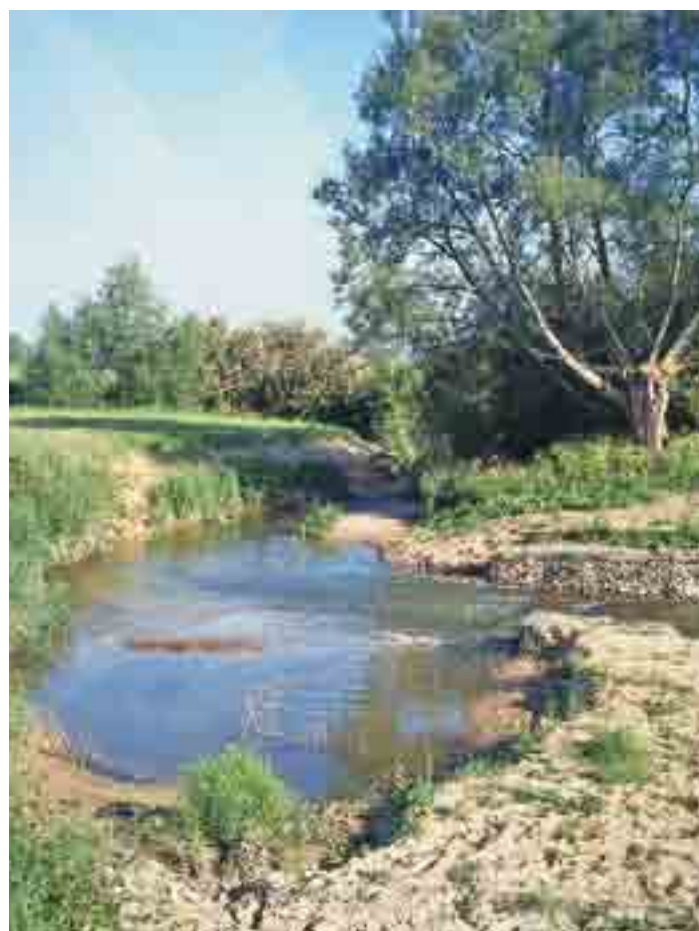
Gabion weir and pool

The river bed approaching the structure increases in width from 2.6 to 4m where it is stoned (1) to create a useful fording point; slopes of 1:8 are incorporated each side. This increase in bed width is necessary to maintain a shallow depth of water for a wide range of flows. A vertical wall of mortared pre-cast concrete kerbing blocks (2) defines the downstream edge of the ford. It serves to set a fixed profile right across the section, as well as reducing the risk of river water flowing underneath the structure causing it to collapse. Water flowing over the wall passes evenly down to the lower channel over a rock apron (3) at a slope of 1:6. During time of spate, downstream water levels rise more quickly than those upstream causing the structure to eventually submerge or 'drown', although not frequently.

A livestock fence was incorporated in the form of two wire cables strained along the crest line and up each side to field level. The cables are strong enough to withstand the pressure of floating debris that inevitably catches on such 'fences' in time of flood but they do not form an impenetrable barrier that otherwise arises if woven fencing is used.

Figure 5.2.2

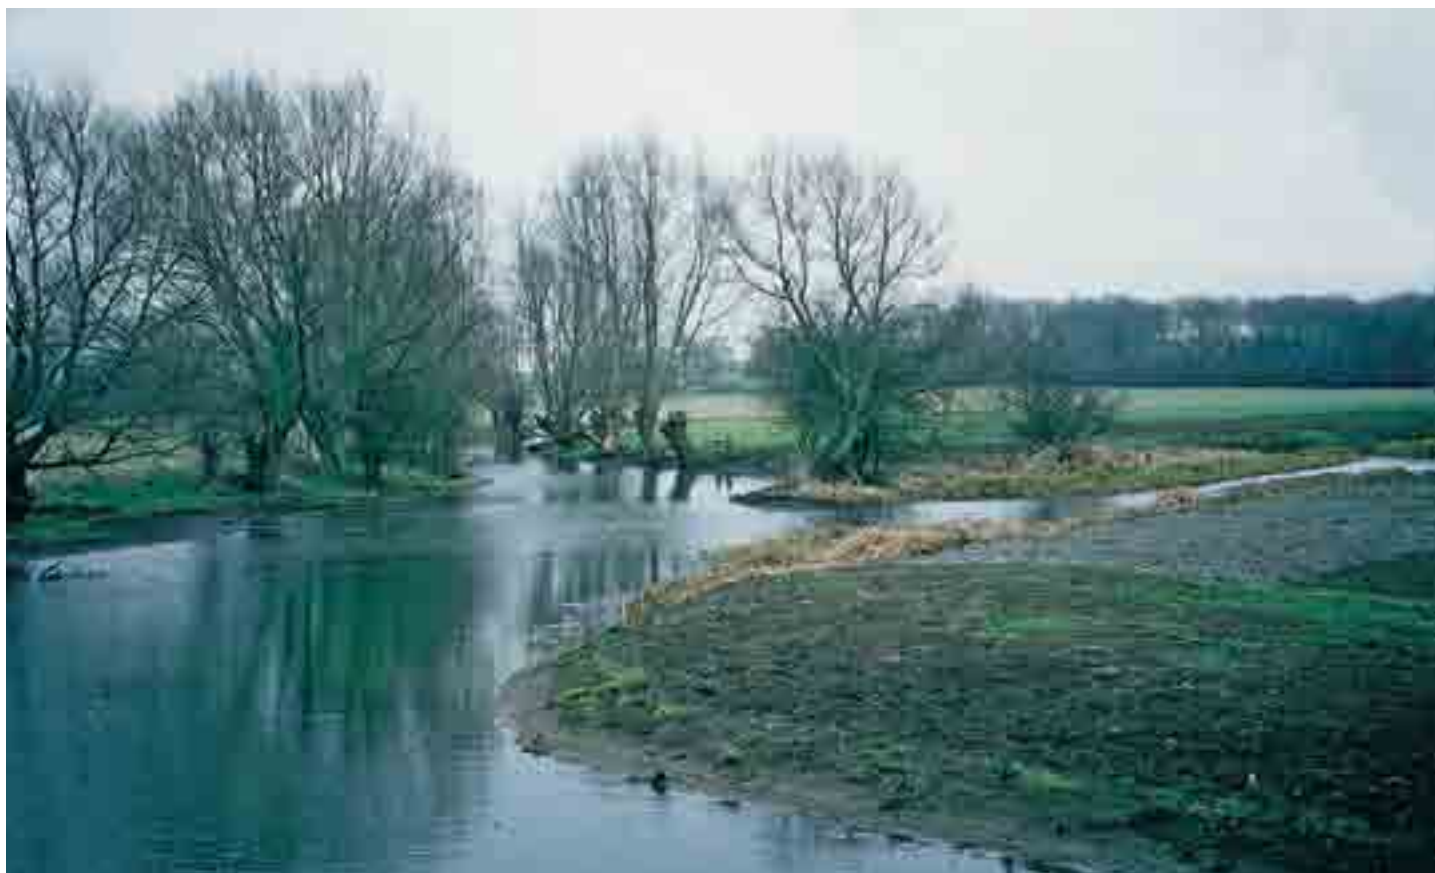
Spillway **S2**. Flood flows indicated by the arrows overtop the spillway, merging with the new channel (not visible) on the Great Eau at Withern

Spillway **S2** begins to operate only after **S1** has filled the new channel with water. Water spilling over **S2** passes directly into the new channel causing it to overflow its banks and initiate field flooding. Scour of the overspill is minimal because this design ensures floodwaters from both **S1** and **S2** merge without excessive turbulence.

The level at which **S2** is set is critical; it is 300mm lower than the floor of the mill further down river, to ensure floodwater is diverted away from the mill. In practice, **S2** replaced an unsightly concrete cascade weir built at the mill to protect it from flooding. The cascade has been boarded off and will be infilled once the performance of **S2** is proven to be satisfactory.

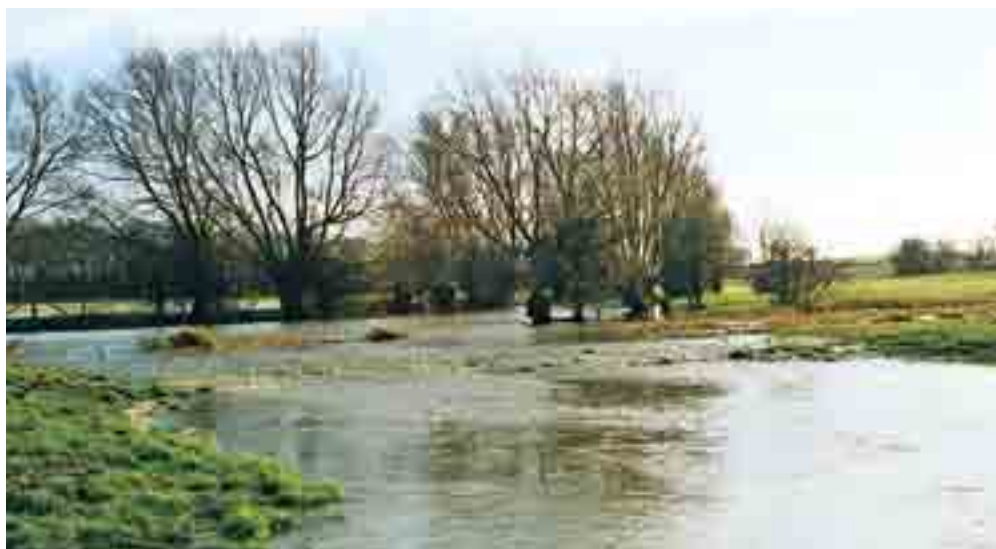
Spillway **S2** in flood

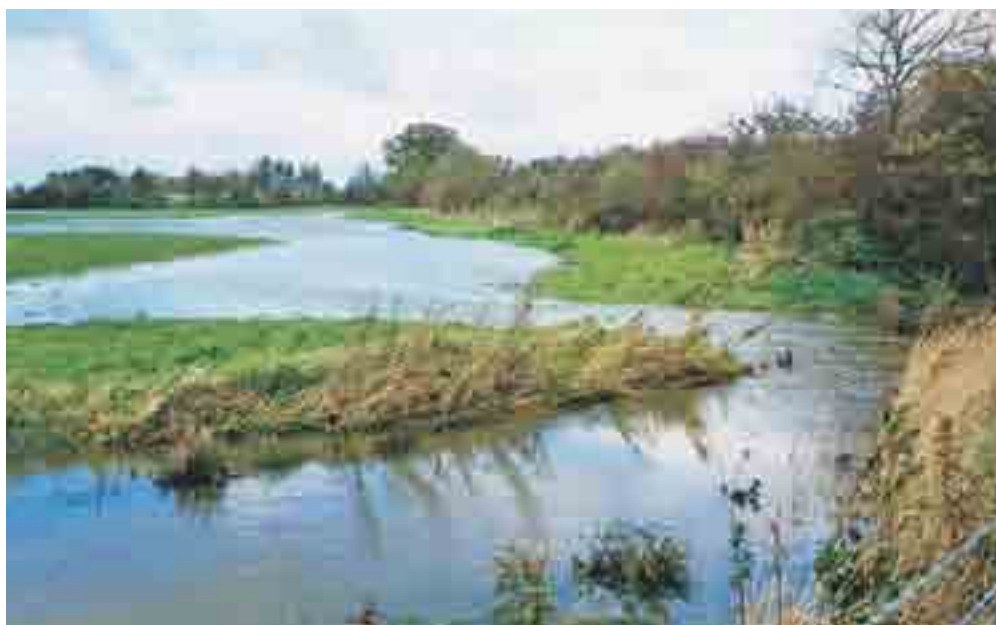
Spillway **S4**. Floodwaters
spilling into field gully.

The drain was enlarged to increase its flow capacity and the bank level at the overspill point, lowered to form spillway **S4**. The spillway is located close to a natural gully that meanders down through the floodplain fields and probably marks an ancient river course. The spillway was completed by shallow excavation of the field to extend the gully right up to the bank of the drain.

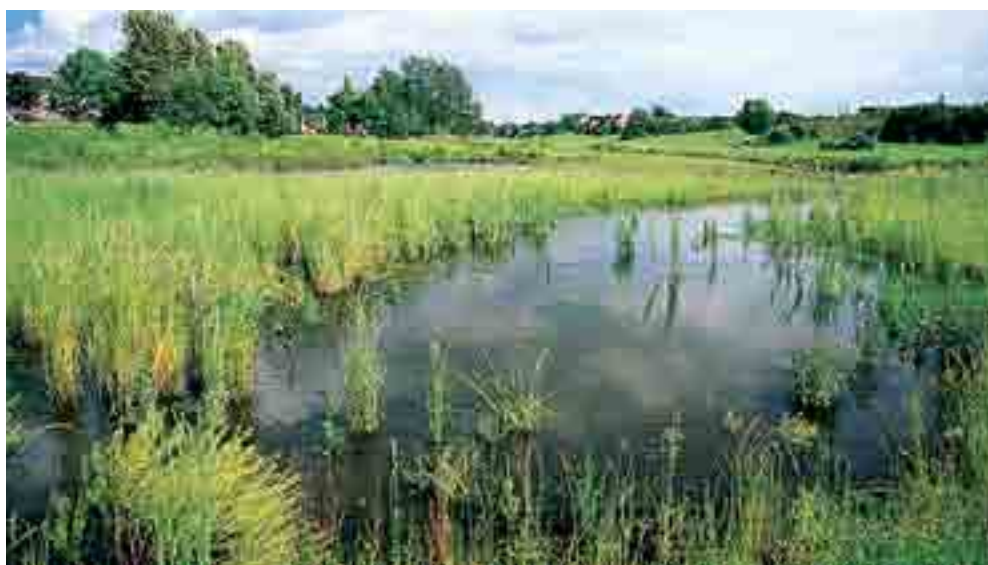
Completed spring-fed scrape

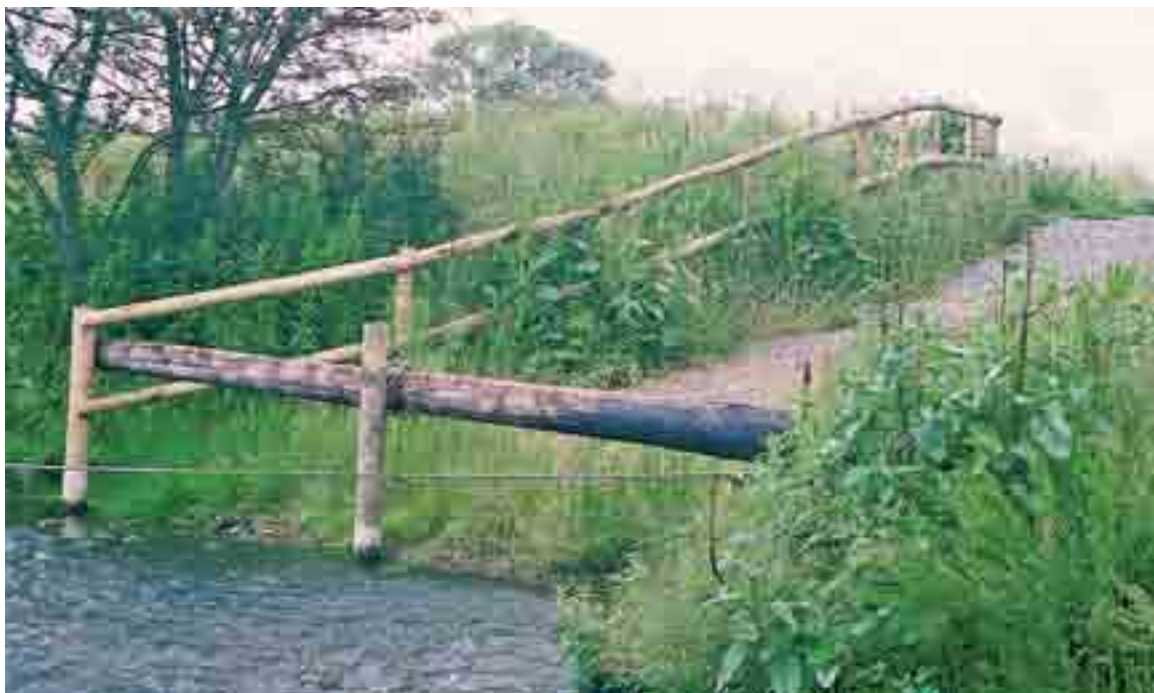
Stock watering point
at ch. 100m

The river fencing comprises a single heavy wire cable strained tightly across on a diagonal line (*see photograph above*). The extra length of the diagonal renders the cable less likely to form a complete blockage of the river if floating debris becomes snagged on it. The angle of the diagonal is aligned to direct turbulence caused by its presence towards the mouth of the watering point, further reducing the risk of siltation.

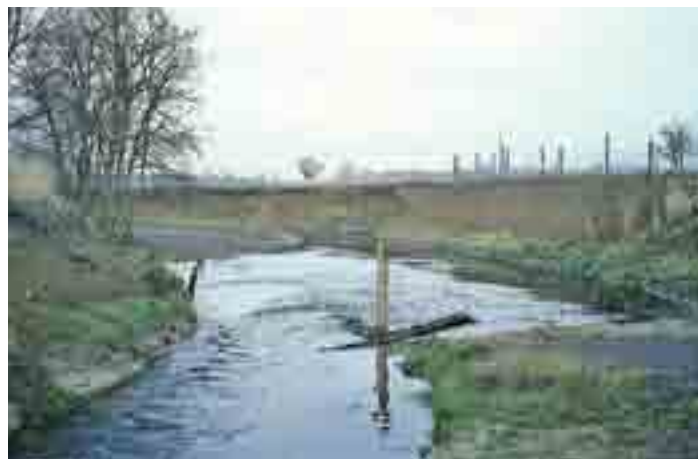
Ford at ch. 280m

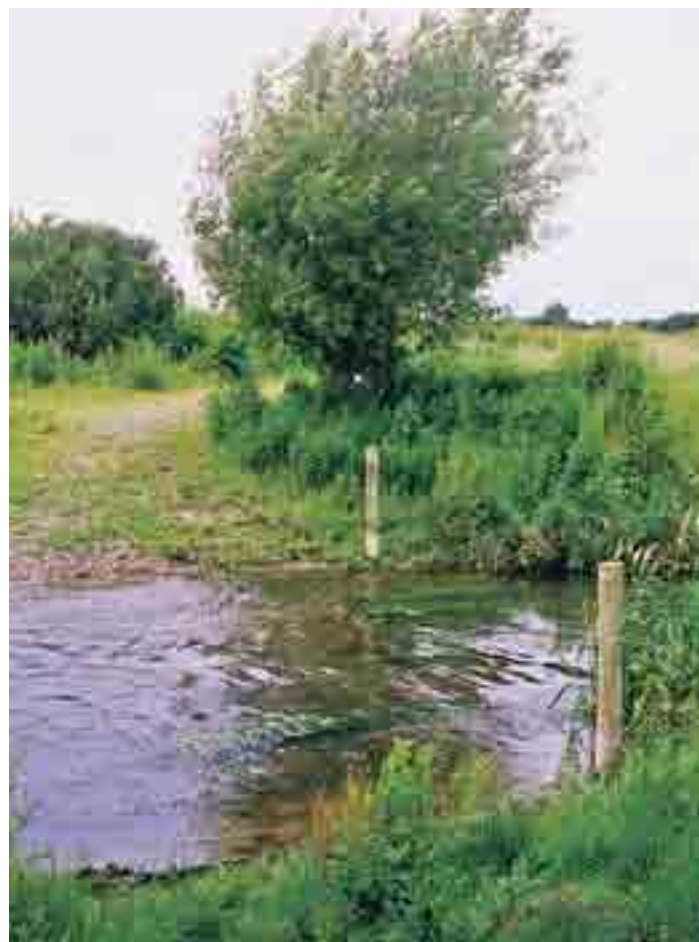
Equestrian ford at ch 620m

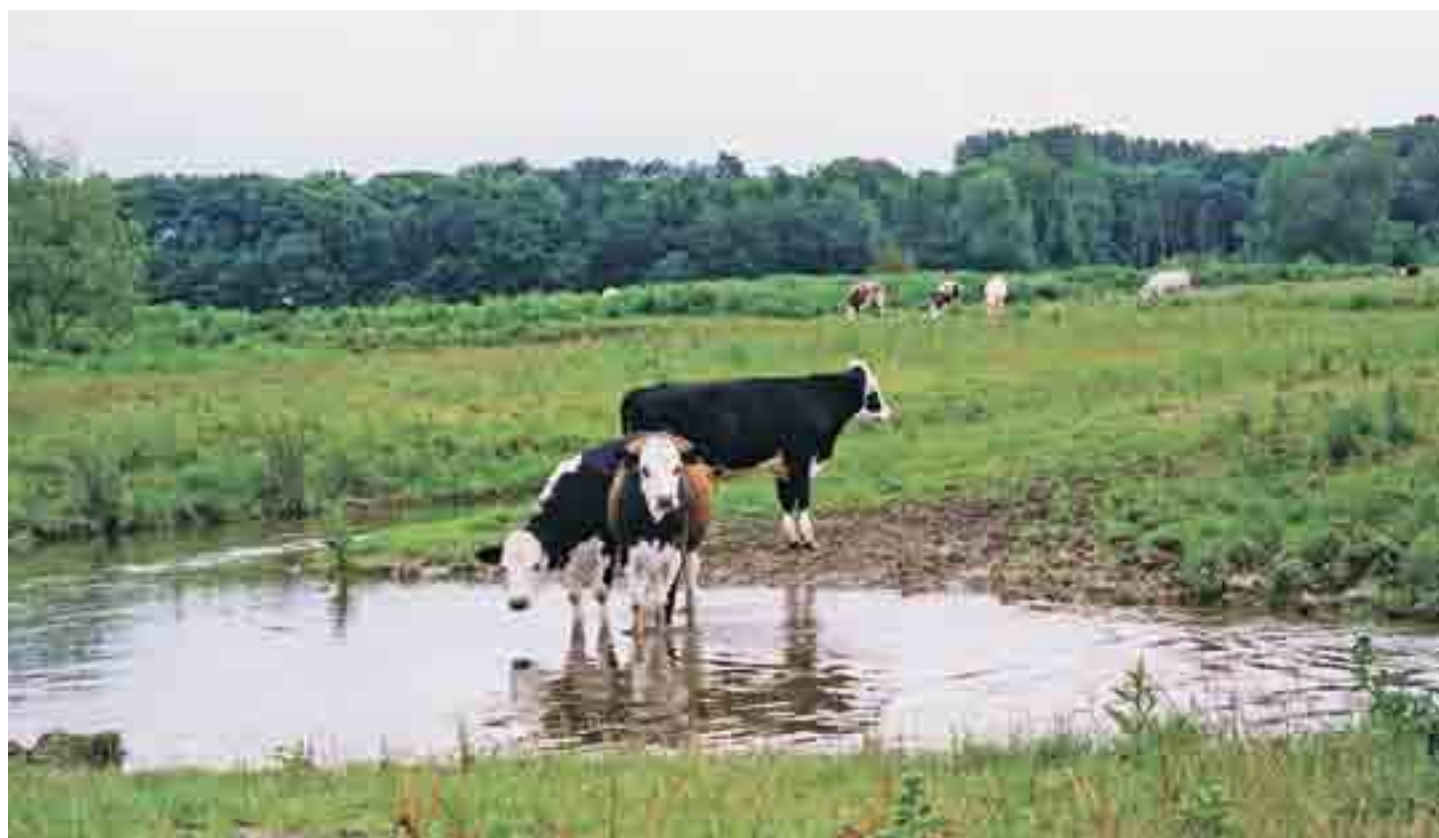
Vehicular ford upstream of mill at ch. 250m

The ford is shown diagrammatically in *Technique 2.2, Figure 2.2.1*. Its purpose is to provide vehicular access across the river in conjunction with the nearby crossing over the mill leat (see *Technique 8.2*). The ford is configured as a point bar located downstream of a sharp bend in the river. It crosses the river diagonally such that the ramp on the inside of the bend could take the form of a natural shoal of gravel that gently rises up to field level, mimicking the geomorphology of upland rivers where point bars and shoals of gravel often serve as crossing points. Because there is no significant bed load of gravel in the River Cole, the bar and shoal had to be artificially created using crushed stone and aggregate.

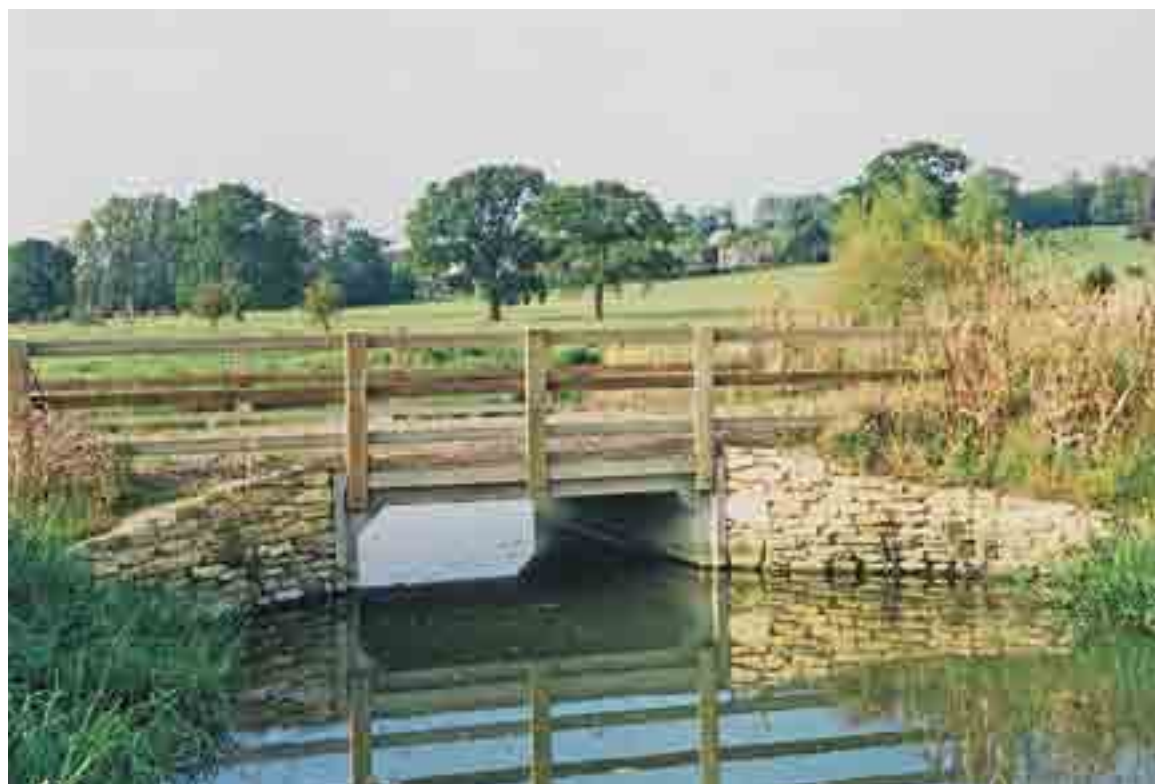
Completed 'bridge'

The upper tier followed a similar curve but was continuously stepped back sufficient to allow a stone wall to be built around the front face - this wall is the only visible element and it is decorative rather than structural. By stepping back the gabions the sloping river banks adjacent could be brought smoothly into line with the gabions and also accommodate an underwater ledge for aquatic marginal plants. The combination of marginal plants and stone walling are intended to draw the eye away from the concrete box which is a relatively minor feature of the overall visual aspect evident in the photo.

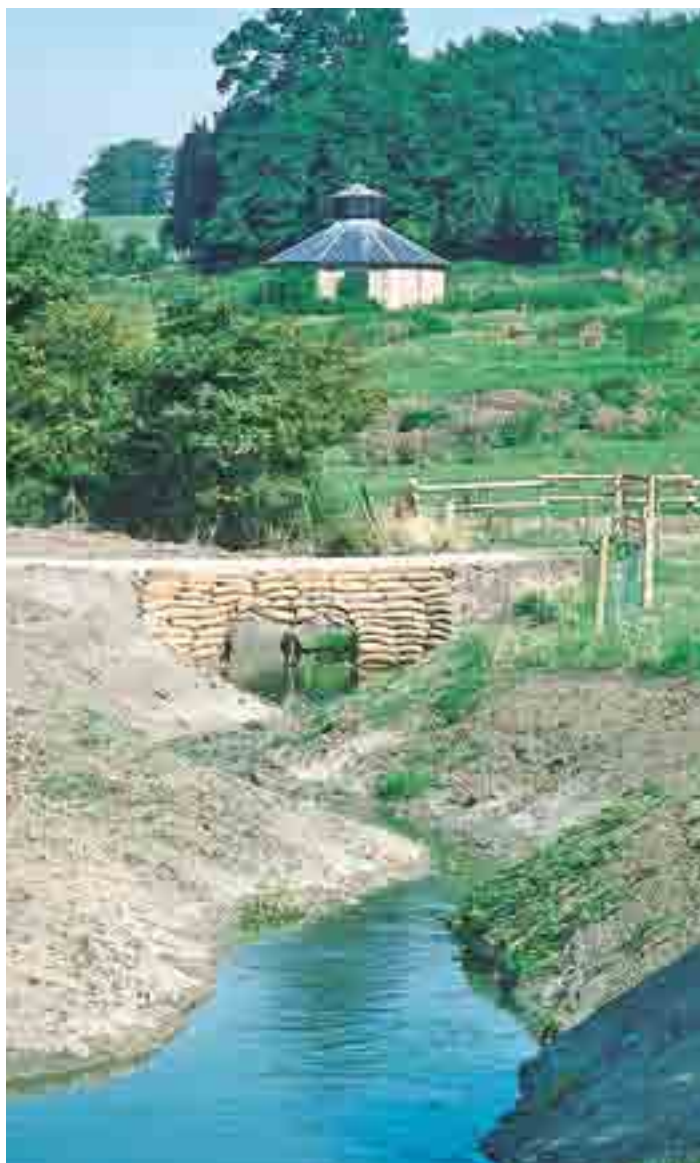
The bagwork is built vertically across the face of the pipes and then curved gently outwards through 90 degrees or more with a slowly increasing batter until it merges smoothly into the sloping banks of the drain. The slopes are achieved by stepping the bagwork rather than laying it flat on the banks; the ledges thus formed attract silt and plant growth. The height of bagwork was curtailed close to the level of the pipe soffits.

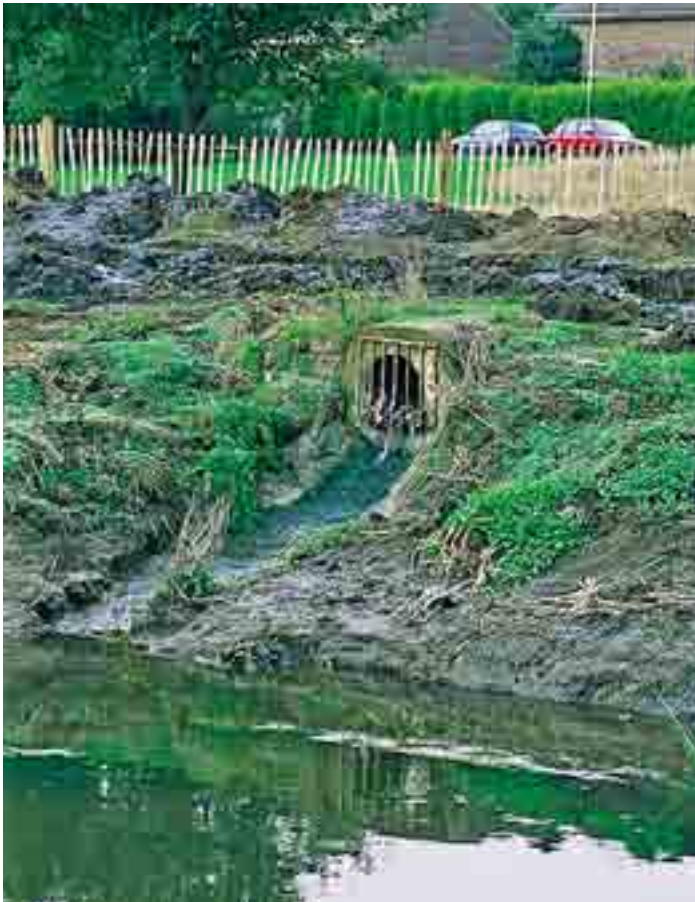
Typical outfall before replacement

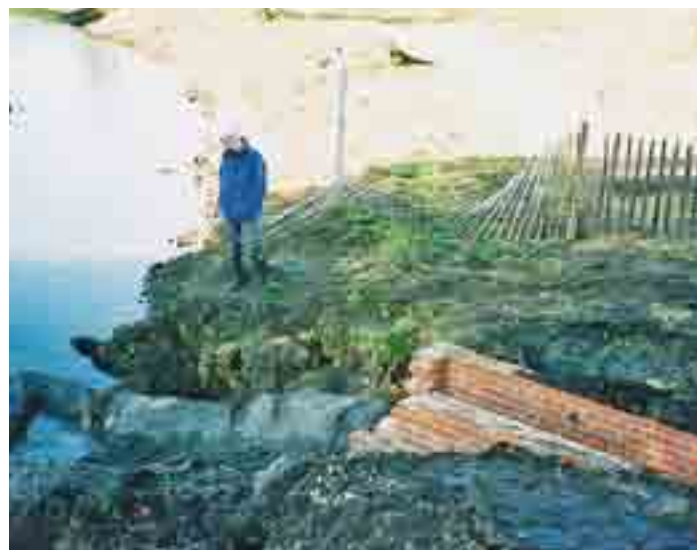
New outfall chamber
under construction

Note: River bank reinstated with soil and toe planting such that no visual evidence of the outfall exists

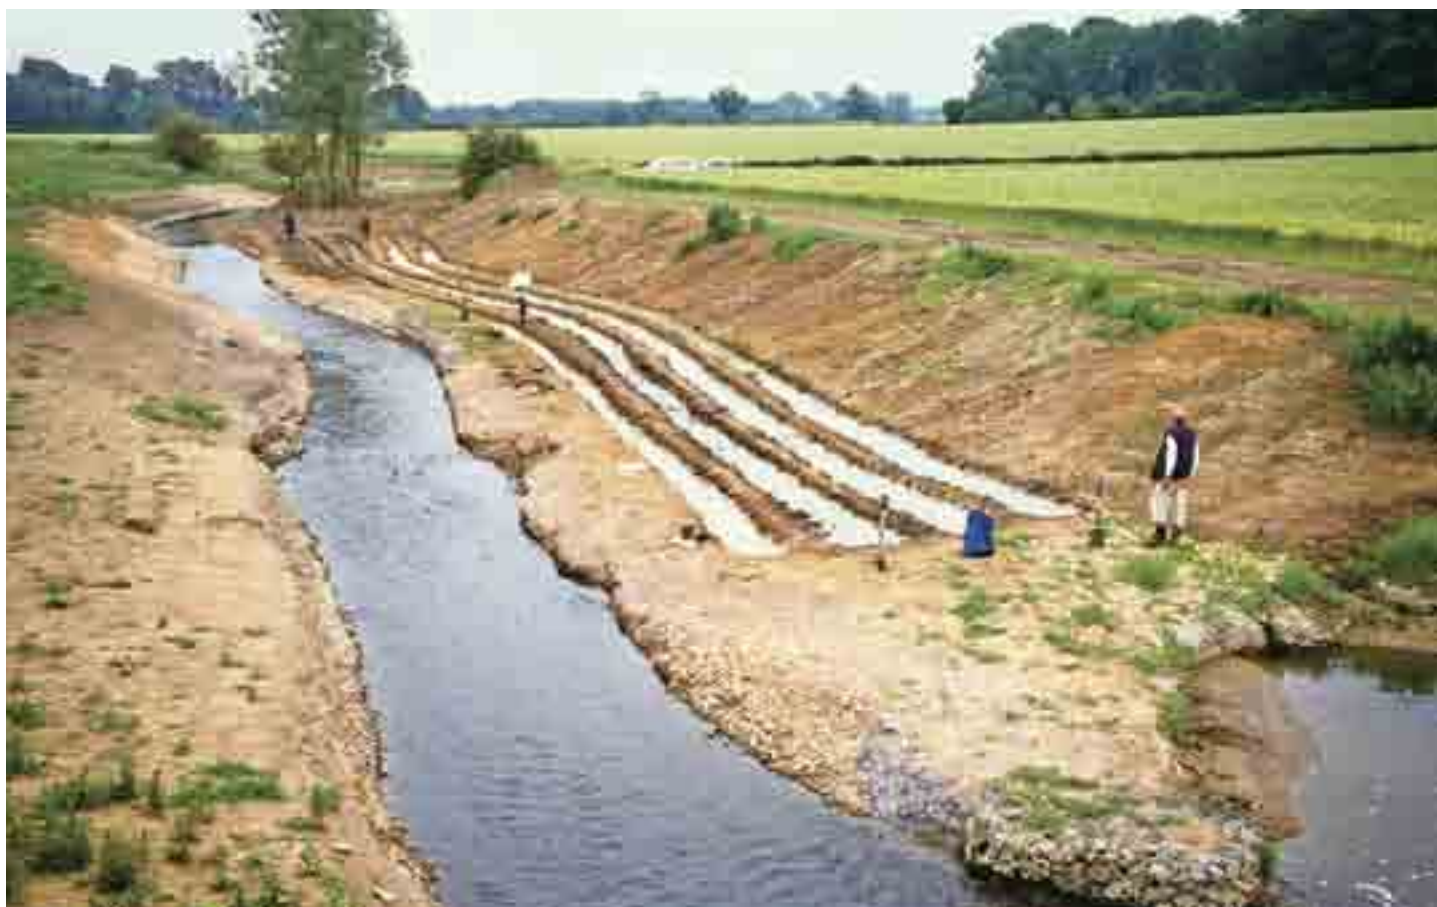
Planting reedbed – Spring 1996

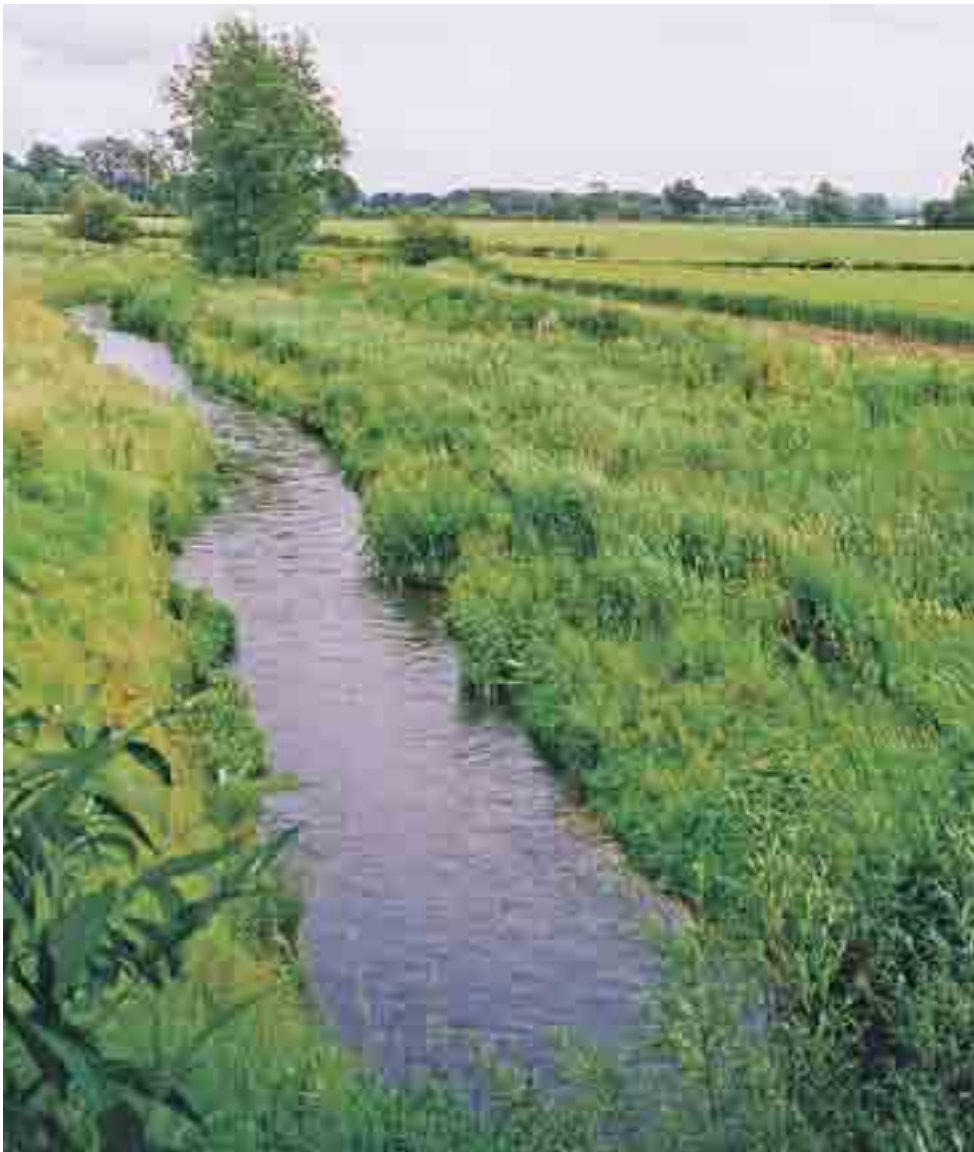
Reedbed established – Summer 1998

The reedbed established exceptionally well with 93% of seedlings surviving to maturity, although seed germination was perhaps only 50%, but still sufficient to achieve full colonisation within two growing seasons. Other aquatic species colonised the area naturally, including greater water plantain and soft rush. Concerns that the River Cole might damage the reedbed when in flood proved unfounded because the overall size of the new river and adjacent reedbed is much greater than the existing cross-section downstream so flood flow velocities are low.

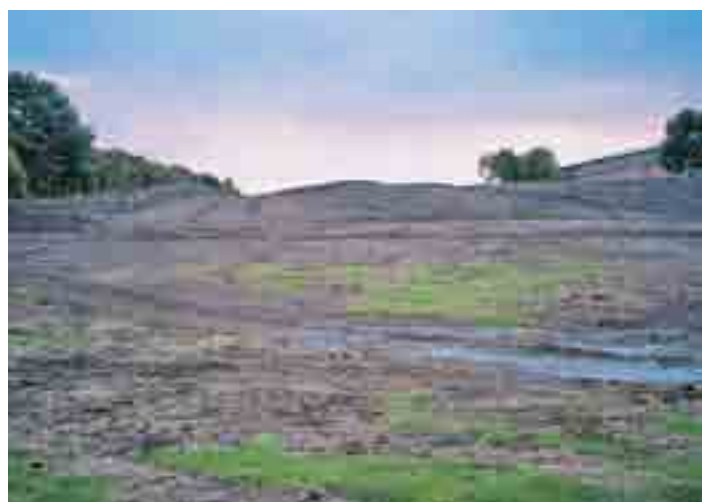
Keepsafe landform during construction

This was a field gently sloping towards the river. The new landform has introduced a small valley feature and has raised the land adjacent to the industrial estate, built on landfill. Carefully positioned tree and shrub planting screens the industrial area on one side and ties in with an original hedgerow on the other. Most importantly, a smooth topographical transition has been created at the old tip face. A land drain was incorporated in the newly formed valley which also acts as a dry route for walkers.
