Restoring Meanders to Straightened Rivers

1.1 New meandering channel through open fields

RIVER COLE

LOCATION - COLESHILL, (OXON/WILTS BORDER) SU234935

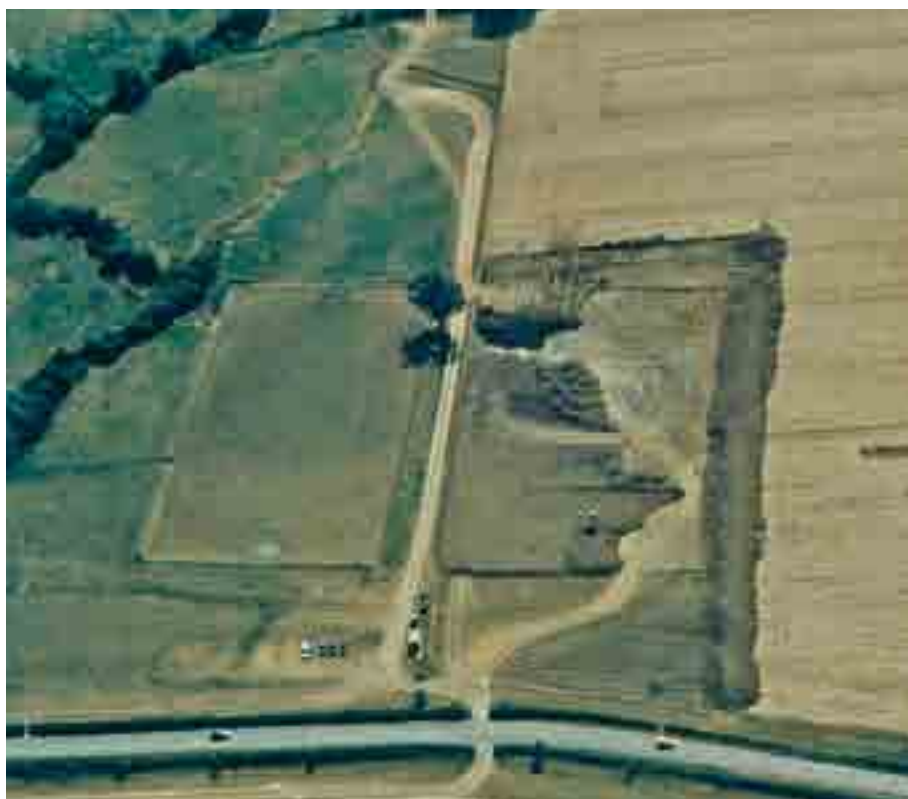
Construction of landform in arable field to right of football pitch – 1995
