Restoring Meanders to Straightened Rivers

1.8 Restoring a meandering course to a high energy river

ROTTAL BURN

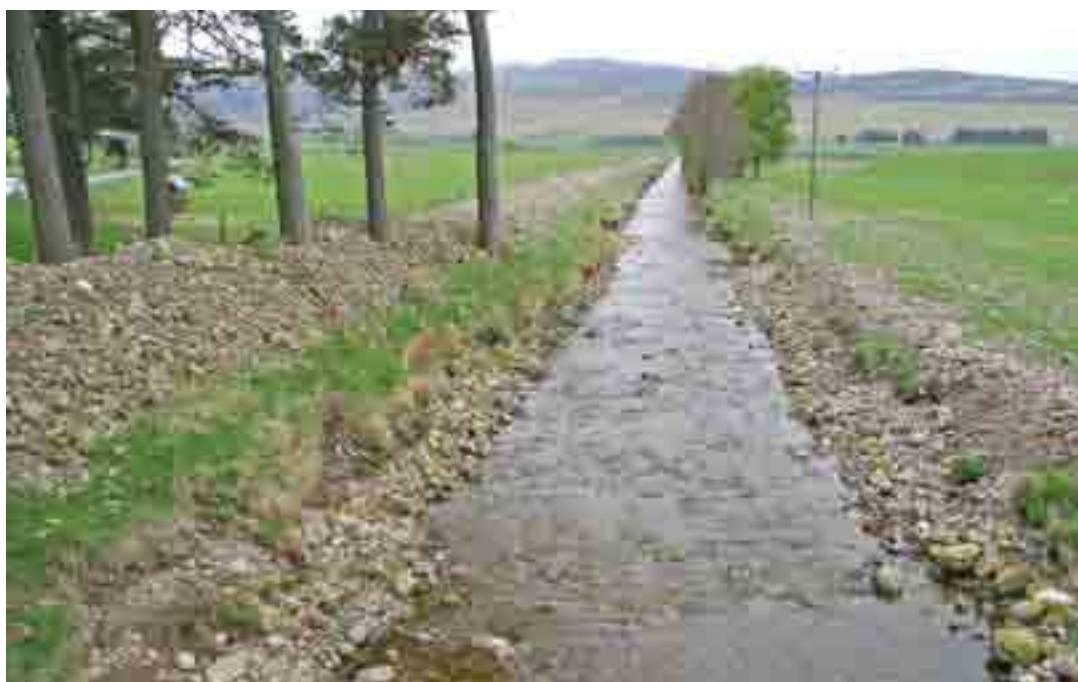
Dredged gravel forms an embankment on both banks. The channel runs in a straight line to the confluence with the River South Esk – May 2006

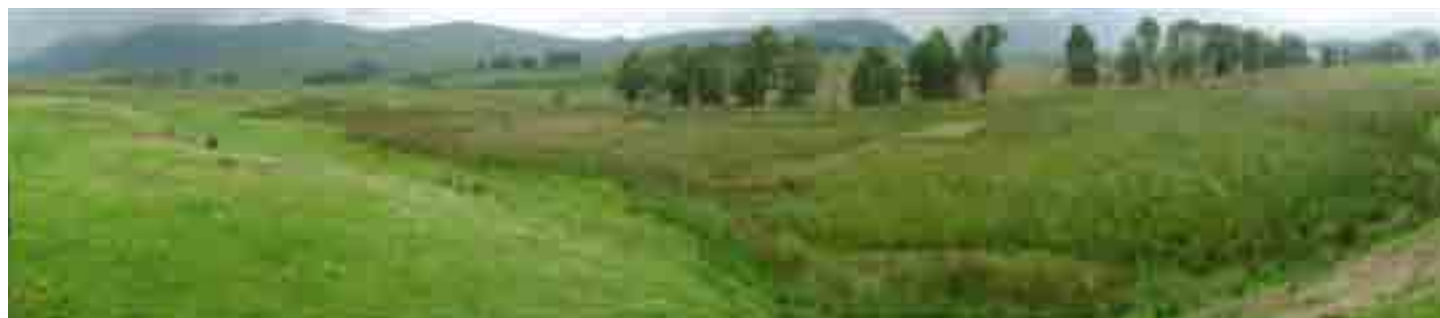
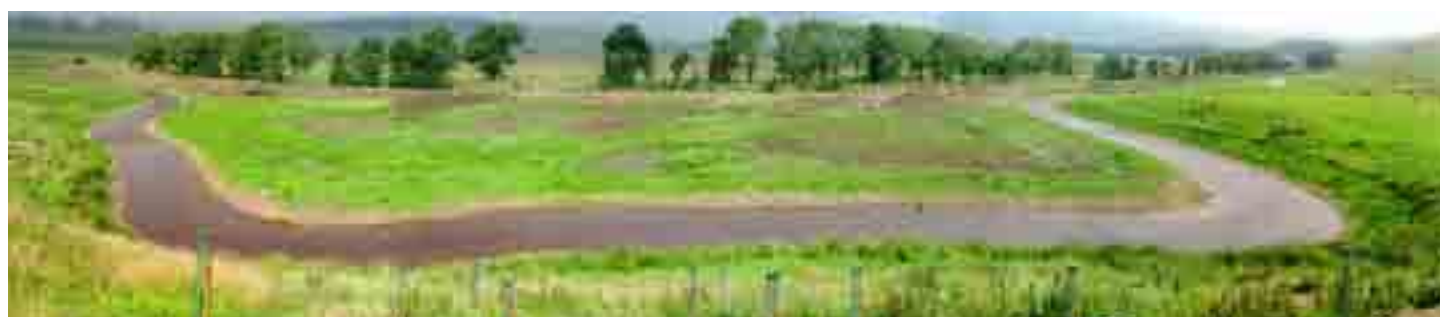
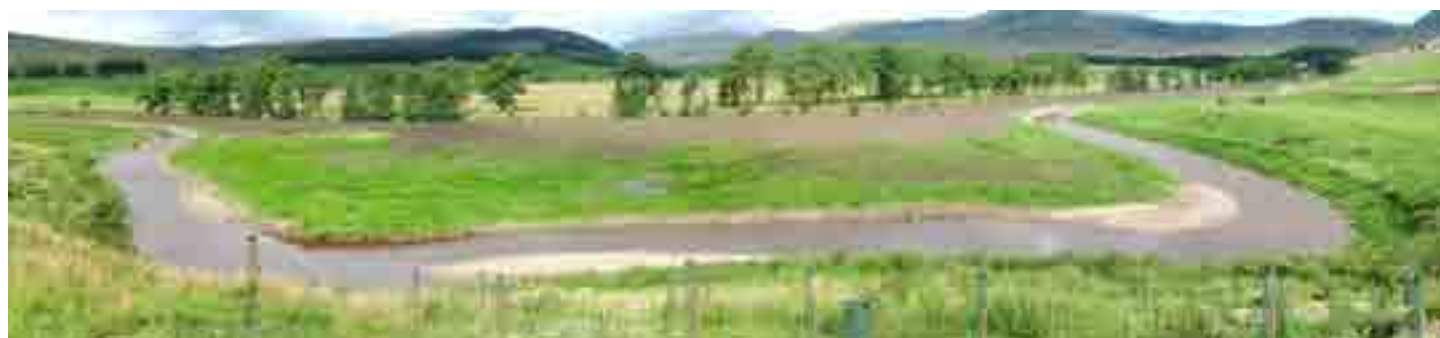
Three panoramas showing the development of the middle reach – 2011 to 2012

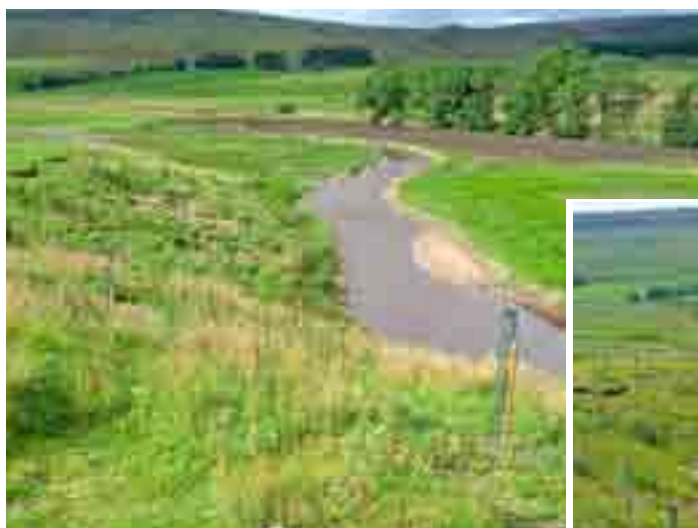
The newly excavated channel, viewed from the knoll, following the old course – Sept 2012

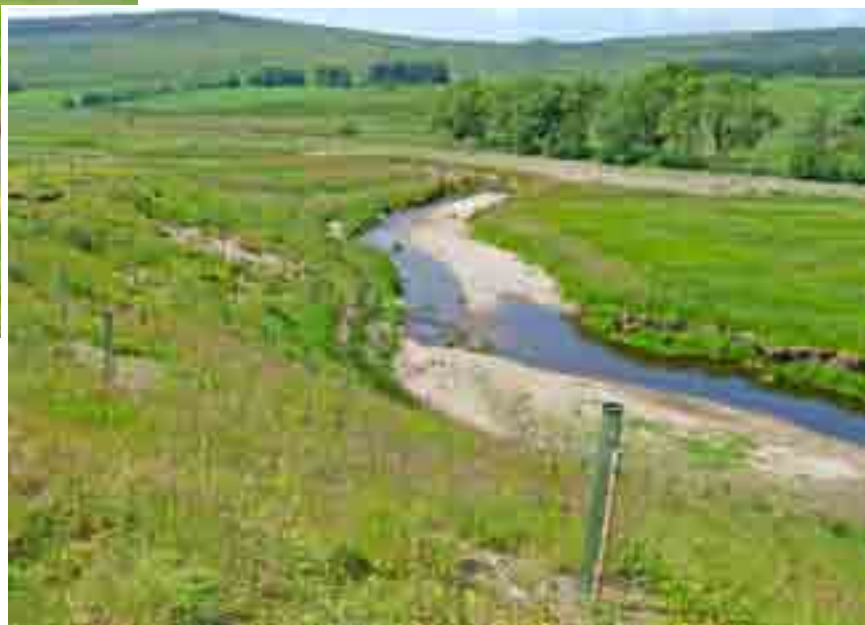
The channel is depositing and moving sediment, creating features – July 2013

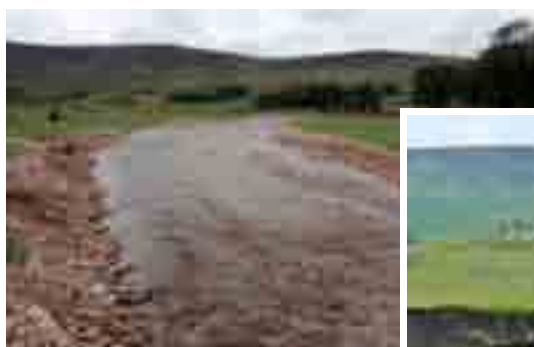
The as-dug channel with cobbles from the old dredgings embankment – 2012

Substrate previously dredged from the burn and won from the embankments was placed on the bed and banks of the newly excavated channel to an approximate depth of 0.3m. The median gravel size was 60mm with the range of material being fine sand to large cobbles. In thirteen locations, additional gravel was placed to a height of 0.3m above the surrounding design substrate level (*Figure 1.8.2*). These locations were where features were expected to occur and were intended as source material for natural processes to use to shape the burn.

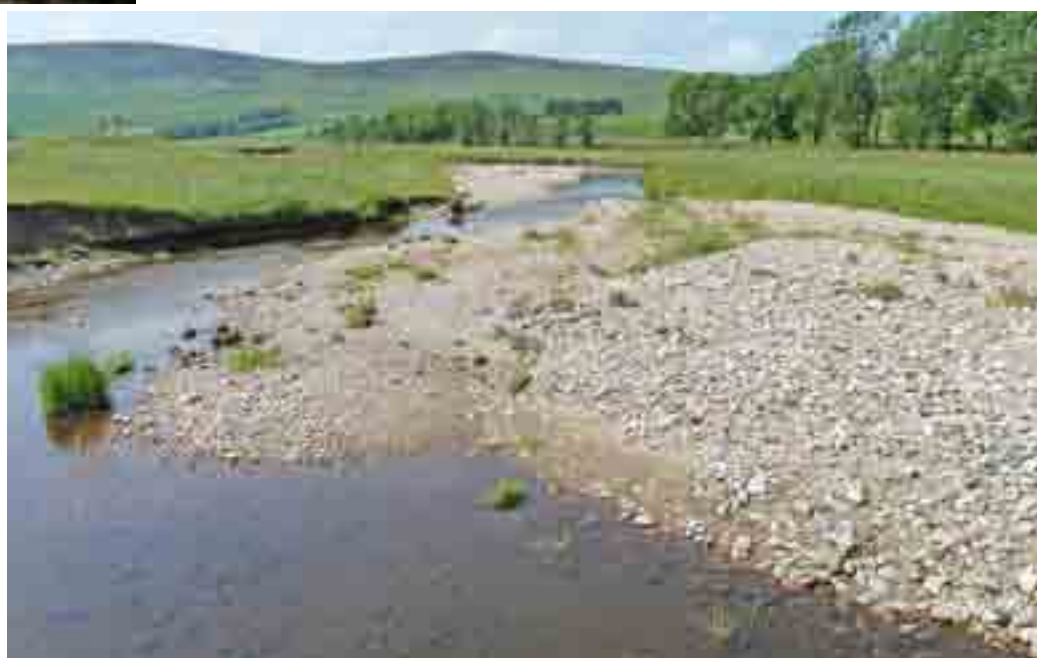
Subsequent deposition and erosion from, now unconstrained, natural processes – July 2013

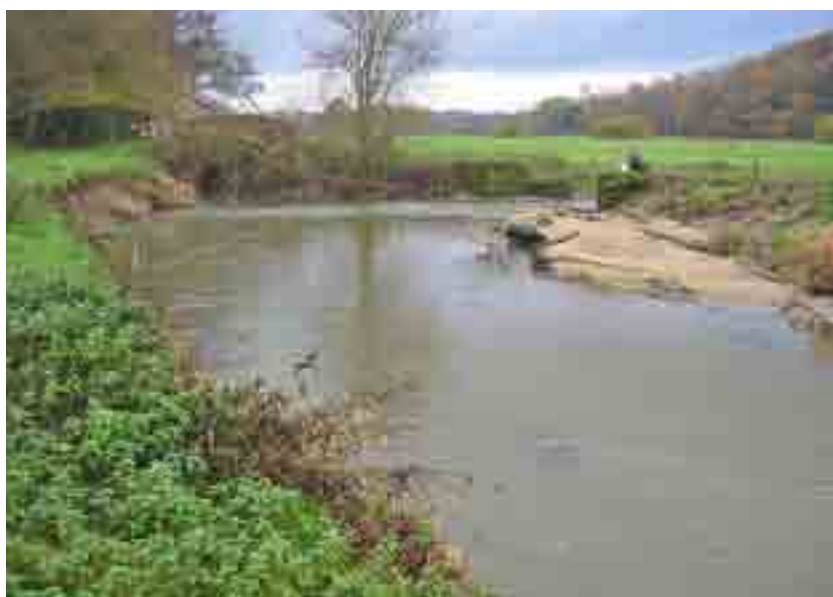
Two ancient stone abutment walls at the exit of the loop indicating the historic channel width – 2004

The bank top width was determined by on-site observation of two stone abutment walls from an ancient bridge that provided a reliable representation of the historic channel width.

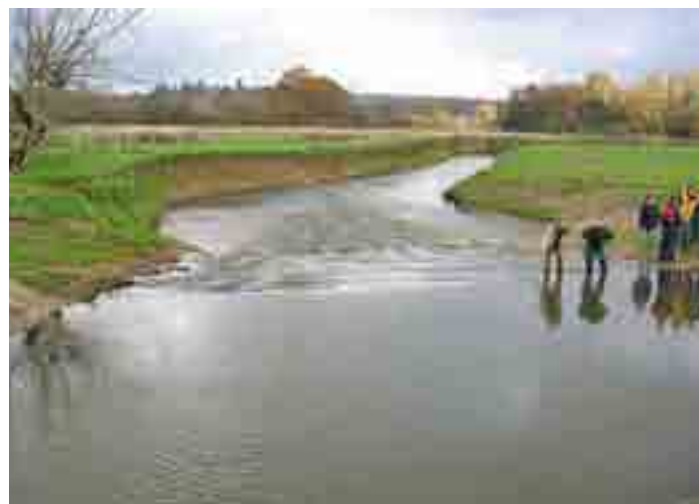
Bed check riffle and ford at entrance to the loop post-construction – 2004

A new gravel riffle was also constructed upstream of the site to replace a riffle that had formed in the canal cut, which became obsolete once the cut was sealed off. New gravels totalled £9,000, labour £13,000 and plant hire costs totalled £28,000.

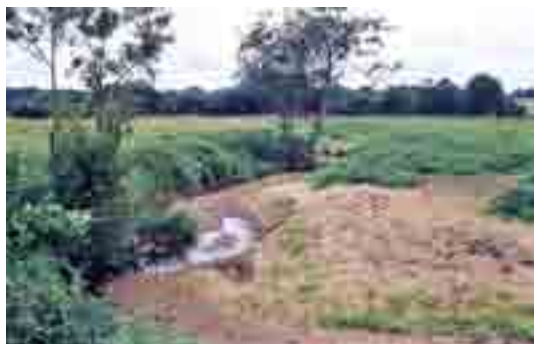
Sand in the meander loop
pre-restoration – June 2004

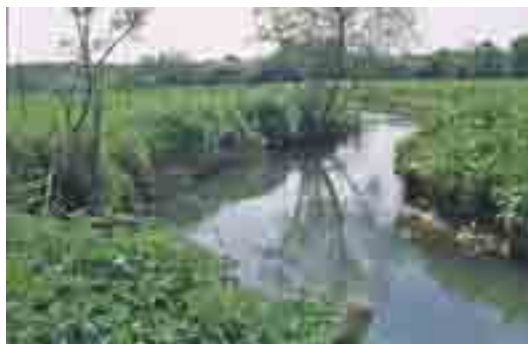
Flow in the excavated meander loop
post-restoration – 2005

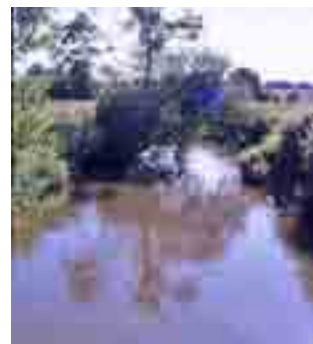
The same meander loop
(three years post works)
– 2007

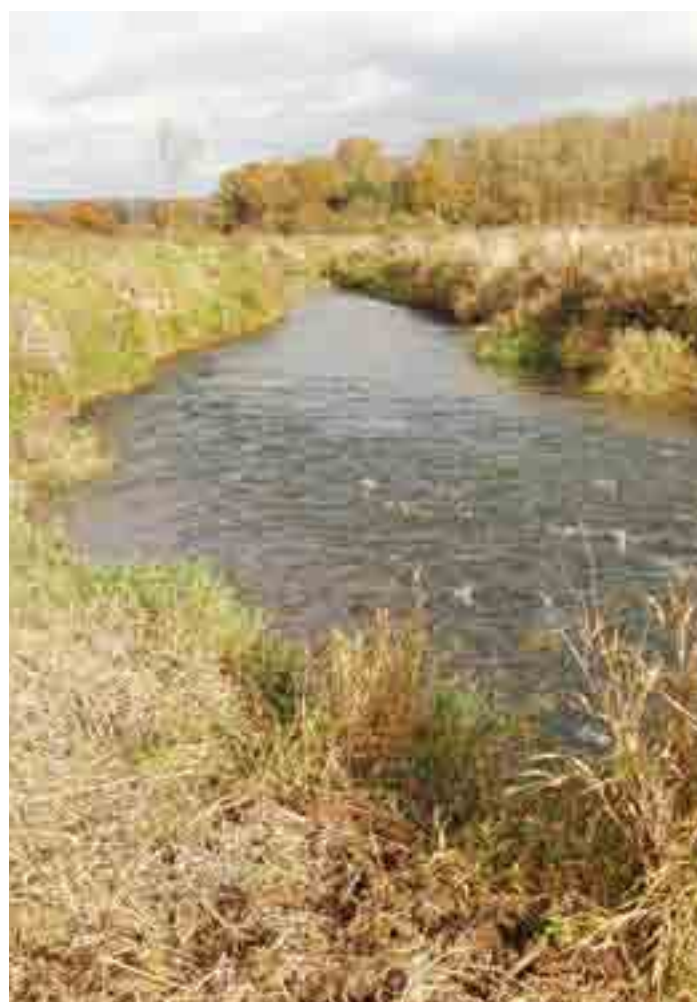
Shopham Loop post-restoration – 2009

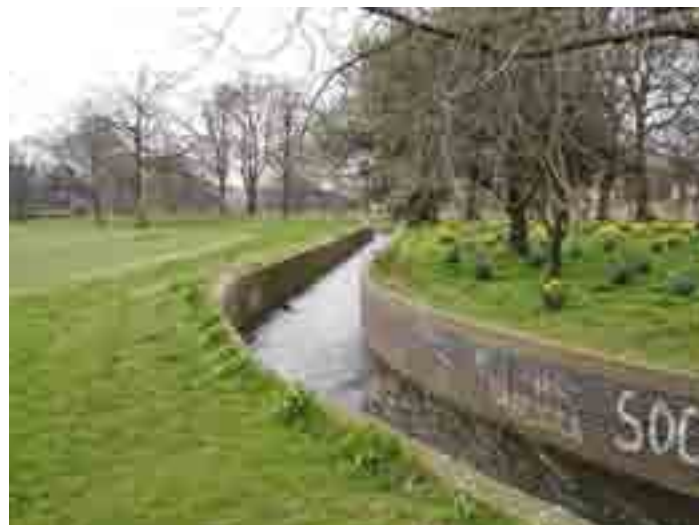
Prior to works part of the channel through Inch Park was brick lined – April 2006

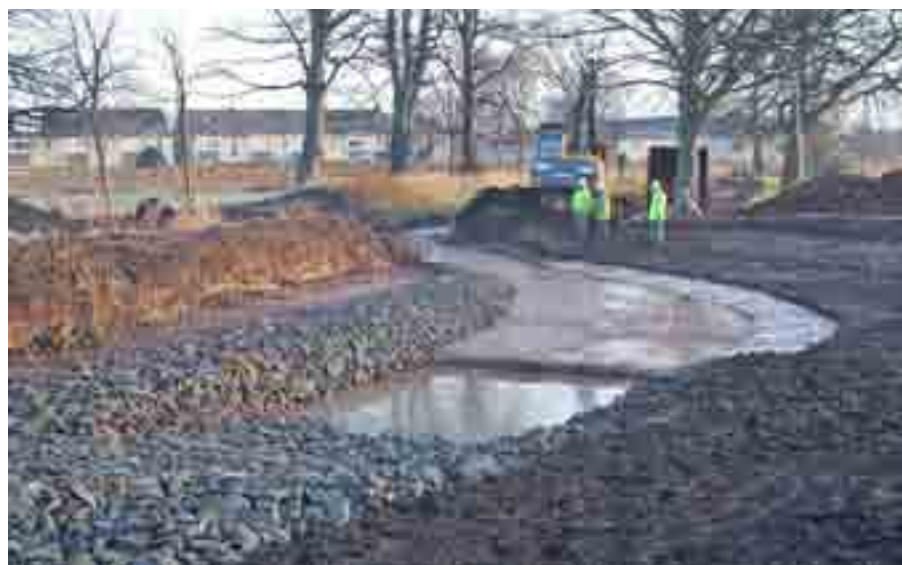
New meander channel cut off-line. 0.075 – 0.3m lumpstone was used to create the riffle and shoal base to prevent excessive bed scour
– January 2009

None of the brick and concrete sections of the existing channel were incorporated into the new design. These were all broken down and in-filled. Densely graded rock (lumpstone) of 0.075m to 0.3m was imported and used to form the riffles and shoals. Gravels for the new channel were recovered and re-used from the sections of the old course which were to be in-filled. It was deemed that over time natural processes would transport substrate, invertebrates and flora to the new sections of the burn. The hydraulic conveyance of the new naturalised course is at least as great as that of the lined channel, ensuring no increase in flood risk upstream.

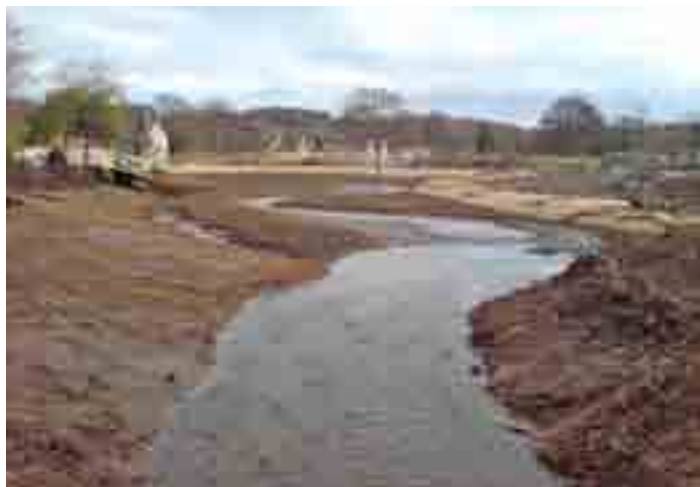
The new meanders were created off-line and, once complete, were connected to the existing channel. Overpumping of some sections of the burn was necessary to maintain flow whilst works were carried out. The downstream end of each meander was opened up first and allowed to fill with water. Each meander was then left for a period to allow sediment to settle and reduce the potential for dirty water to pass downstream. The upstream end was then opened very slowly to control the initial flow through the new meander in order to prevent scouring of loose materials. During construction settlement ponds were created to control and retain muddy water draining from the site.

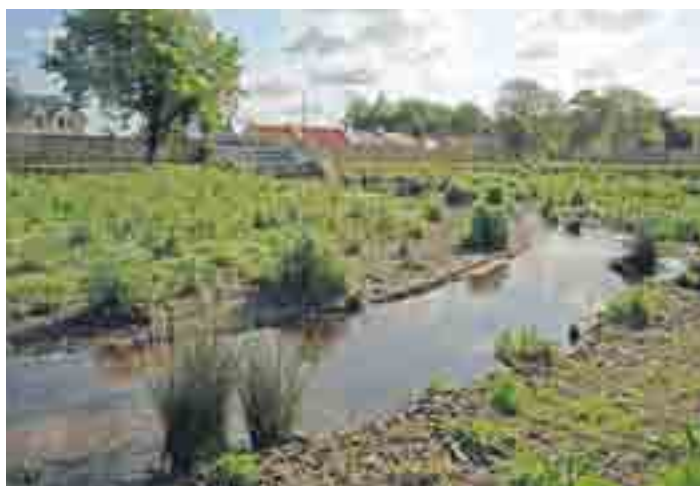
Wetland area at low flows. The height of the floodwall demonstrates the flood storage capacity within the park
– March 2010

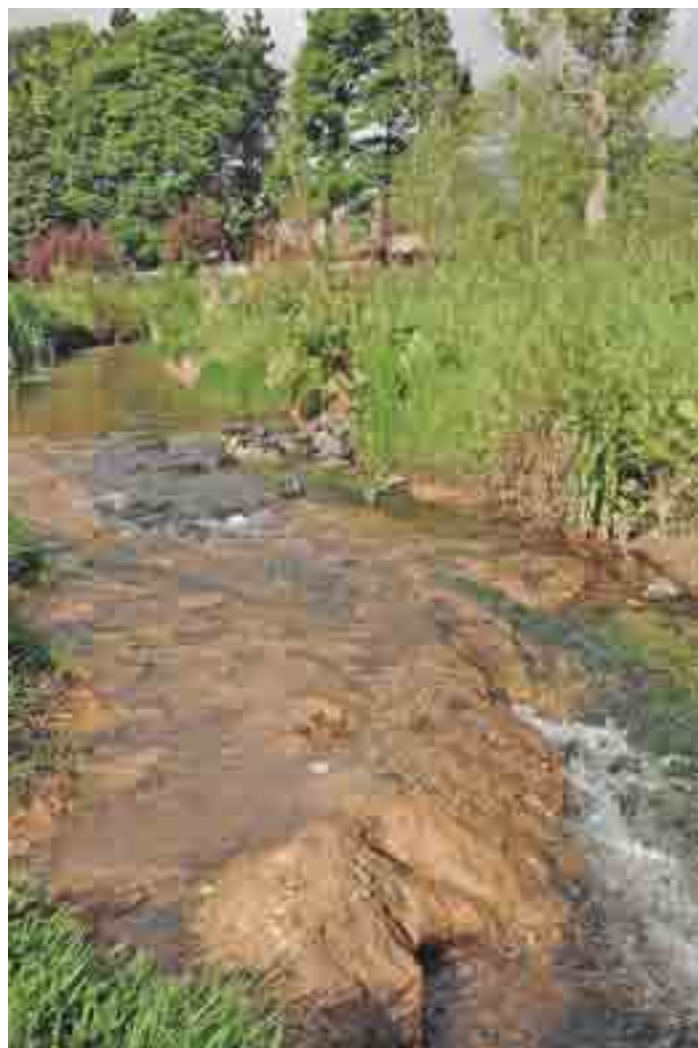
Eroded clay forming a stable cascade and adding to the diversity of features within the channel – May 2011

The shoals around the meanders have trapped significant quantities of fine silt during high water events and vegetation has begun to colonise the sediment, disguising the lumpstone structures. Gravel has been transported out of some parts of the new meanders and replacement with gravel transported from upstream has been slow. At one location a less dense lens of sandy clay within the channel has eroded to form a small cascade and pool.

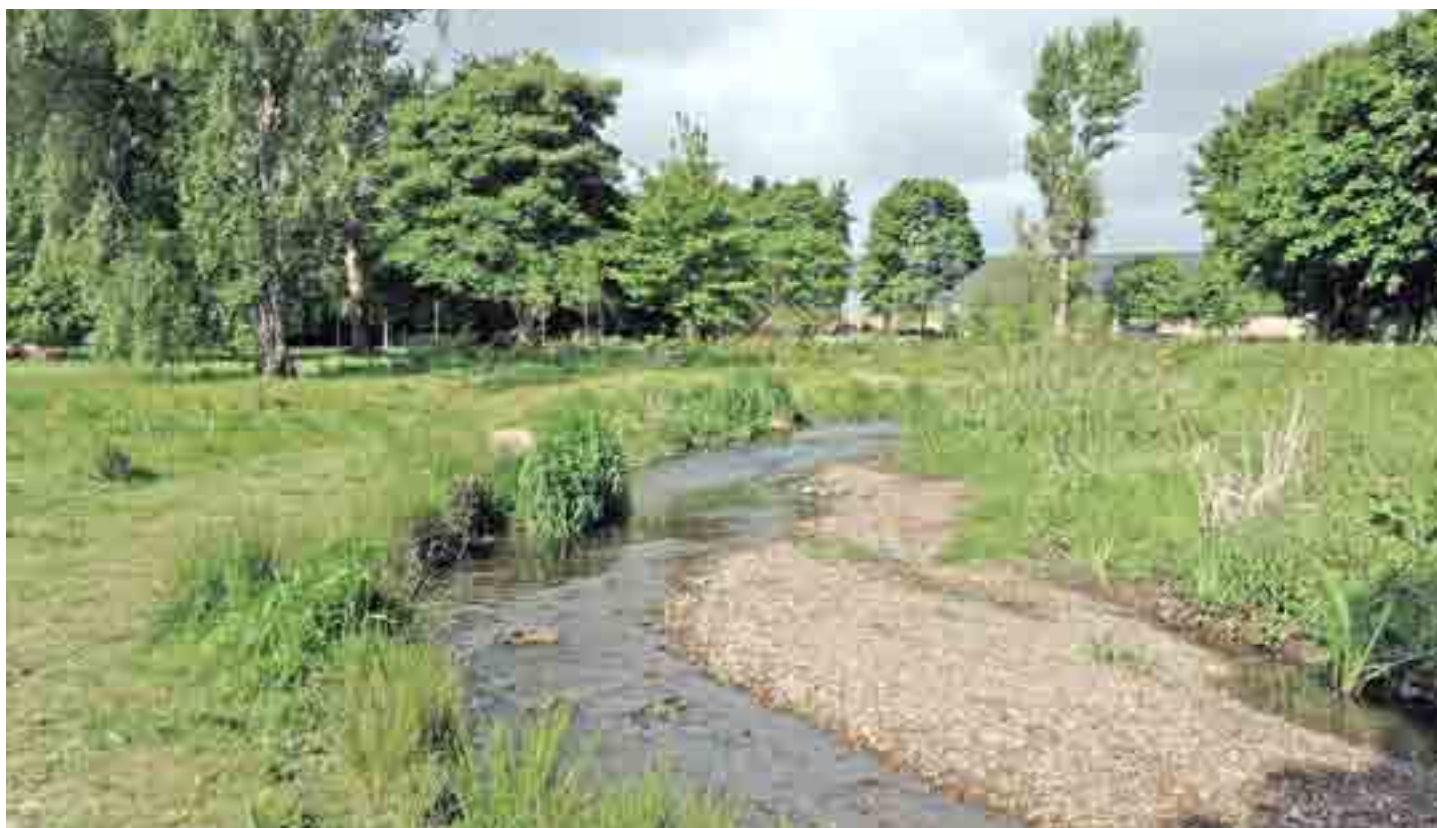
The new course of the Braid Burn through Inch Park after two years. Marginal vegetation has established well and natural processes have enhanced the in-channel morphological features that were created – May 2011

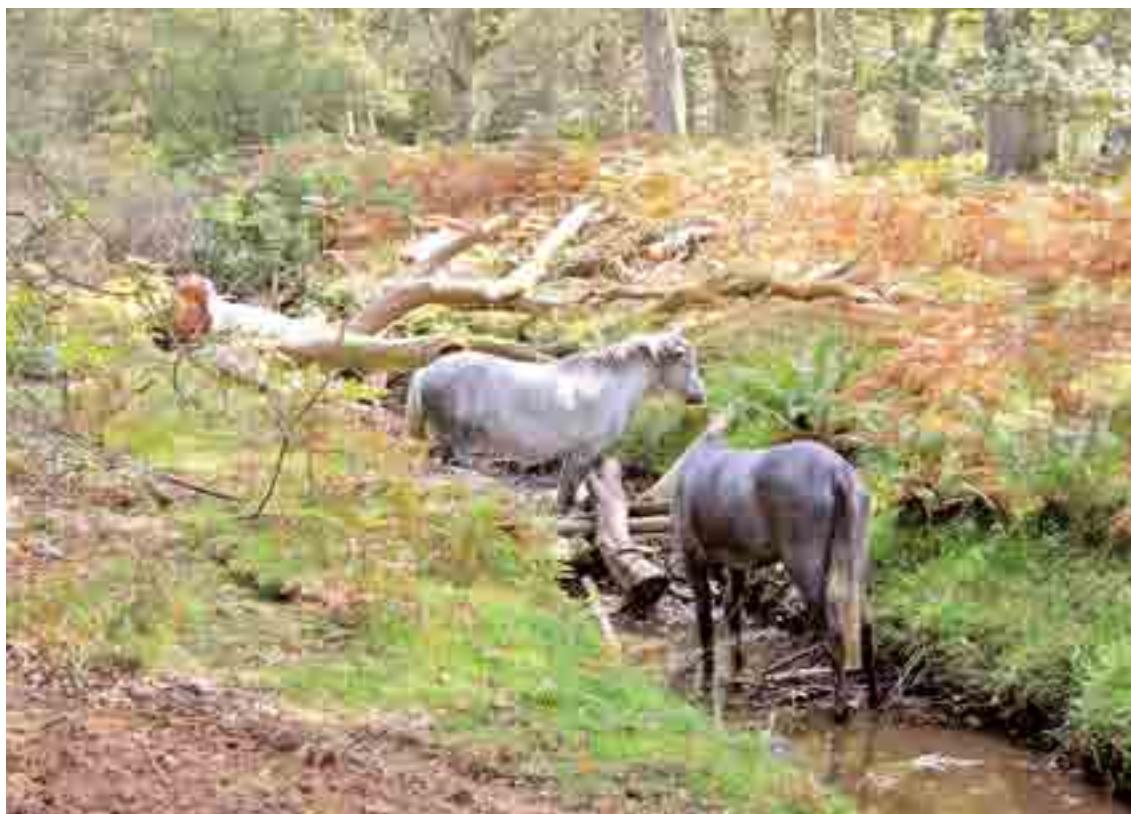
The degraded channel was restricting both natural river processes and easy access across the forest for roaming animals – 2009

One example of this degradation is on Highland Water, a small headwater sub-catchment (4.9km²) of the Lymington River. Prior to restoration the channel was up to 1.2m deep and 4m wide restricting the natural seasonal flooding of the surrounding forest. The previously wet woodland and mire habitat had dried out and the increased channel size presented a barrier to the freely roaming forest animals.

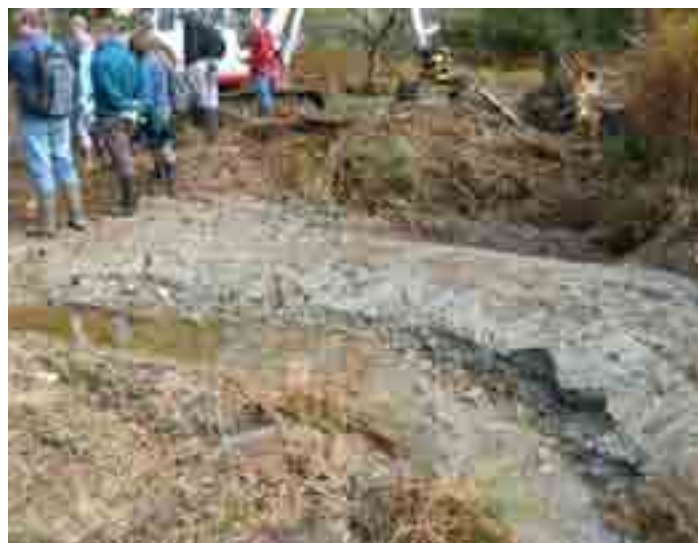
Clay infill was tightly packed at crossing points at 10 metre intervals along the channel to prevent seepage – October 2009

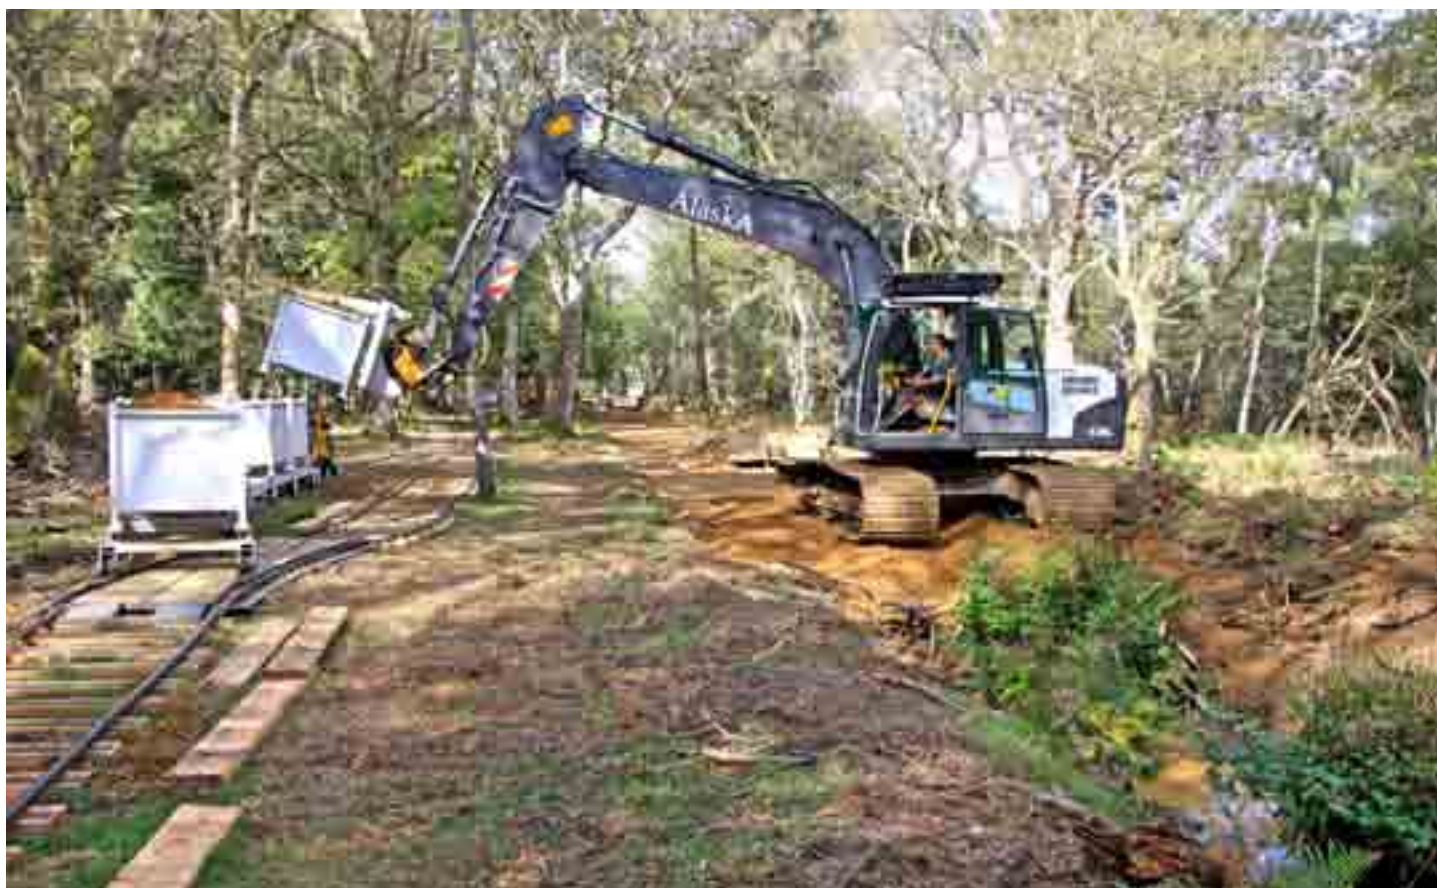
Innovative tramway designed to reduce the impact of works on the sensitive forest habitats, especially during wet site conditions – 2009

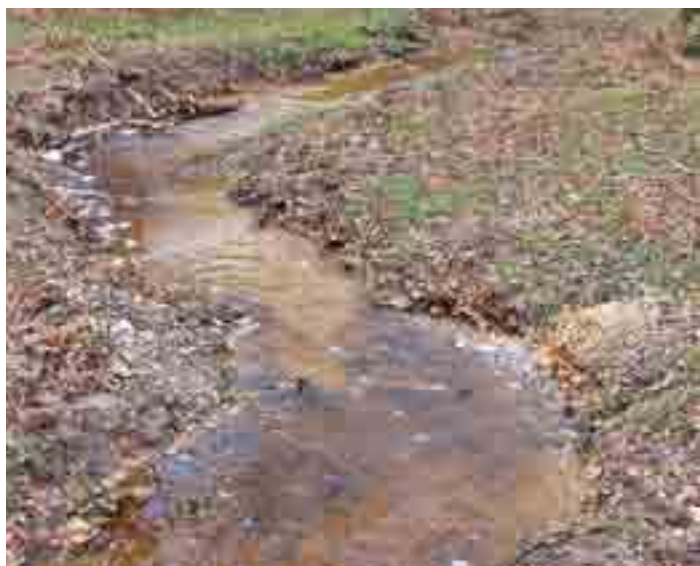
Immediately post-construction flow begins to grade materials. Pools and riffles are developing – 2009

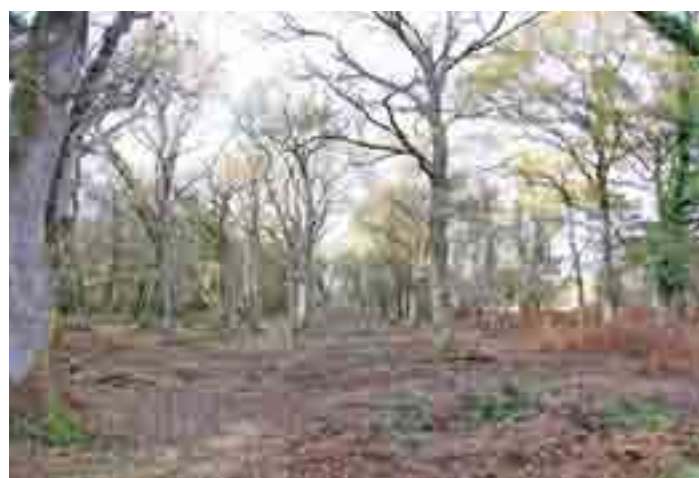
Well-placed shrubs and deadwood blend the old channel into the landscape within days – 2009

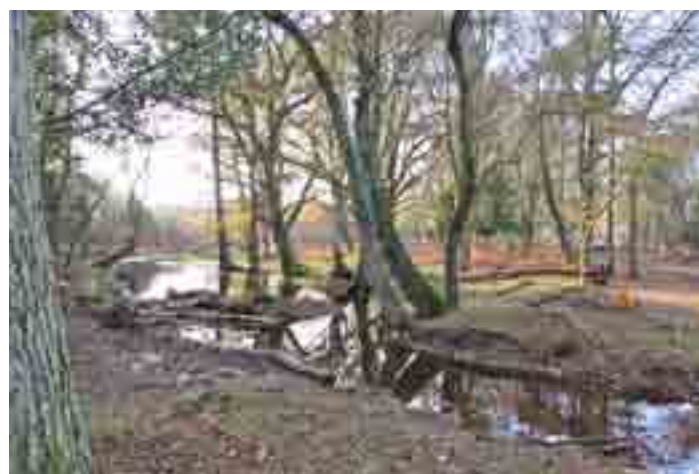
The restored course includes both narrow and wide sections – 2009

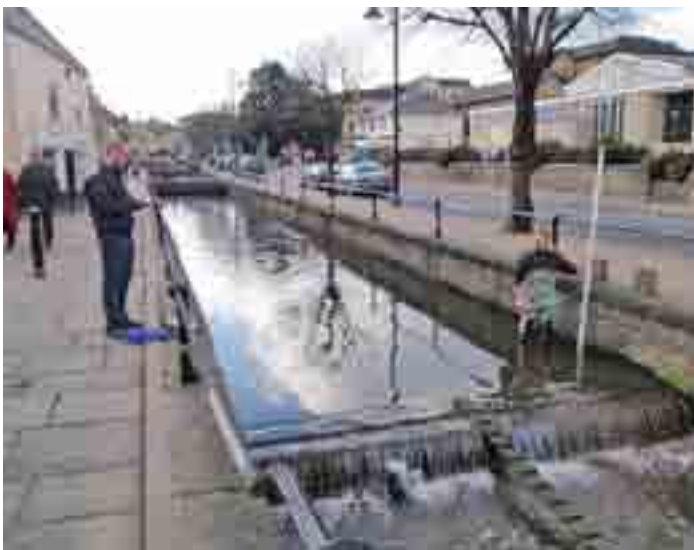
Measuring existing channel dimensions prior to works - 2011

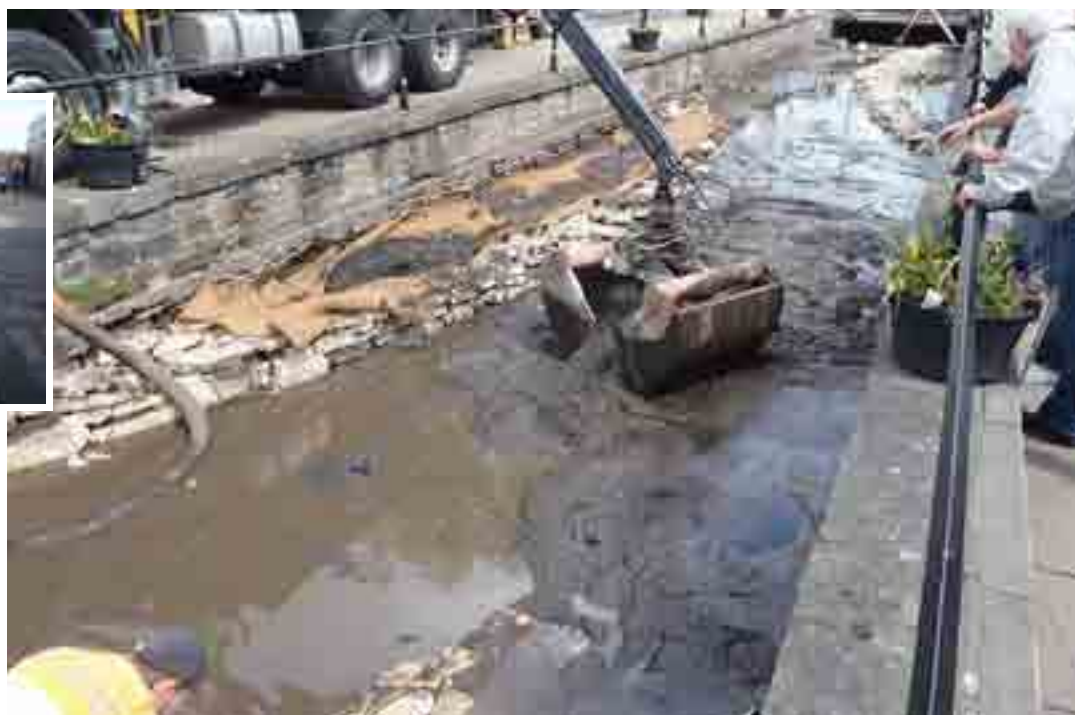
Silt is used to fill the marginal berms ready for planting – 2011

Accumulations of silt were removed from the channel and retained on site for use as backfill in the new design. Three weirs were removed, retaining only the two sides of each structure which were incorporated into the channel berms. This was at the request of the council who wanted to be able to install temporary boards across the channel to retain water depth, should severe drought conditions occur.

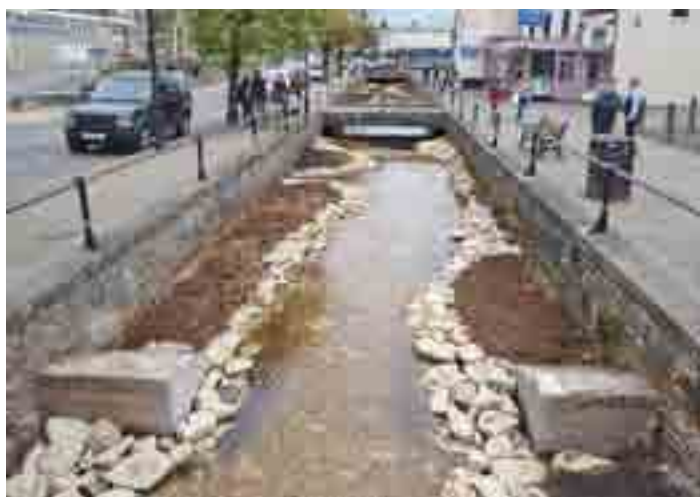
Two sides of the weir have been retained and incorporated into the berms – 2011

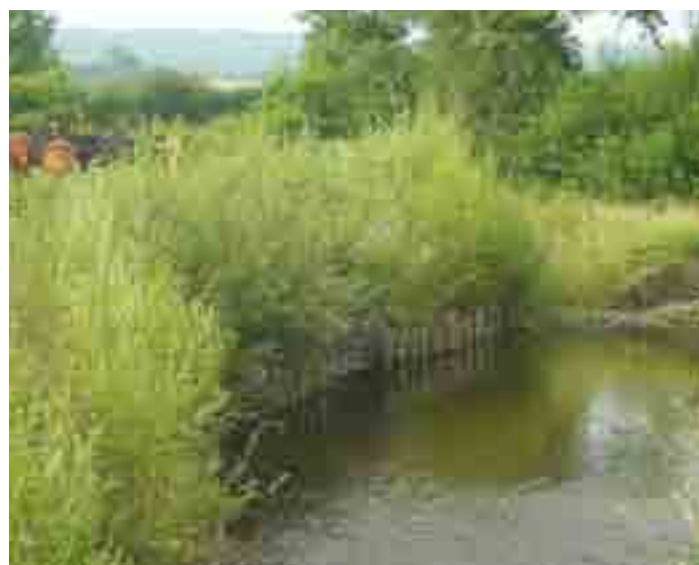
Growth of root wads along bank two years after installation. Brushwood protection can just be seen between root wad growth – 2006

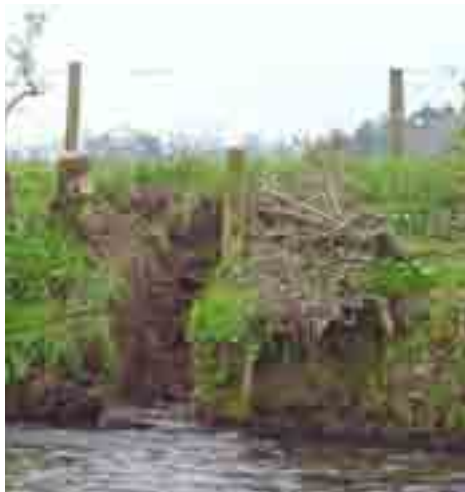
1

Trench excavated in bank – 2004

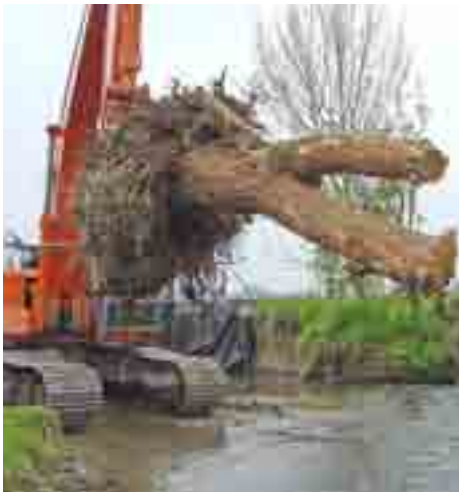
2

Excavator moving root wad into position– 2004

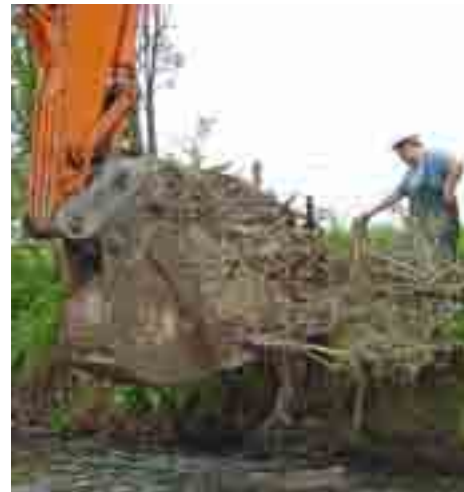
3

Installing root wad in bank– 2004

Forty root wads were installed over eighty metres of bank, with two to three metres of trunk left attached to the root wad. Crack willow (*Salix fragilis*), grey willow (*Salix cinerea*) and white willow (*Salix alba*) with an average trunk diameter of between 0.3m and 0.6m were used. Live willow was chosen as each tree should root and shoot to quickly bind the surrounding bank. All trees were sourced from within the Dulais catchment and two adjacent river valleys.

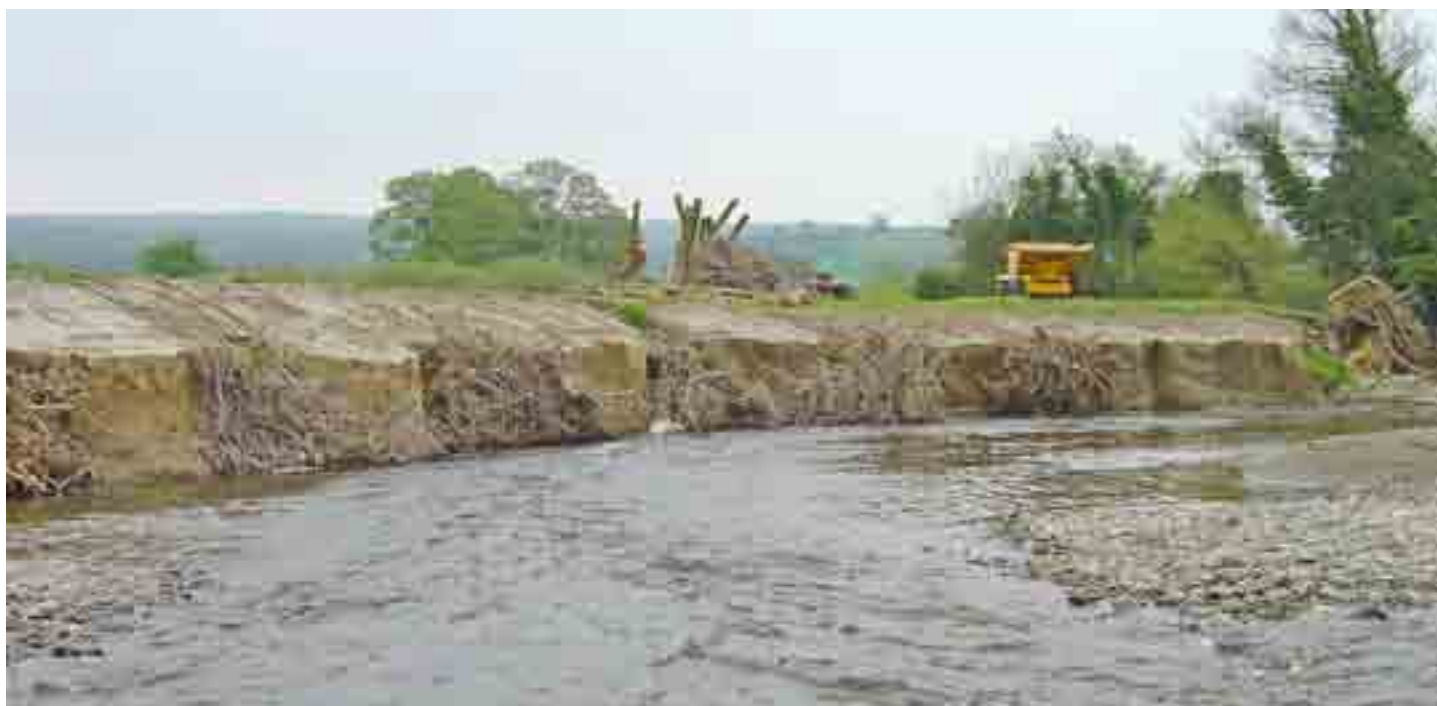
Figure 4.8.2

PLANFORM SHOWING INSTALLATION METHOD FOR ROOT WADS

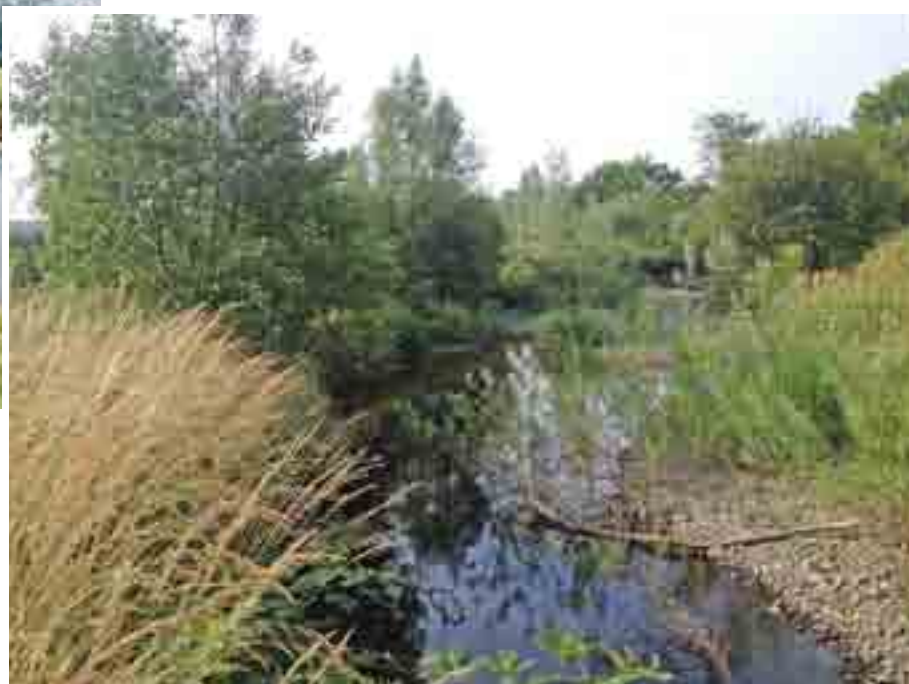
Root wads have become established, stabilising the bank and reducing erosion – August 2013

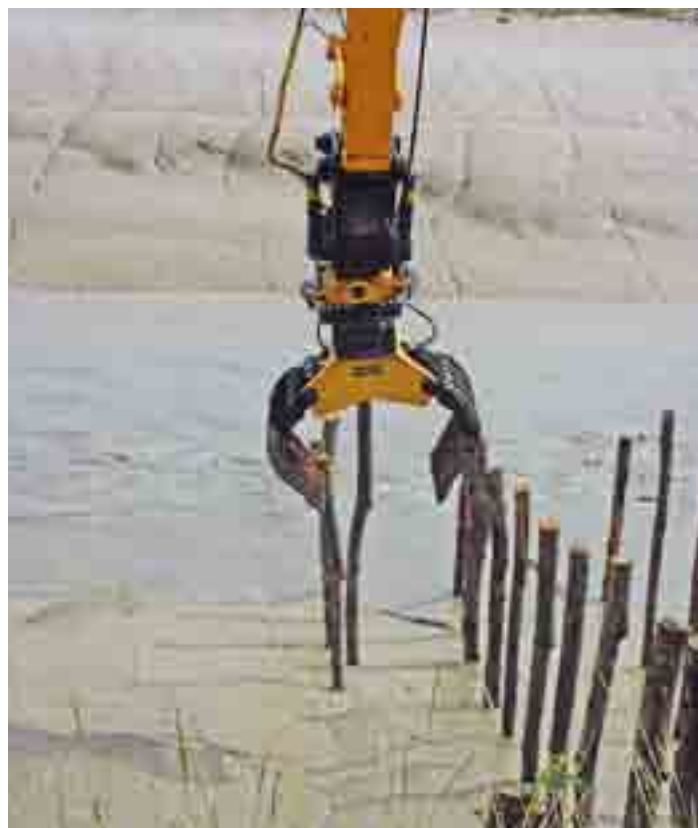
Installation of a matrix of sweet chestnut posts to secure the brushwood mattress – 2005

Hardwood sweet chestnut (*Castanea sativa*) posts were used (minimum diameter of 0.125m). These ranged from 2.1m up to 4.5m in length to allow for the variation of the eroded bank profile and to ensure that at least 1.5m of each post was driven into the bank. The posts were installed in a 1m grid along a 200m section of bank, with an average width of 11m (see Figure 4.9.1) by a long-reach excavator. A hazel (*Corylus avellana*) brushwood mattress was then laid between the posts, using 3m to 4m long brush. Brush was installed to extend slightly beyond the last posts at the toe of the structure, to encourage sedimentation in this critical area by increasing roughness.

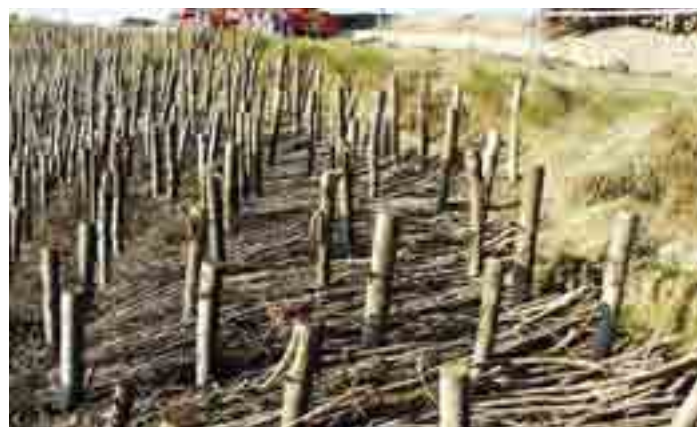
Once brushwood mattress installation is complete, rock netting is secured to the posts to prevent wash out – 2005

The brushwood created walkways and safe access across the site. Hexagonal galvanised rock netting (generally used on rock and chalk escarpments to prevent rock falls) was stapled to the posts across the whole surface of the structure to prevent any brushwood being lost whilst silt was depositing. Completing this as soon as possible was essential to minimise the risk of the structure failing during construction in the event of an extreme tidal event occurring before the whole structure was stabilised. The final slope of the repaired bank had a design angle averaging 40°.

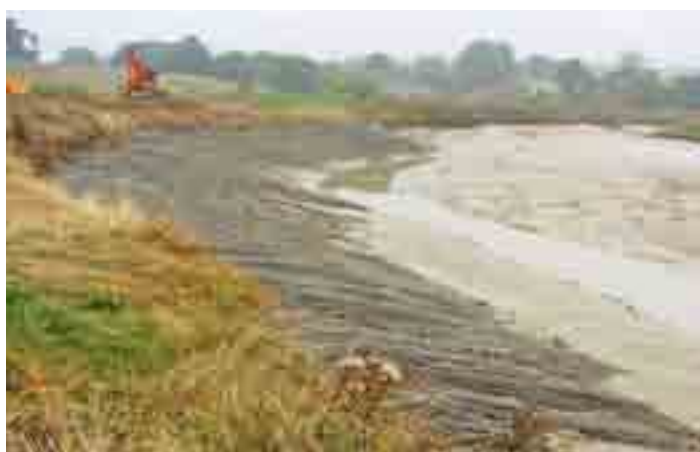
Section of bank post-restoration showing successful accretion of sediments across most of the structure, with some netting still exposed – 2005

Some of the brushwood became compressed by the weight of accreted sediment, leaving the netting standing proud above the brushwood. Cutting holes in the netting around the posts would enable it to settle with the compressed brushwood.

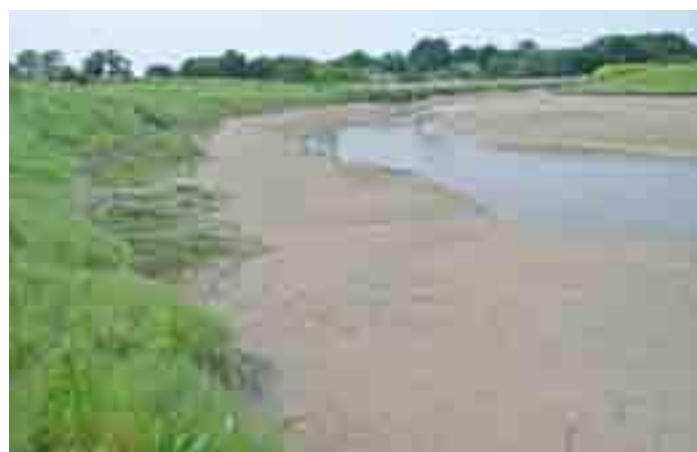
Seven years post-restoration the structure has continued to retain sediments and has been stabilised further by vegetation on the upper bank – June 2012

Fixed point photography has shown that after seven years this technique is continuing to prevent erosion, with vegetation developing well, especially at the top of the bank.

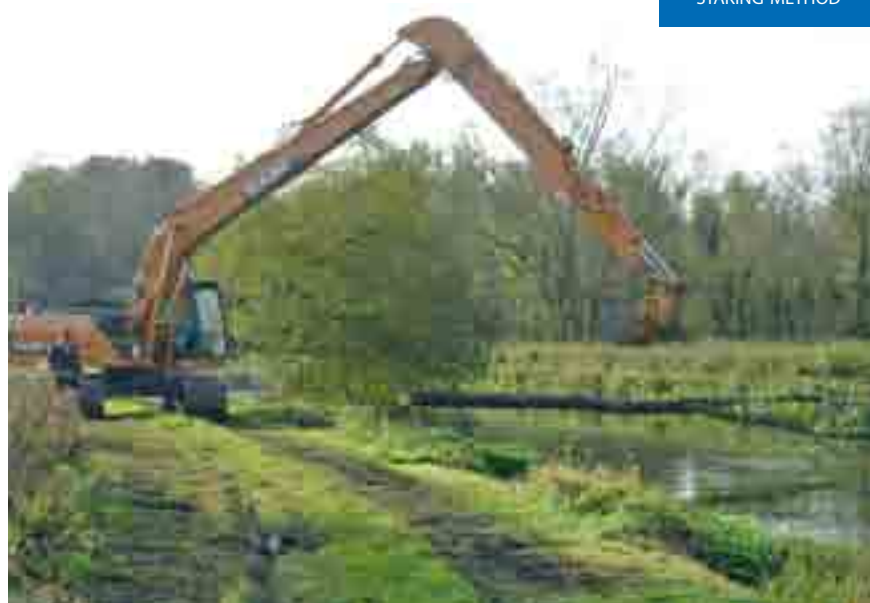
PHOTOGRAPH OF
STAKING METHOD

The sharpened end of tree trunks being pushed 2m horizontally into the bank using a long reach excavator – 2008

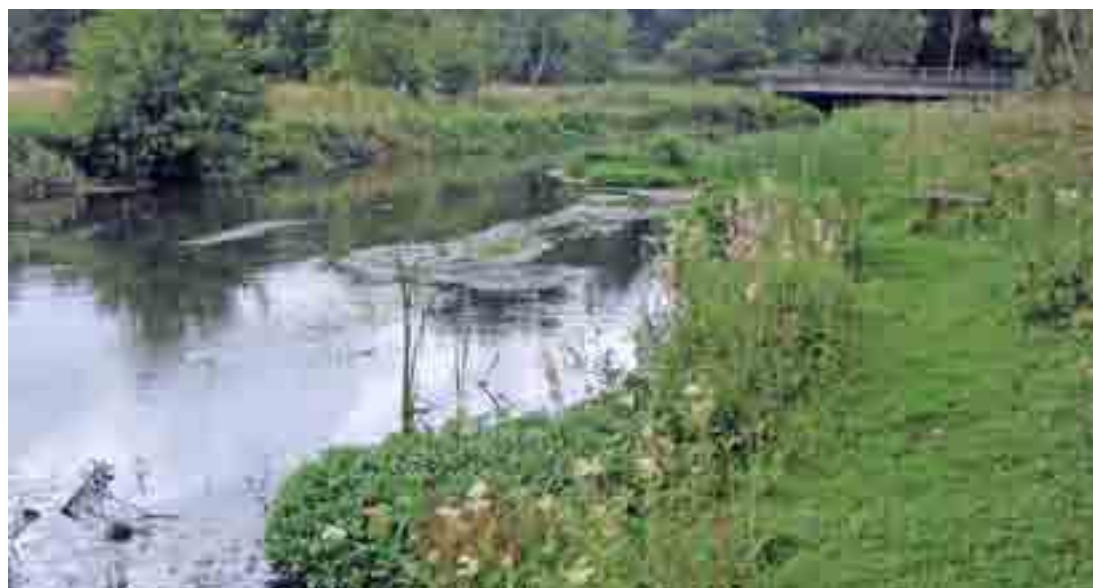
One year later, wood deflectors are collecting rafts of weed and providing shade, cover and habitat. Silt has been deposited between the deflectors.

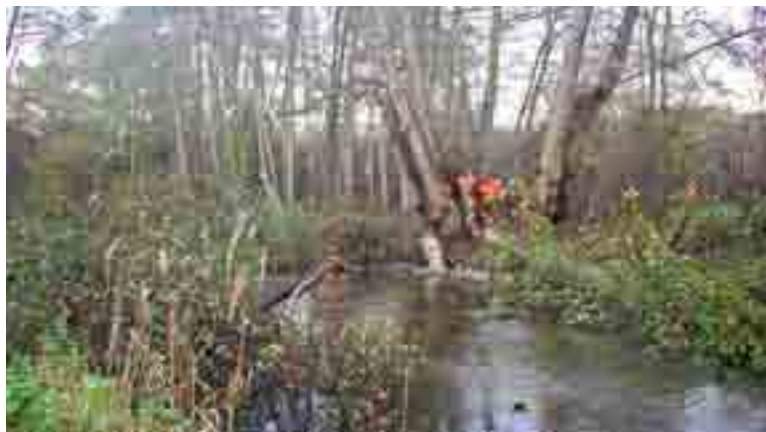
- 1** Select trees which are already leaning over the water and are likely to eventually fall in the river.
