Restoring Meanders to Straightened Rivers

1.8 Restoring a meandering course to a high energy river

ROTTAL BURN

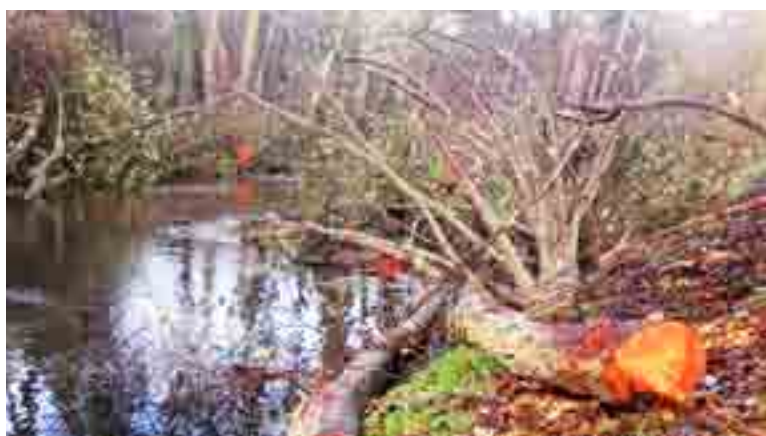
- 2** Fell them so that they remain attached to the stump (often referred to as 'laying' or 'hinging') or so that part of the trunk stays on the bank. Allow branches to penetrate the river bed to increase the stability of the tree and to prevent the tree from rolling or being mobilised by the flow.

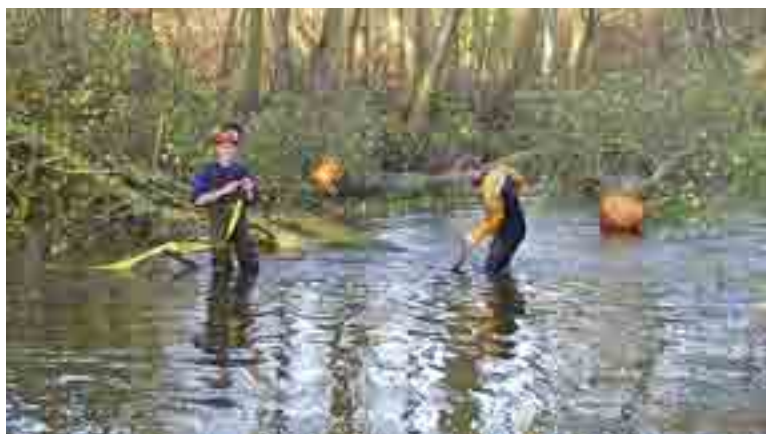
- 3** Modify the position if necessary to maintain an open channel if the felled tree blocks the flow. If absolutely necessary, prevent movement with a 1.5m stake.

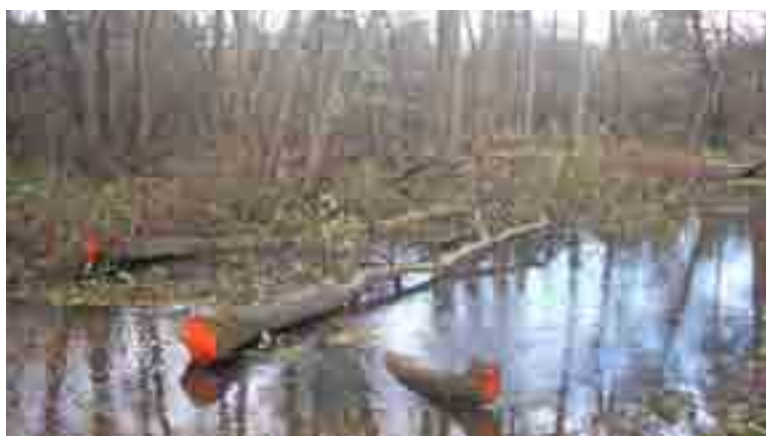
- 4** Fell more than one tree on top of each other to provide a greater mass to the structure and give a dense web of branches.

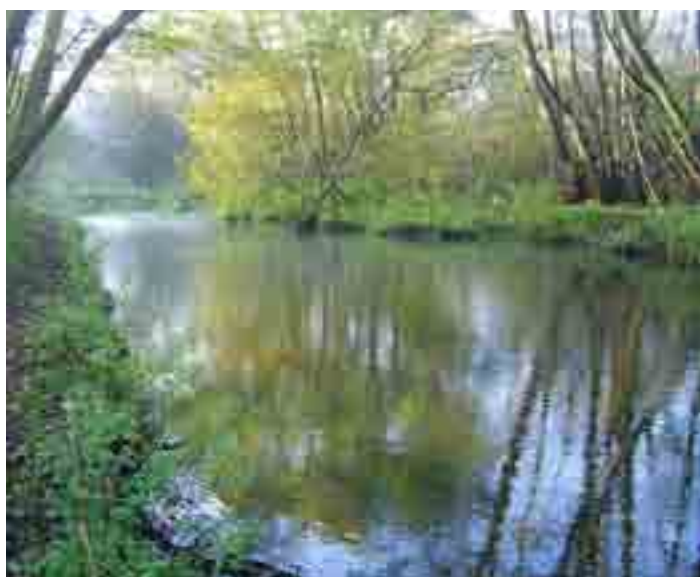
Before – Over widened silt laden channel

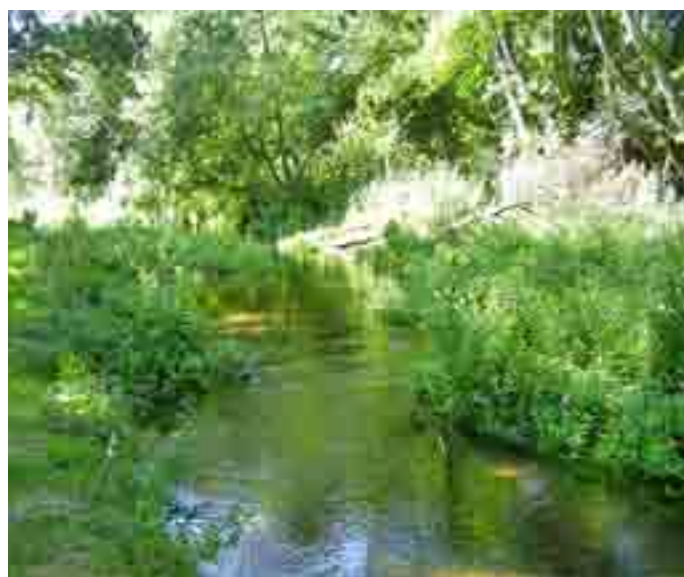
After – With narrowed channel and vegetated berms where silt has built up downstream of the felled trees – 2012

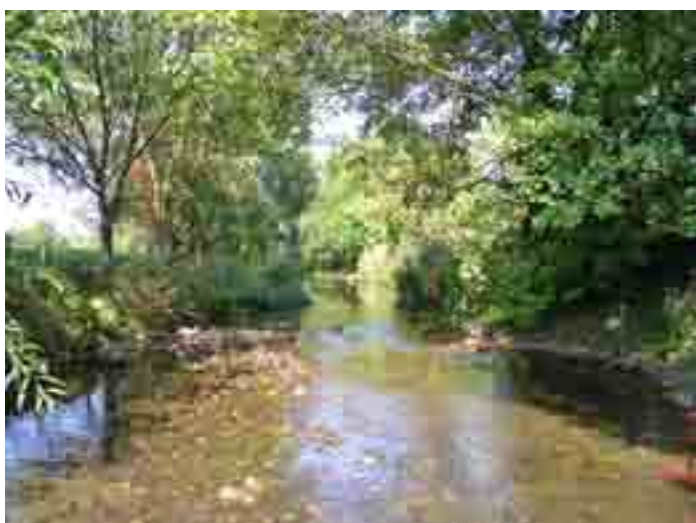
Over-widened channel prone to low flows.
Little or no marginal or submerged vegetation
- July 2005

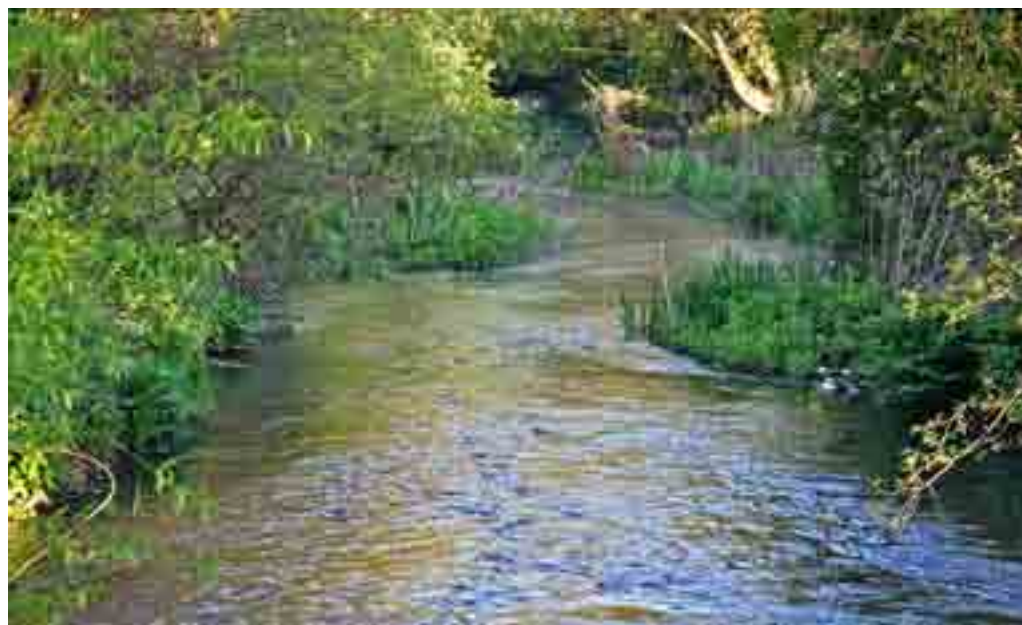
5 years on the channel is narrower and more sinuous. Vegetation, both submerged and riparian, has established well – May 2010

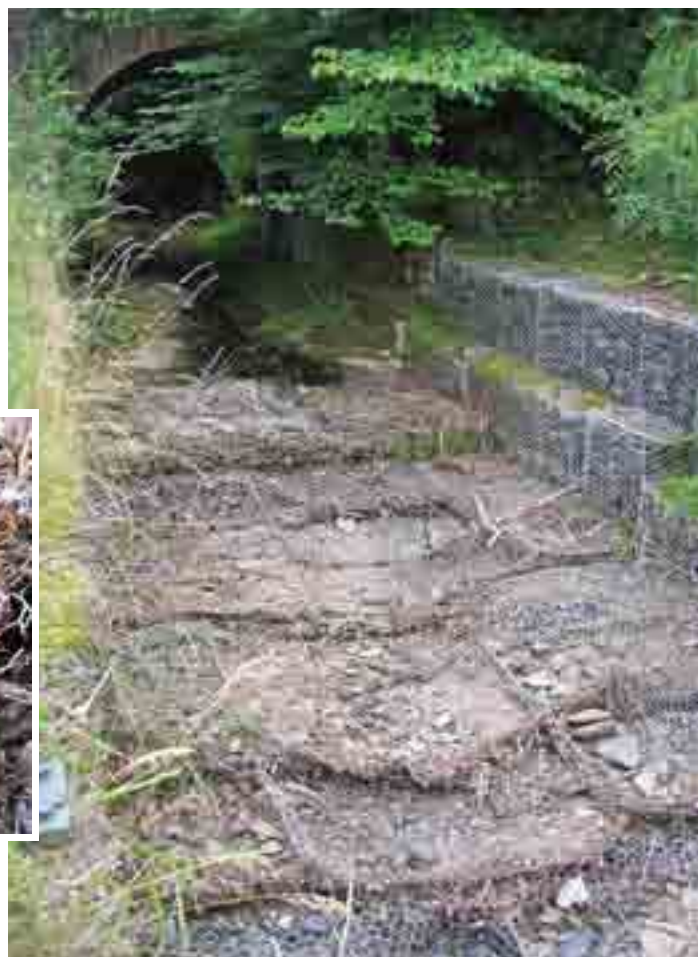
Before restoration works showing complete failure of the wire structure and no surface flow – August 2006

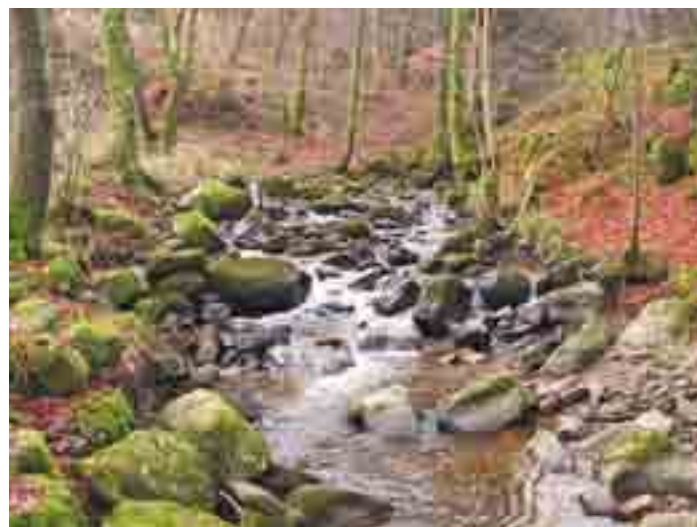
The natural channel, a few hundred metres upstream, showing the variable step-pool configuration formed by large boulders – November 2005

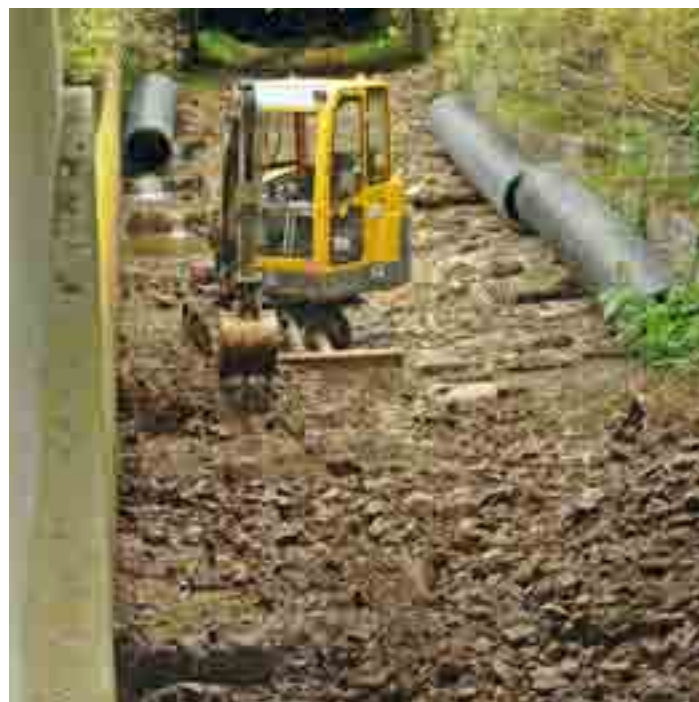
Wire from mattresses in bed removed. The stone was retained to use in the new step-pool system – 2007

First, the wire from the disintegrating mattresses was removed. The cobbles that had been transported downstream were retained for reuse. The work was carried out during a dry period, with all of the low flow in the burn routed through a 0.5m diameter pipe.

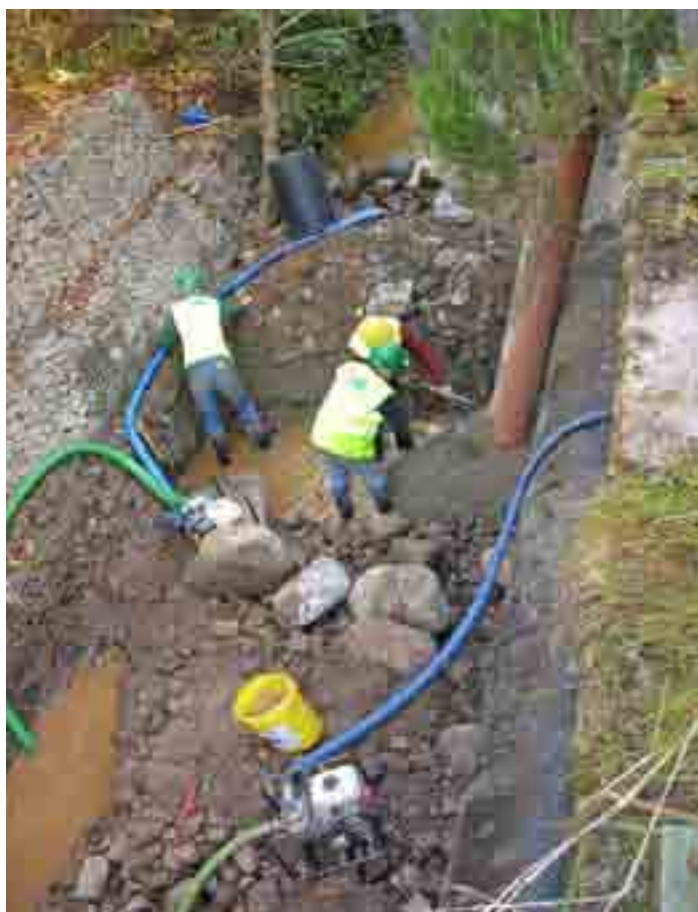
Excavating for the concrete base to bed the larger boulders – October 2007

The high gradient meant that there was a need to ensure that the keystones did not move. For this reason, a buried concrete base and steel pins were used to fix the most critical bed elements. Where concrete was to be used to bed-in the steps, it was specified to be buried at least 0.5m below the stone and cobble base to ensure that it remained unseen (*Figure 5.9.1*).

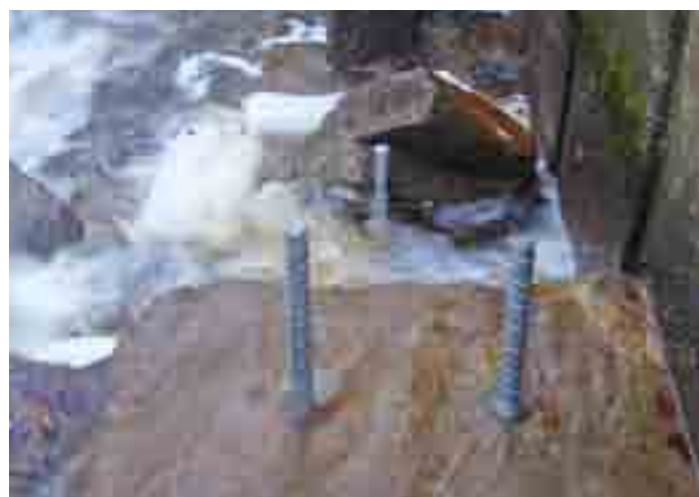
Steel pins in the concrete retaining wall toe awaiting boulder placement – 2007

The vertical concrete right bank (i.e. the road bridge footing) was constructed with a 0.5m wide toe which had previously been hidden beneath the wire mesh bed. This stepped ledge needed to be hidden by the new works (for aesthetic reasons and to prevent undercutting) and therefore provided a secure foundation for locating a number of the keystones. The boulders and concrete ledge were both drilled and the boulders then fixed in place with resin and steel pins.

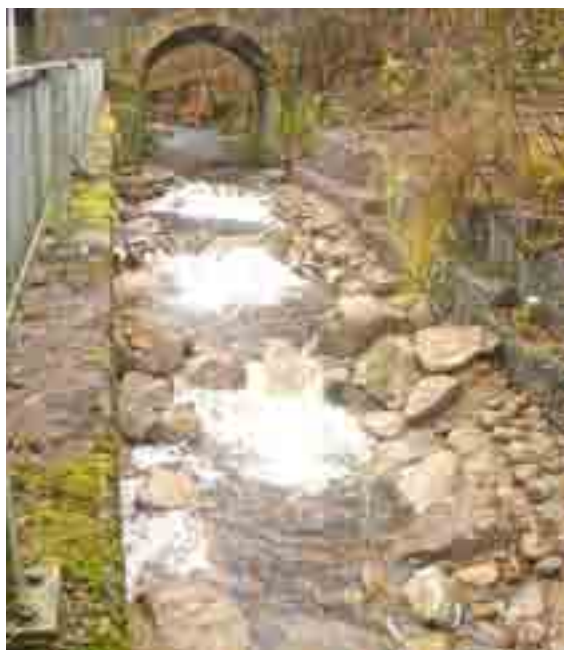
Immediately after
completion
– December 2007

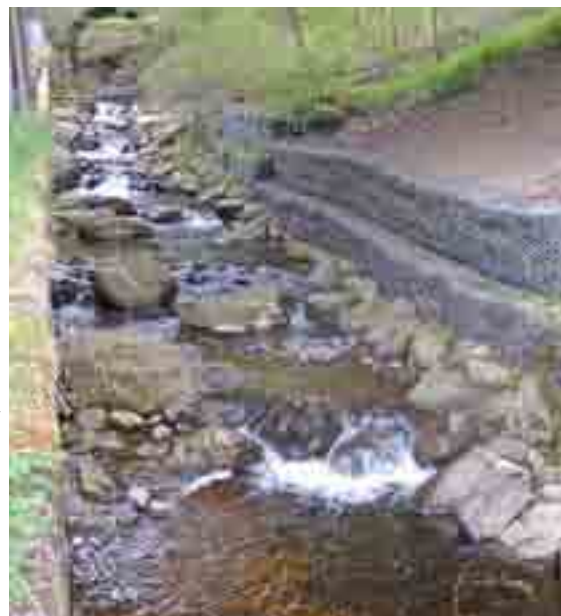
Beneath the A9,
five years after
– May 2012

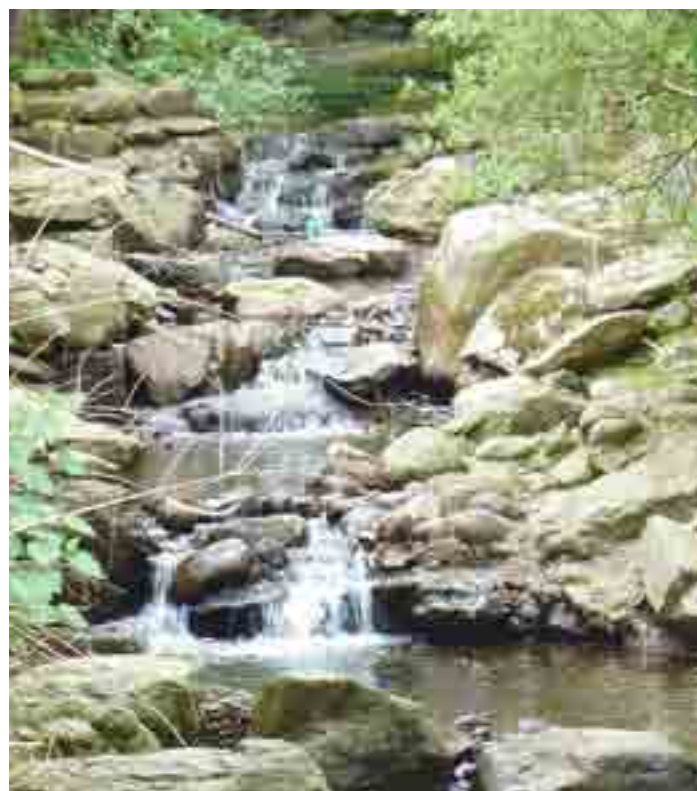
The restored reach mimicking the step pool configuration
of the upstream reach– May 2011

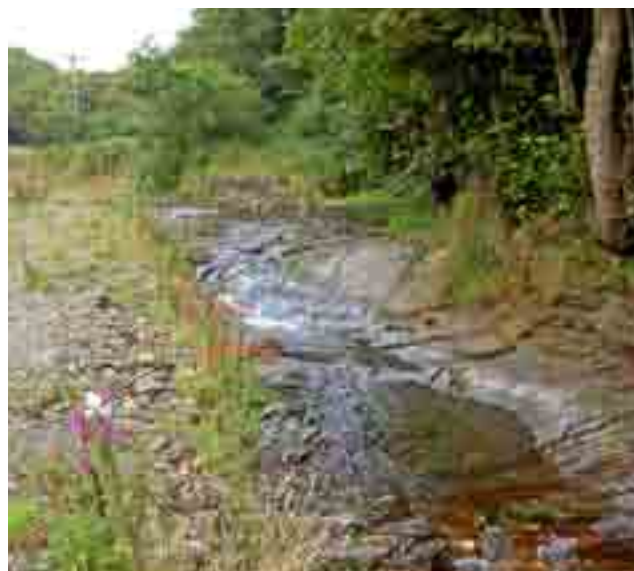
Natural cascade and pool upstream of Boscastle
- 2006

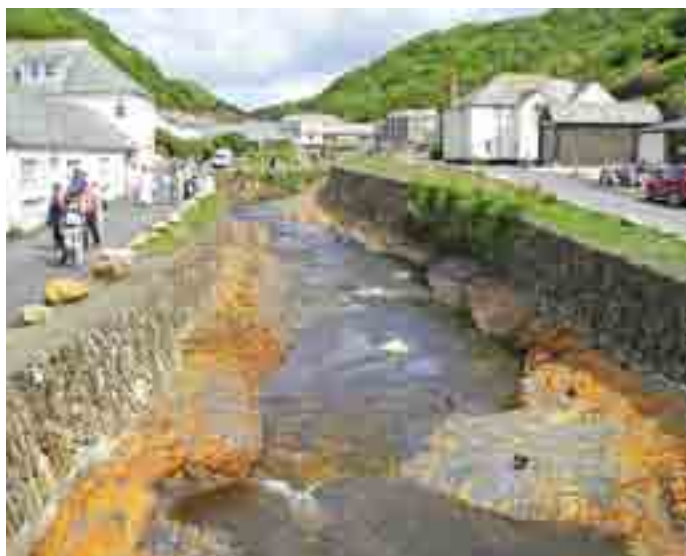
© Halcrow
The low flow course had to be entirely excavated to best mimic millennia of erosion of a hard rock bed.

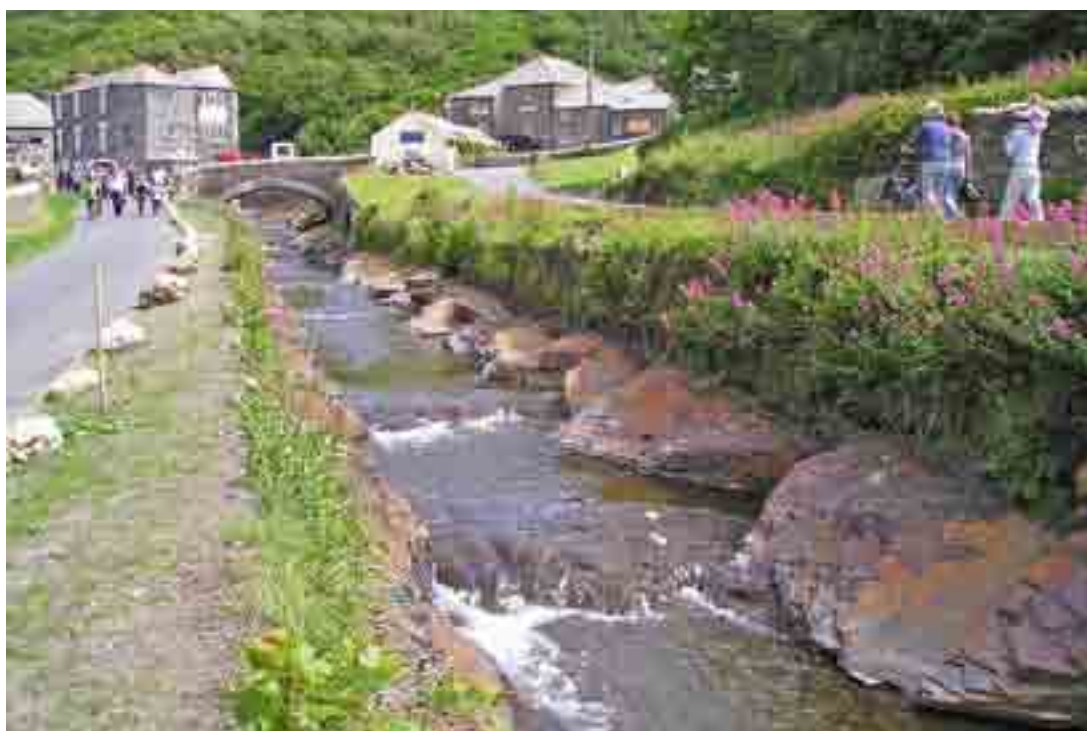
Deepened channel using natural fracture lines within the bedrock. Retaining walls becoming vegetated

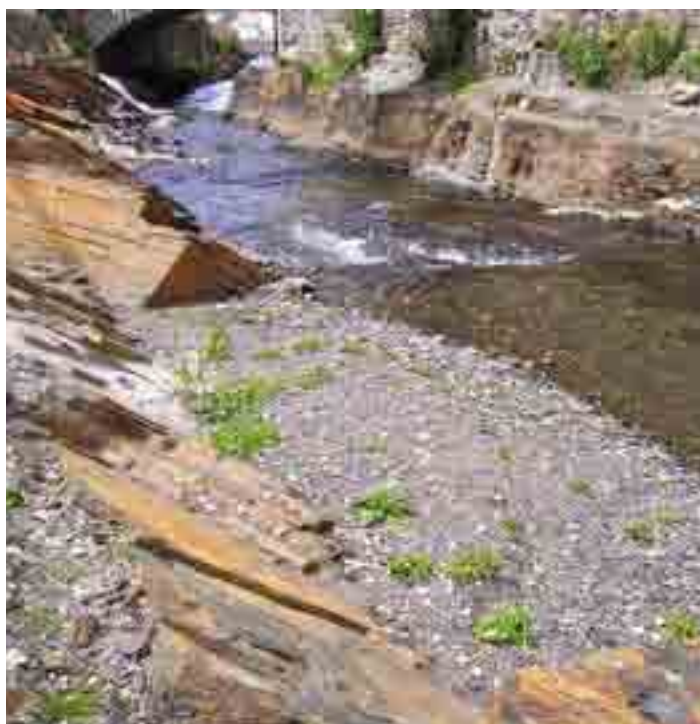
Gravel beaches have formed within the bedrock channel

The re-profiled river has performed well during the years since completion. The excavated profile has remained stable, as have the individually sculpted cascades, pools and embayments. Within the latter a good diversity of flow characteristics provides niche habitats, with some gravel in sheltered eddies as well as small beaches. It is also visually attractive, enhanced by the sound of the cascading water. This contrasts markedly with the flat, featureless river bed that existed before.

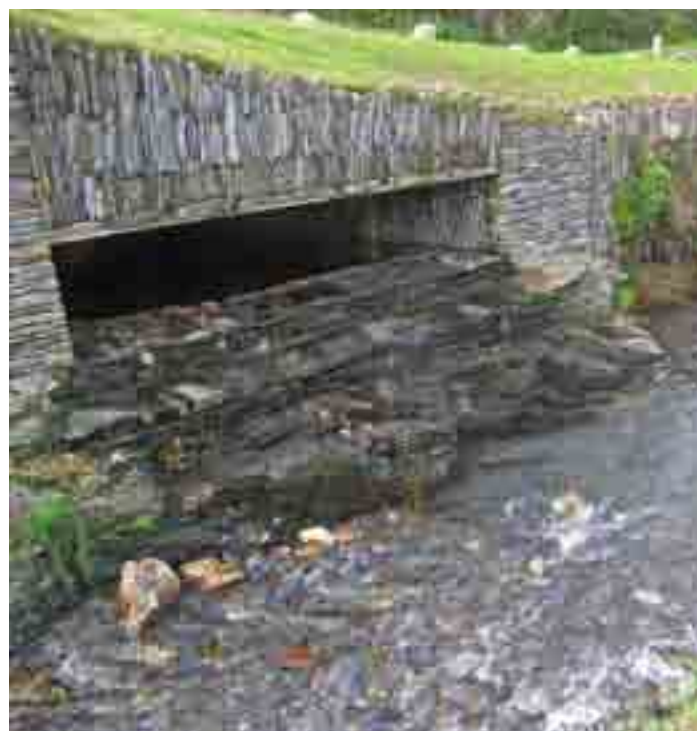
River Jordan outfall. The over-deepened pool has clearly filled with large stone sediment – October 2008

A single negative aspect has been the excessive deposition of stony sediment at one location. This is where the bed was significantly cut down below the optimum mean bed gradient of 1 in 45, to provide greater flow capacity where an overspill culvert of a tributary stream, the River Jordan, enters (See Figure 5.10.2). Bed material has simply filled this over-deepened pool to bring the bed back up to the 1 in 45 mean. Consequently there are no rock features in the bed here. This outcome was foreseen and this 'pool' had been designed such that the excess fine deposits would remobilise during flood flows, thus

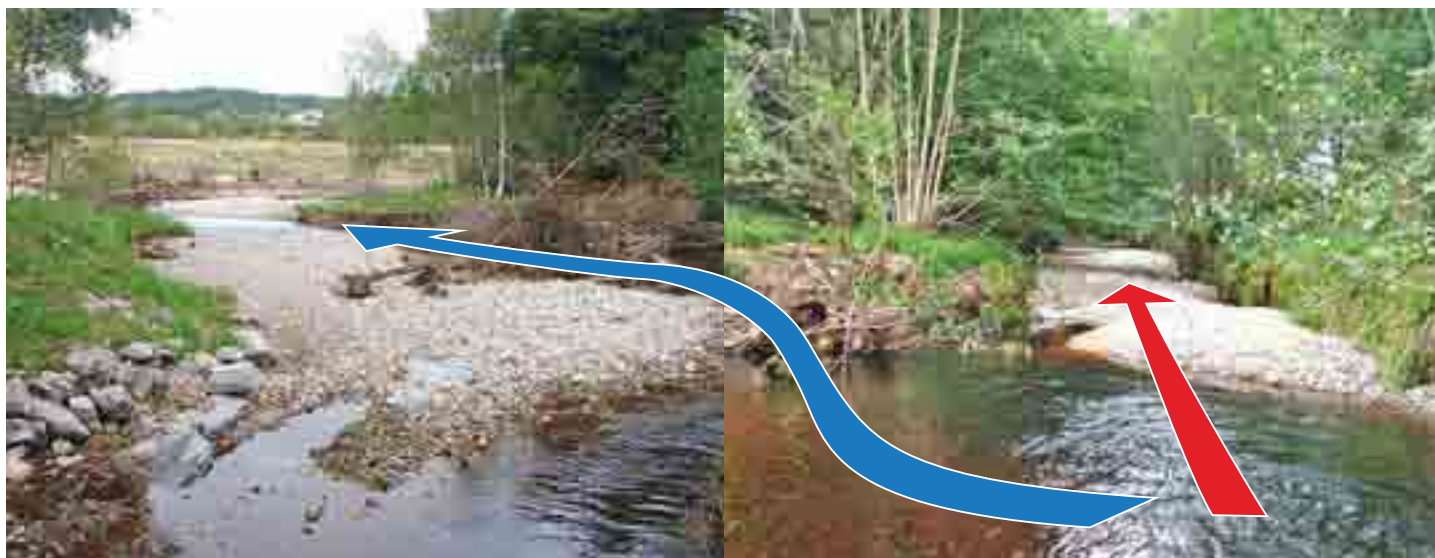
The upstream breach two years post construction: widening of breach and gravel deposit to the left; abandonment of the old course on the right (blue arrow=new route, red arrow=old route) – 2010

Approximately one year after the banks were breached in September 2009 the channel experienced an estimated 30m³/s flood flow (of the order of a 1 in 10 year event). The stone protection at the upstream breach was partially washed out, as anticipated. The breach enlarged such that the majority of the flow was diverted along the new route after the flow subsided. The result was rapid development of river features, including the formation of an outwash fan (see Figure 6.4.1). Some ecological degradation has occurred in the short term, as the old channel is now dry except during very high flow events.

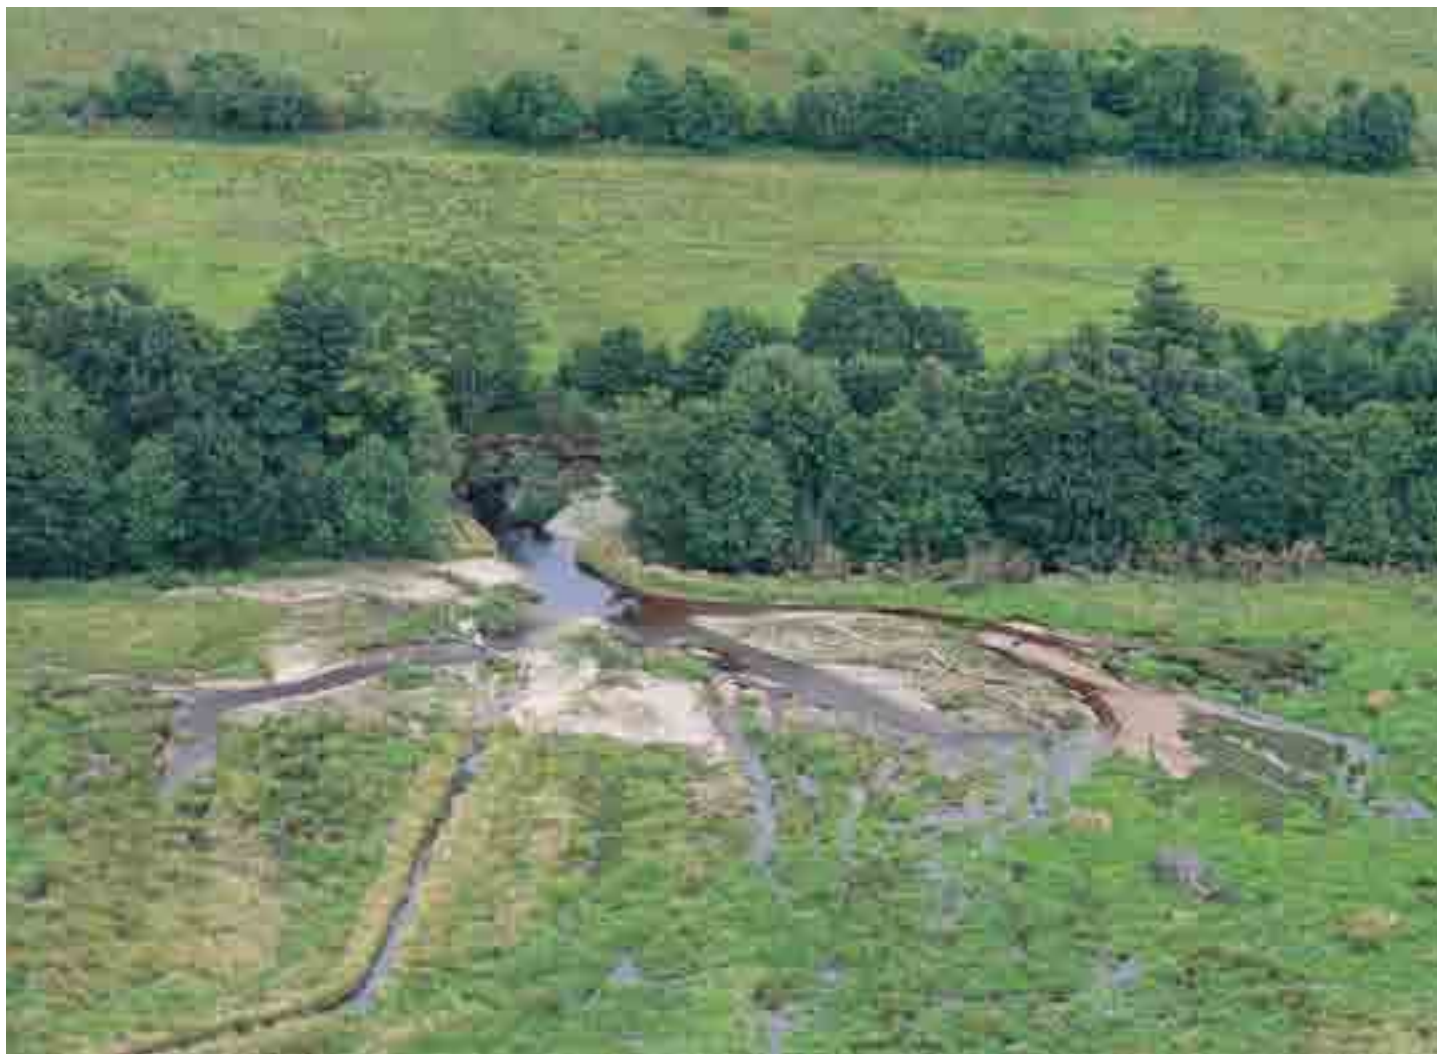
Sediment accretion area/outwash fan has developed
at the upstream breach – July 2011

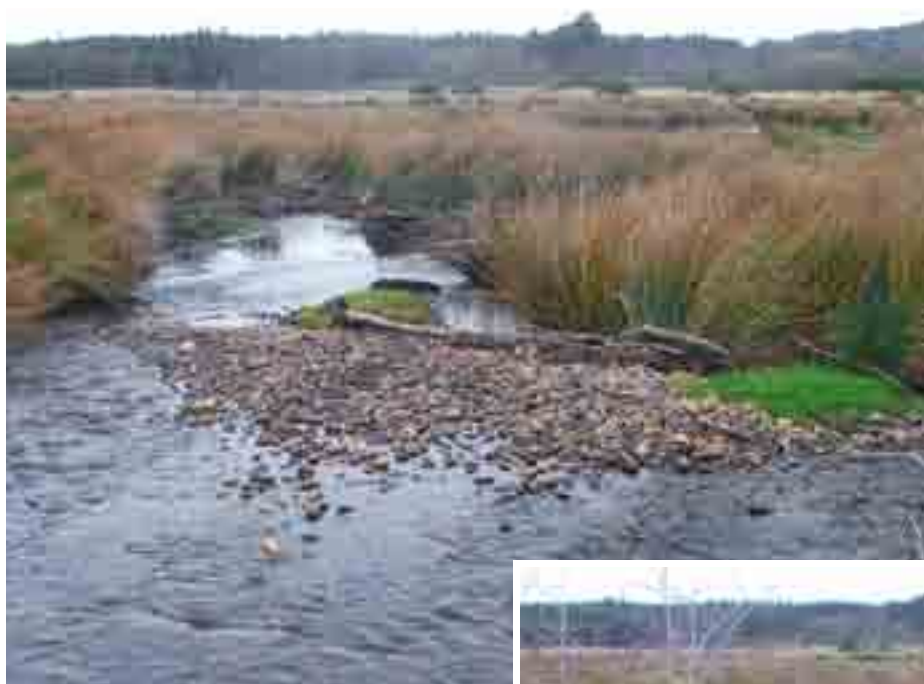
Channel development. The accretion area is storing woody material and river sediments – March 2012

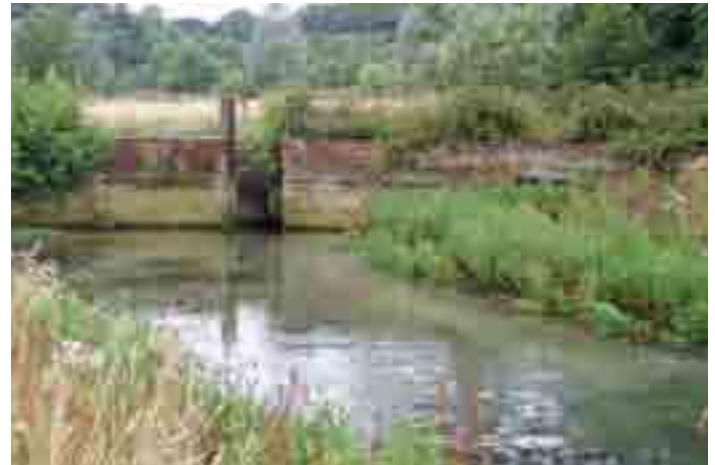
Downstream extent of the reach. The sluice boards have been completely removed – August 2007

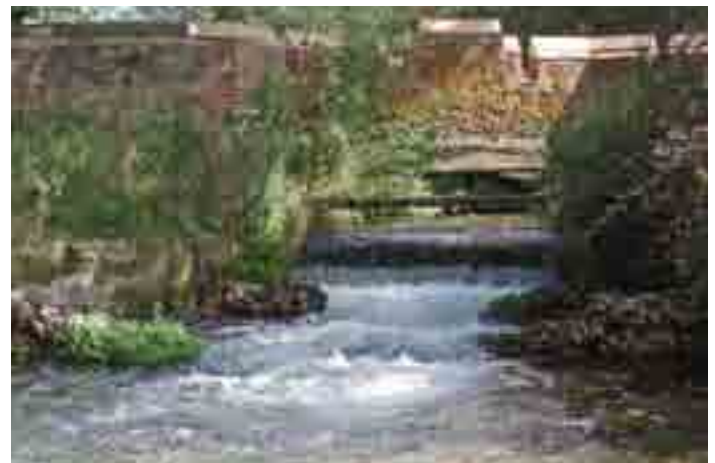
Pool and traverse fish easement after completion. Vegetation has already begun to establish on the rock rolls – August 2007

The easement was constructed using twenty rock rolls to create jumps approximately 0.3m high, the height that brown trout are able to traverse. Two lines of rock rolls were laid across the downstream face of the weir creating three steps for migrating fish to negotiate the barrier. A gap of approximately one metre was built into each line of rock rolls to concentrate the flow. These gaps were offset to reduce flow velocities through the easement and to create fish resting areas.

It was recognised that initially water would probably percolate through the rock rolls. However it was envisaged that the sediment would deposit in the rock rolls and they would quickly vegetate.

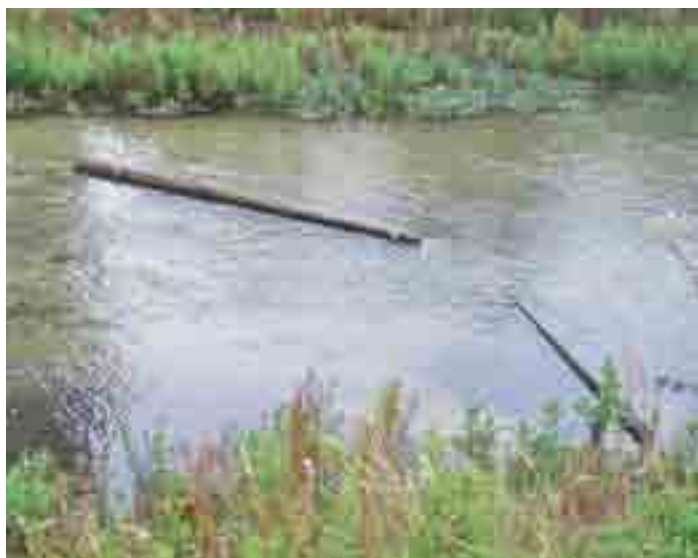
© Environment Agency The newly installed deflectors face upstream and concentrate flow. The old silt bed has formed new banks and has since been colonised by vegetation – February 2007

The deflectors were generally installed in pairs, some opposite each other and some offset. The locations were determined by working with the river. Hillington Fly Fishing Club was responsible for this work so the addition of the deflectors did not contribute to the Environment Agency project cost.

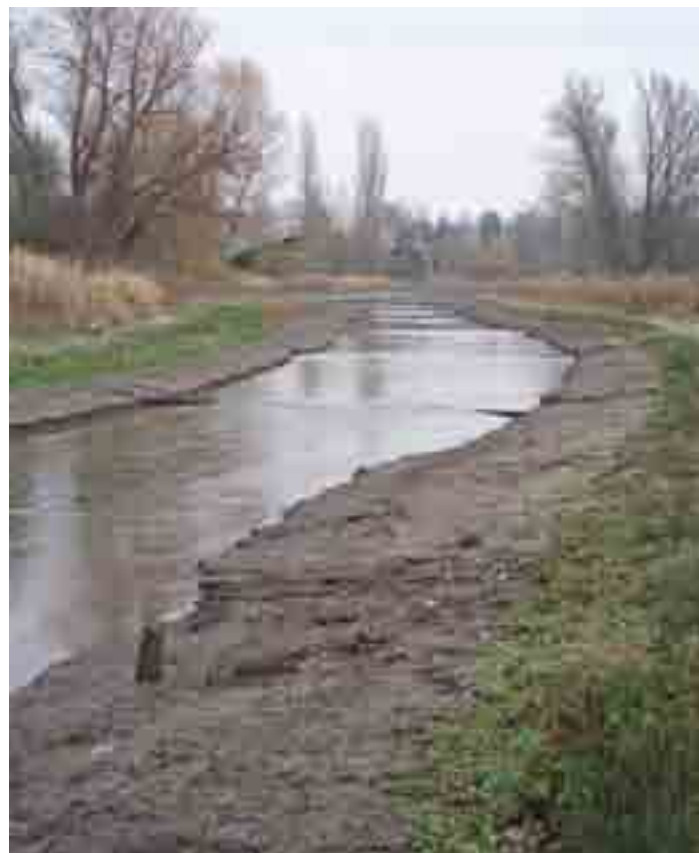
One pair of deflector boards, installed at an offset angle, after six months. Marginal vegetation has rapidly colonised the silt helping to stabilise it further – August 2007

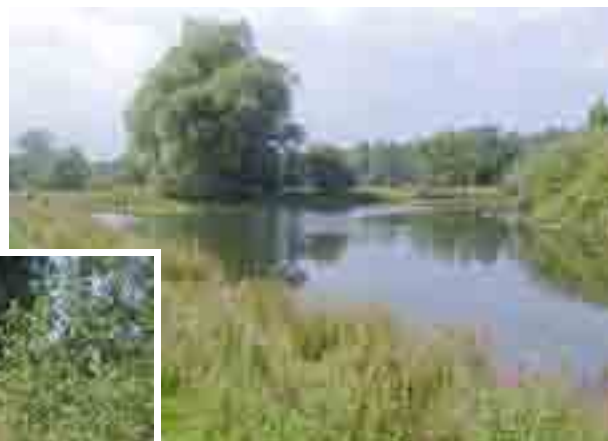
Prior to restoration works. The on-line lake was over deep due to the presence of sluice boards impounding water – August 2006

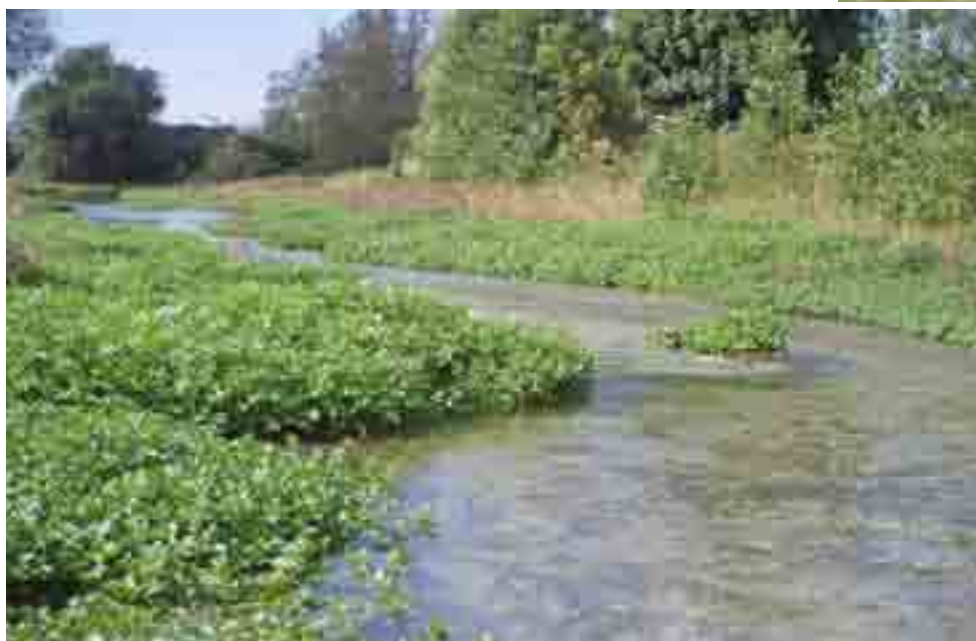
Post restoration works. The channel is narrower and shallower with diverse marginal vegetation and good spawning habitat – September 2007

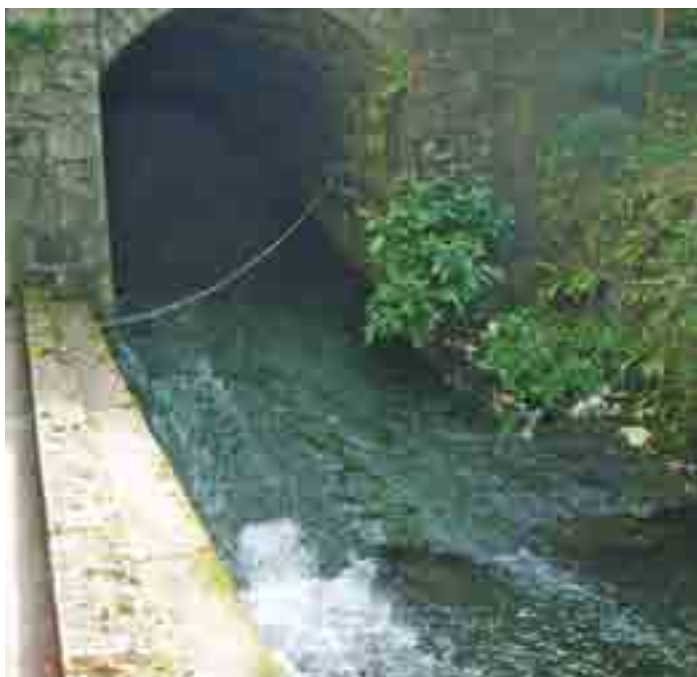
Existing culvert beneath buildings was impassable to fish due to depth, velocity and slope of the concrete bed and apron – August 2010

Initial scoping identified significant hydromorphological pressures within the town. The site was classified as "bad ecological status" for Water Framework Directive (WFD) in 2009. A major cause of this was identified as a perched culvert with a concrete bed and steep apron, located in the centre of Coleraine. This was

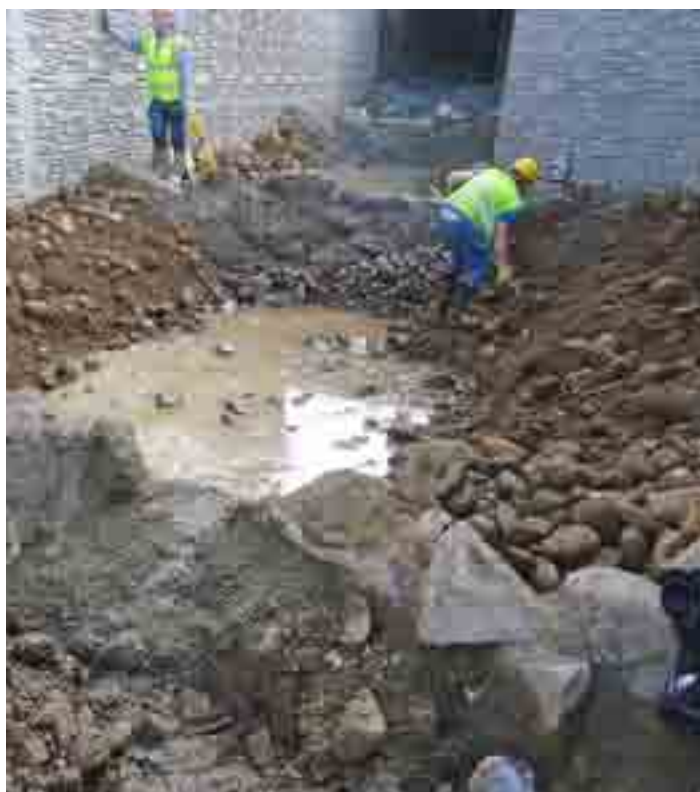
Cascade during construction – May 2012

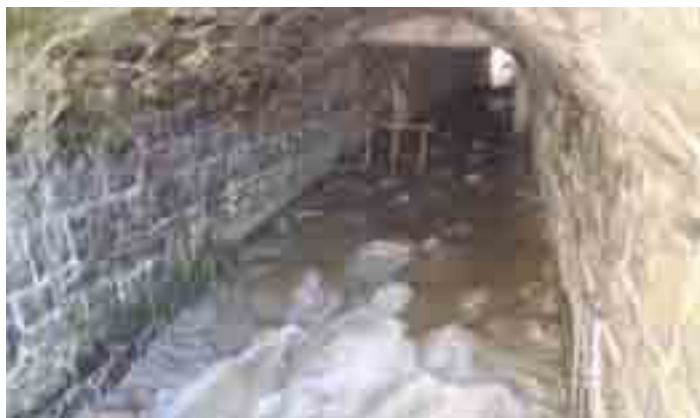
Culvert shortly after construction completed – May 2012

Stainless steel baffles (0.15m high) were secured across the culvert at 2.5m intervals to prevent scouring of the placed bed material.

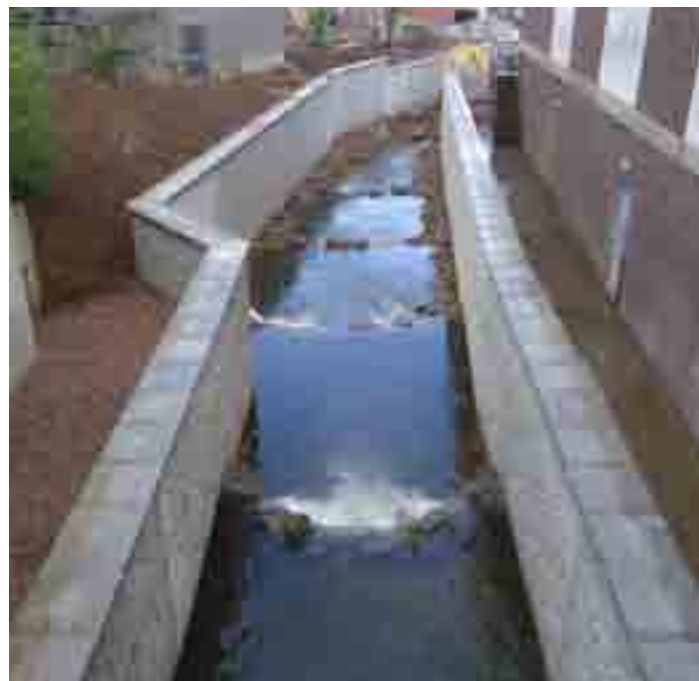
The channel post-construction during low flows – May 2012

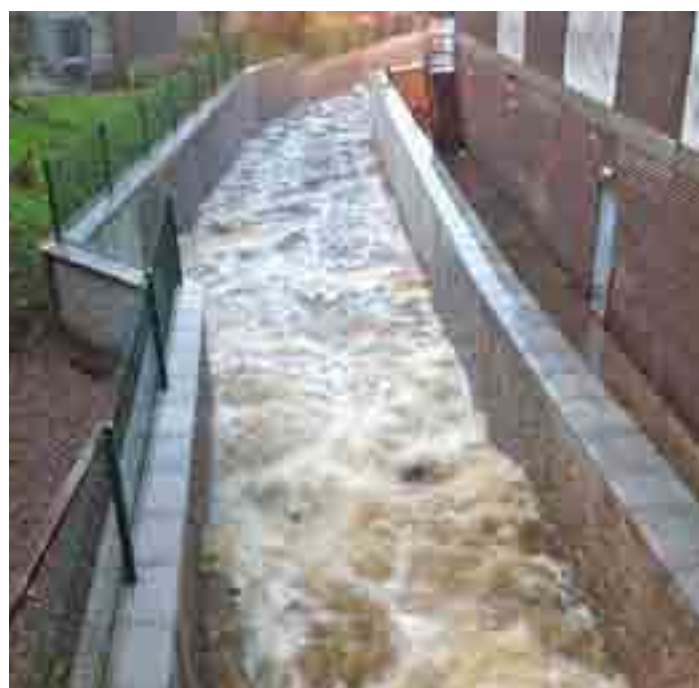
High flow event in channel demonstrating good fish passage opportunity – June 2012

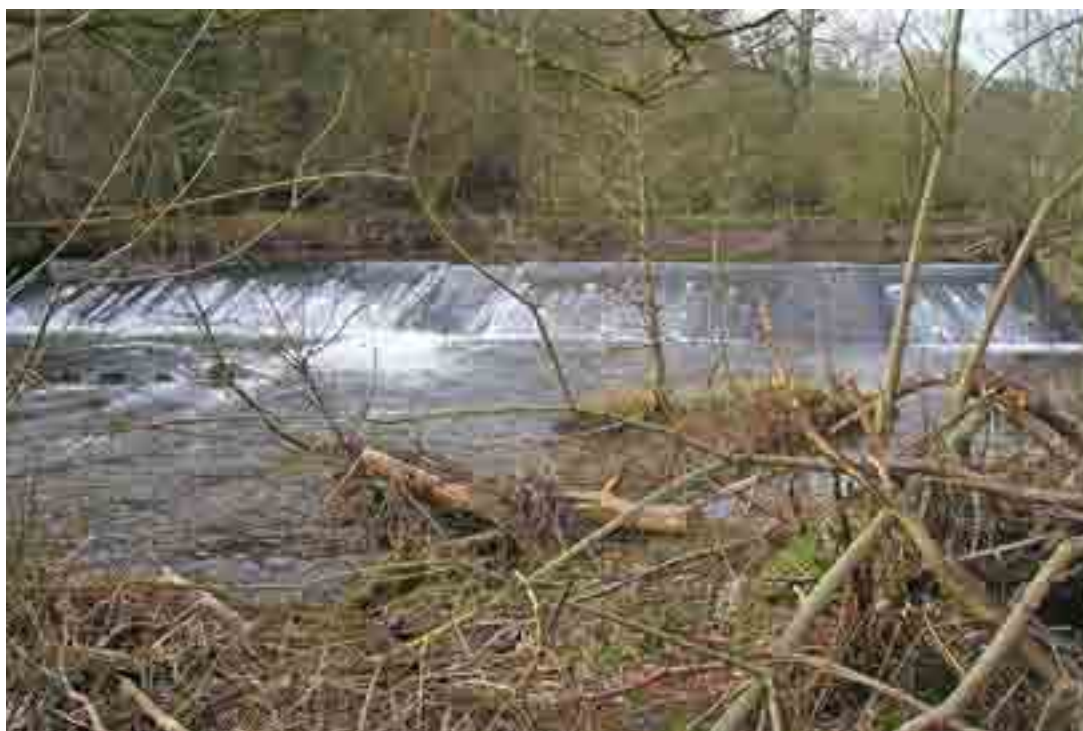
The 2.6m high Kentchurch Weir prior to removal – 2011

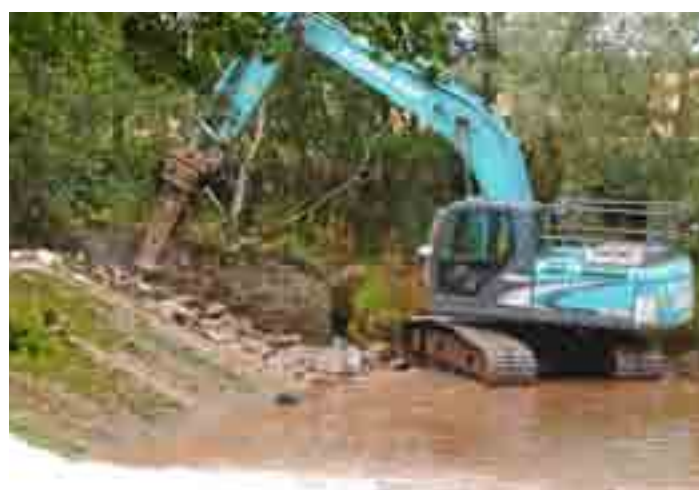
Initial breakout of the weir on the left bank – 2011

To remove the weir a 20 tonne 360° excavator and a 6 tonne swivel skip dumper were used. Demolition started with a 3m width on the left bank which was taken right down to bed level. Once the weir was breached a line of jumbo sand bags was used to channel the flow through this breach. This enabled the contractor to demolish the rest of the weir in the dry as the impoundments had been de-watered.

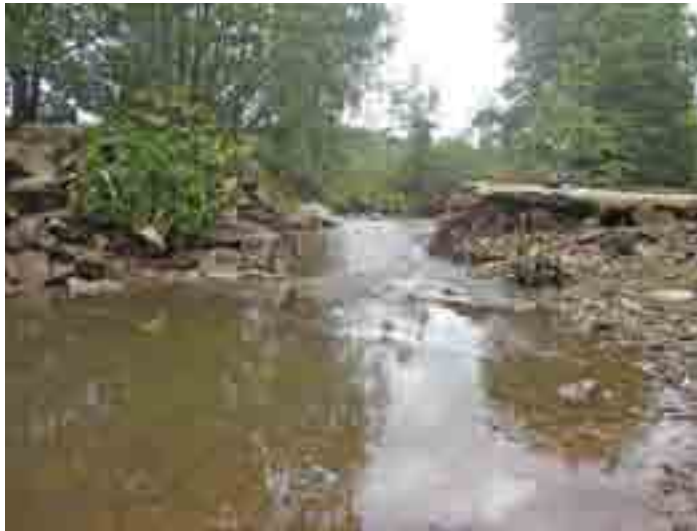
Breach in the weir on the left looking downstream from within the previous impoundment – 2011

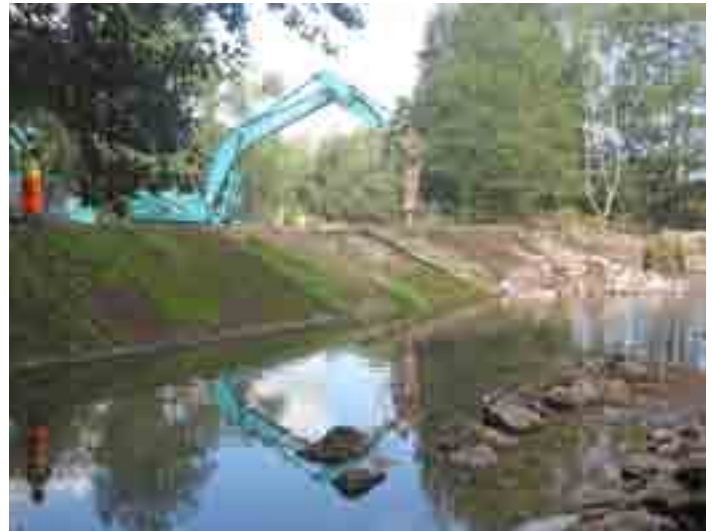
Demolition of the remainder of the weir continued once the upstream impoundment had been de-watered – 2011

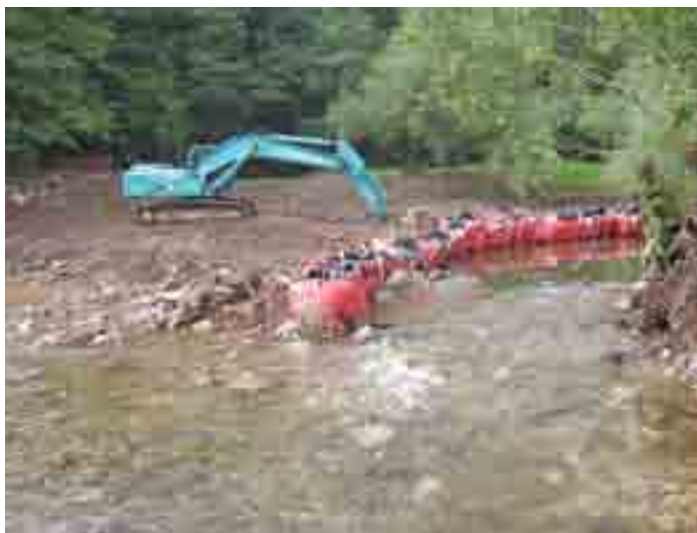
Line of jumbo sandbags channelling the flow through the initial breach allowing the remainder of the weir and material built up behind it to be removed – 2011

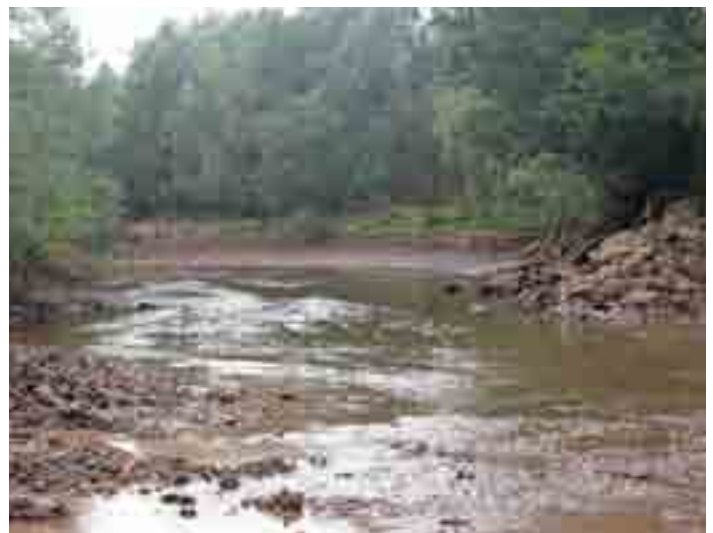
Looking upstream with the weir completely demolished. The drop in water level is evident on the left bank – 2011
