Restoring Meanders to Straightened Rivers

1.8 Restoring a meandering course to a high energy river

ROTTAL BURN

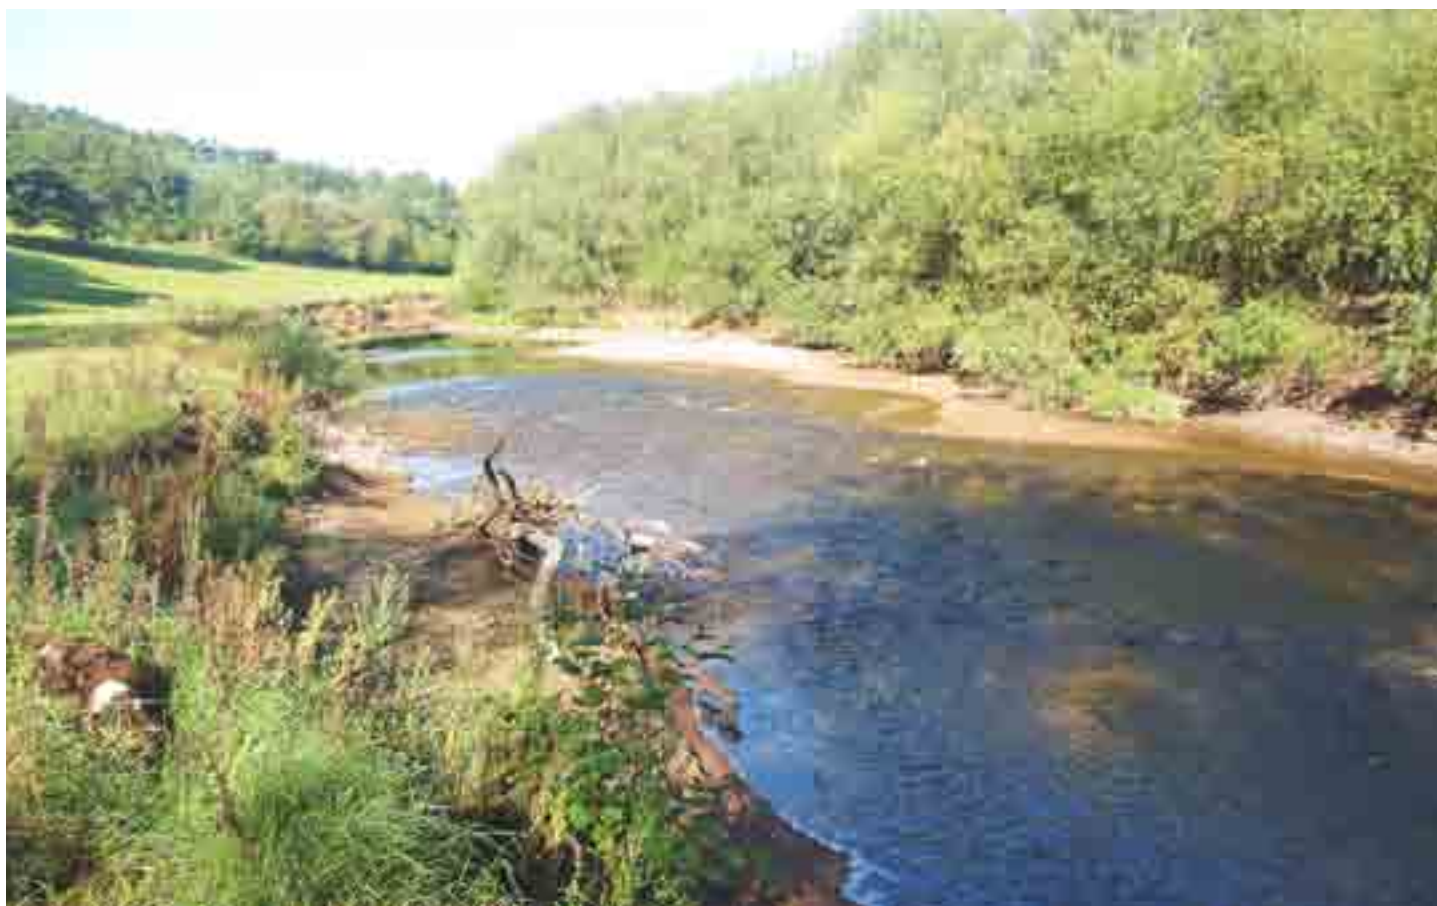
Looking upstream showing the exposed river bed after water levels have been lowered – 2011

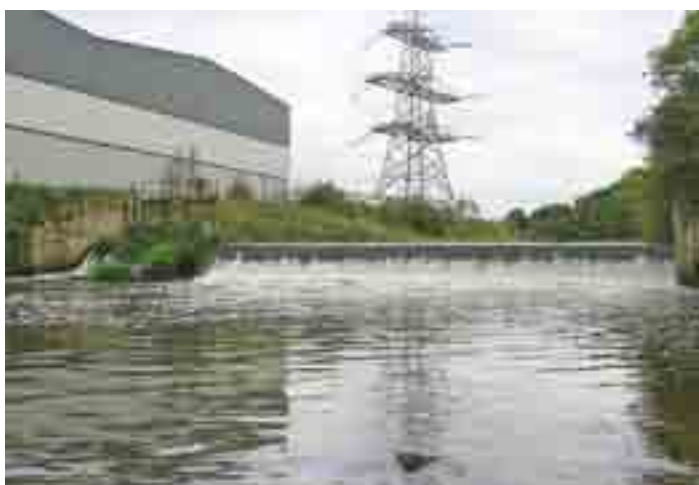
© Environment Agency Padiham Weir prior to works creating a total barrier to upstream fish migration – October 2005

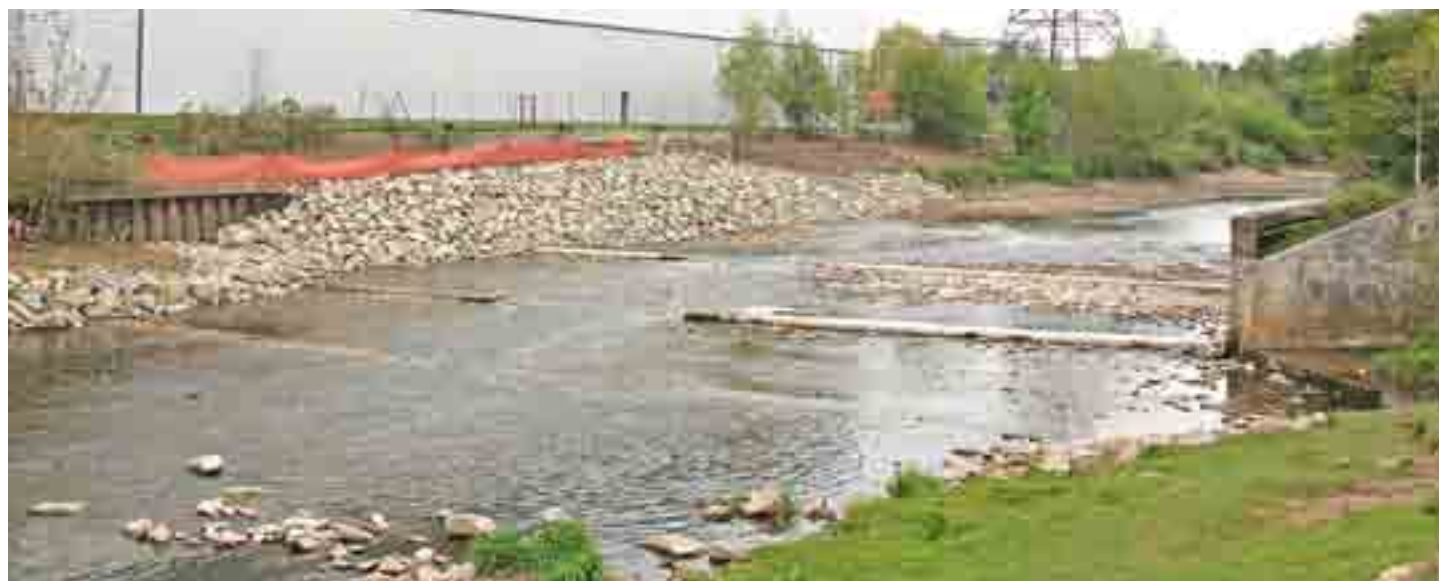
The site on completion. The low flow channel is visible through the centre of the bed check weirs – October 2010

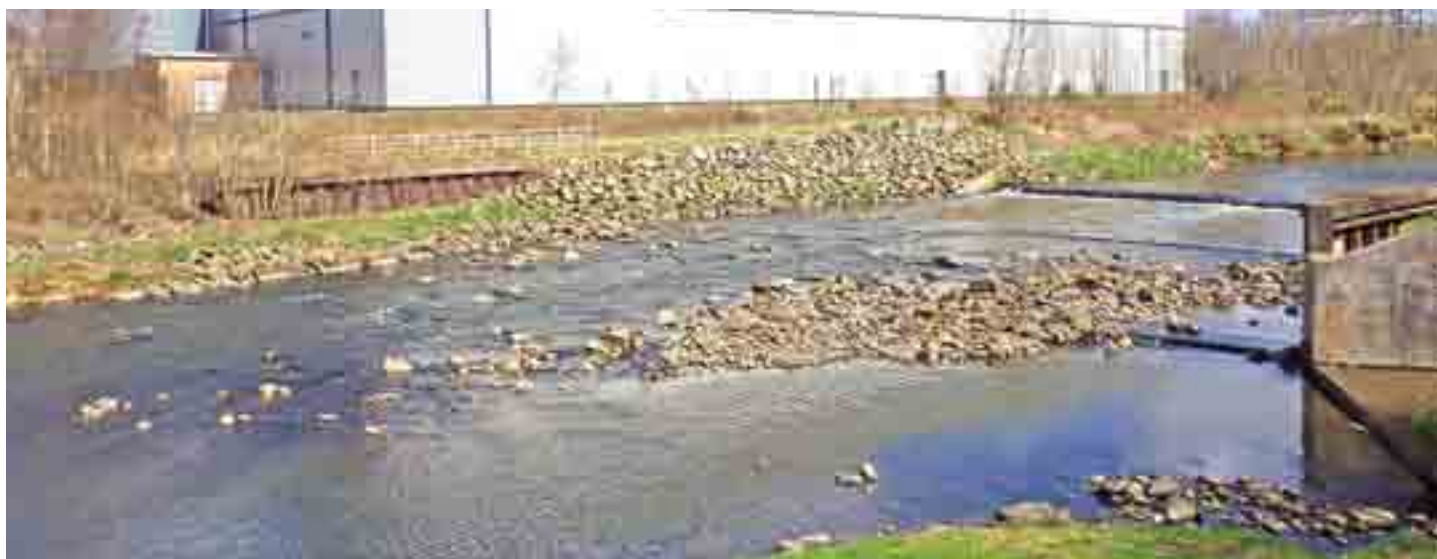
The site after three years. Some of the material entrained during high flood flows has been carried downstream but the majority has remained in the vicinity of the rock ramp and is visible near to the left hand bank – April 2013

The material used in the rock ramp was selected to withstand the expected stream power at the site, however exceptionally high flows over a sustained period during 2012 appears to have caused significant scour and erosion both above and below the weir. Flow volumes experienced during 2012 resulted in velocities capable of entraining the material used for the rock ramp (the 1 in 50 year return period flood event in June had a peak flow of 220m³/s compared to median annual flood flow of 173m³/s).
