Restoring Meanders to Straightened Rivers

1.1 New meandering channel through open fields

RIVER COLE

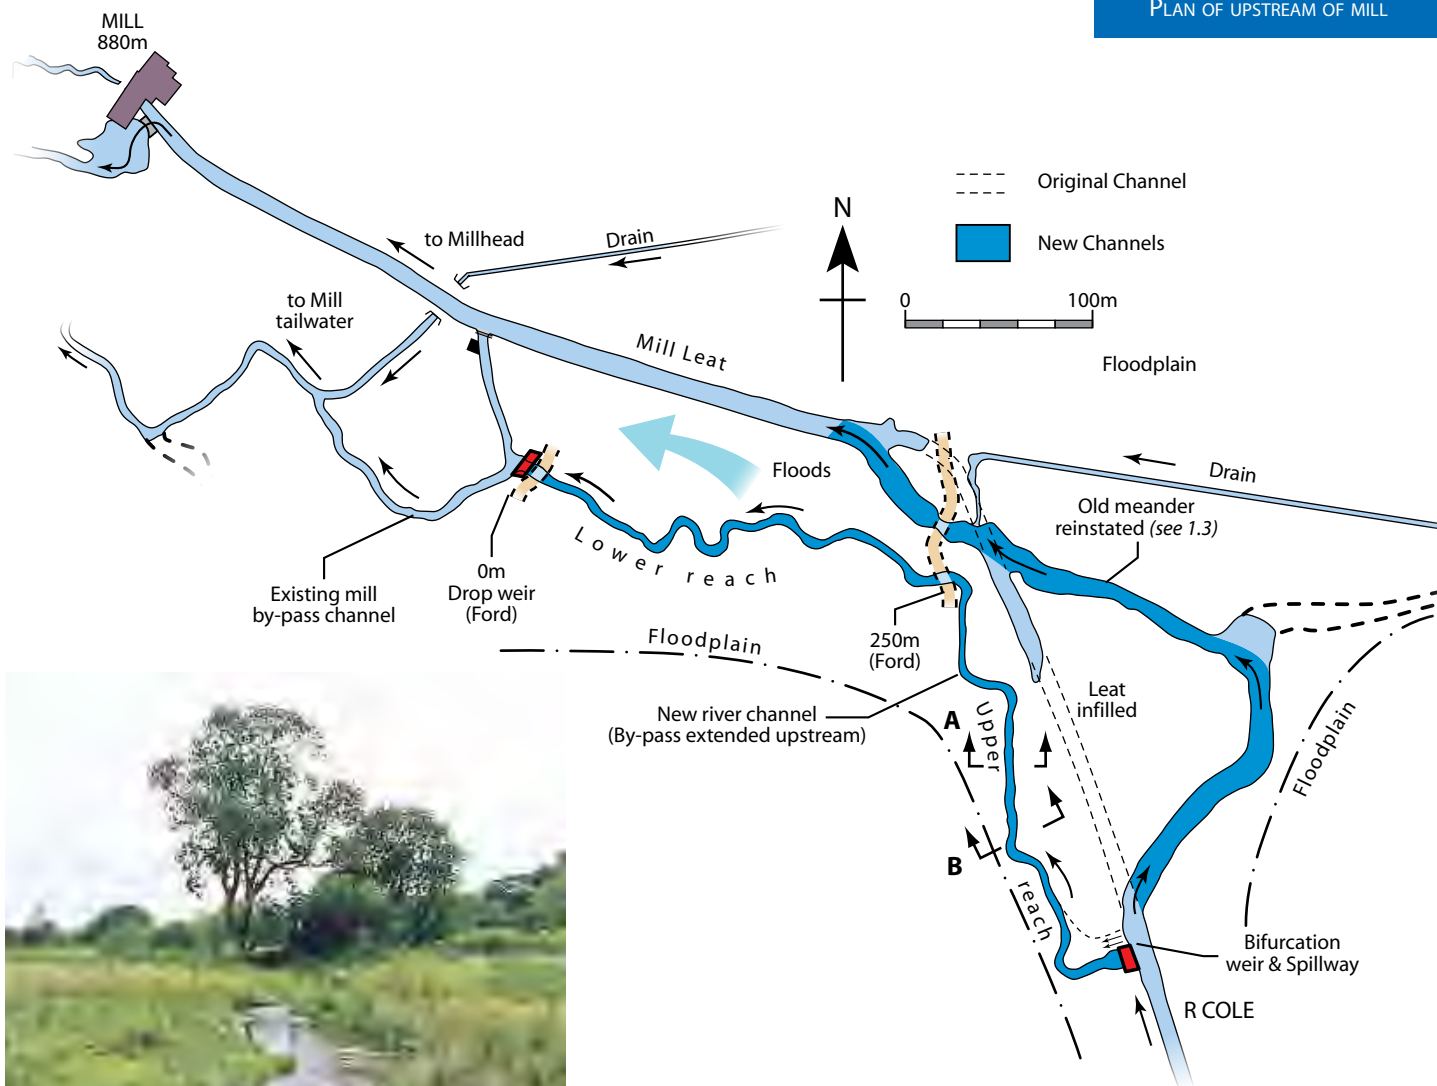
Figure 1.1.1

PLAN OF UPSTREAM OF MILL

Alignment of channel (Figure 1.1.1)

The existing mill by-pass follows an ancient course of the River Cole. Remnants of its ancient course were also evident in the fields between chainage zero and 250m, (lower reach), so the new channel was set to follow these at a fairly uniform depth of c. 1m. Upstream of ch. 250m the new channel deviates from any natural course because it had to be aligned roughly parallel to the mill leat which is unnaturally close to the edge of the floodplain. Land levels along this upper reach rise significantly above the average for the floodplain, hence the new channel is deeper. Meanders were set out to 'mimic' the natural form evident in the lower reach.

BACKWATERS AT 1, 2, 3 DELINEATE COURSE OF LEAT PRIOR TO NEW BRIDGE AND NEW MEANDER IN LEAT (SEE FIGURE 1.1.1)

Figure 2.2.3
BACKWATERS ON LOWER MEANDERS AT CH 310M AND 380M
(SEE FIGURE 1.1.1)

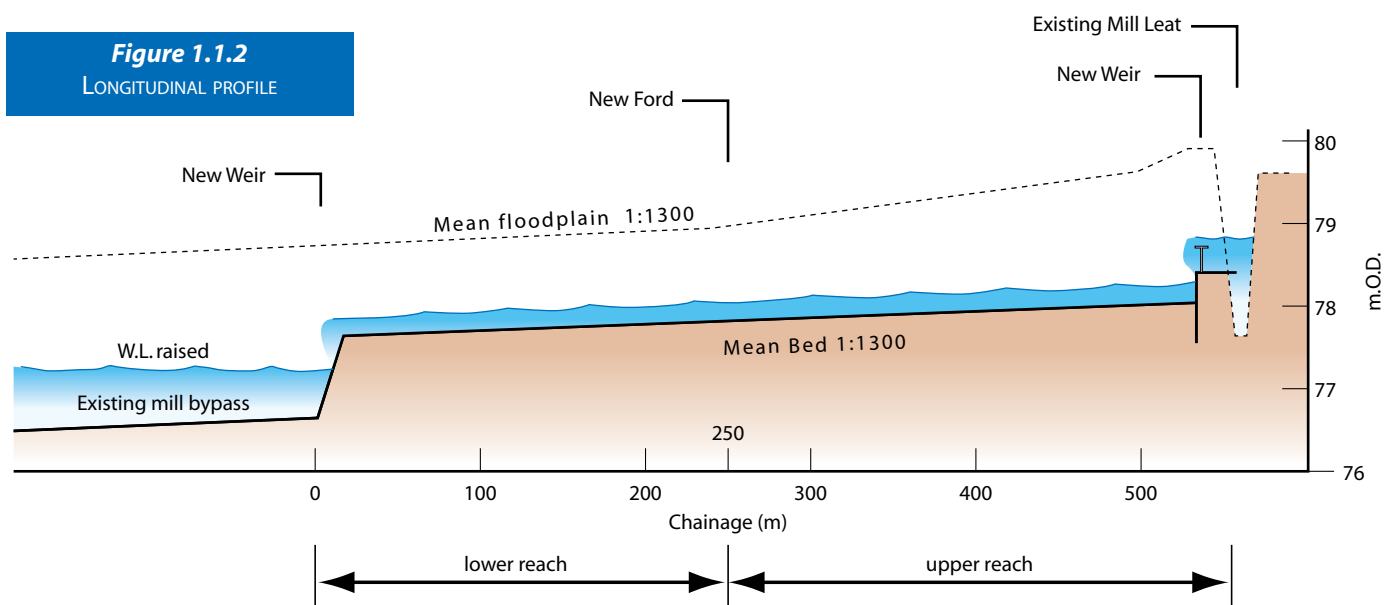
Figure 1.1.2
LONGITUDINAL PROFILE

**Design***Longitudinal profile (Figure 1.1.2)*

The new mean bed gradient was set at 1:1300 to match the mean floodplain gradient. The bed elevation was set to give the shallowest channel possible whilst having just sufficient depth to contain summer spates. The resultant channel bed is elevated higher than the old mill by-pass, but is lower than the retained water level in the mill leat which feeds it. Drop weirs were therefore required at each end (see *Techniques 5.1 and 5.2*).

Whilst weirs are generally undesirable, the alternative of deeper channels was more so at this site. The drop at the downstream end was reduced in height as a consequence of introducing new meanders downstream of the mill; these raised normal water level in the existing mill by-pass to historic levels (see *Technique 1.2*).

Section A shows a normal flow channel 2.6m wide by 0.8m deep - the geomorphology of the Cole indicates this to be the ideal size of channel. Because overall channel depth needed to exceed 0.8m (Figure 1.1.2). The upper banks were graded back as flat as practical.

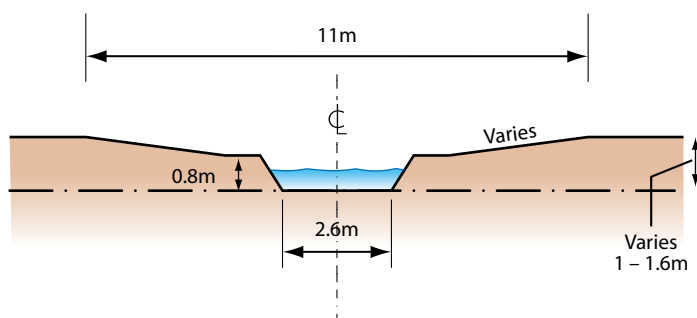
Figure 1.1.3

SECTION A THROUGH SYMMETRICAL CHANNEL

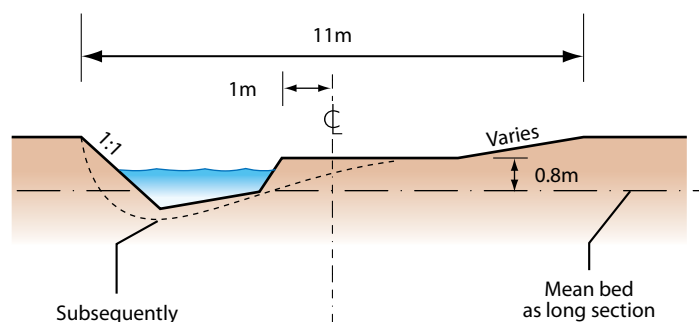
Figure 1.1.4

SECTION B THROUGH SYMMETRICAL CHANNEL

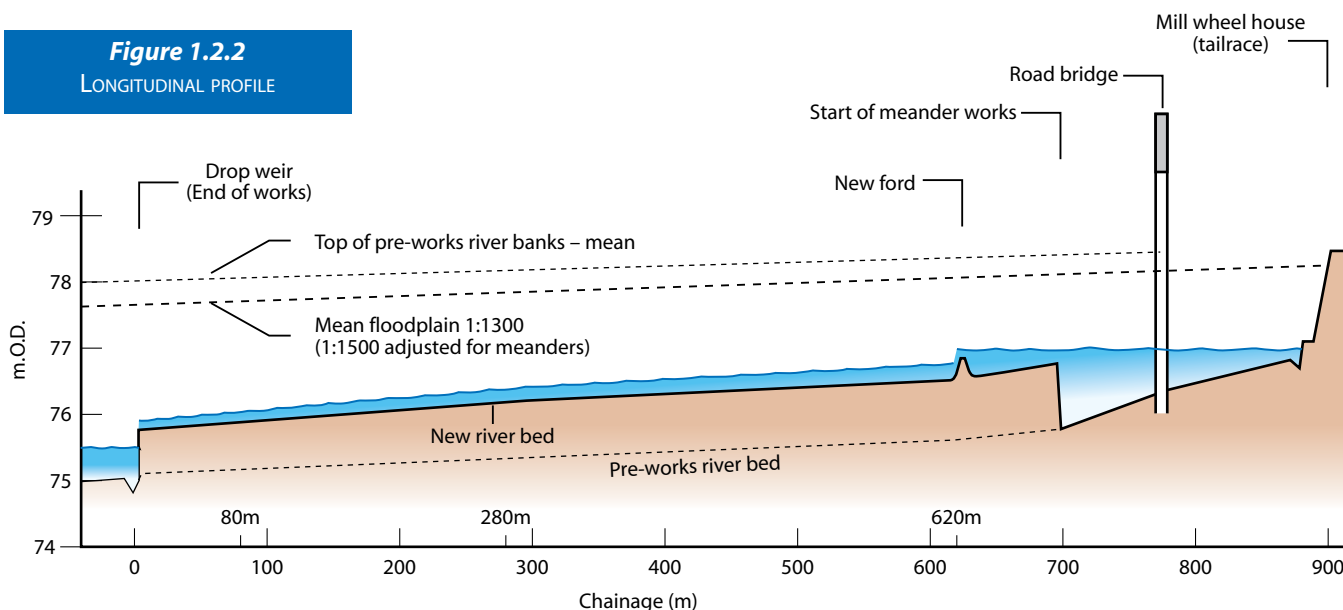
Figure 1.2.2

LONGITUDINAL PROFILE

**Design***Longitudinal profile (Figure 1.2.2)*

The elevation of the new river bed was raised by up to 1.0m, the maximum possible that still enabled water to flow freely from the old mill wheel tailrace. The bed gradient would ideally have paralleled that of the mean floodplain gradient (1:1300 straight; 1:1500 meandered) but was steepened to reduce the height of the drop structure needed at the downstream end of the reach. The actual bed gradients constructed are: chainage 0-280m at 1:740; 280-620m at 1:1000; 620-700m at 1:460; these equate to a mean of 1:700.

The raised bed enabled impoundment of water upstream of the works, restoring historic levels in the mill pool and the mill by-pass. A stone ford was built at ch. 620m to safeguard water levels against any downward scour of the new bed.

These were all lowered by c. 0.4m to levels that approximated to the mean floodplain levels (Figure 1.2.2).

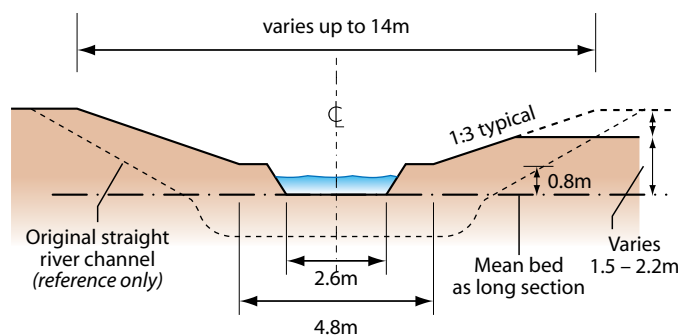
Figure 1.2.3

SECTION A THROUGH ASYMMETRICAL CHANNEL

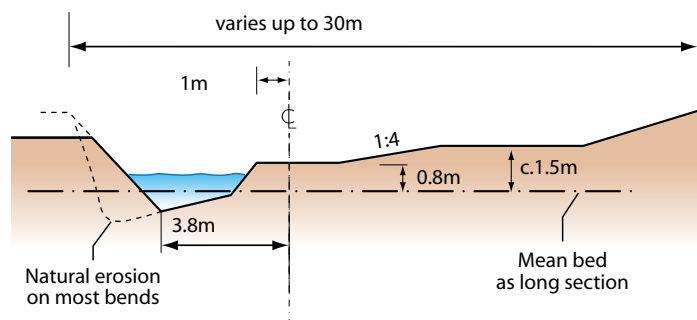
Figure 1.2.4

SECTION B THROUGH ASYMMETRICAL CHANNEL

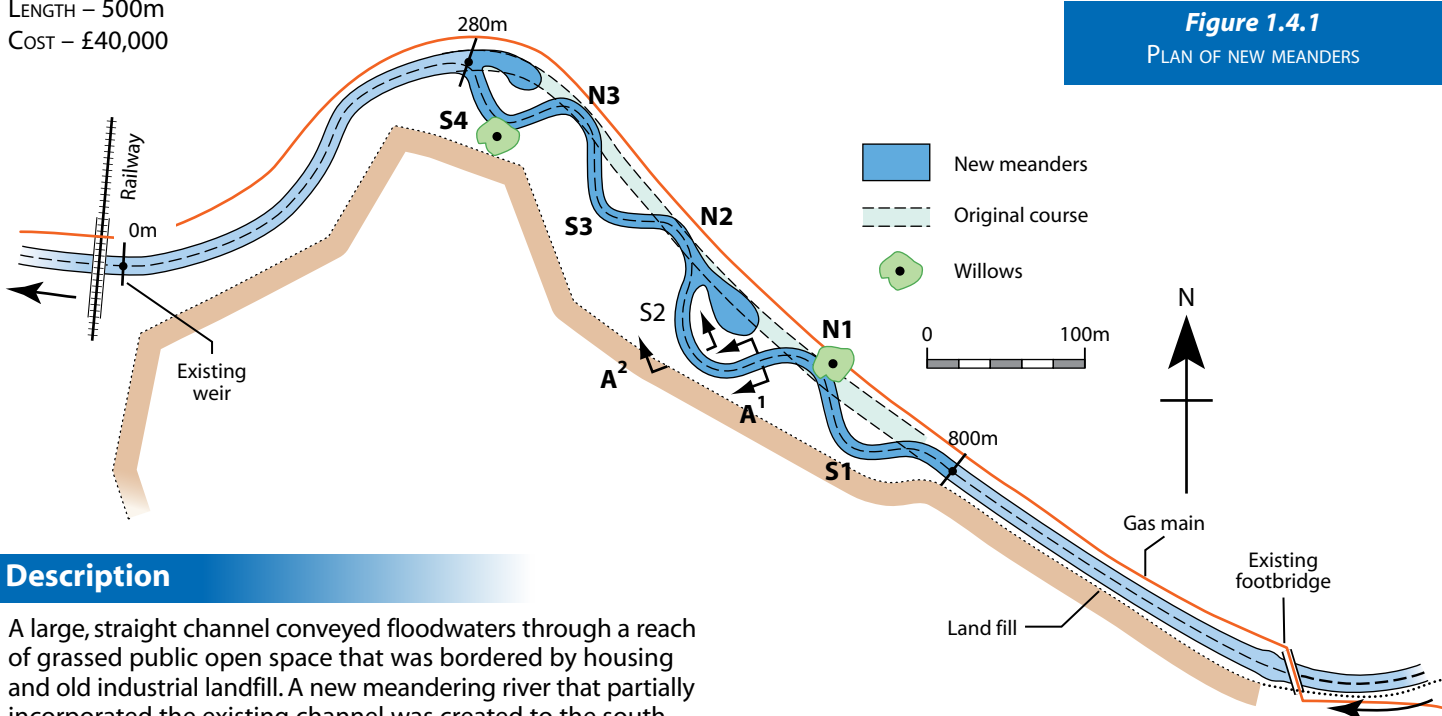
Figure 1.4.1
PLAN OF NEW MEANDERS

A large, straight channel conveyed floodwaters through a reach of grassed public open space that was bordered by housing and old industrial landfill. A new meandering river that partially incorporated the existing channel was created to the south side. The risk of flooding, affecting people and property, was safeguarded.

Alignment of channel (Figure 1.4.1)

bank. Bends **S4** and **N1** were located to retain two mature willows on the banks. The remaining meanders are set out between and checked against geomorphological criteria to finalise the layout. High flows in this channel and other constraints precluded any possibility of 'mirroring' historic meander patterns that were sustained by entirely different hydraulic criteria.

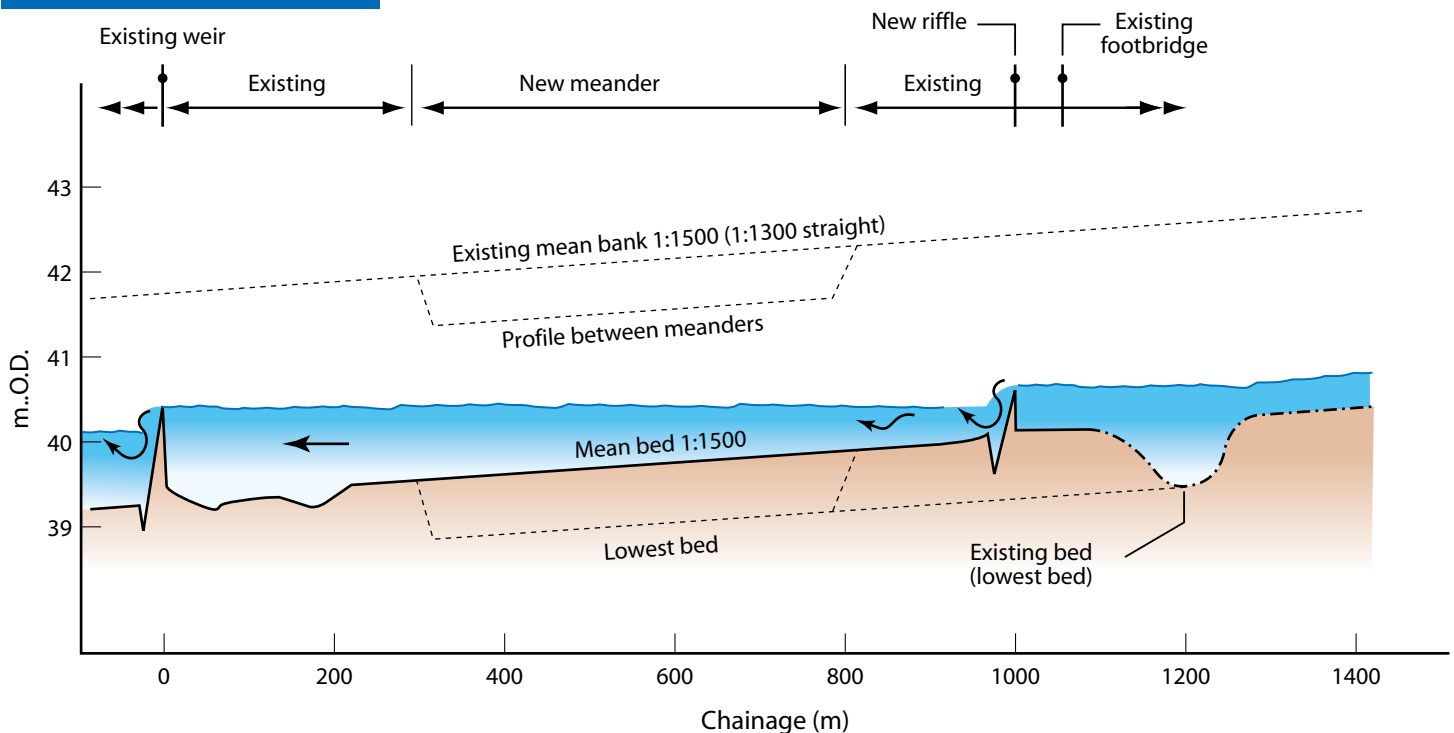
Figure 1.4.2
LONGITUDINAL PROFILE

The original mean bed gradient of 1:1300 paralleled the mean bank gradient at a depth of c. 2.4m. The new mean bed gradient and level matches the existing but flattens to 1:1500 because of the increased length created. meander was expected to reach c. 1m depth as observed at an existing bend at ch. 1200m. This is shown as 'lowest bed' on the long section 1m below mean bed. Conveyance of floodwaters across the new meanders was facilitated by a general lowering of inter-meander land levels by c. 0.6m. This also enhanced water storage aspects of the 1 in 100 year flood hydrograph, attenuating the peak flow downstream.

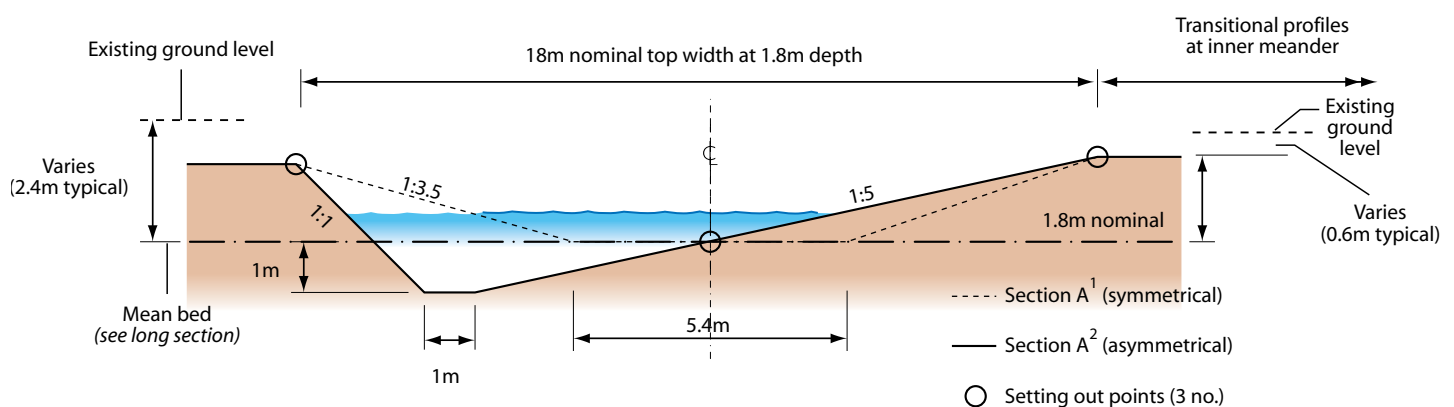
**Figure 1.4.3**
SECTION THROUGH NEW MEANDERS

As well as the general lowering of land levels described above, considerable profiling was specified to ensure inundation in time of flood was progressive from the downstream leg back towards the start of each meander. Similarly, special consideration

Cross-sections (Figure 1.4.3)

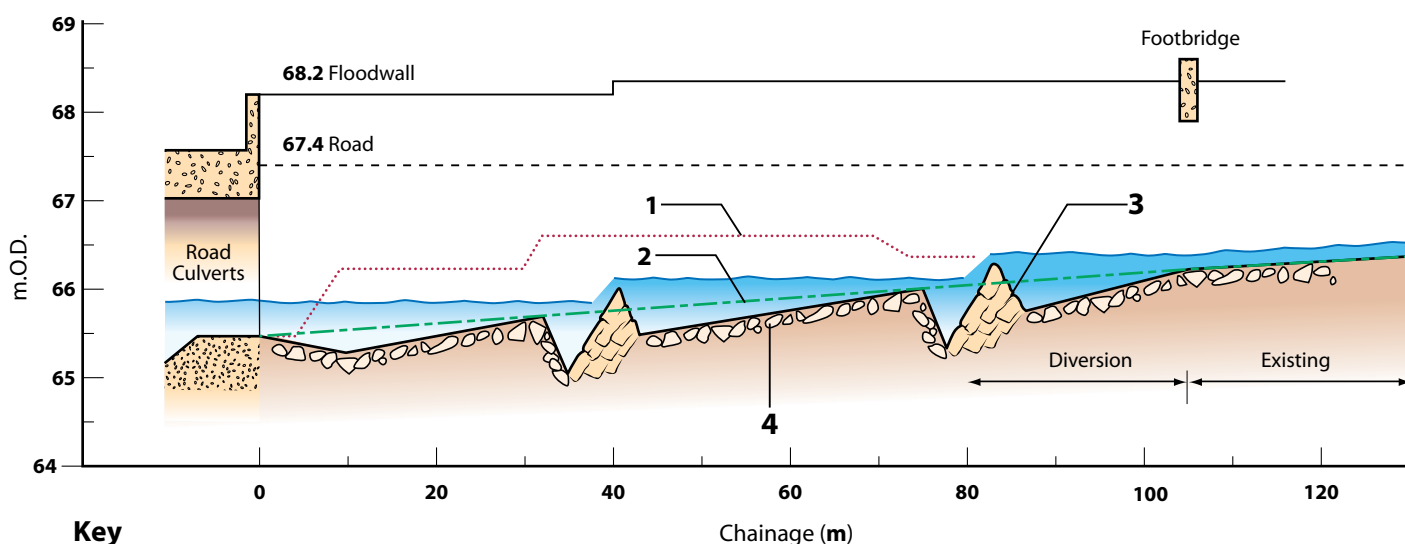
Figure 1.5.2
LONGITUDINAL PROFILE

The gradient of the new river bed became 'fixed' between the culvert invert and the existing upstream level. *Figure 1.5.2* shows the resultant longitudinal profile with a mean bed gradient of 1 in 140. This gradient is much steeper than arises naturally on this part of the river with consequent high water velocities when the river is in flood.

Key

- 1 Original bed level – concrete channel with two drop weirs
- 2 New mean bed gradient at 1 in 140
- 3 Two stone riffles built to stabilise river bed; pools upstream and downstream of each
- 4 Actual bed profile of gravel and cobble substrates

shown as feature 3 on figure 1.5.2. They are located just downstream of each meander bend where underwater bars of river bed substrate e.g. gravels would naturally accumulate in the form of riffles. The stonework on adjacent walls and river bank was linked across the bed with stone laid at the same dip slope. Technique 5.4 shows details of these. They incorporate a gently sloping downstream face, much like a riffle. This enables the easy passage of migratory fish to be achieved and creates a 'tumbling' water feature rather than a sharp fall.

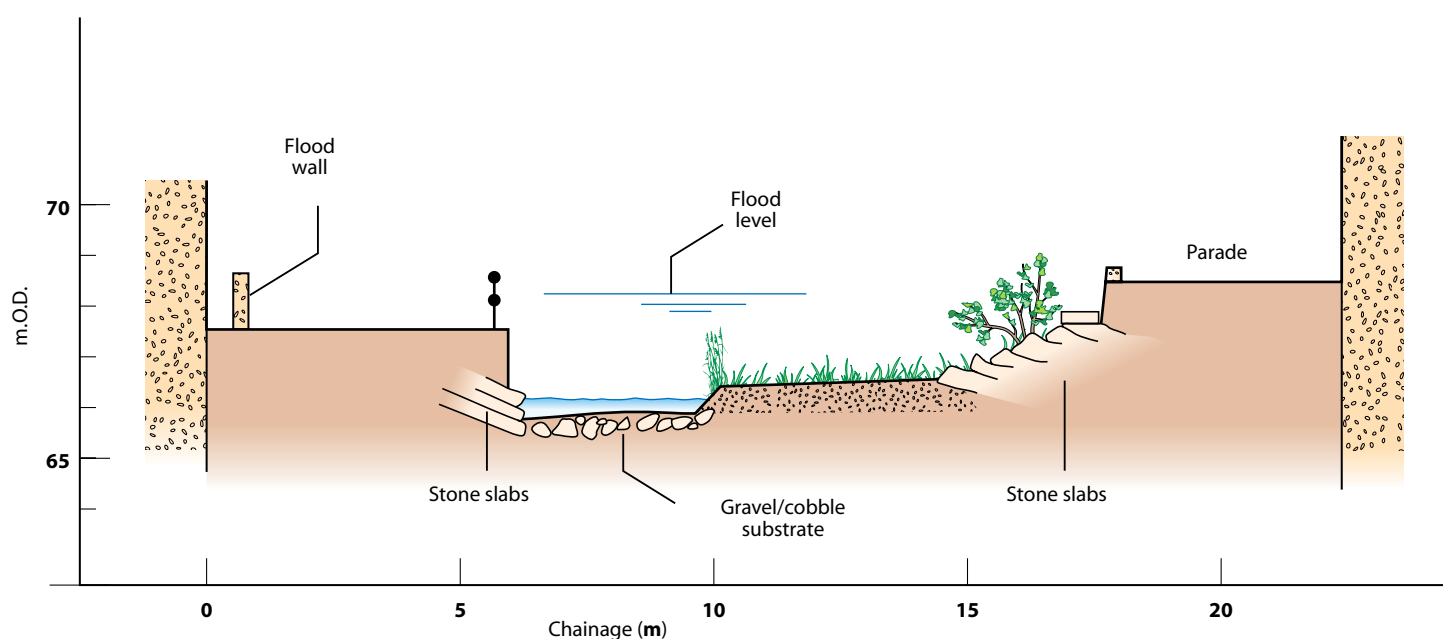
Figure 1.5.3

Slabs were laid at a consistent angle to project into and above the water creating the appearance of the walls being built on natural rock. Contrasting faces on opposite sides of the river were achieved by maintaining the 'dip' in the same direction i.e. smooth dip slopes one side and jagged escarpment faces on the other. As the river alignment approaches the culverts in the same direction as the selected dip-slopes, slabs were laid with the dip parallel to the retaining wall. This enabled a series of 'craggy' current deflectors to be incorporated into the foot of the wall.

SECTION A THROUGH RIVER AND STONE SLABS

At the bottom of earth slopes on outer bends liable to erosion
Slabs were laid exactly as above with consistent direction of dip and strike torevet these banks with varying faces depending upon the channel alignment of each location. See section A–A, figure 1.5.3 for aspects of both wall foundations and bank revetments.

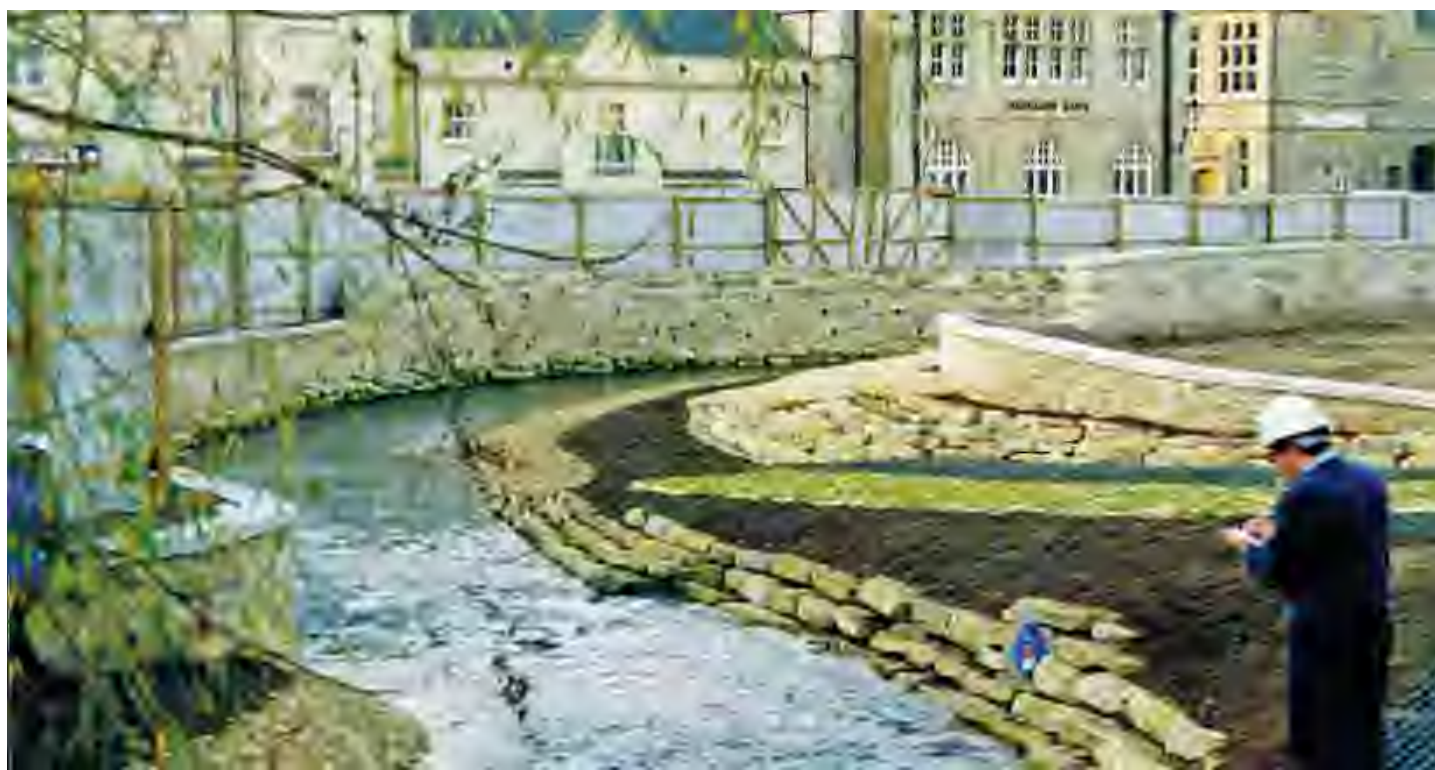
View of Section A (*fig 1.5.3*) on completion

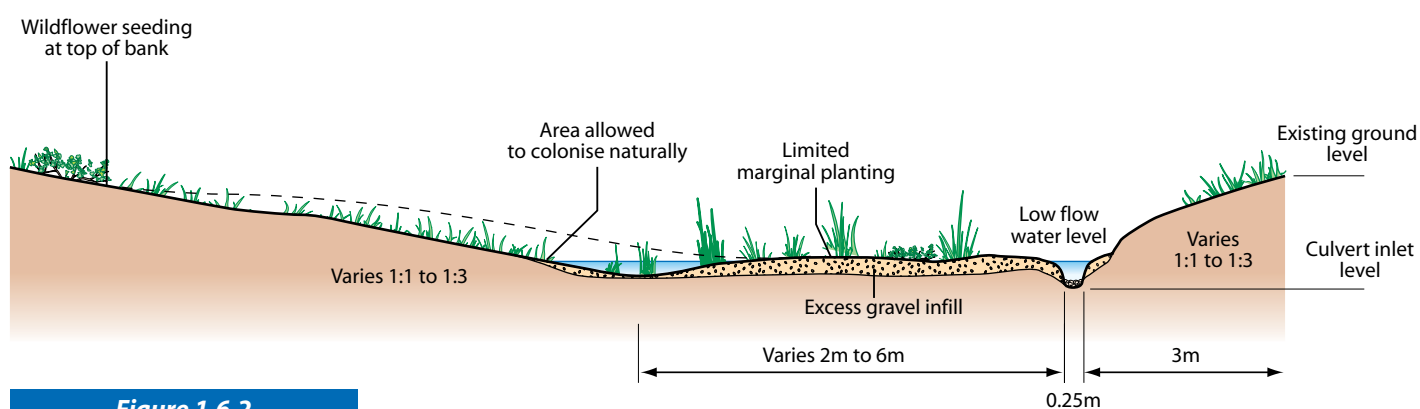
Figure 1.6.2

SECTION A THROUGH RAISED BED
AND MARGINAL SHOAL

The design of the river channel was based on the historical layout, fluvio-geomorphology, flooding considerations and present day use of the park (cricket pitches). To avoid being overly prescriptive, the design drawings were kept relatively simple. The conditions encountered on site meant the final course is slightly different from the design plan (*Figure 1.6.1*). Indicative cross sections were provided at key locations with the main objective always a shallow, safe, accessible bank (*Figures 1.6.2 and 1.6.3*).

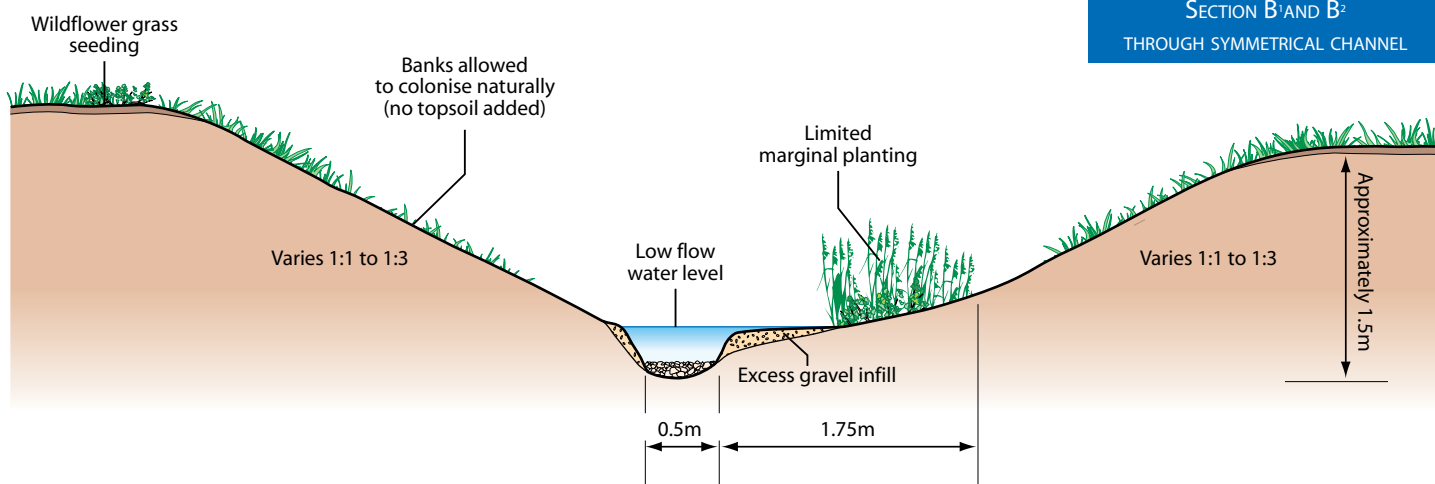
Figure 1.6.3

SECTION B' AND B"

THROUGH SYMMETRICAL CHANNEL

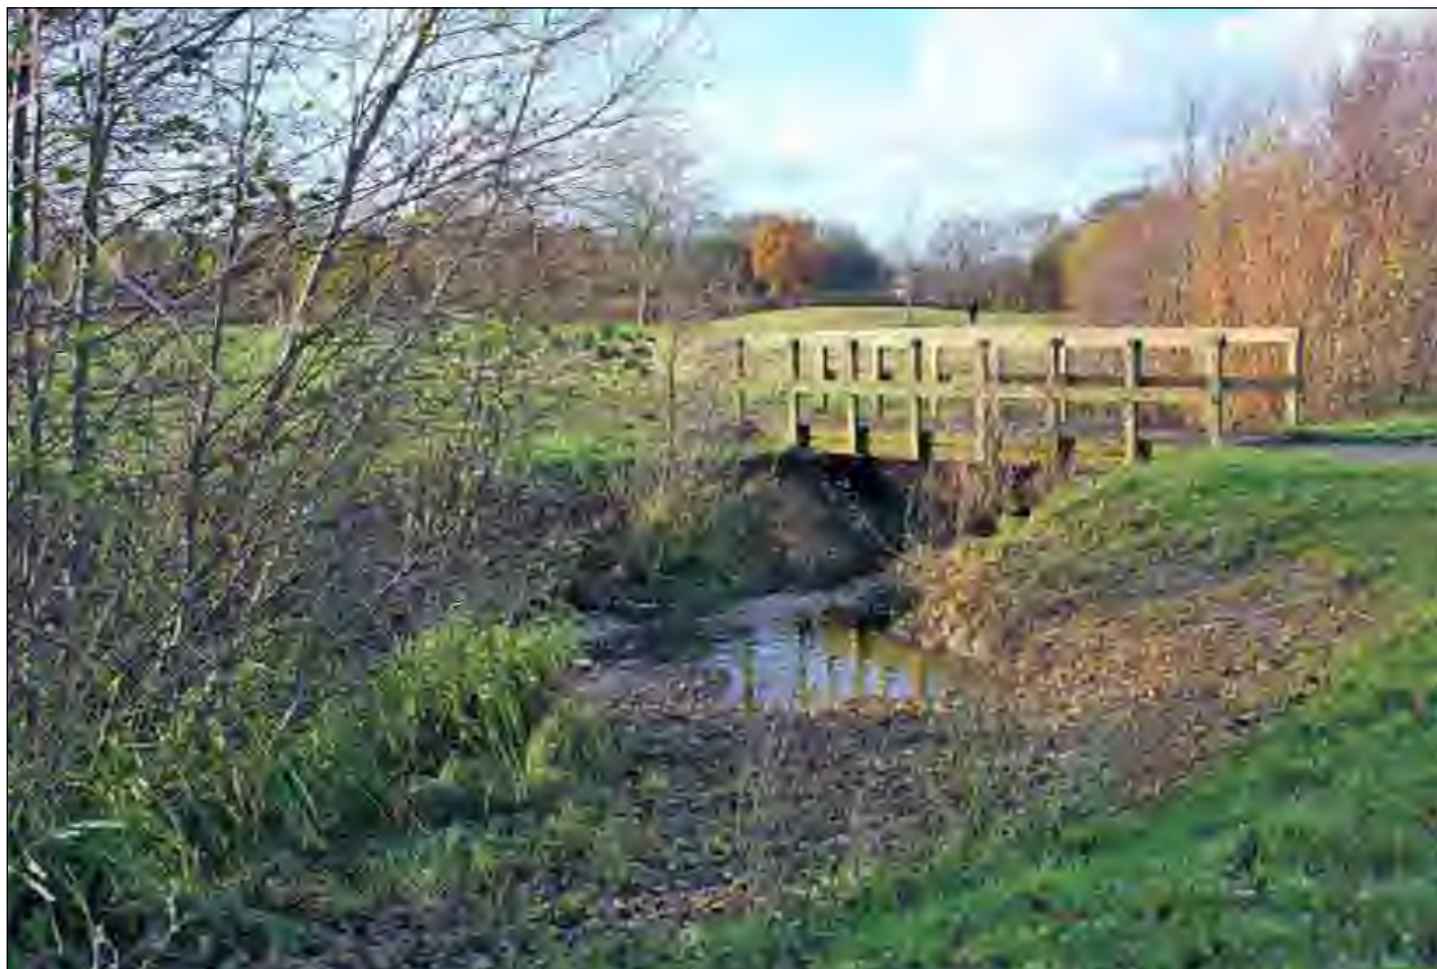
Effective narrowing of the channel, and asymmetric shallowing of the bed has occurred following restoration – 2012

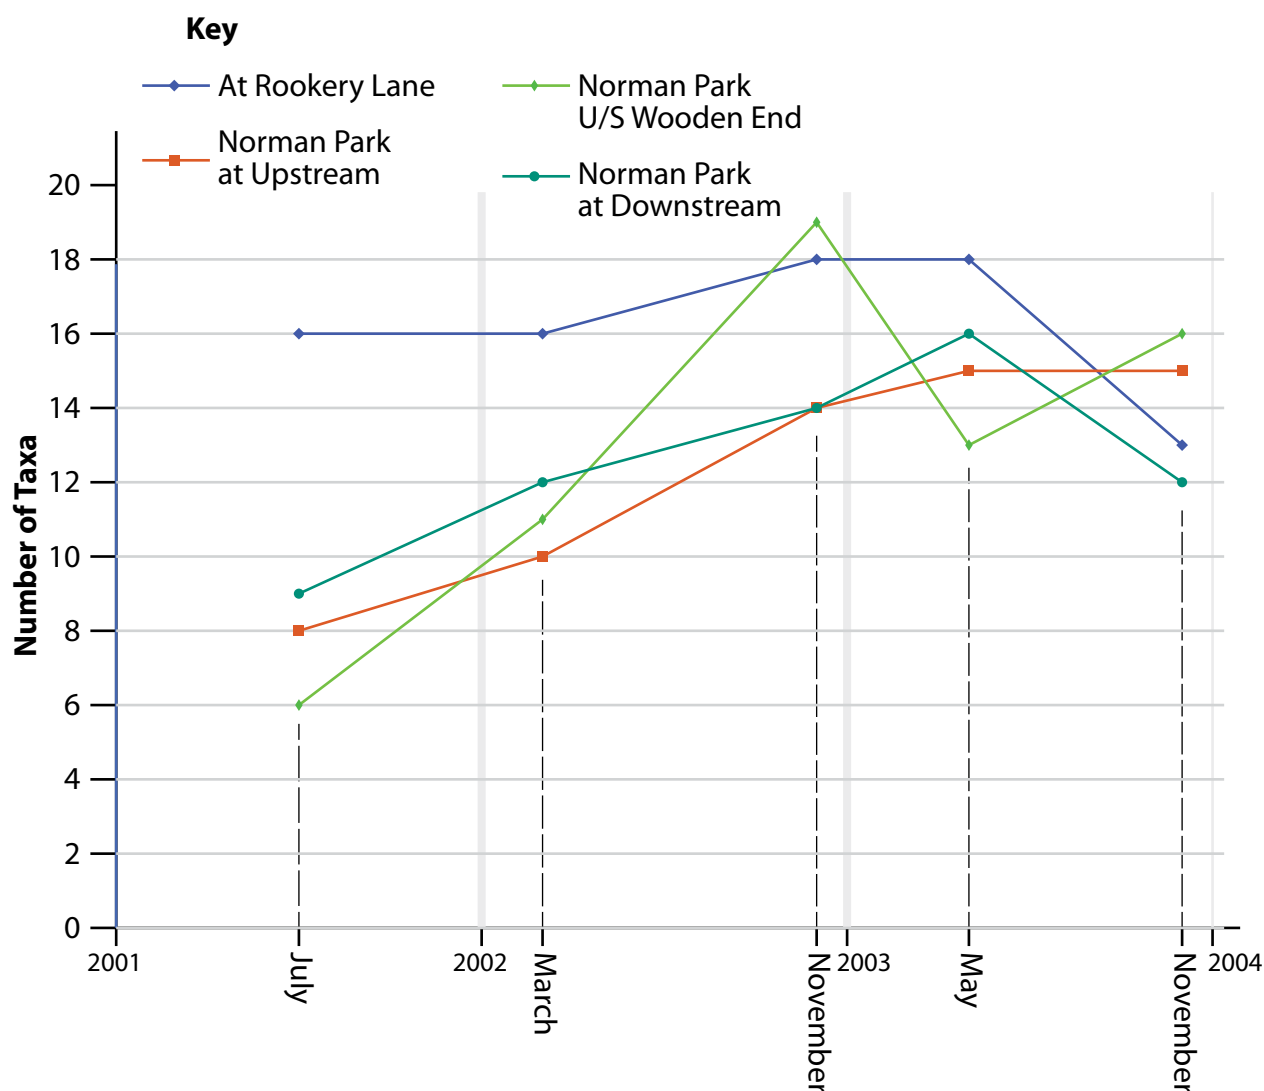
Changes in the number of invertebrates between 2001 and 2003.

By 2003 numbers for the control site (Rookery Lane) and the restored sites were similar demonstrating ecological improvement in the de-culverted stretch of the river.

Macroinvertebrate sampling was undertaken between 2001 and 2003 and this showed an increase in the number of taxa recorded following the works. Further sampling is planned for 2013 in order to compile a more complete dataset.

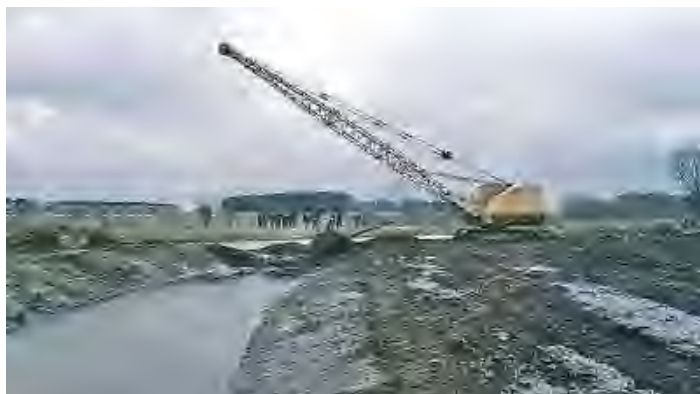
The structure, 6m wide by 10m long by 2m high, was constructed using 1.5m by 1m prefabricated concrete blocks below a 0.75m depth of boulder sized limestone, surfaced with 0.25m of cobble sized limestone. The 'weir' was designed to be permeable to provide a sweetening flow to the canalised channel. Flows, where levels exceed the 2m crest, will overtop and discharge through the retained canalised 'flood relief' backwater channel.

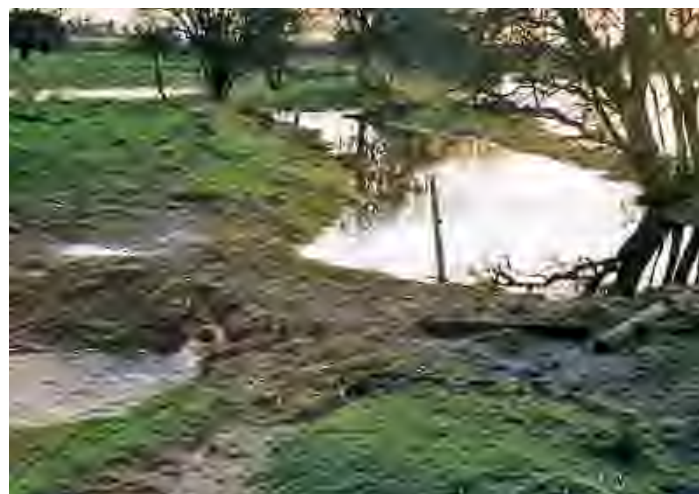
In the middle of the meandering reach a marshy backwater section was isolated with a bund and a sluice at the upstream end to protect the habitat from high velocity flood flows.

Sluice, bund and upstream flooding area

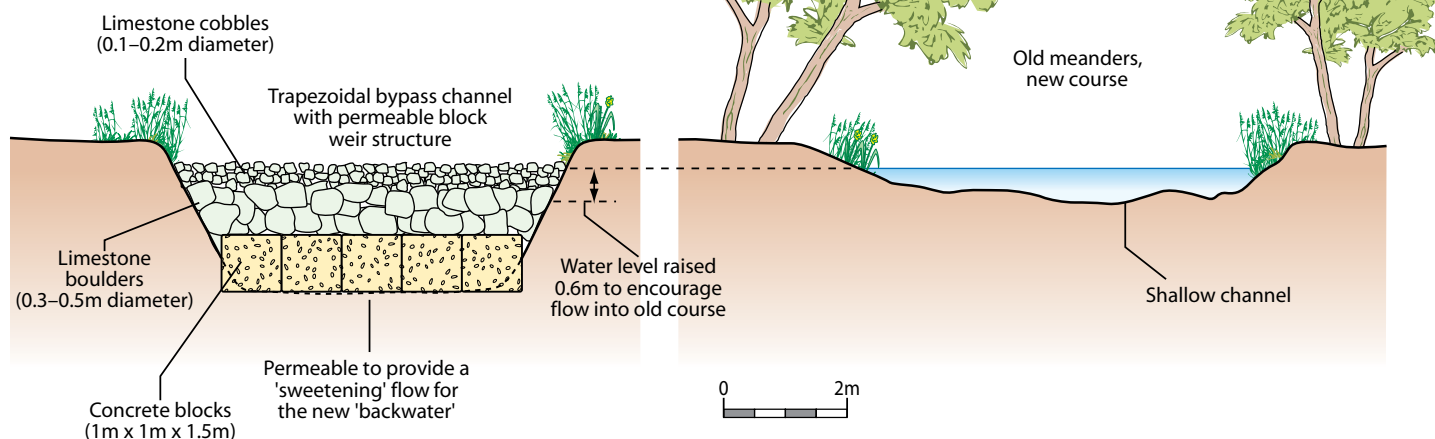
Figure 1.7.2

SECTION THROUGH STONE DAM
AND MEANDERS

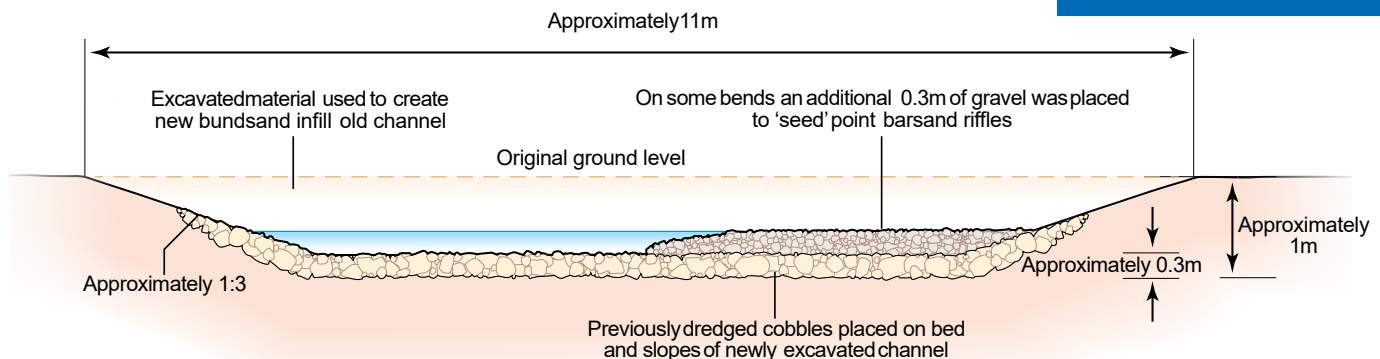
Figure 1.8.2

TYPICAL CROSSSECTION SHOWING A SIMPLE APPROACH TO THE CHANNEL DESIGN

The initial design concept specified the 45 degree bank angles of the upstream reach, and a varying bed profile at meanders. However, during construction the bank slopes were formed at shallower slopes of 1 in 3. This was to reduce the potential for erosion in the sandy soils and to help vegetation establishment.

In a further change, and working on the principle that the channel would quickly rework its material, the cross section at each meander was formed as a flat profile (similar to the straight runs – Figure 1.8.2). This allowed the bed of the channel to be used as a haul road for placing the gravel substrate. As a result, the channel profile remained relatively similar throughout but with distinct bed gradient changes over the three zones.

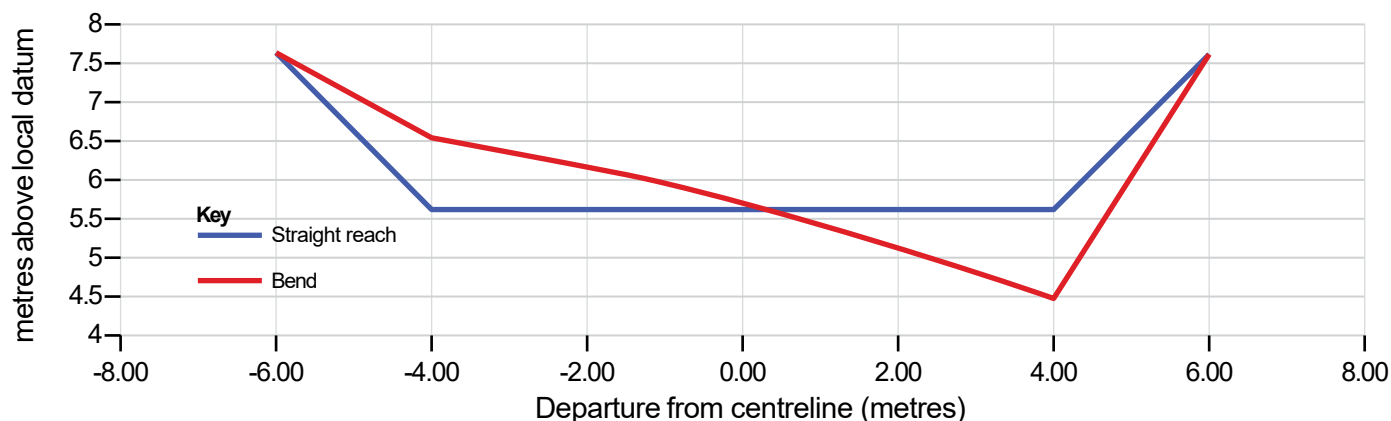
Figure 1.9.2

DESIGN CROSS-SECTIONS FOR STRAIGHT REACH AND BEND APEX

Expert judgement and field observation was supported by a model to inform the more detailed channel design. However it was impractical to excavate the complex shapes optimised by this model. Therefore the loop was excavated to one of two basic cross-section designs, namely bend apices and straight reaches, while points on the transition between them were interpolated (see Figure 1.9.2). The bed level was set to reflect existing conditions in the River Rother at each end of the loop and to improve connectivity with the floodplain during high flow events. A large scrape was excavated to create wading bird habitat and to provide clay for construction of the bund.

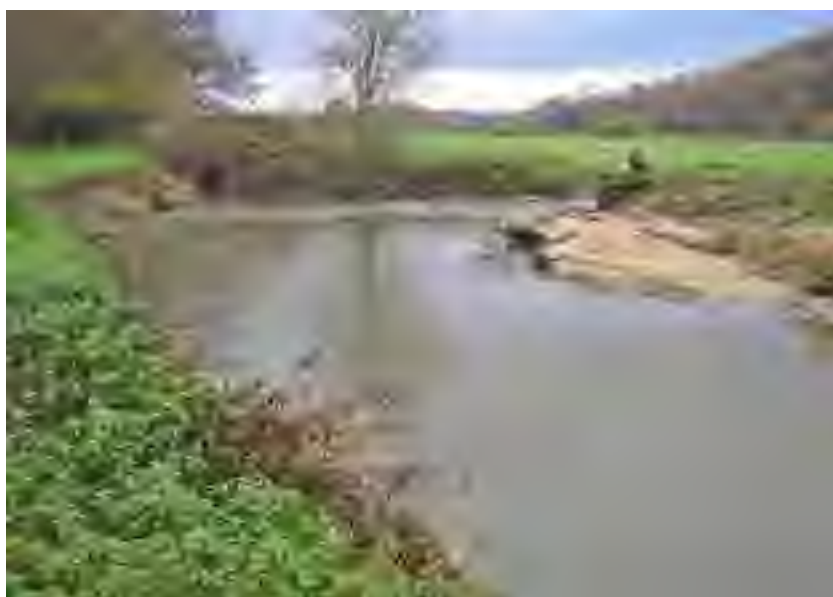
Two ancient stone abutment walls at the exit of the loop indicating the historic channel width – 2004

The bank top width was determined by on-site observation of two stone abutment walls from an ancient bridge that provided a reliable representation of the historic channel width.

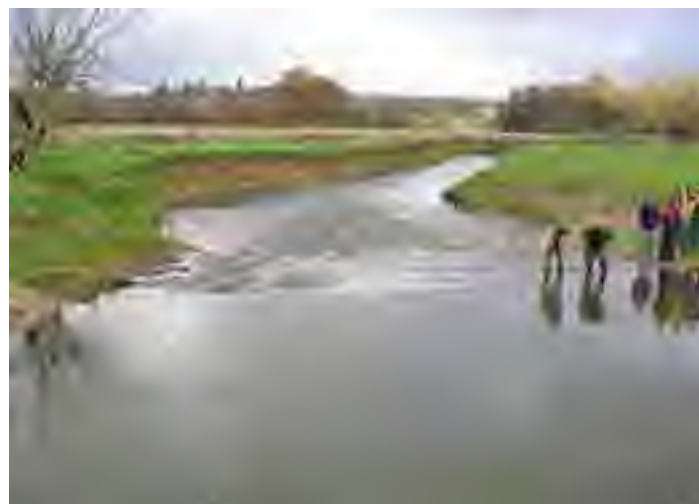
Bed check riffle and ford at entrance to the loop post-construction – 2004

A new gravel riffle was also constructed upstream of the site to replace a riffle that had formed in the canal cut, which became obsolete once the cut was sealed off. New gravels totalled £9,000, labour £13,000 and plant hire costs totalled £28,000.

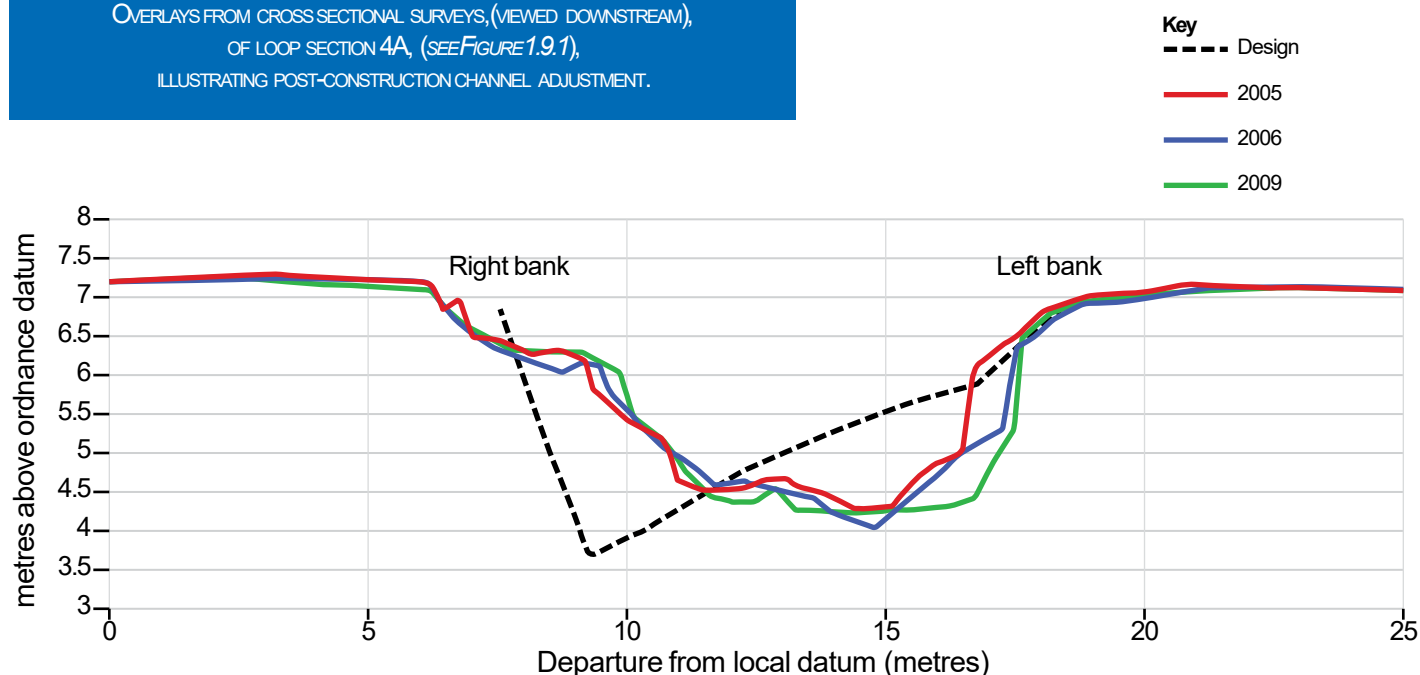
Figure 1.9.3

OVERLAYS FROM CROSS SECTIONAL SURVEYS, (VIEWED DOWNSTREAM), OF LOOP SECTION 4A, (SEE FIGURE 1.9.1), ILLUSTRATING POST-CONSTRUCTION CHANNEL ADJUSTMENT.

Monitoring of the site between 2002 and 2009 indicated a positive performance of the technique. Changes were observed in cross-sectional area (see Figure 1.9.3) suggesting a dominance of erosion over deposition in the loop. There was no significant (more than one metre) lateral channel change between autumn 2004 and a survey in 2006, but small-scale channel adjustment has been widespread. Therefore it can be concluded that the pre-restoration issue of sedimentation in the loop has been resolved and that the newly-excavated channel is slowly adjusting to a more natural, and desirable, form.

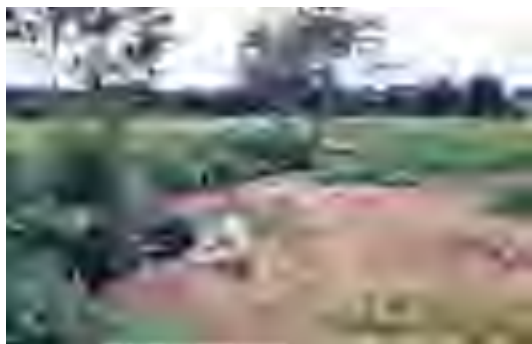
Sand in the meander loop
pre-restoration – June 2004

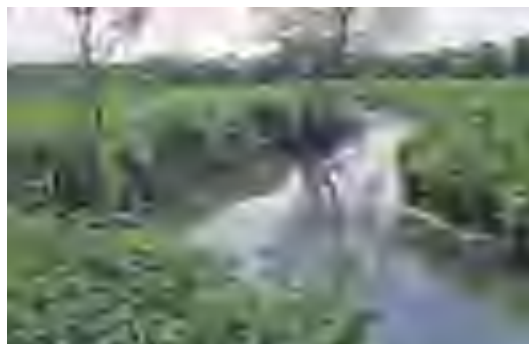
Flow in the excavated meander loop
post-restoration – 2005

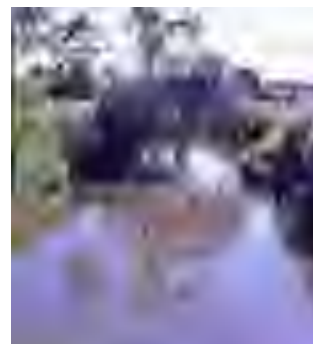
The same meander loop
(three years post works)
– 2007

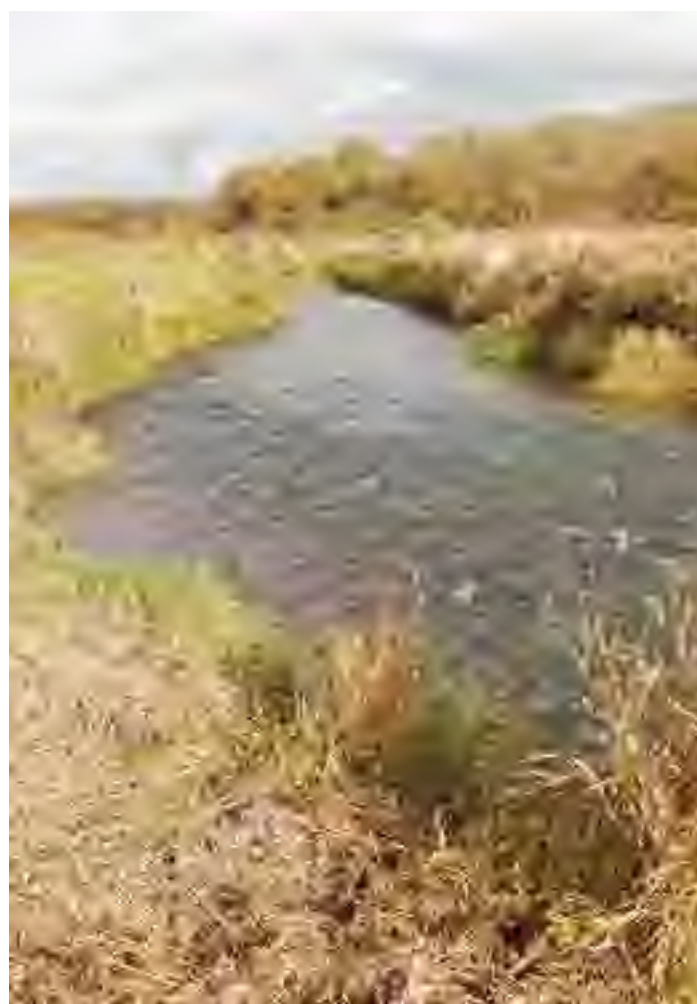
Shopham Loop post-restoration – 2009
