Restoring Meanders to Straightened Rivers

1.1 New meandering channel through open fields

RIVER COLE

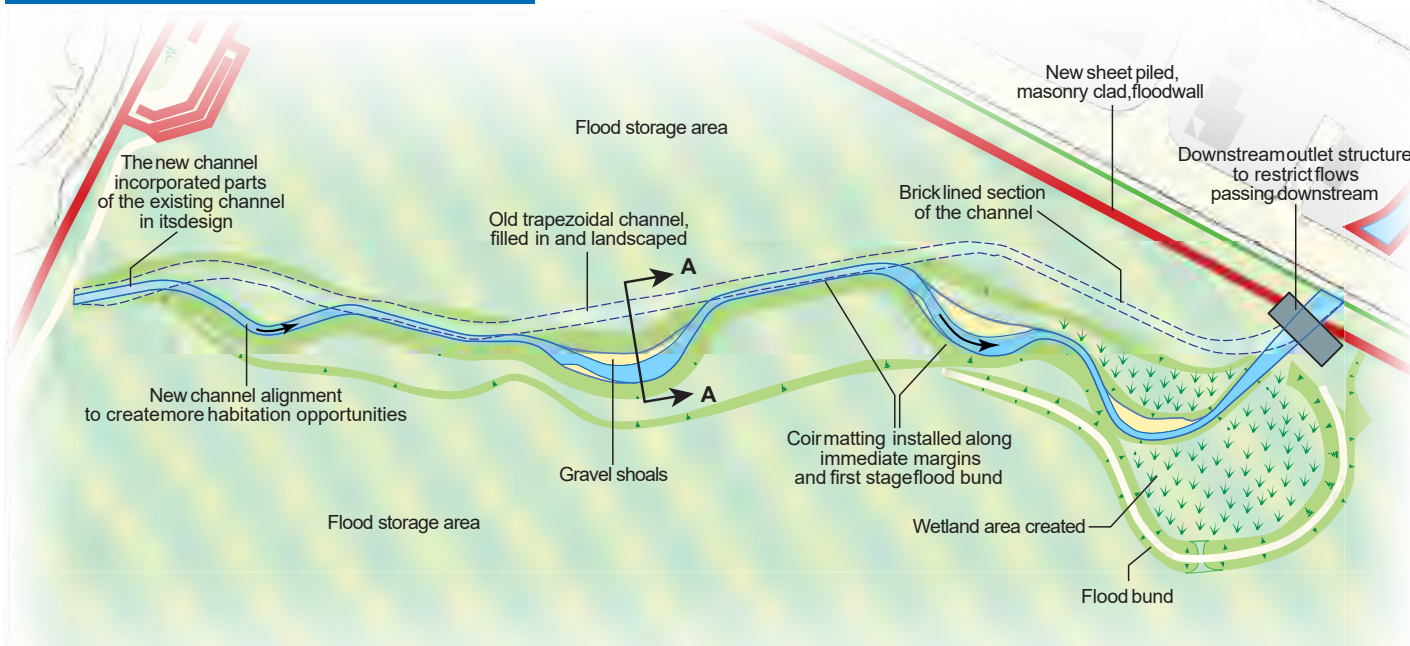
Figure 1.10.1

PLANFORM OF THE BRAID BURN THROUGH INCH PARK

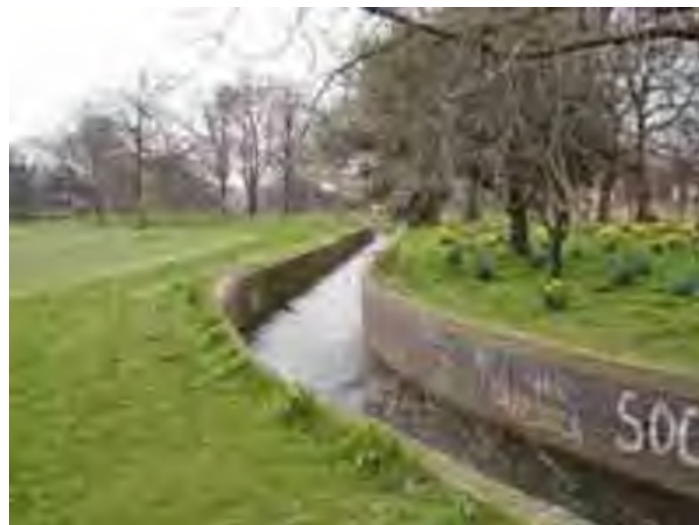
Prior to works part of the channel through Inch Park was brick lined – April 2006

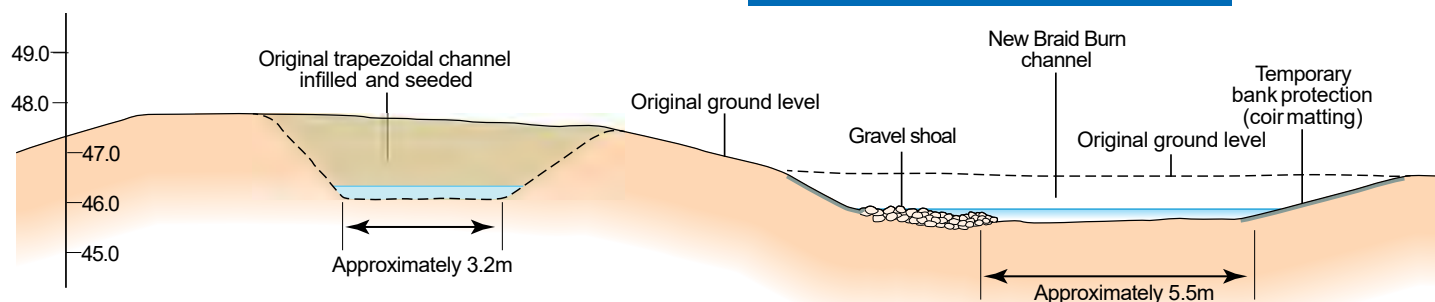
Figure 1.10.2

NEW BRAID BURN CHANNEL AND REPROFILED BANKS
SECTION A-A (SEE FIGURE 1.10.1)

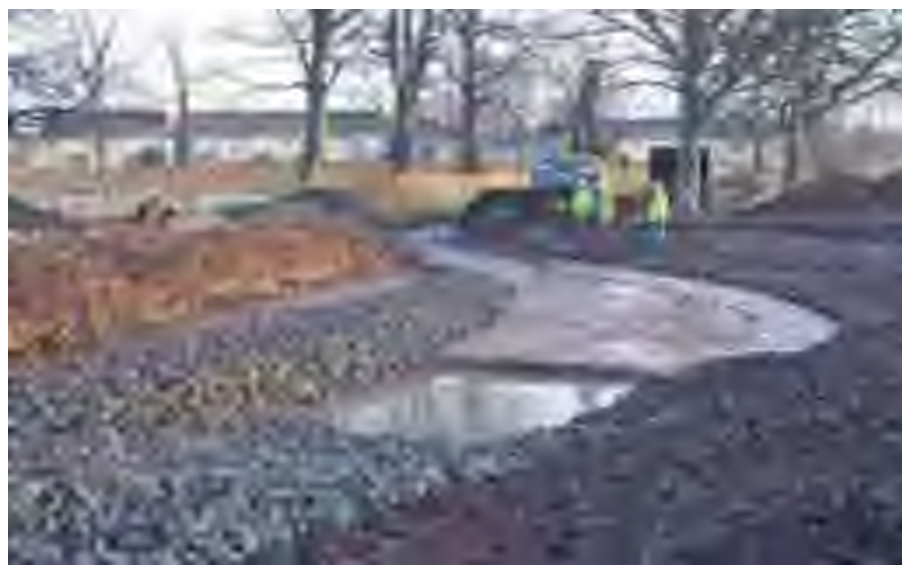
New meander channel cut off-line. 0.075–0.3m lumpstone was used to create the riffle and shoal base to prevent excessive bed scour
– January 2009

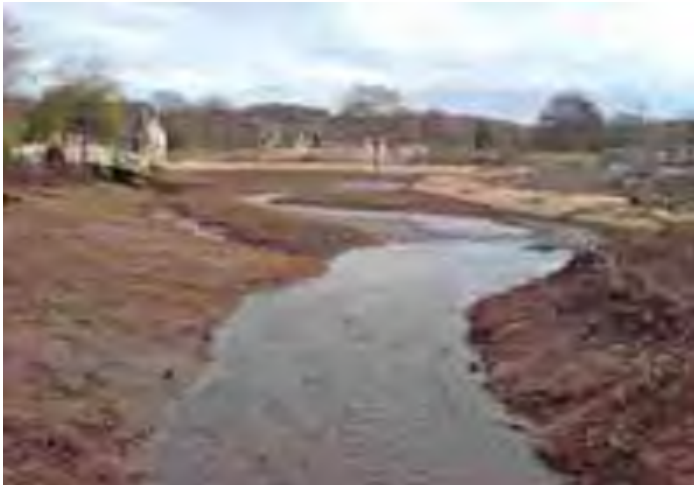
The gently sloped banks provide additional capacity and promote the natural processes of sediment transport and vegetation colonisation – February 2009

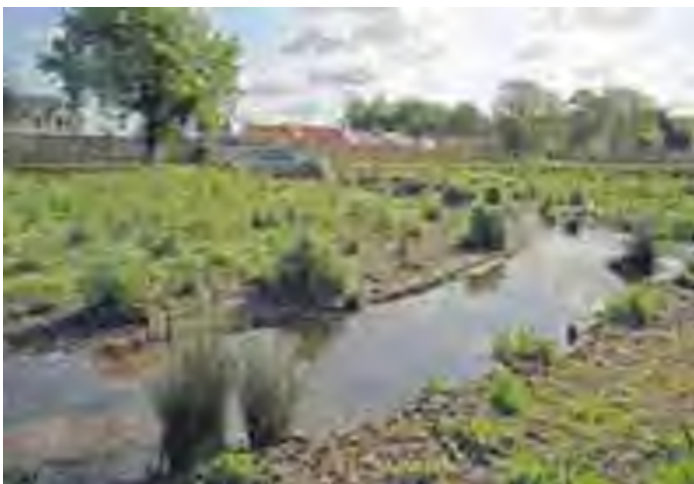
Wetland area at low flows. The height of the floodwall demonstrates the flood storage capacity within the park – March 2010

A debris screen was installed at the downstream outlet structure as part of the flood protection scheme to intercept floating debris and help prevent blockage of downstream culverts. A wetland has been created in a low-lying area adjacent to the outlet. The wetland is covered during higher flows enabling fine sediment and nutrients to be retained.

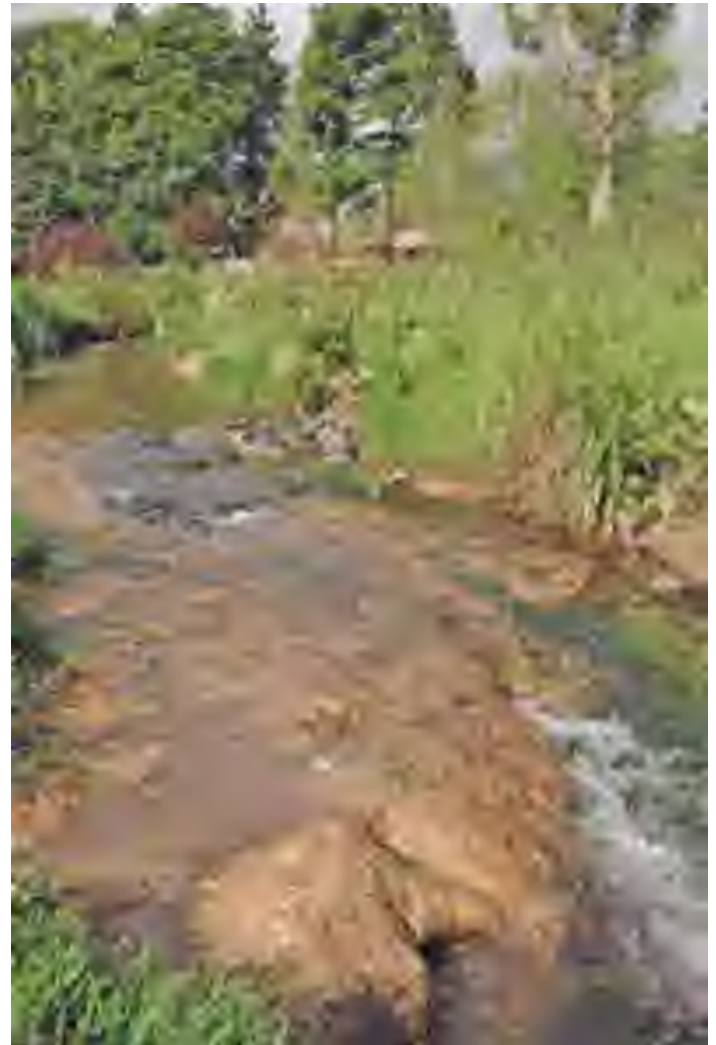
Eroded clay forming a stable cascade and adding to the diversity of features within the channel – May 2011

The shoals around the meanders have trapped significant quantities of fine silt during high water events and vegetation has begun to colonise the sediment, disguising the lumpstone structures. Gravel has been transported out of some parts of the new meanders and replacement with gravel transported from upstream has been slow. At one location a less dense lens of sandy clay within the channel has eroded to form a small cascade and pool.

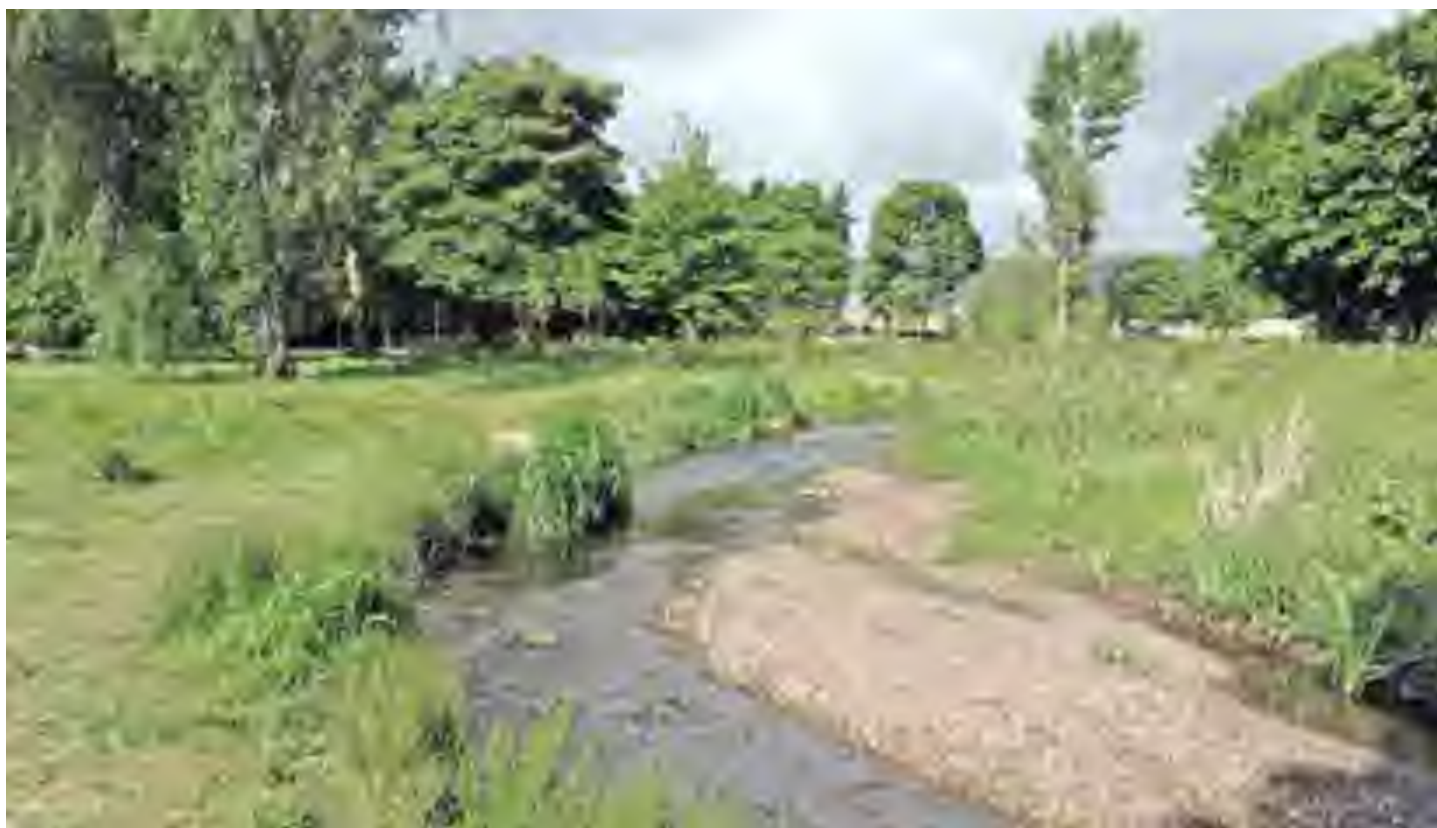
The new course of the Braid Burn through Inch Park after two years. Marginal vegetation has established well and natural processes have enhanced the in-channel morphological features that were created – May 2011

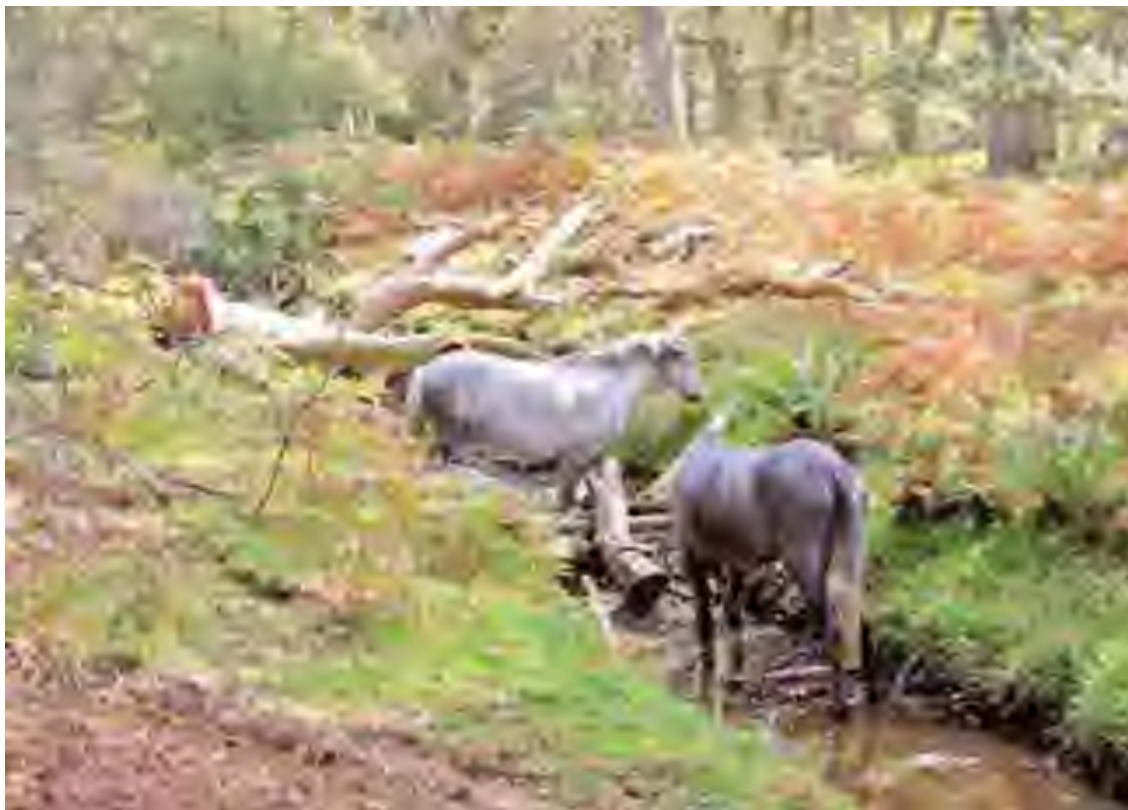
The degraded channel was restricting both natural river processes and easy access across the forest for roaming animals – 2009

One example of this degradation is on Highland Water, a small headwater sub-catchment (4.9km²) of the Lymington River. Prior to restoration the channel was up to 1.2m deep and 4m wide restricting the natural seasonal flooding of the surrounding forest. The previously wet woodland and mire habitat had dried out and the increased channel size presented a barrier to the freely roaming forest animals.

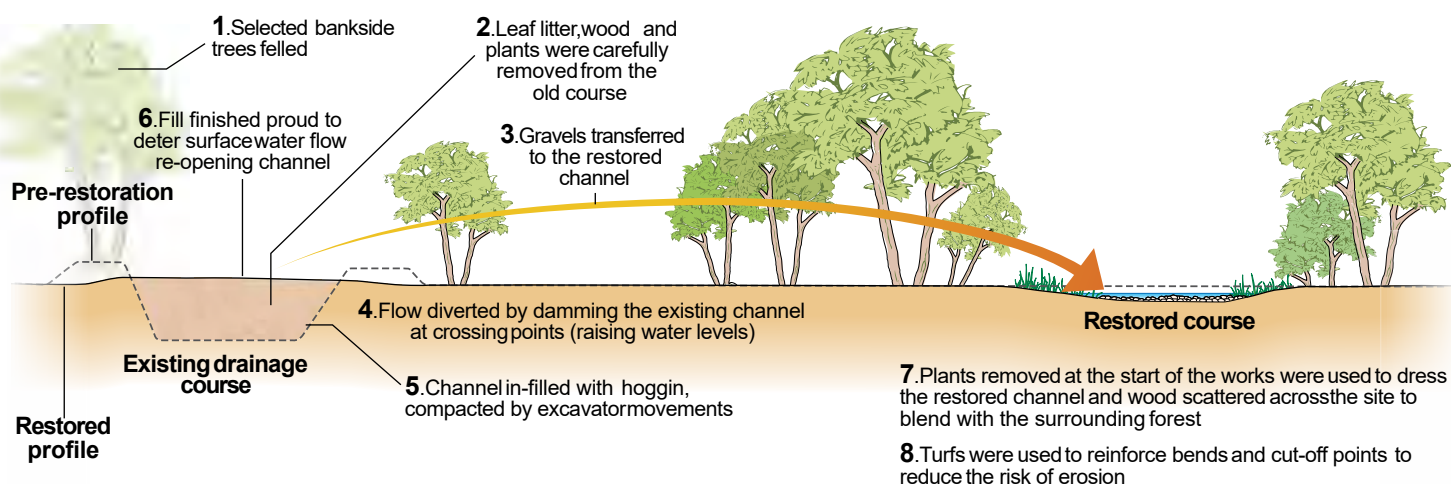
Figure 1.11.2
STAGES OF TECHNIQUE IMPLEMENTATION

The work was carried out in the following stages (See Figure 1.11.2):

Flow was diverted from the existing to the restored channel, section by section (See Figure 1.11.2) from one crossing point to the next moving down the reach. Adopting this phased approach enabled a controlled diversion of the flow into the new channel, reducing the risk of initial channel instability occurring.

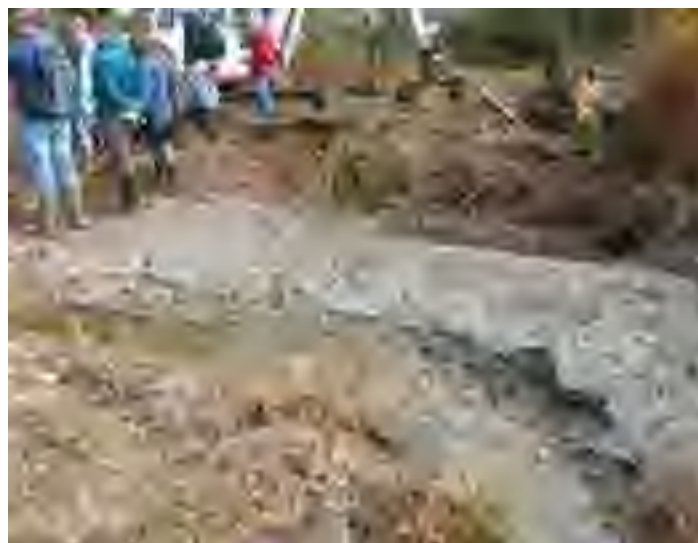
Clay infill was tightly packed at crossing points at 10 metre intervals along the channel to prevent seepage – October 2009

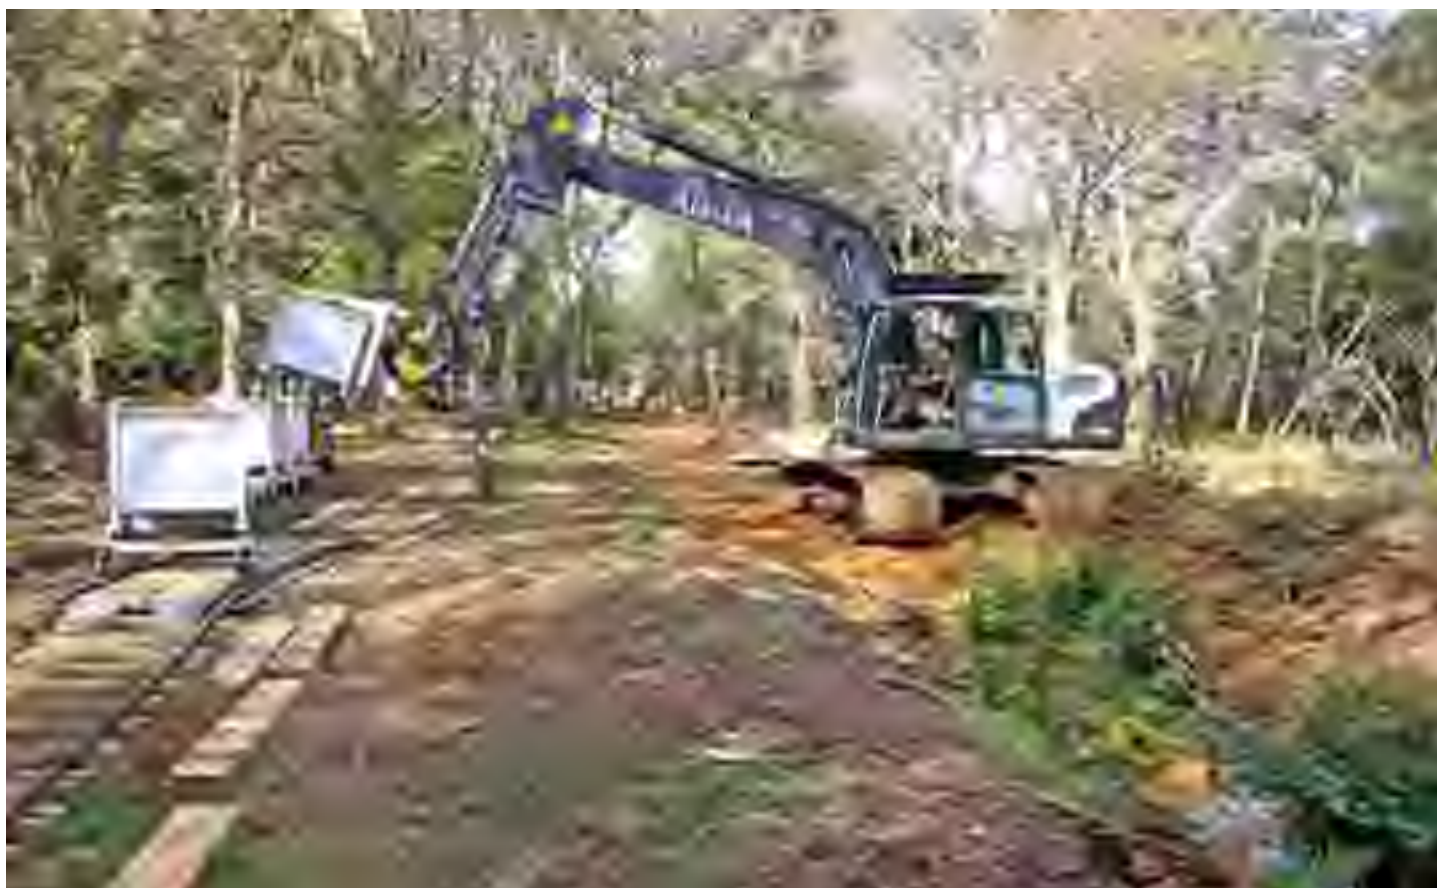
Innovative tramway designed to reduce the impact of works on the sensitive forest habitats, especially during wet site conditions – 2009

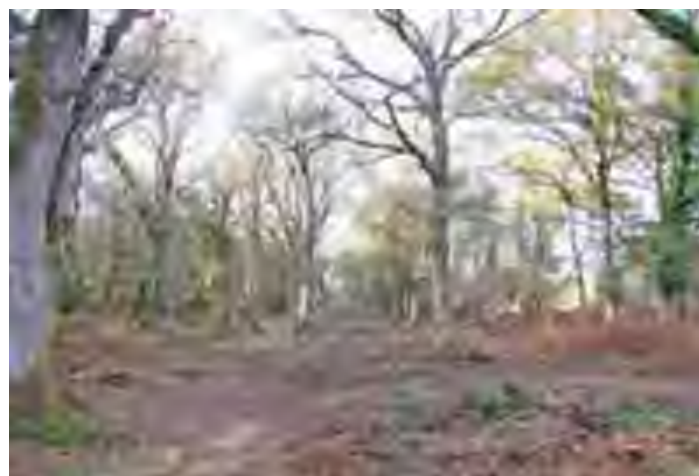
Well-placed shrubs and deadwood blend the old channel into the landscape within days – 2009

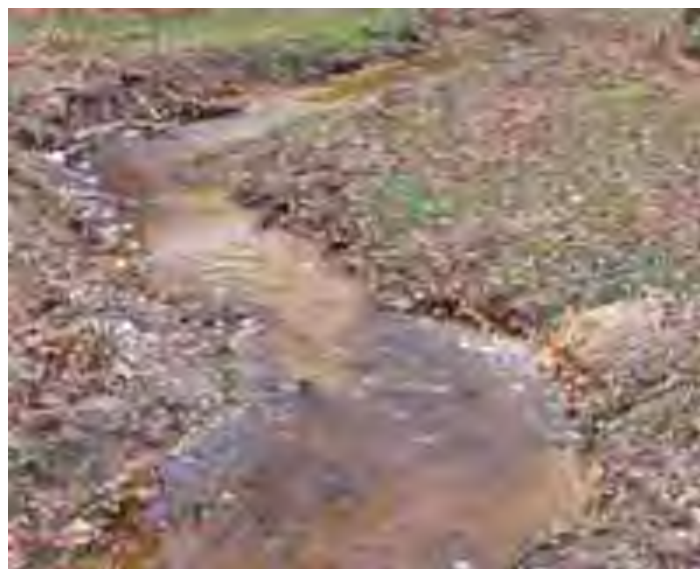
Immediately post-construction flow begins to grade materials. Pools and riffles are developing – 2009

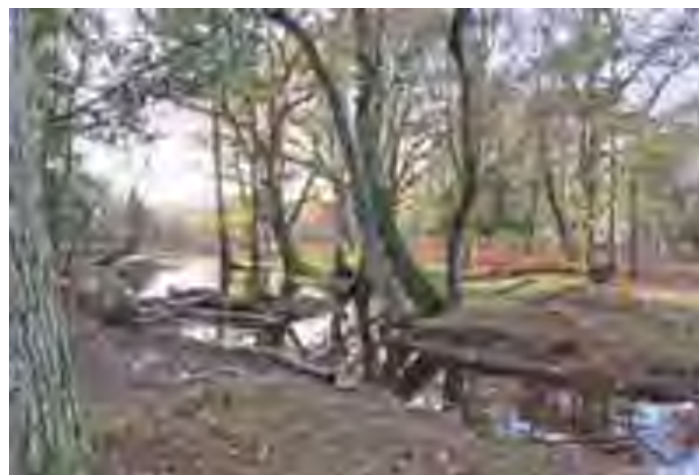
The restored course includes both narrow and wide sections – 2009

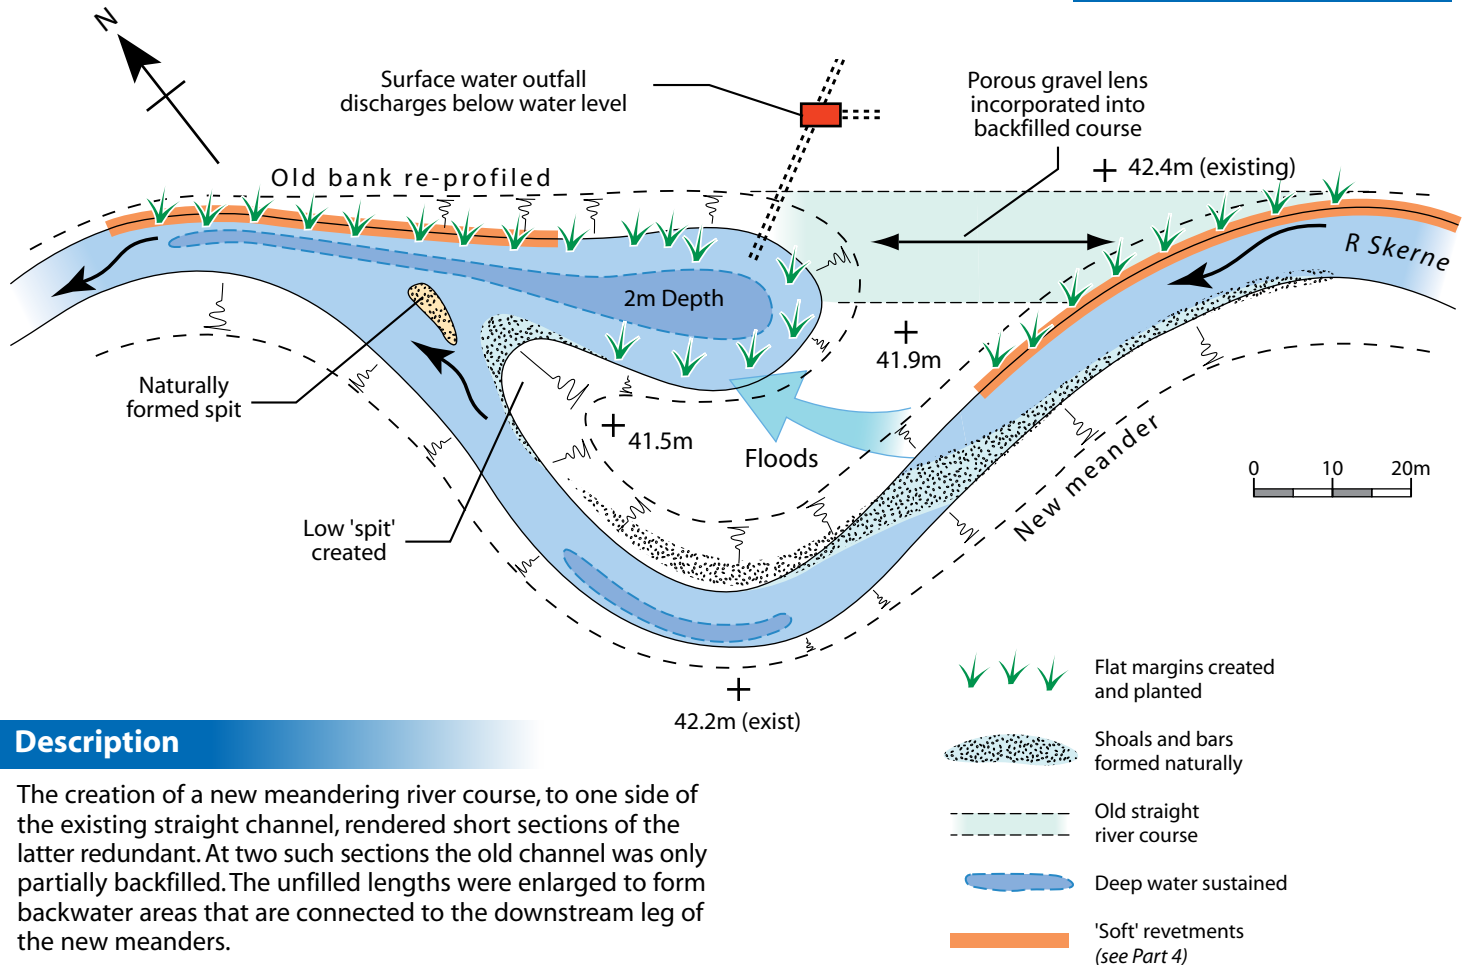
Figure 2.1.1

PLAN OF BACKWATER AT BEND N2

The redundant lengths of channel were trapezoidal in section and needed to be enlarged and reprofiled to achieve their full ecological potential. Both were similarly designed - the largest is shown in *Figure 2.1*.

The hydraulic design of the meander ensures progressive submergence of the backwater during floods. *Figure 2.1* indicates the way in which the land between the backwater and the river channel is profiled to ensure that the downstream leg (and the backwater) submerges before floods flow directly across the meander corridor. Floods sweeping over the backwater flow on downstream, merging with the main river flow. The complex currents that result at this stage affect the patterns of sediment deposition at the junction of the backwater with the main river channel. Large eddies inevitably arise, and these can easily cause sediments to settle out right across the junction, eventually closing it off from the river completely. The floodwater currents passing through the backwater help to reduce this risk; it was anticipated that a shallow spit of sediments would form, but not complete close the backwater. The formation of such a spit was reflected in the profiling of the land at the junction.

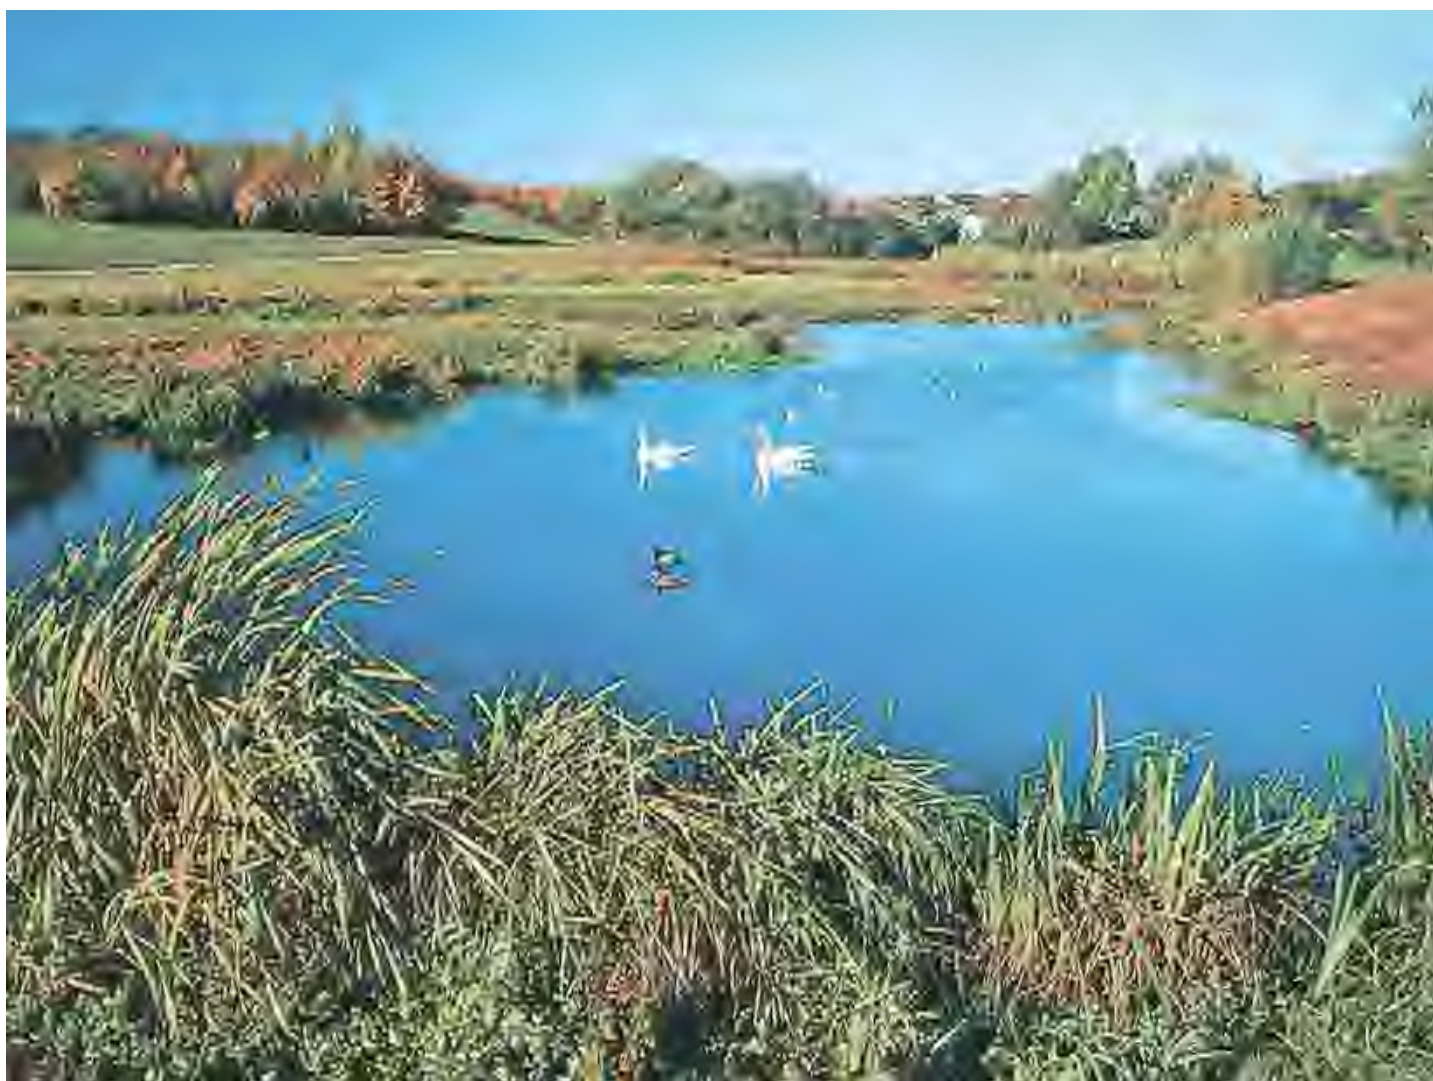
Large Backwater – November 1996

The backwaters are a strikingly successful feature of the project. They not only add to overall visual amenity but attract much bird life because of the diversity of habitats especially at the junctions. People are attracted to the backwater to feed the birds which further encourages them. The eddy currents anticipated are much in evidence, and have led to the natural formation of the small spit highlighted. This is a desirable feature that should help to maintain deep water because of the narrowing effect and increased velocity.

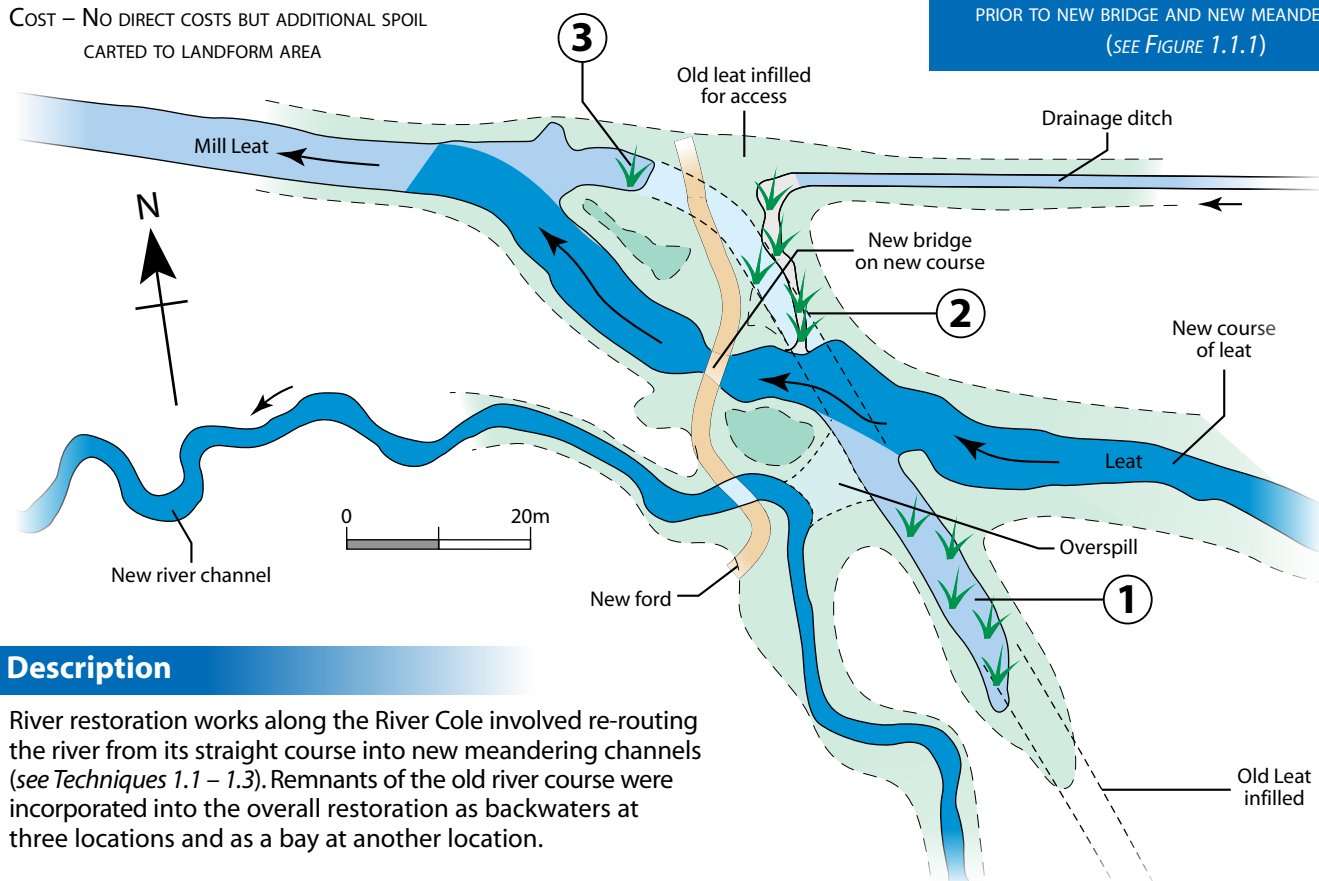
Figure 2.2.1

BACKWATERS AT 1, 2, 3 DELINEATE COURSE OF LEAT PRIOR TO NEW BRIDGE AND NEW MEANDER IN LEAT (SEE FIGURE 1.1.1)

Backwaters on mill leat (Figure 2.2.1)

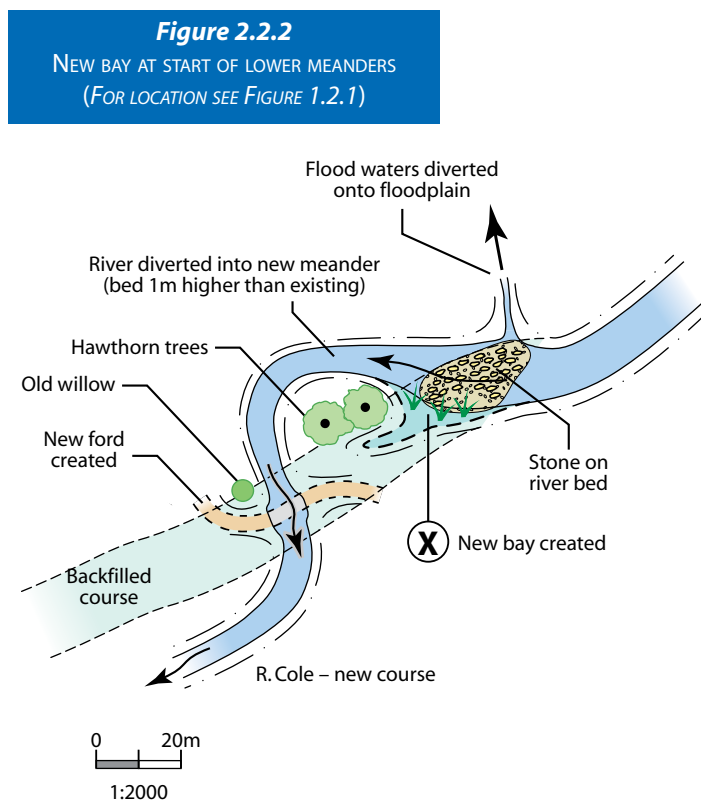
View of shallow bay X

The new meandering channel is smaller than the existing channel upstream and its bed is elevated c.1m higher. As a result, water in the upstream channel is impounded and slow moving which contrasts with a marked increase in velocities within the new channel. The design of the junction of the old and new channels reflects these hydraulic conditions. The risk of downward scour of the new bed was alleviated by backfilling the existing channel bed where it abuts the new and adding a layer of stone to create a secure transition. To complete the diversion, the old channel was backfilled in a manner that created a small marshy bay within which the slower moving floodwaters can eddy freely before entering it. This was preferable to complete backfilling and having torevet the fill to resist erosion.

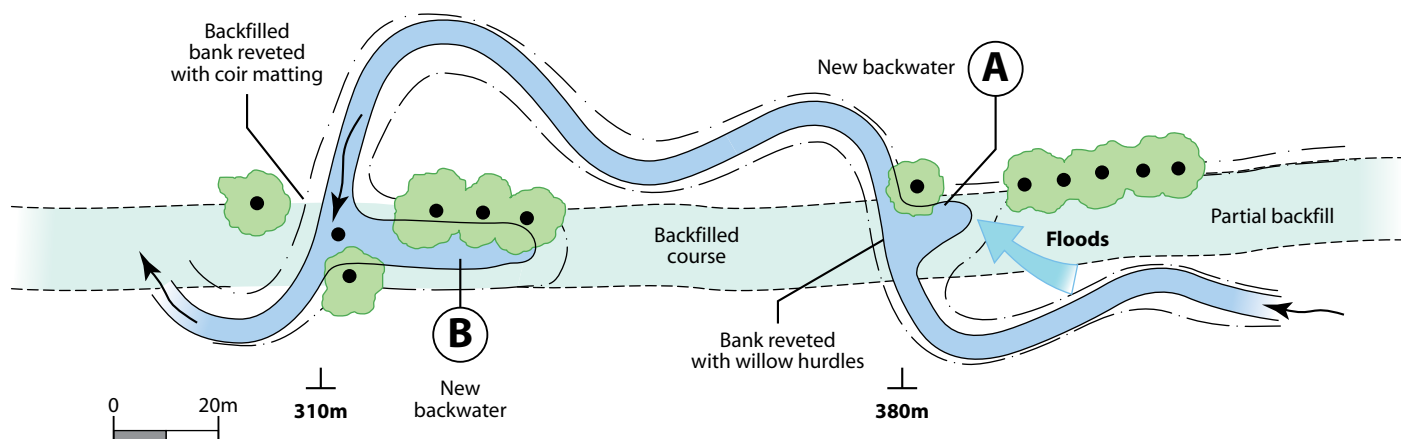
Figure 2.2.3
BACKWATERS ON LOWER MEANDERS AT CH 310M AND 380M
(SEE FIGURE 1.1.1)

Backwaters within lower meanders (Figure 2.2.3)

Two backwaters were created where the new course crosses over the old course. One is much larger than the other, and each is different in nature.

Backwater **B** contrasts with **A** in that the retained trees along the old course all overhang open water and the new channel approaches from behind the trees rather than towards them. The hydraulics are entirely different as a result. The old river bank, behind the trees, remains at a high level preventing any floodwater from passing into the backwater save for small volumes that occasionally pass over the infilled length of channel. The backwater is thus a quiet refuge of still water, and hydraulic interaction with the river is limited to rise and fall of water levels.

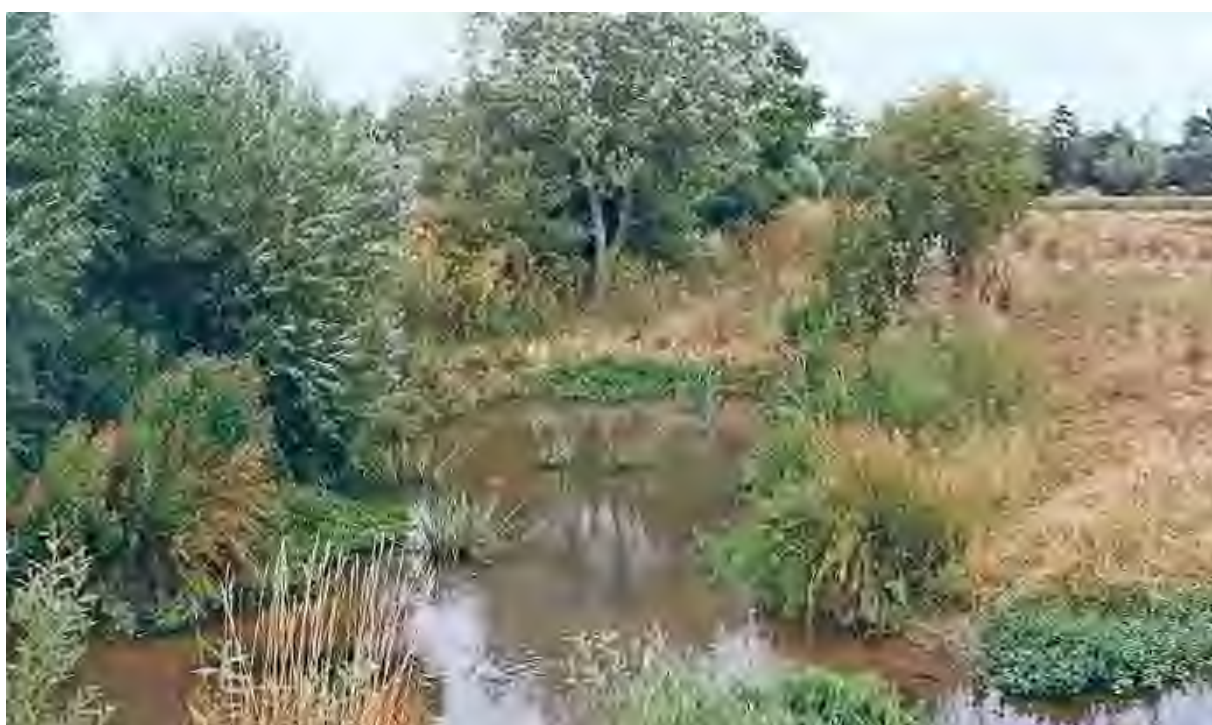
Small backwater **A**

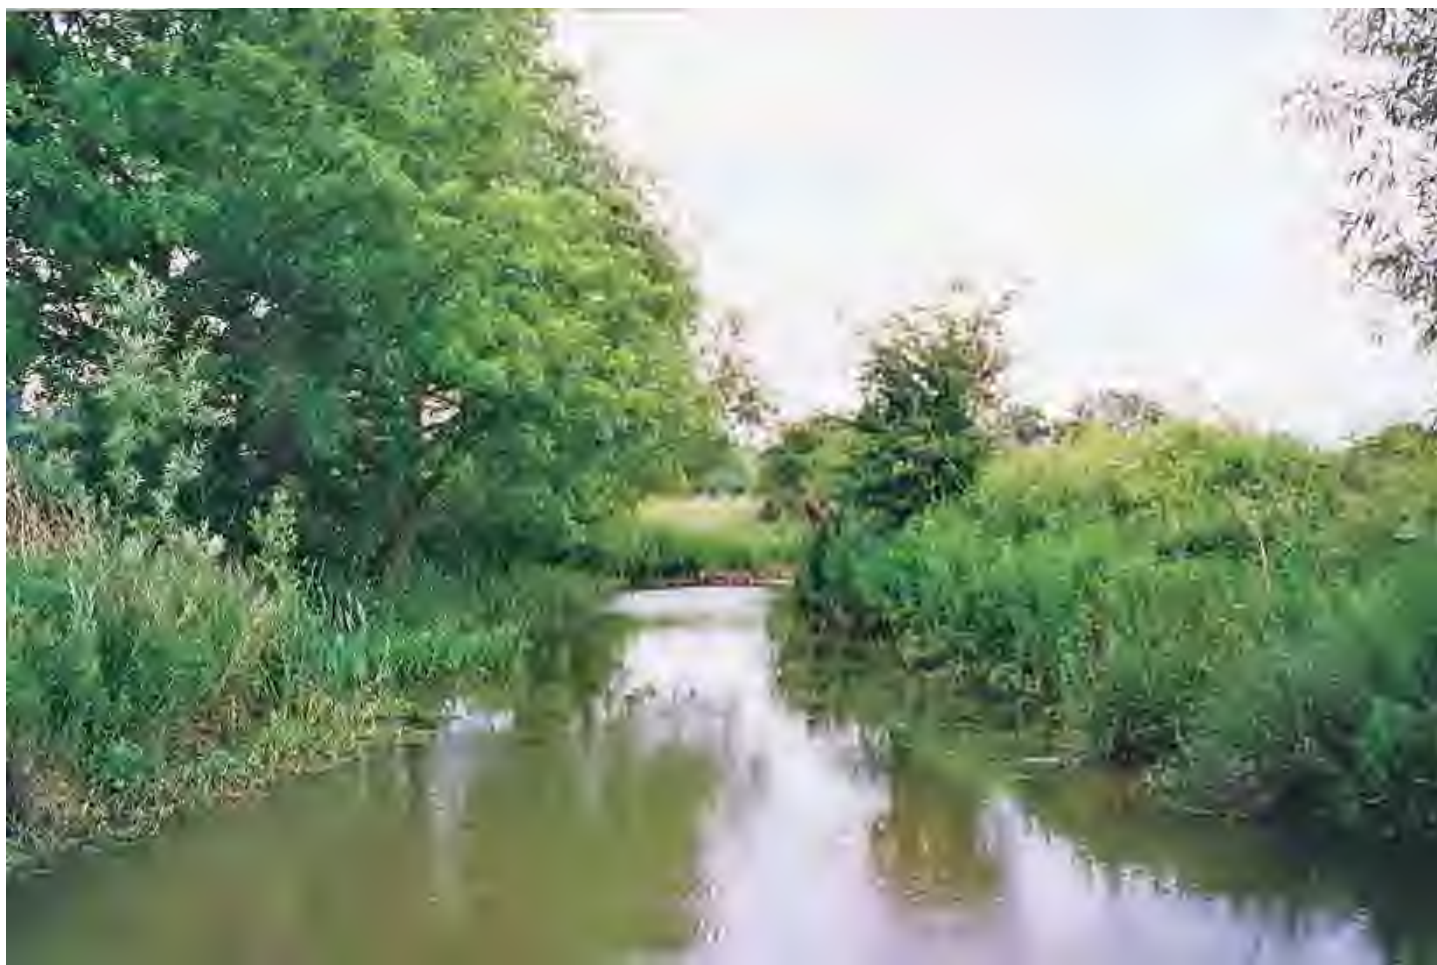
Large backwater **B****Subsequent performance 1995 – 2001**
