Enhancing Straightened River Channels

3.1 Current deflectors

RIVER SKERNE

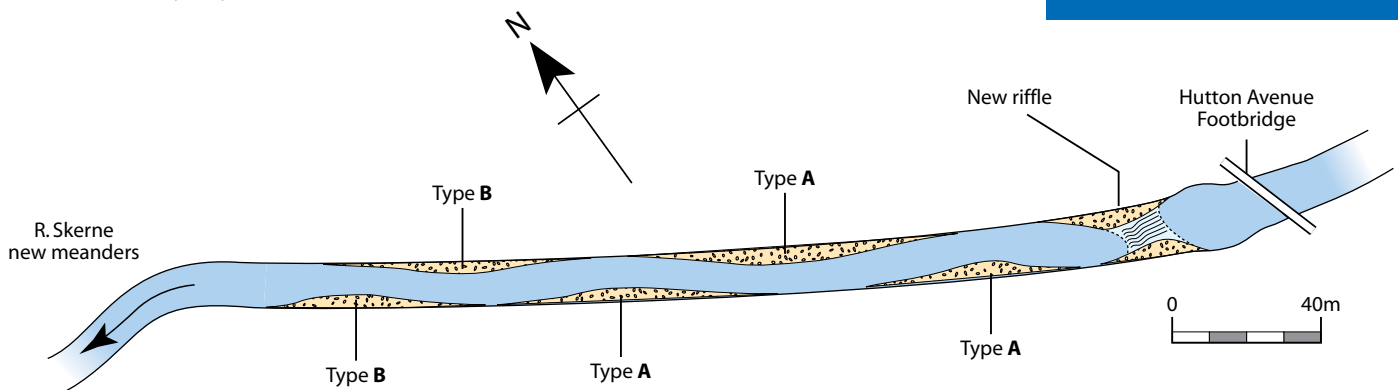
Figure 3.1.1

PLAN OF LOCATION OF DEFLECTORS

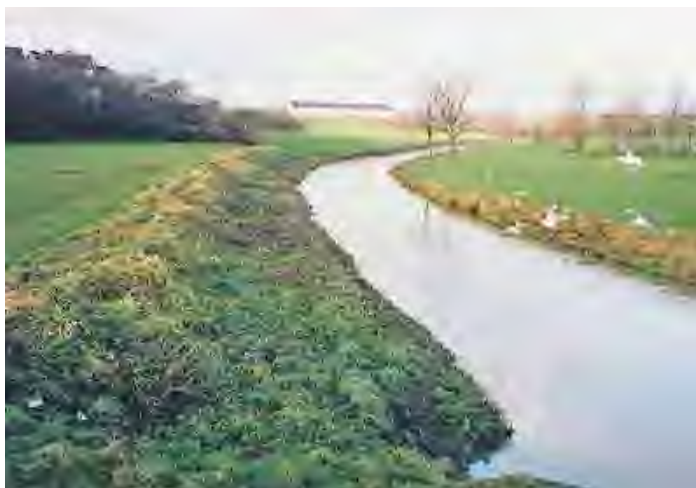
View downstream before deflectors constructed

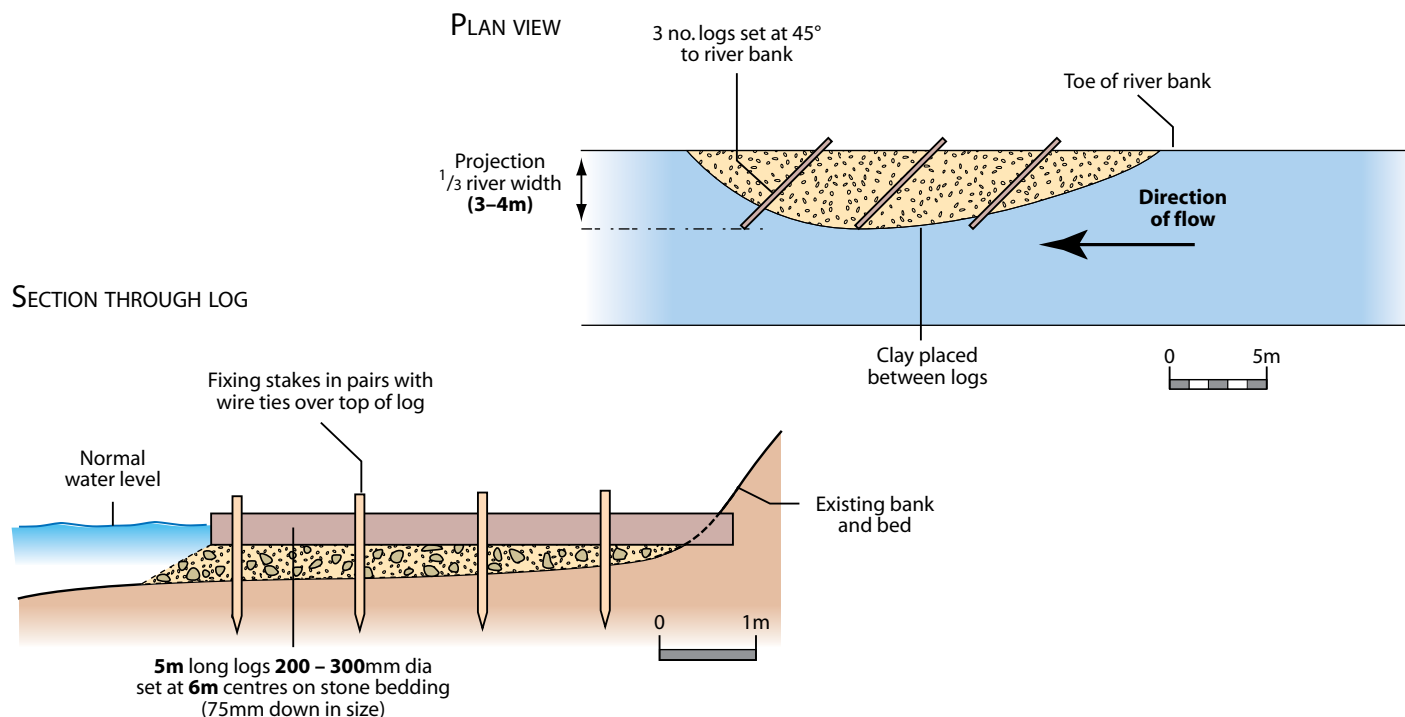
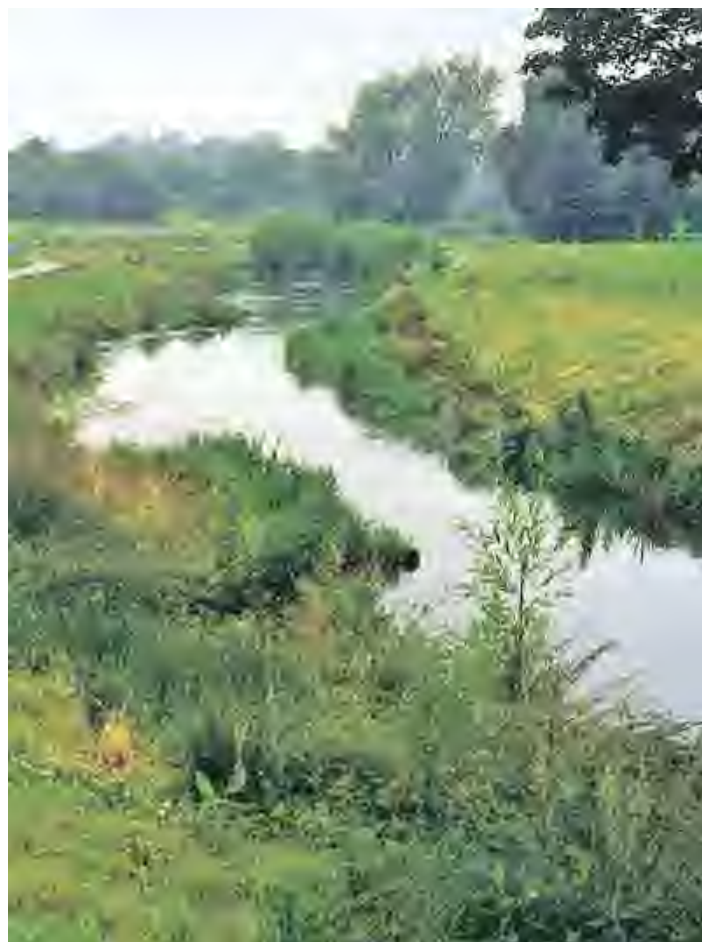
Figure 3.1.2
TYPE A DEFLECTOR

The type **A** deflectors were specified at about 200mm above water level and type **B** sloped from 300mm above water level at the bank down to water level at the projecting end.

Two variations of the designs were introduced. The deflectors of 'type A' point downstream (Figure 3.1.2), whereas those of 'type B' (Figure 3.1.3), point upstream. This was done to help determine the most effective alignment for future application of the technique.

As a result of these factors, over winter floods washed out much of the fill from 'type A' deflectors, leaving them perched above the water level, and causing erosion of the opposite river bank. Conversely, 'type B' deflectors had no discernible effect on the river regime.

Repairs to 'type A' deflectors comprised removal of the logs and replacement with pre-planted fibre rolls set at the surviving shoal level, as well as some planting using fibre mattresses. 'Type B' were not modified but some plant pallets were introduced near the bankside.

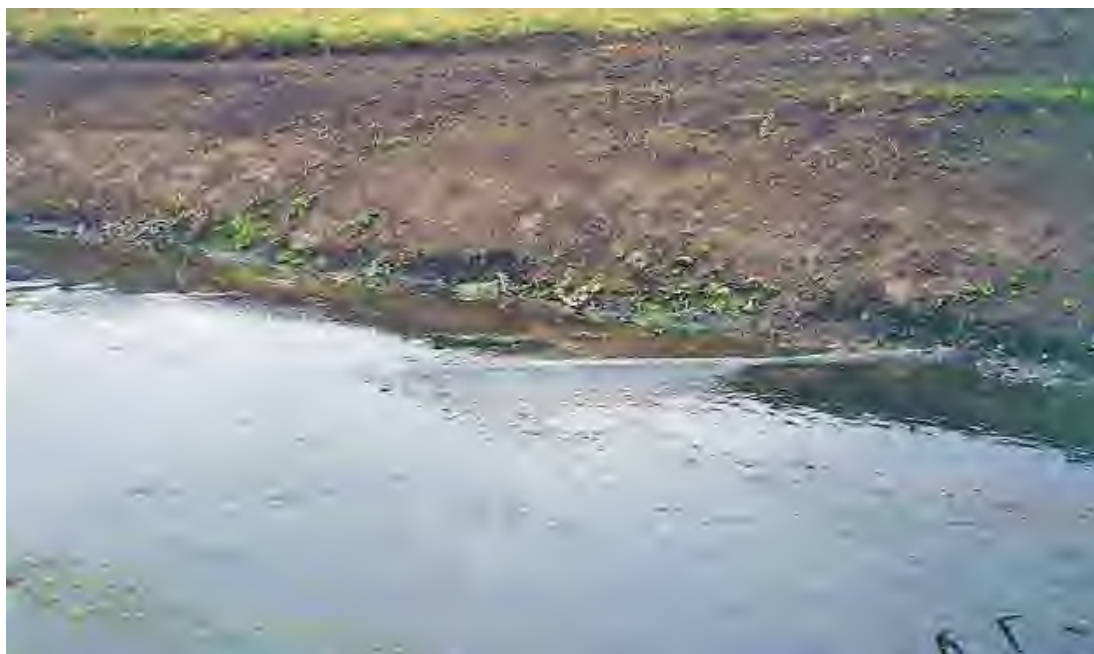
Type **A** deflector
– vegetation established

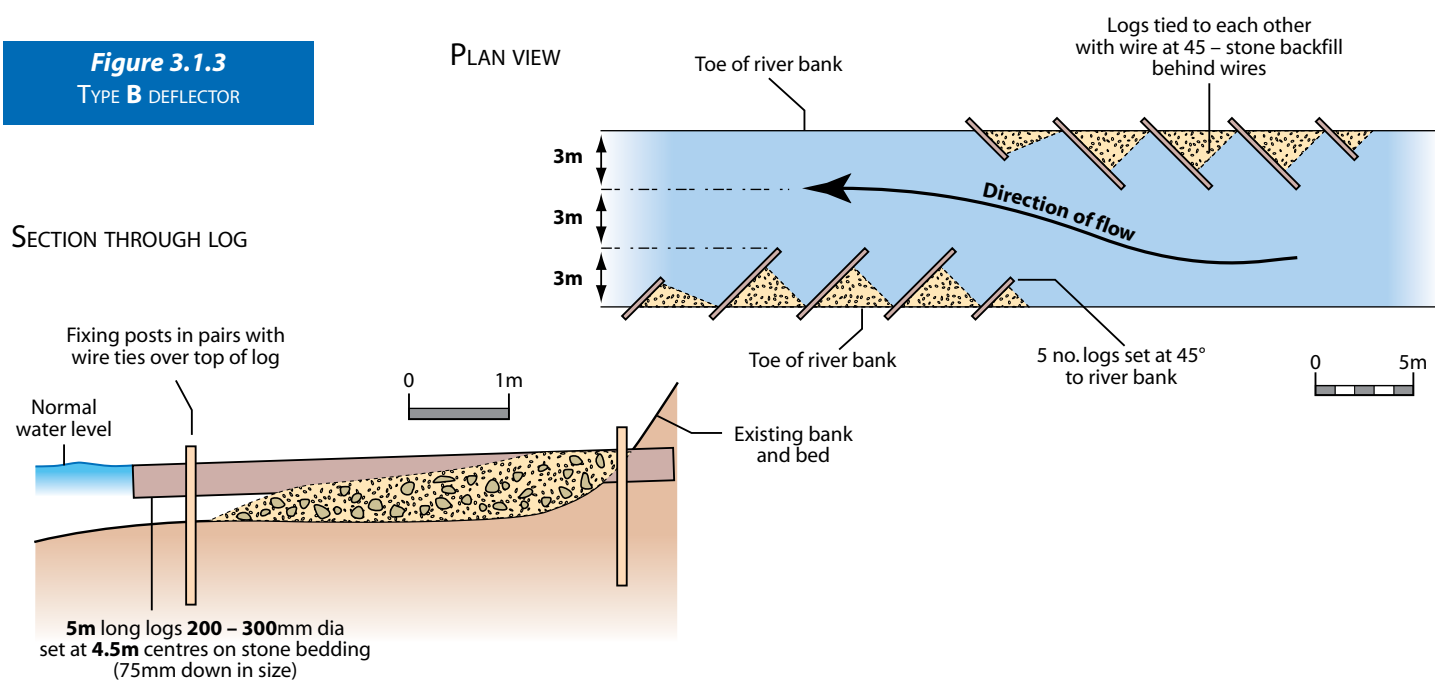
Figure 3.1.3

Type B deflector
before planting

TYPE B DEFLECTOR

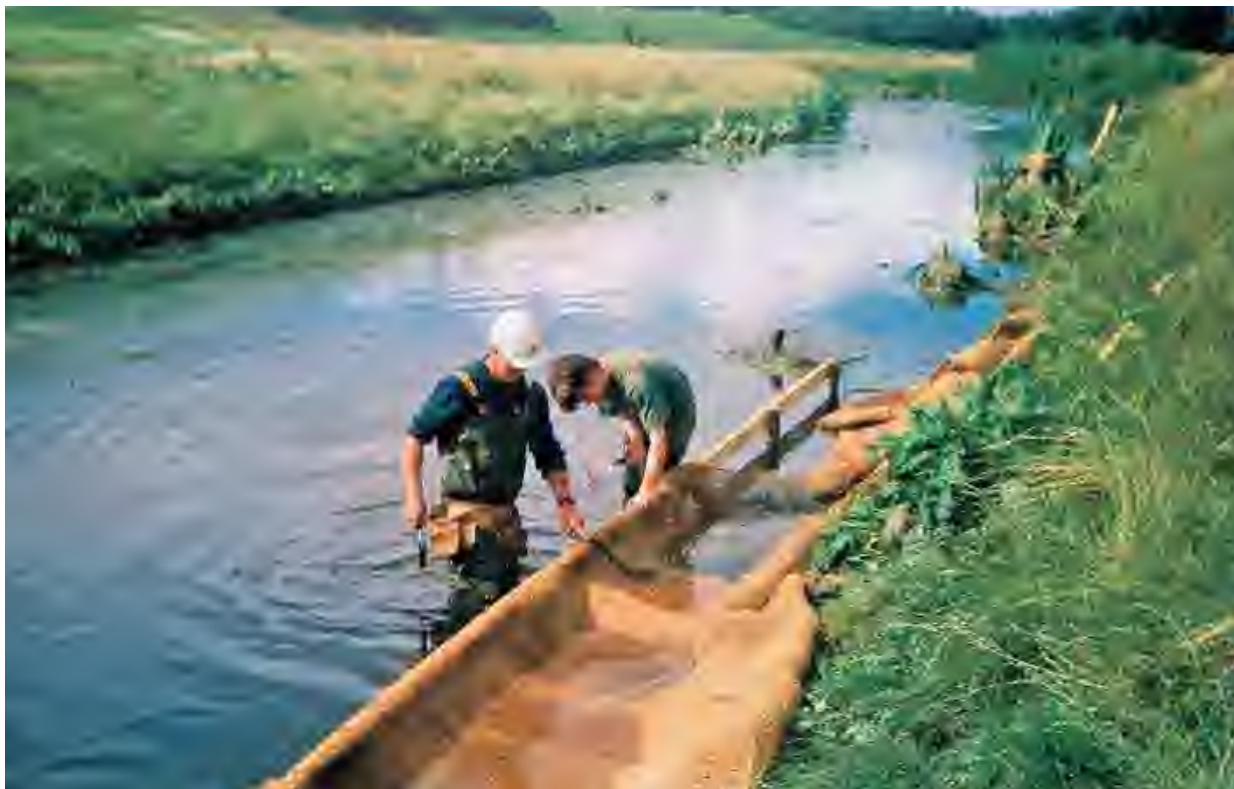
Attaching coir matting to create Type **A** ledges on River Skerne

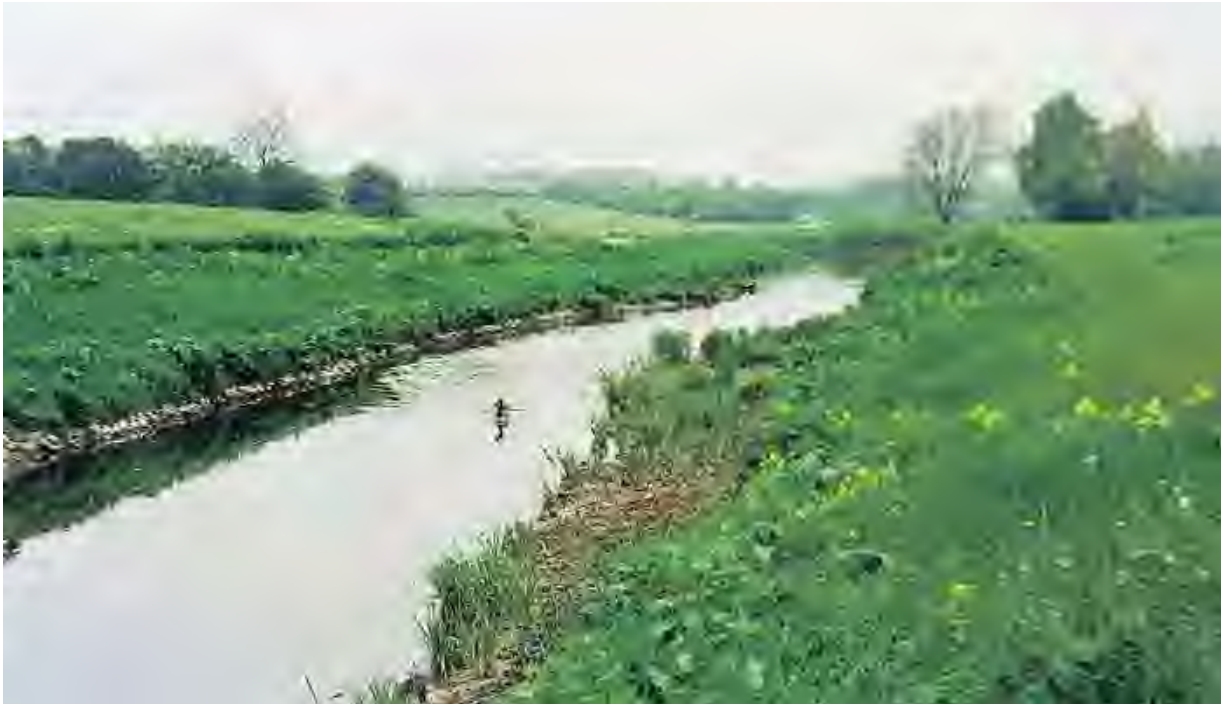
Type A Ledge
on the Skerne
– May 1998

Type A margins using plant pallets were installed downstream of the footbridge in the autumn of 1997 and overwintered satisfactorily in dormant conditions after several floods. Early summer 1998 growth was patchy with some silt banks smothering pallets. Growth was sufficient to ensure the spread of species to generate the dense cover required. Notable species that survived include occasional purple loosestrife and meadowsweet.

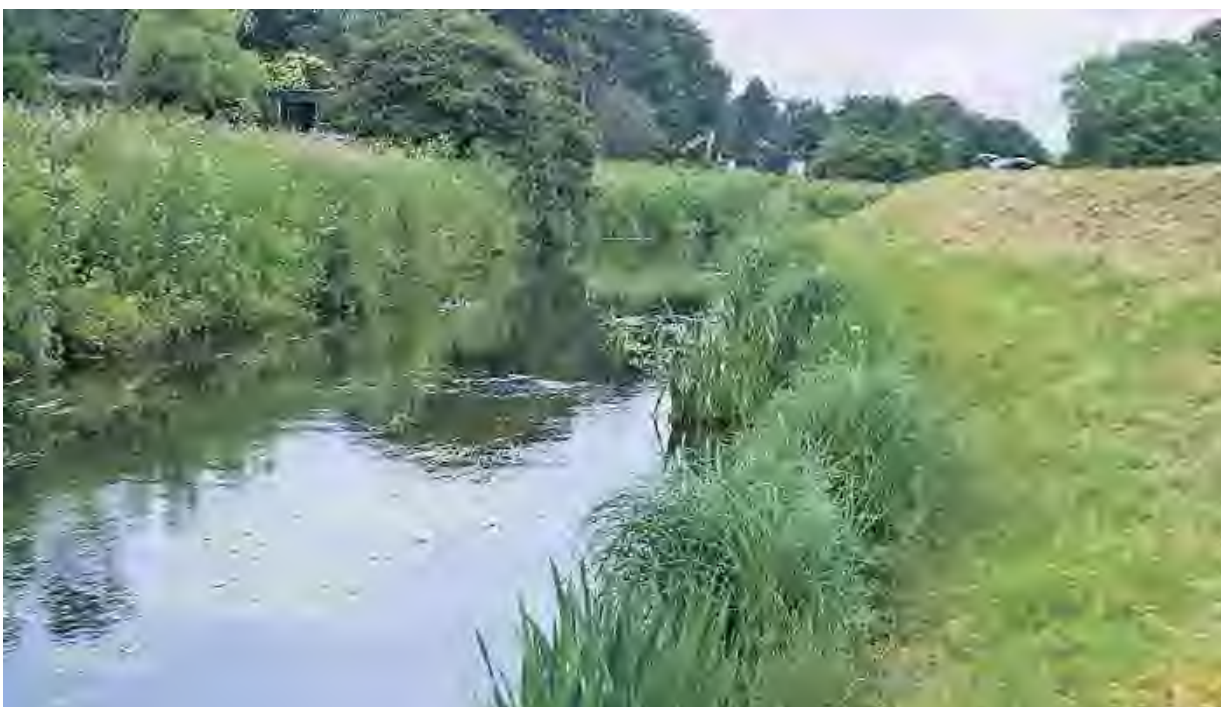
Type B Ledge
on the Skerne
after 2 years

Type B margins utilising plant rolls were installed upstream of the footbridge in August 1996. In 1998 they are attractive features much favoured by resident ducks that have created some bare patches between well established runs of lesser pond-sedge, yellow flag and reed canary-grass. The attraction of silt within the overwinter dormant vegetation along the ledges is significant; ledges have built up by as much as 300mm in places before being assimilated within new spring growth.

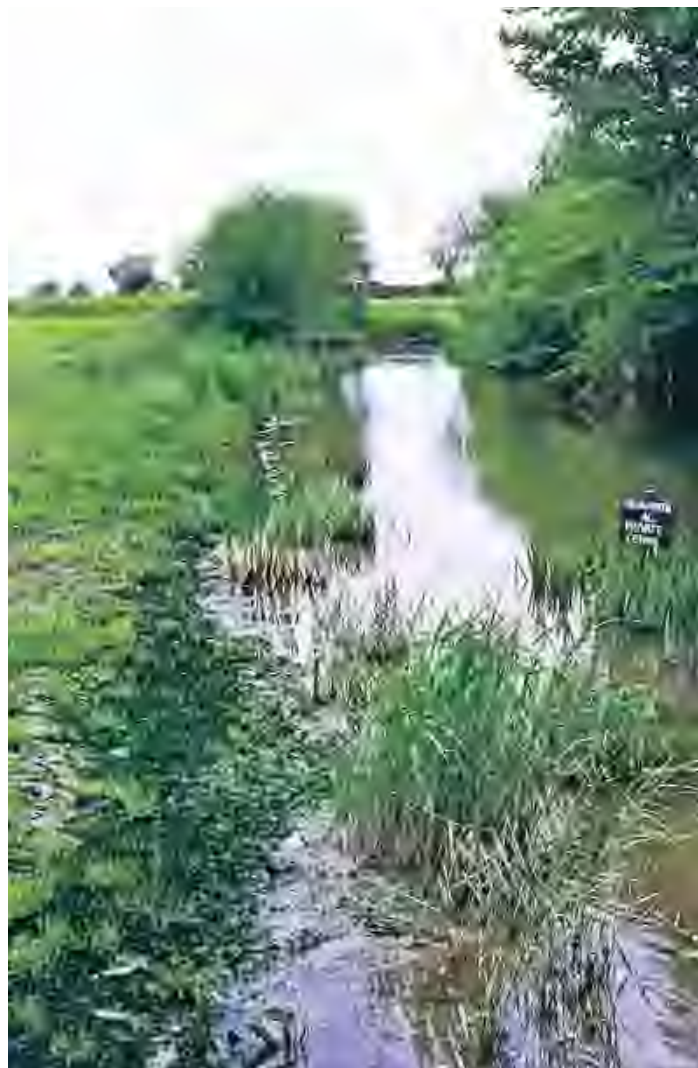
Type **A** and **B** ledges on the Cole after one winter

The ledges overwintered well in dormant conditions with no structural damage by floods although little more than 50% of the plants appeared to have survived to grow on during summer. The ledges are developing very well (1998) and creating both emergent vegetation habitat and landscape enhancement in the short stretch of river that previously had the least habitat and visual amenity value.

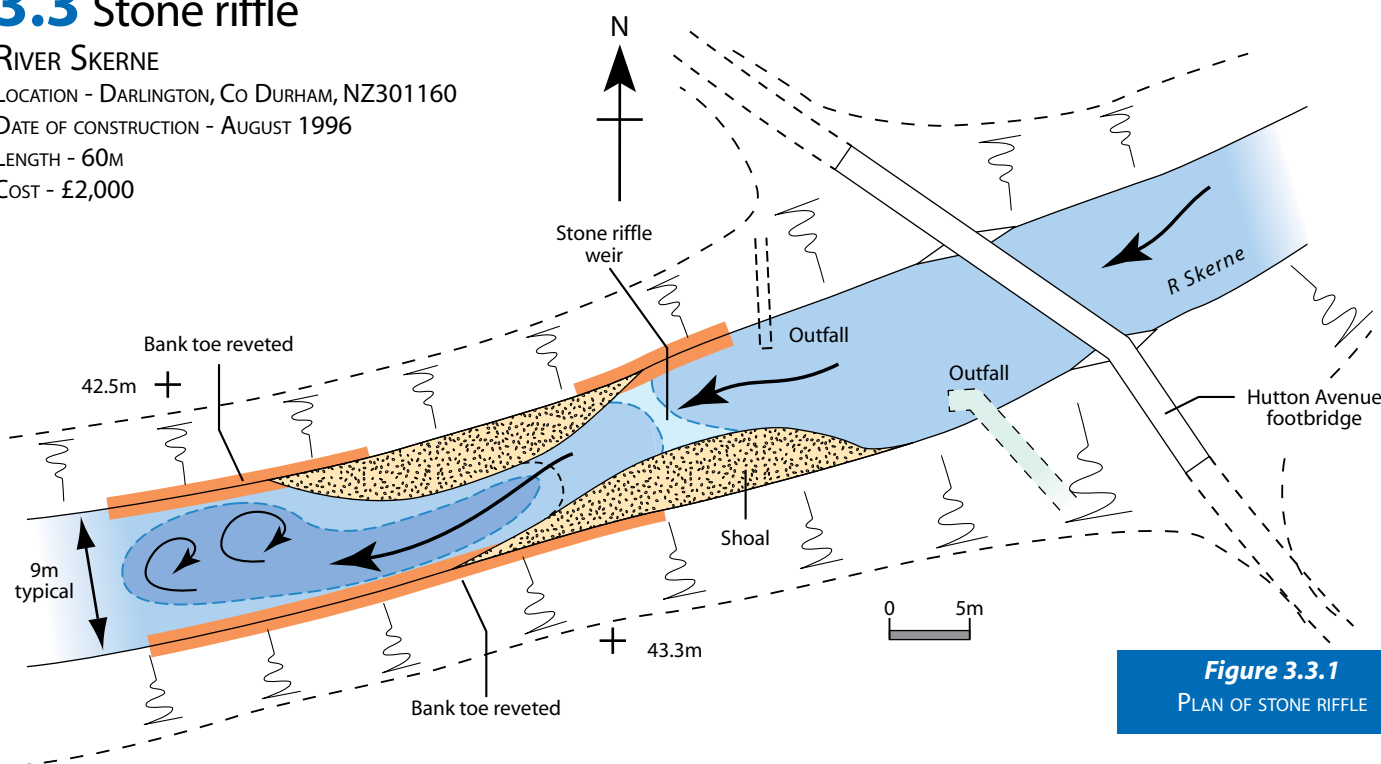
Figure 3.3.1
PLAN OF STONE RIFFLE

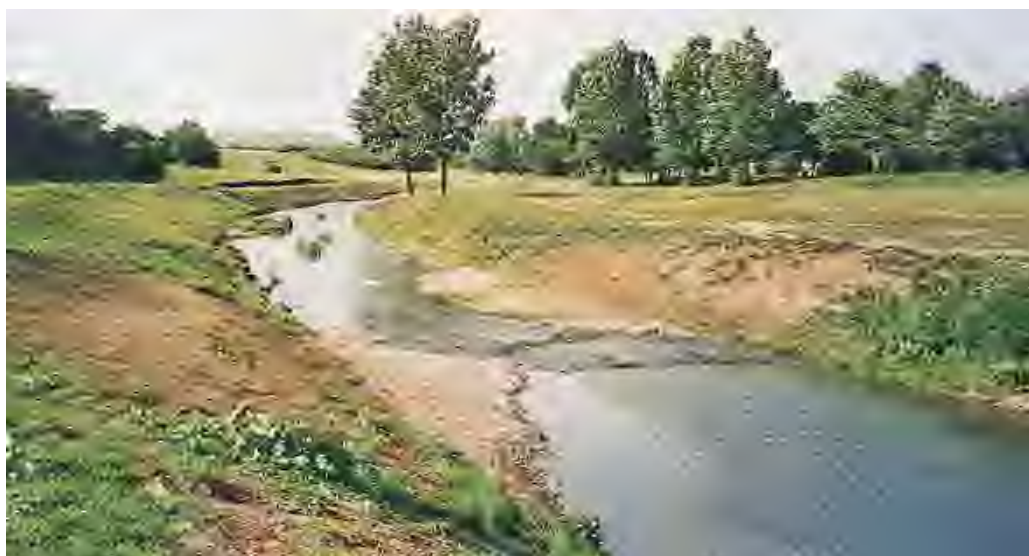
Stone Riffle downstream of
Hutton Avenue footbridge

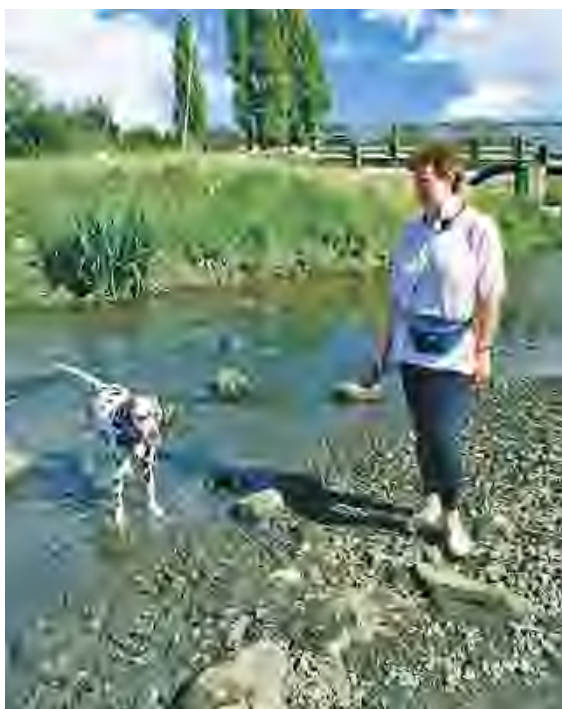
The riffle allows easy access down to the river
– November 1996

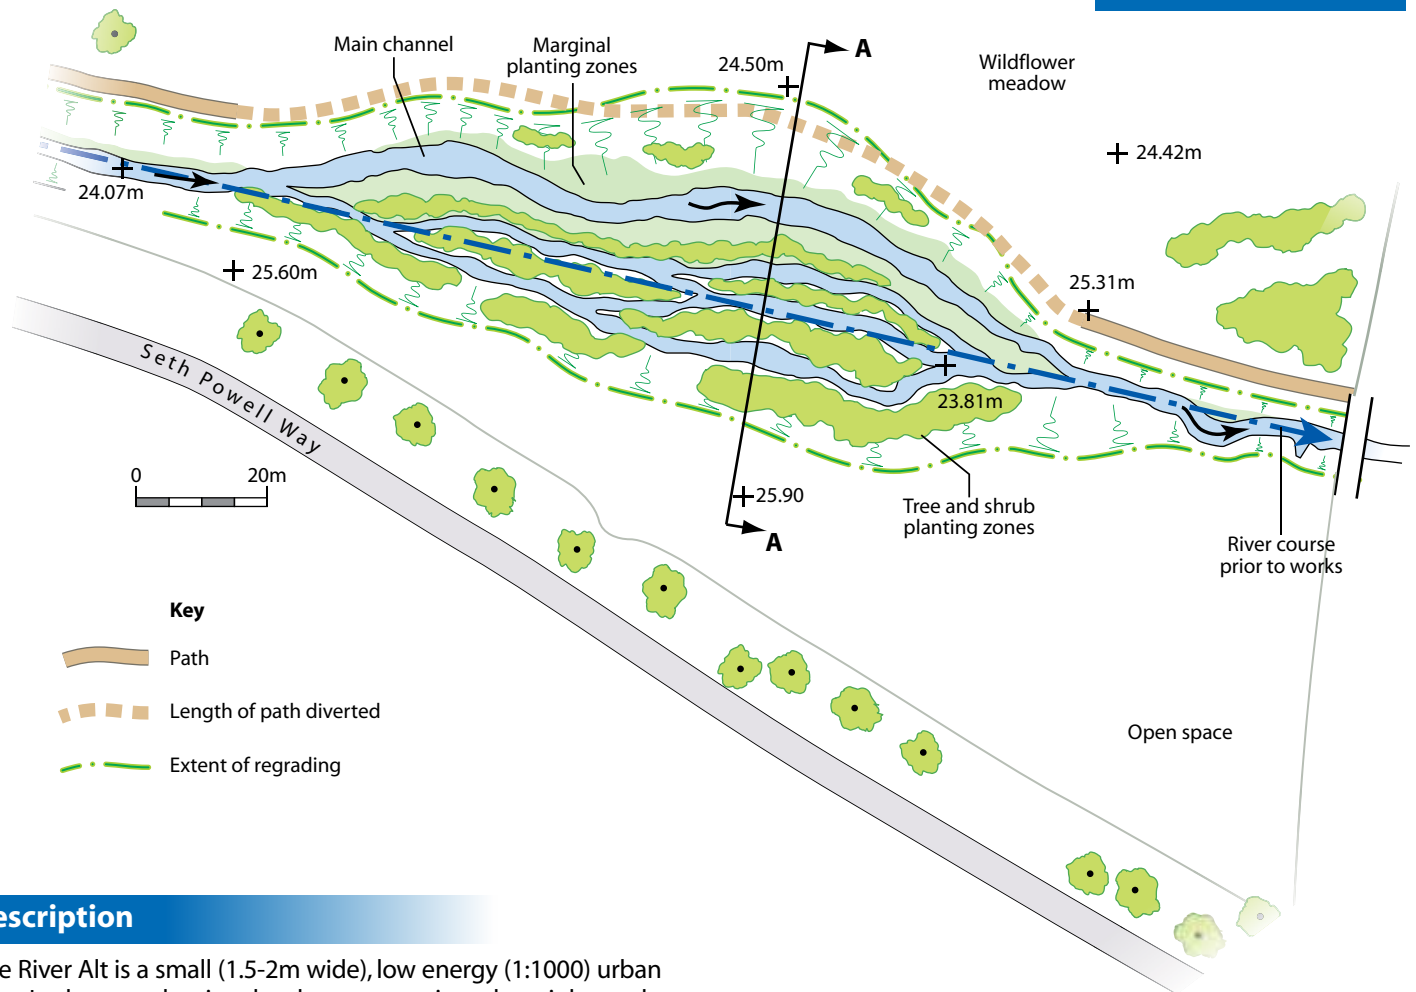
Figure 3.4.1
PLAN OF THE WIDENED
BRAIDED CHANNEL

The 1.5 metre 30 degree banks were excavated back on either side of the existing course, creating up to a 30m width of 'floodplain'. This work was carried out over 140m. The 'floodplain' comprises a 'main' channel and several braided channels separated by marginal berms. In order to achieve a matrix of channels, standing water and damp areas, interspersed by trees and shrubs, ground levels needed to vary. Due to the uncertainties of ground condition and in order to work with the natural conditions as much as possible, this was supervised on-site to avoid over-specification on the design drawings, and to allow for adjustments as necessary.

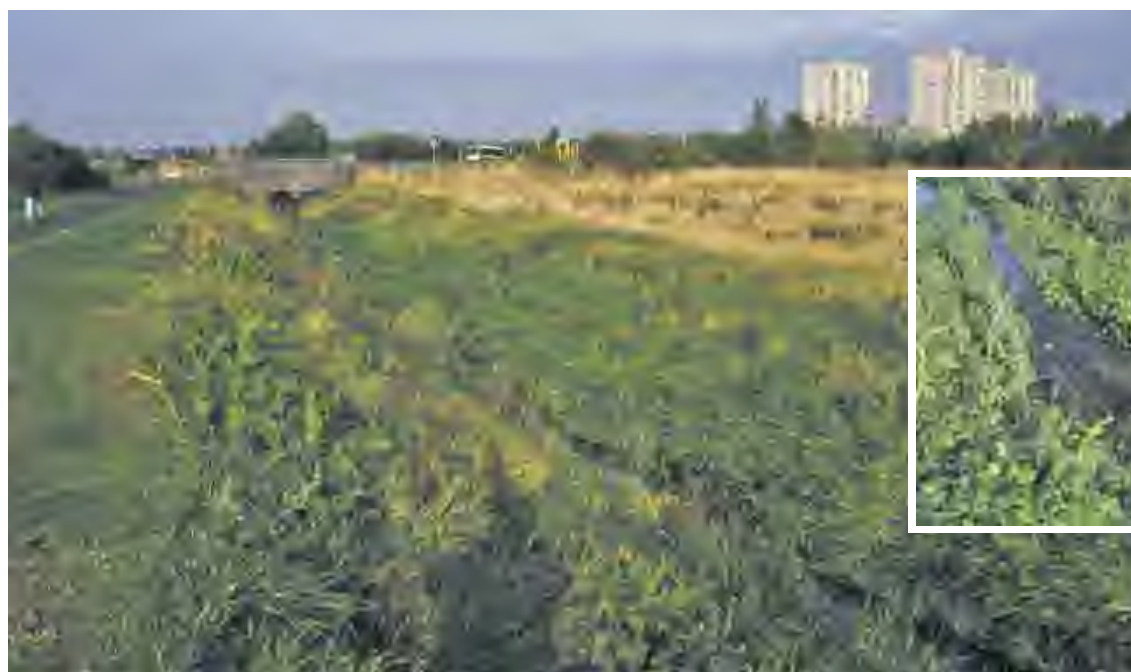
Before:
The Alt, straight
and steep sided

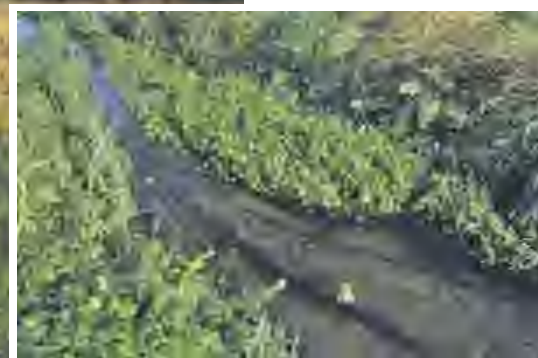
Bed dominated
by silt

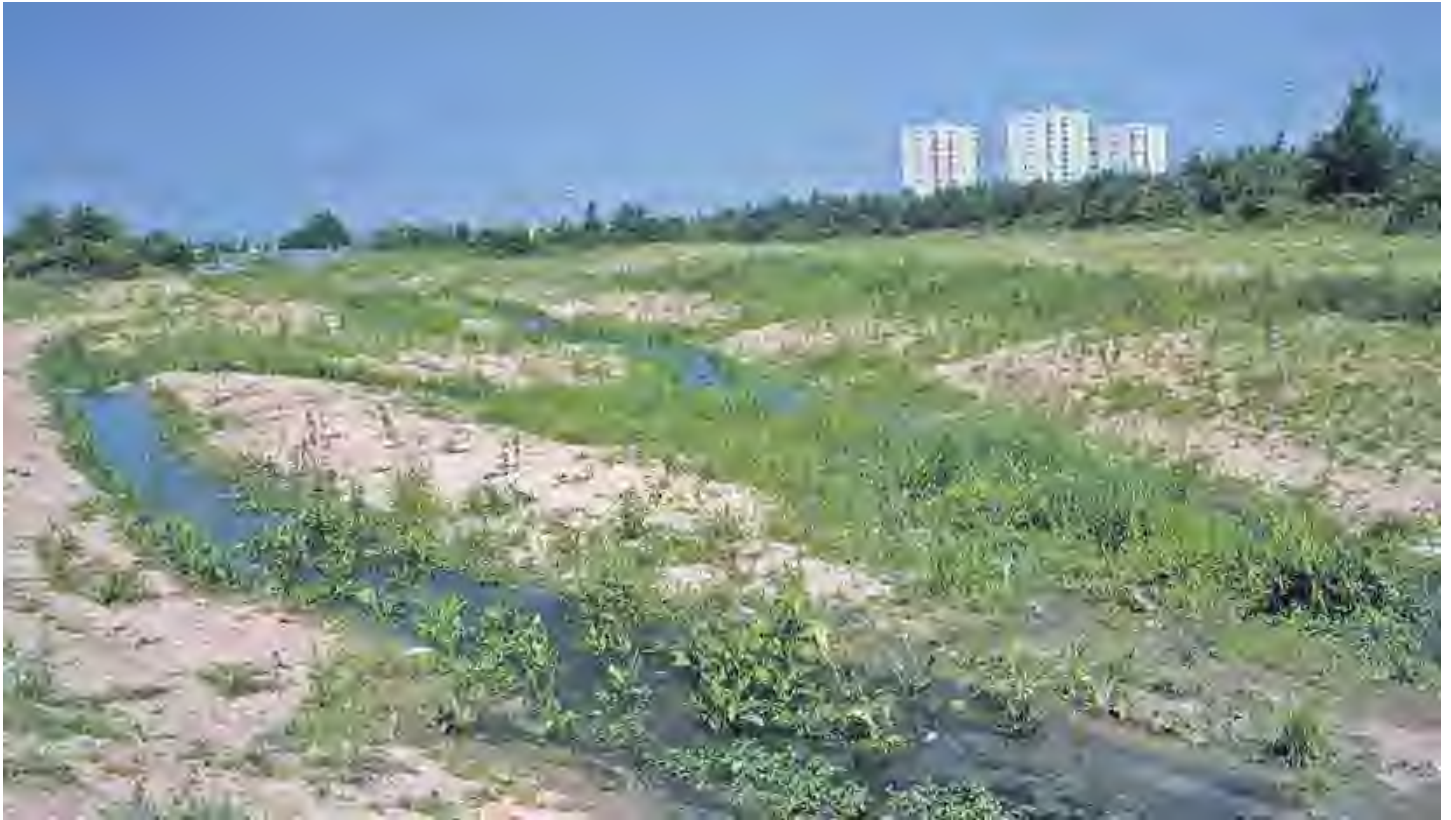
The excavated 'floodplain' area

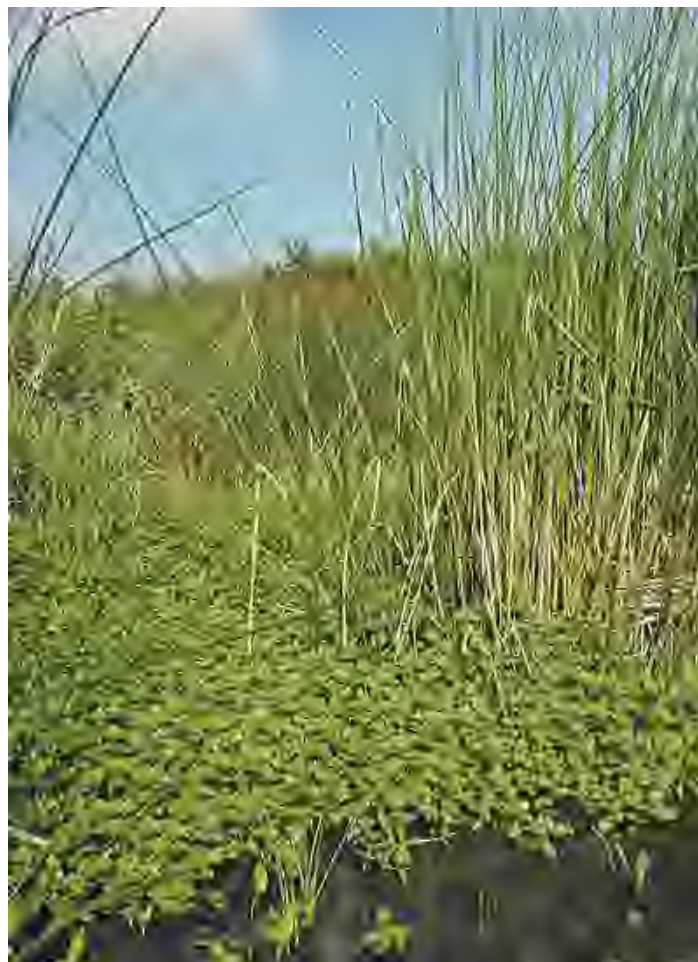
A good diverse vegetation structure has developed along and between the channel threads

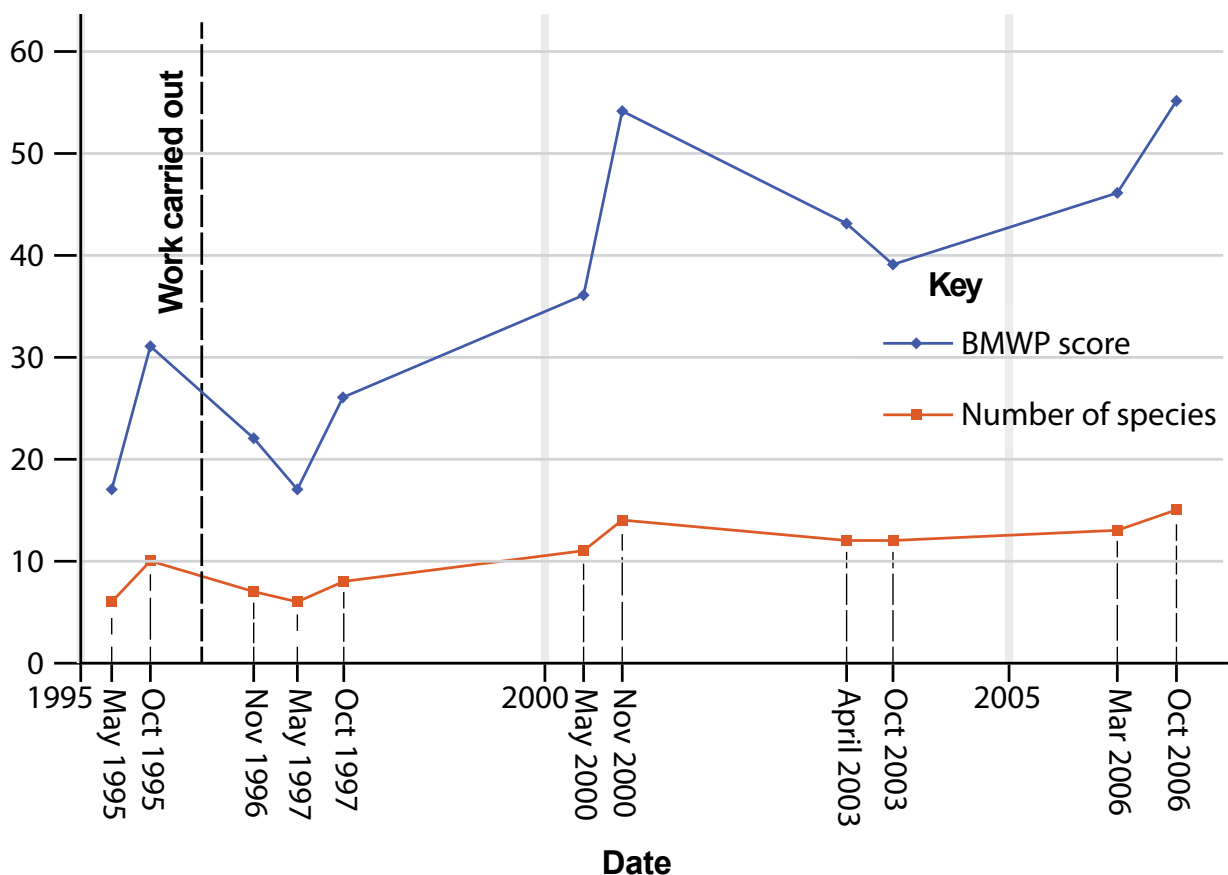
Change to overall number and diversity of invertebrates at the downstream end of the site between 1995 and 2006.

(Stock Bridge Site, SJ43210 92717. EA data)

Water quality and invertebrate sampling was undertaken between 1994 and 2006 and indicates that there has been an overall improvement in the number and diversity of macroinvertebrates at the site. Further to the improvements in water quality, noted in 2001, the Biological Monitoring Working Party (BMWP) scores shown below indicate that water quality downstream of the site has improved following the works. The BMWP uses invertebrates as biological indicators of water quality. A high BMWP score is indicative of cleaner water.

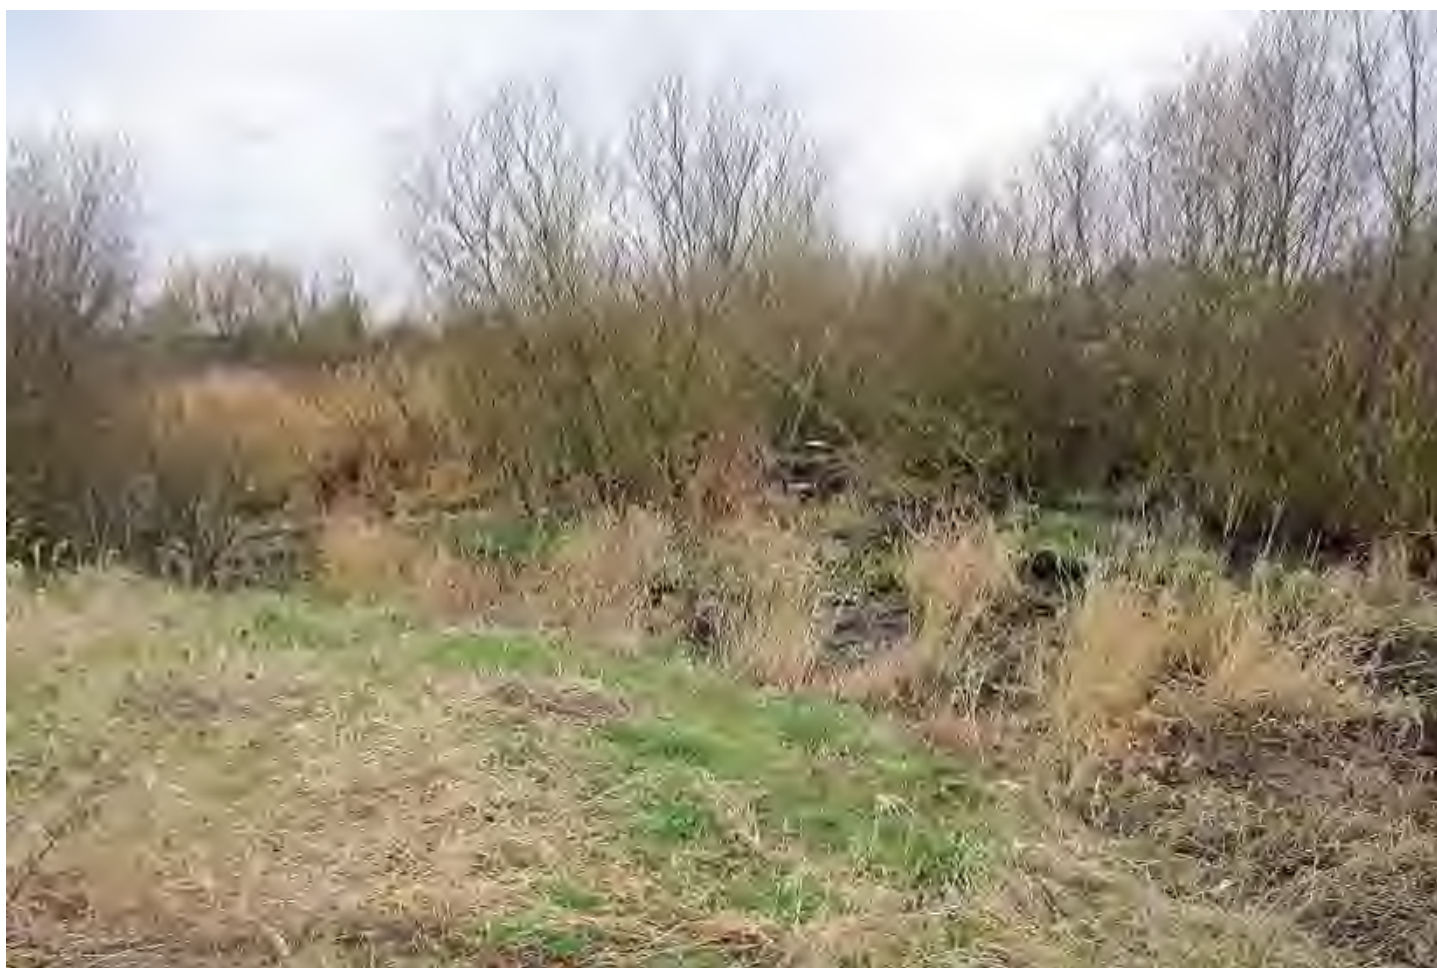
One of the choked braided side channels – March 2012

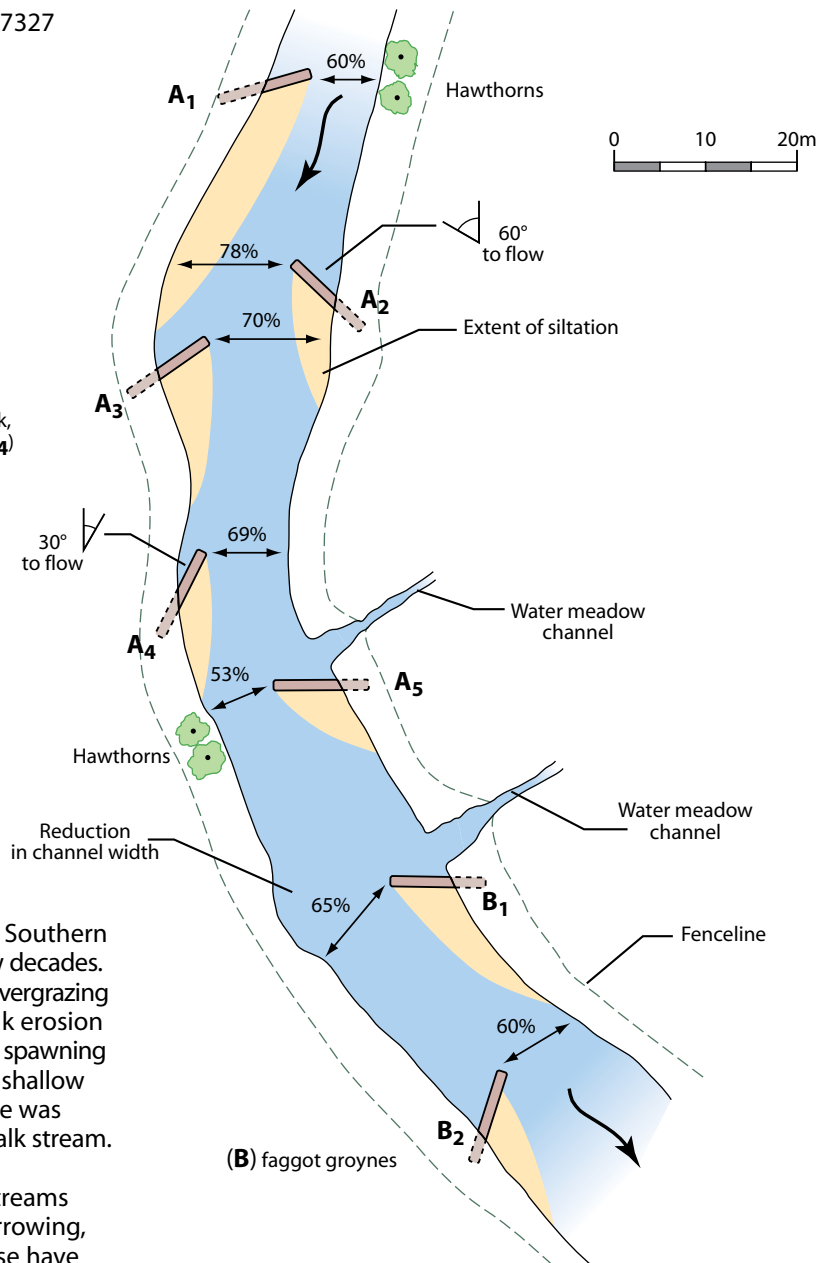
(A) groynes comprising chalk, all 60° (except A₄)

Figure 3.5.1
PLAN OF NARROWING WORKS

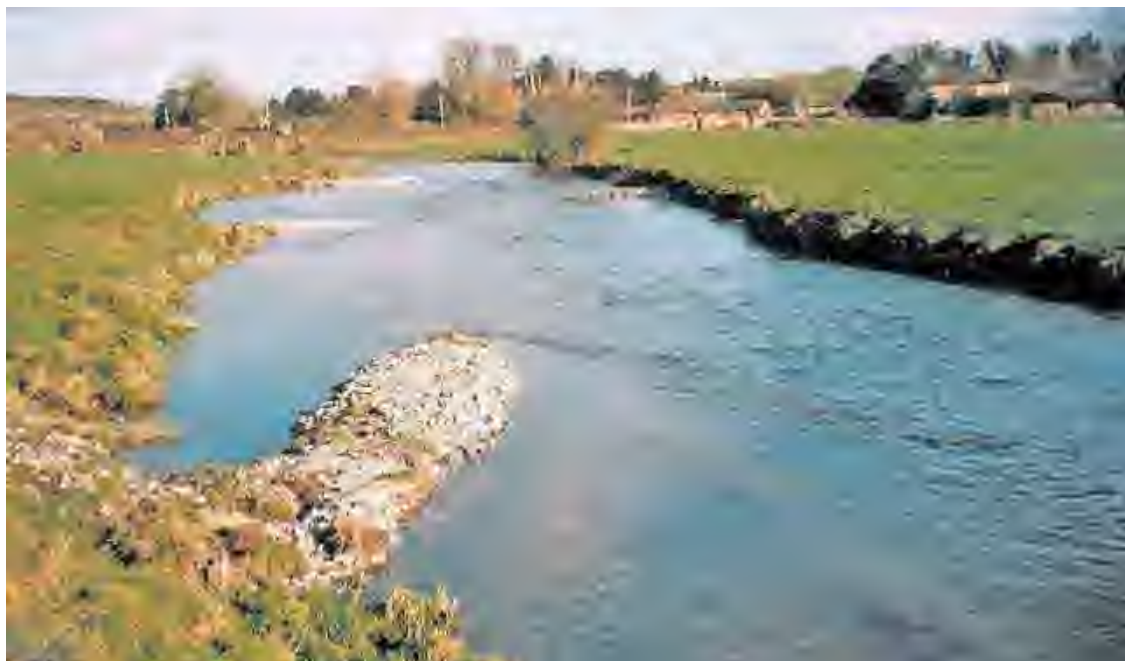
Completed chalk groynes

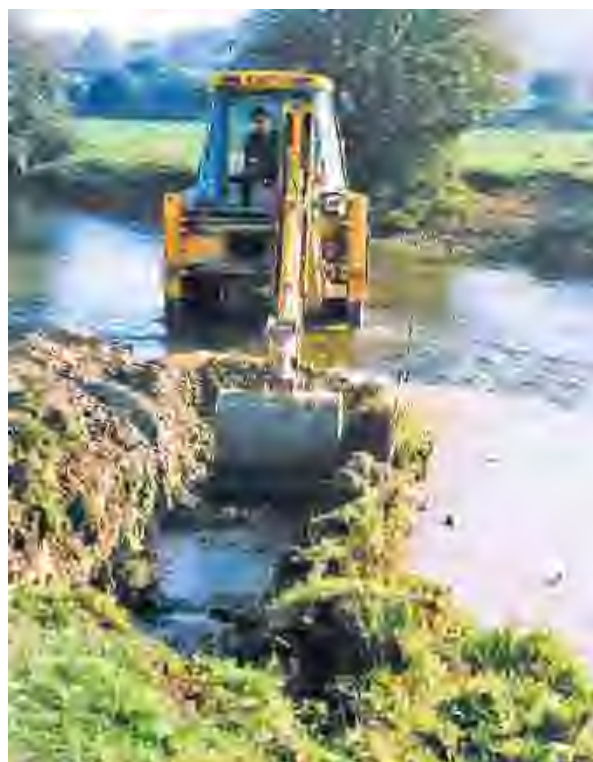
Figure 3.5.2
SECTION THROUGH CHALK GROYN

After marking out the area with pegs a JCB dug a trench 0.5m deep and 1-2m wide, with the excavated bed and bank material placed to one side. The trench was cut into the existing bank to anchor the completed groyne. The trench was then filled with either chalk or faggot bundles to provide reinforcement and stability and the excavated material from the original trench replaced on top.

During construction of the chalk groynes the chalk was rammed down with the JCB bucket. For the faggot groynes the stakes were hammered in by hand, and the JCB bucket was used to hold down the faggots whilst they were wired in place.

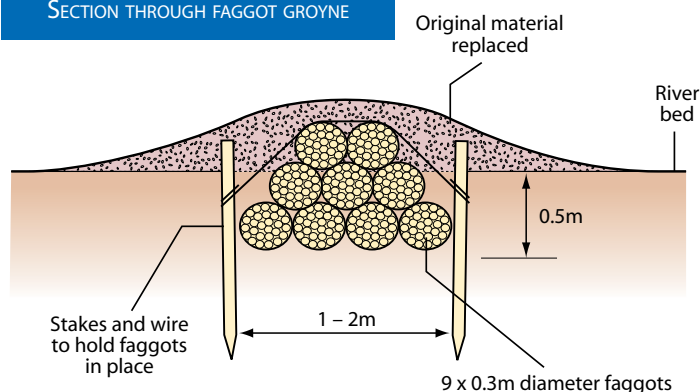
Figure 3.5.3

SECTION THROUGH FAGGOT GROYPNE

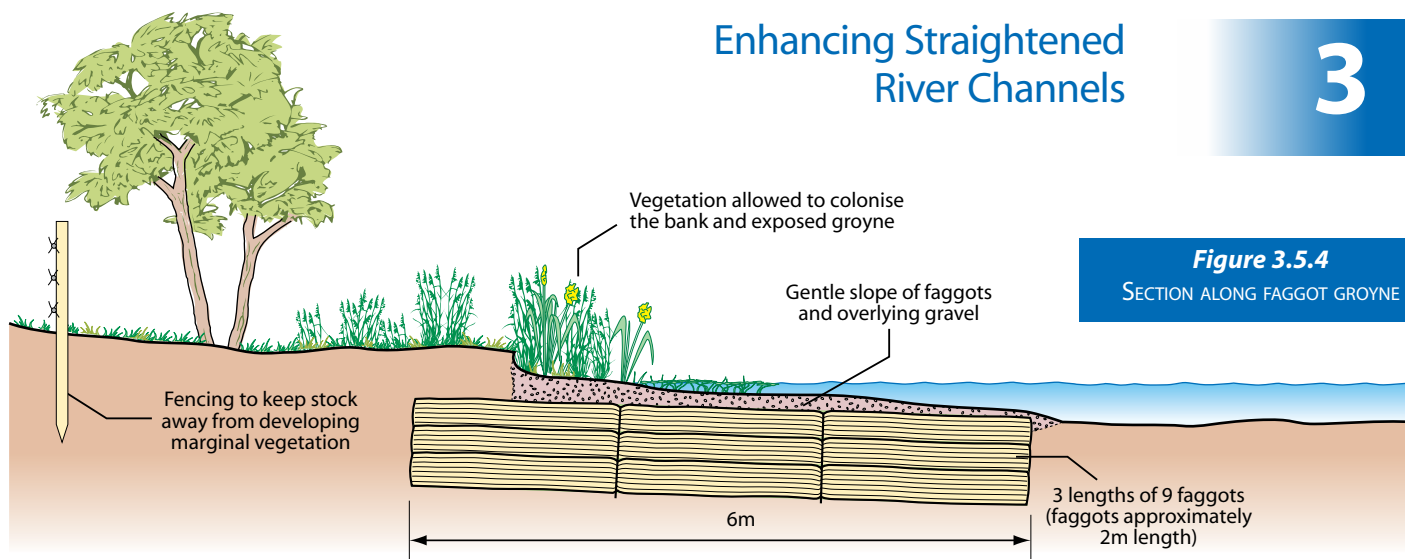
Figure 3.5.4

SECTION ALONG FAGGOT GROYPE

The use of faggots was a trial element of scheme but, as they were more costly and less effective in the long term, they would not be recommended for use in future projects of this nature.

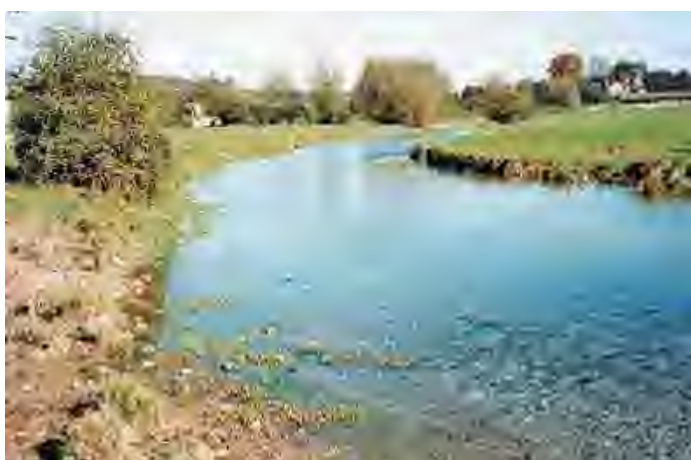
Cattle poached, wide and shallow

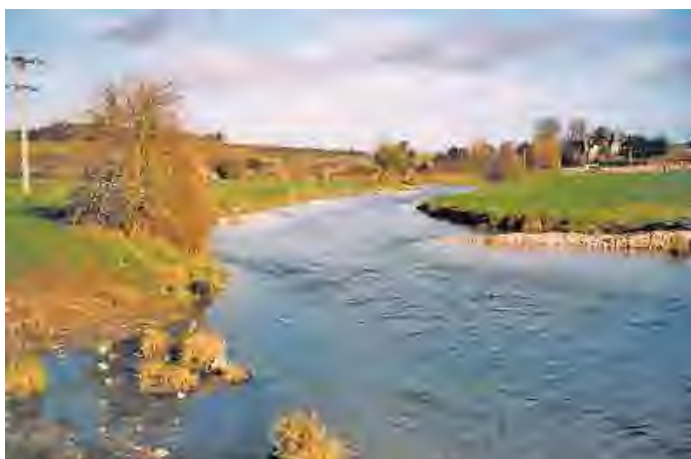
Groynes in place already increasing flow diversity

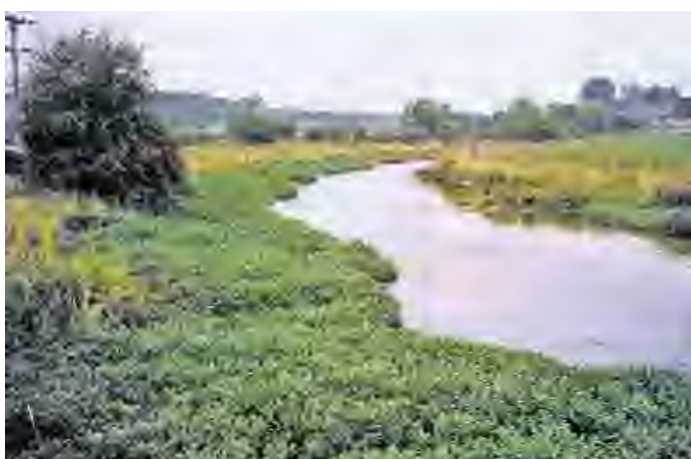
Silt deposits were quickly colonised and the river narrowed

Following the works rapid siltation occurred, resulting in channel narrowing. In the 2007 survey an approximately 30% reduction in channel width was observed compared to pre works. The variations in flow characteristics observed in 2002 remain the same.

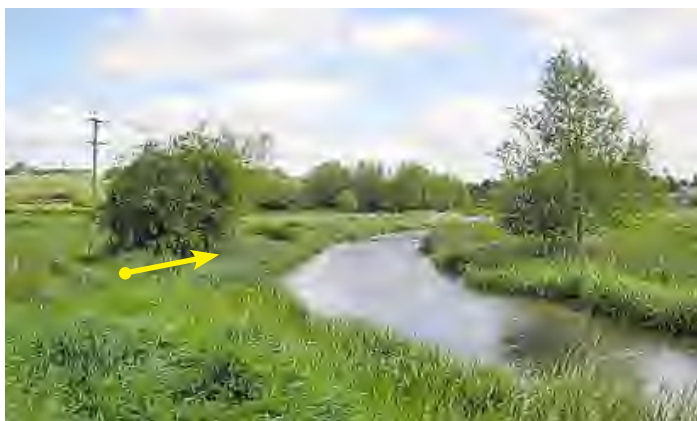
The narrowed channel – May 2007
(Arrow indicates location of 2012 photograph)

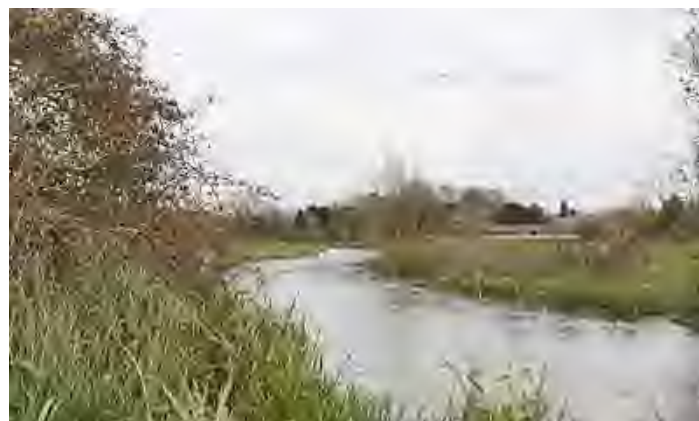
The site after 15 years showing the development of vegetation – November 2012
