Enhancing Straightened River Channels

3.1 Current deflectors

RIVER SKERNE

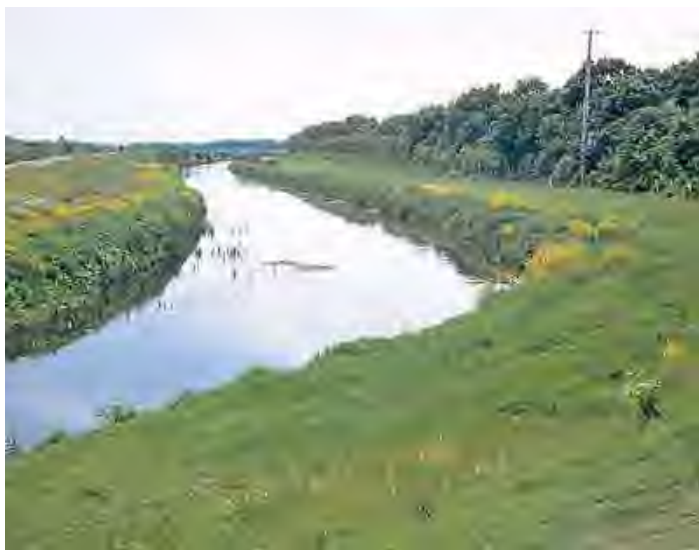
River Dearne. Wide and straight, choked in summer

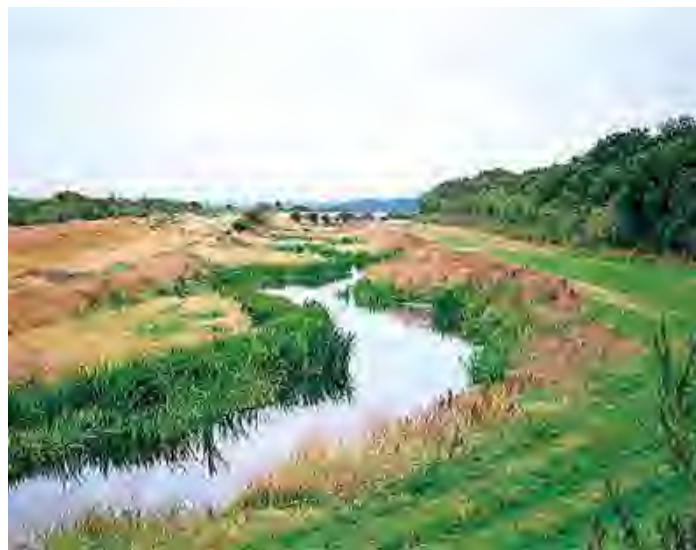
New sinuous reed-fringed course

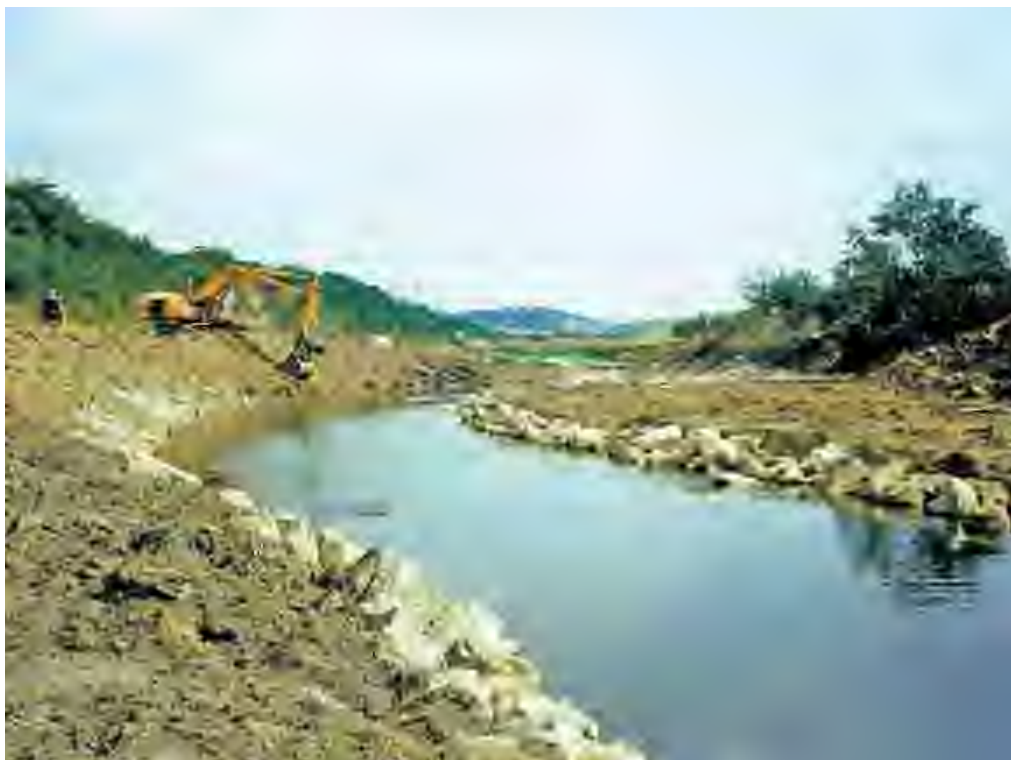
Placement of limestone boulders and berm back-filling

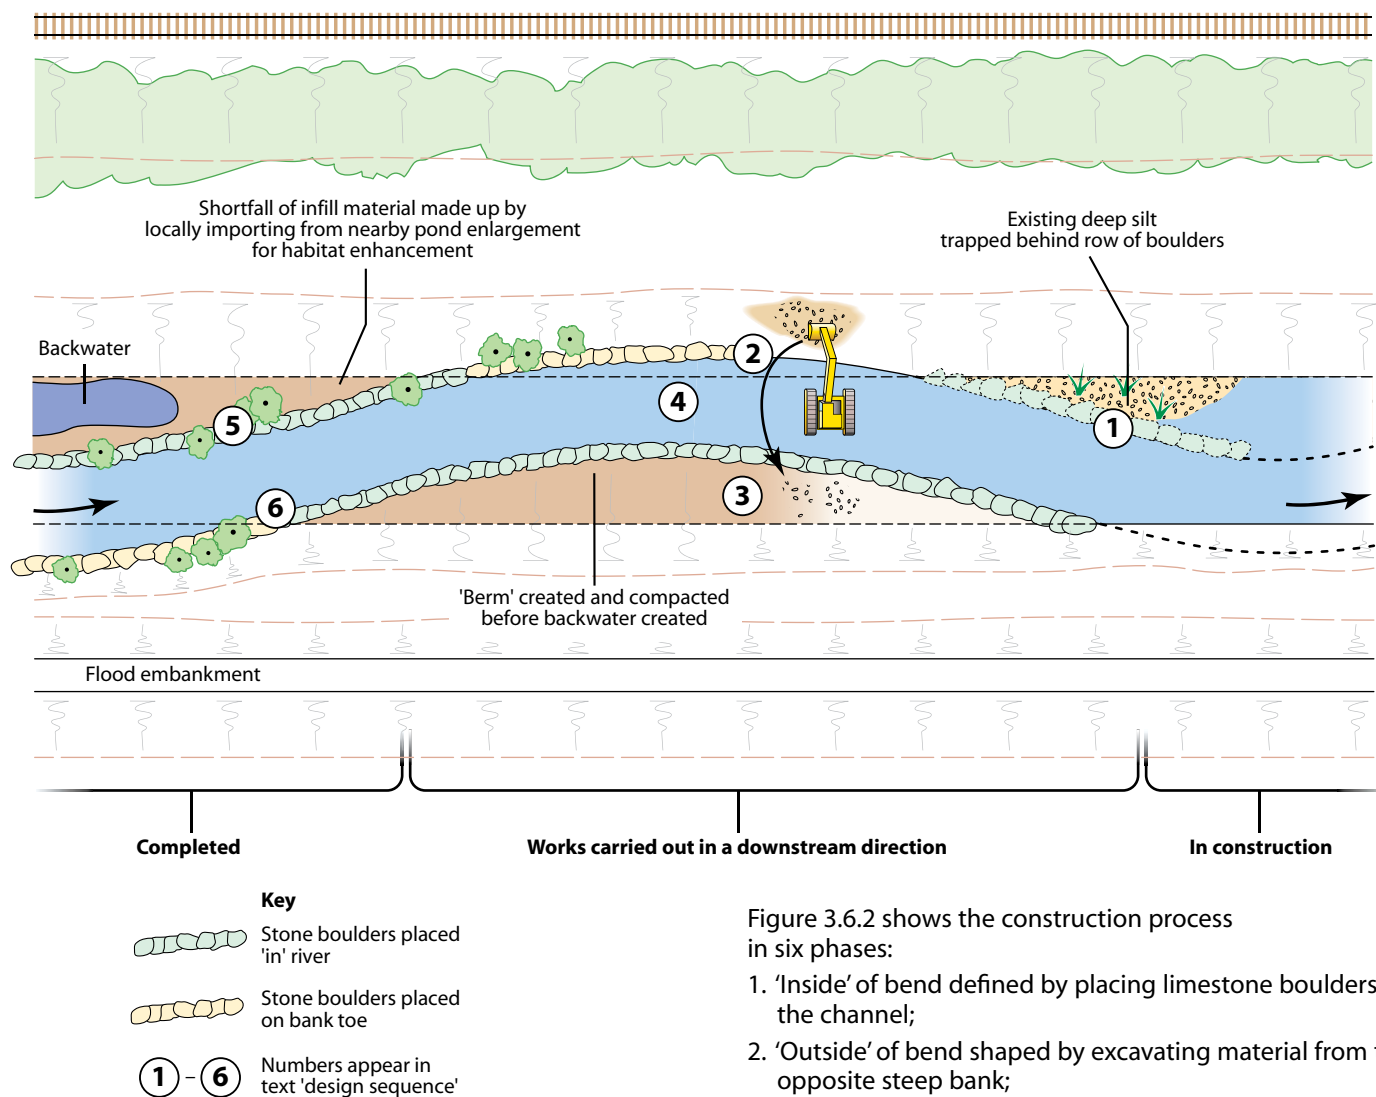
Figure 3.6.2
PLAN OF WORKS

Figure 3.6.2 shows the construction process in six phases:

1. 'Inside' of bend defined by placing limestone boulders into the channel;
2. 'Outside' of bend shaped by excavating material from the opposite steep bank;
3. Material from 2 used to backfill the 'inside' bend forming a low berm;
4. Additional limestone boulder armouring placed on toe of 'outside' bend;
5. Backwaters excavated within the low berms created;
6. Berms and banks seeded with a grass mix and later planted with standard trees.

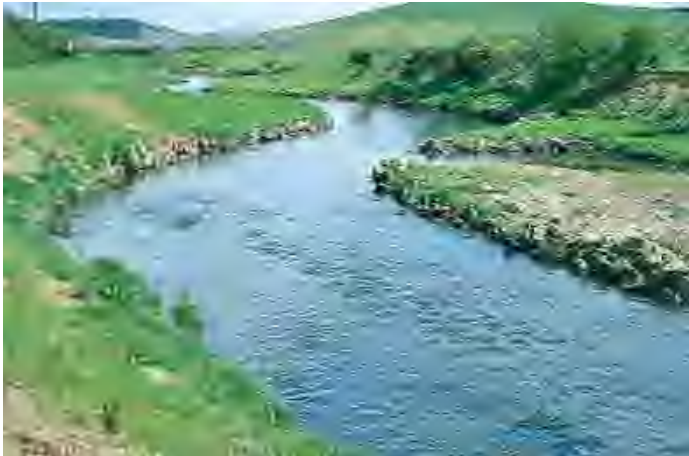
Narrowing increased velocities and created riffles used for fish spawning

By creating a sufficiently narrow low-flow channel the effect on the silty bed was immediate. Within two weeks of completion the majority of the silt had been cleared. Deposition of gravel and silt occurred rapidly on the inside of the bends with pools (up to 2m deep) having since developed at the apex. The silty areas have promoted the colonisation of marginal plant species.

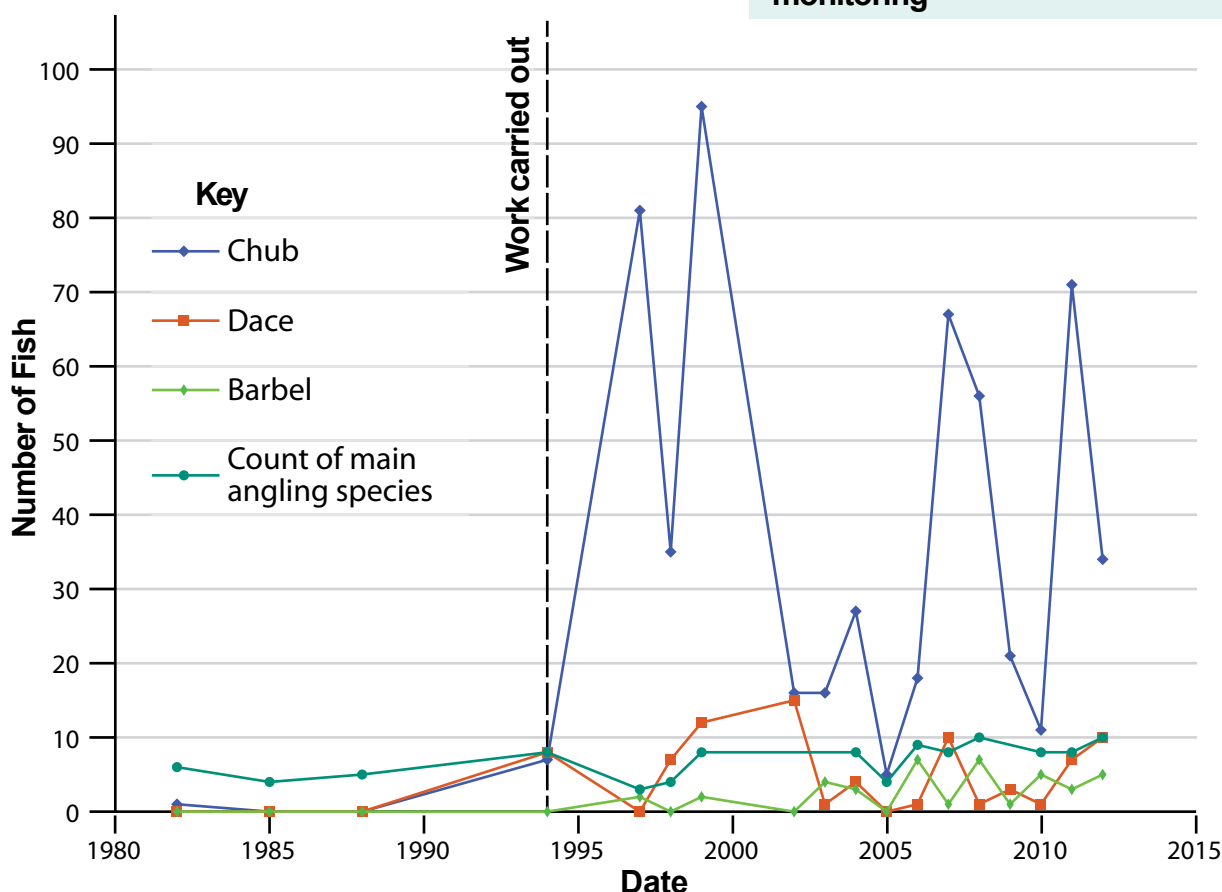
Fisheries data showing changes in the count of species of anglers over time.

The data indicates improvement in the count of the main angling species and significant increases in the numbers of some individual species. (Pastures Bridge site, EA data)

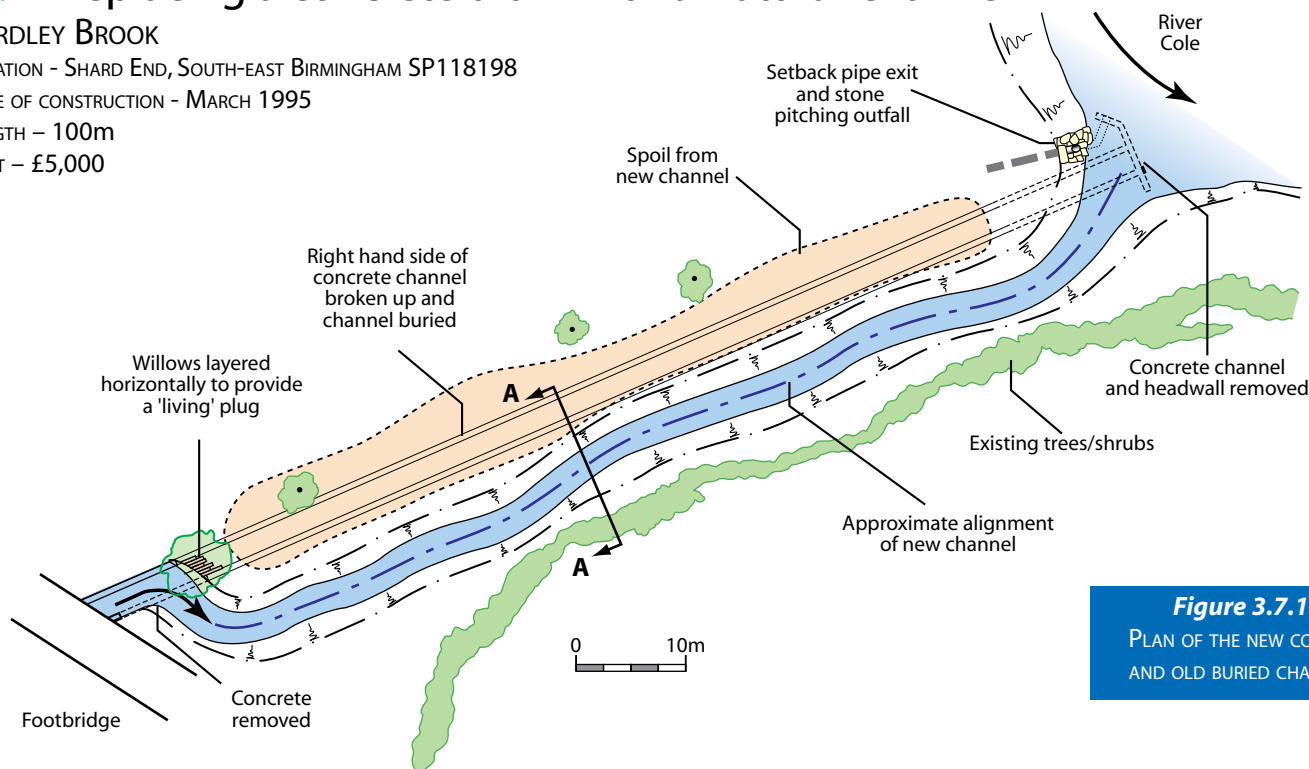
PLAN OF THE NEW COURSE
AND OLD BURIED CHANNEL

Figure 3.7.1 shows the 100m sinuous channel that was excavated alongside the brook. The new course was excavated at a greater depth than the concrete channel bed. Previously the bed of the River Cole had been approximately 0.7m below the concrete outfall, as a result of deepening of the Cole over the lifetime of the concrete brook. A simple 'V' shaped channel was dug with sloping earth banks as it was decided that the brook could sufficiently shape itself. Over-specifying the design would not be cost-effective.

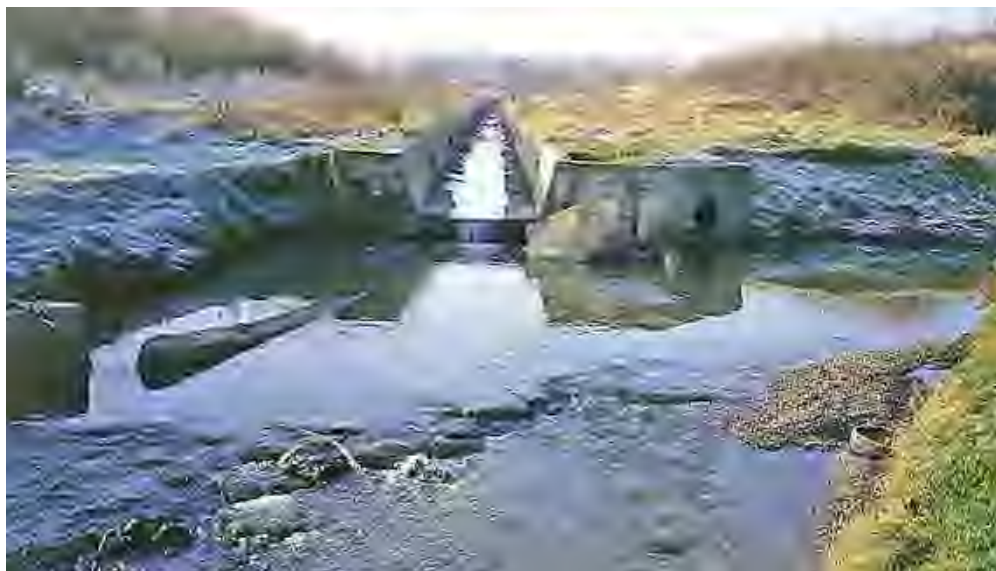
Yardley Brook entering
the River Cole before
works

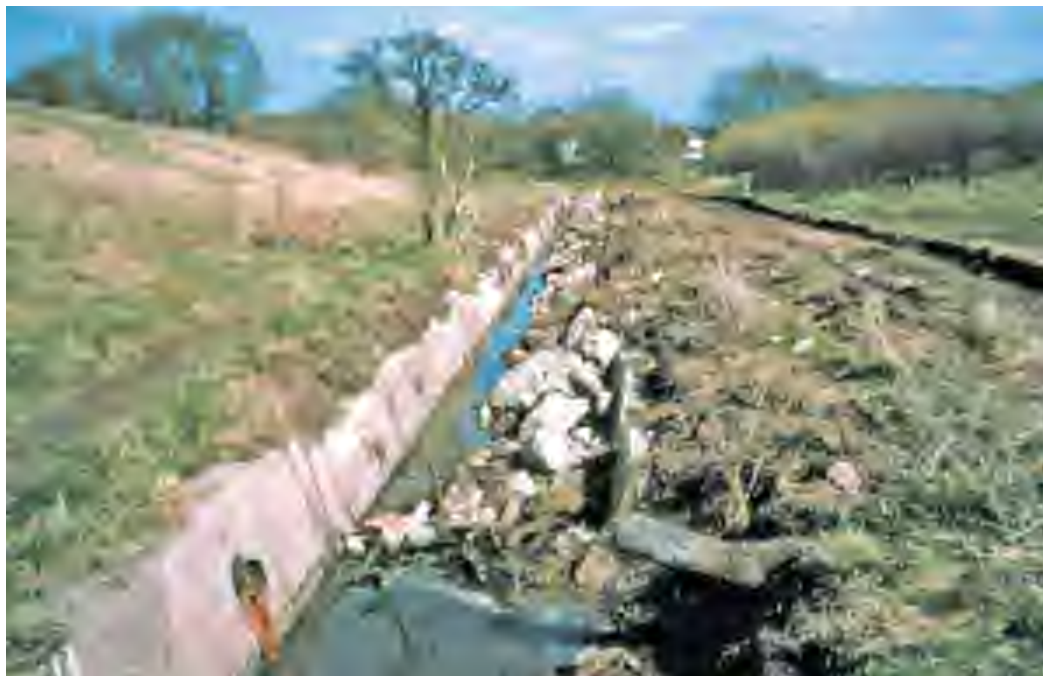
Concrete channel being broken up

The lip of the concrete channel was broken up using an excavator, to ensure that once buried the remnant channel would not protrude above ground level. The broken concrete was pushed into the barely flowing channel.

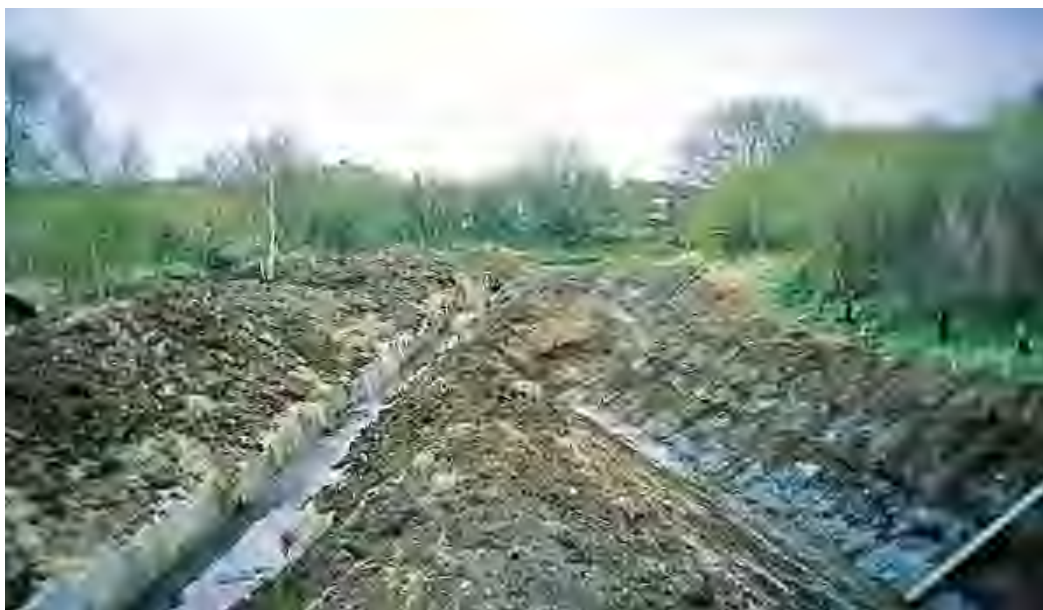
The 'new' brook being excavated adjacent to the old channel. Spoil stockpiled

All spoil was stock-piled between the new and the old channel, and where this became too narrow, on the opposite bank of the old channel. This maintained the flow through the old drain and allowed all work to be carried out in the dry. Once completed, flow was diverted through the new course, and the old channel was filled using the spoil from the new.

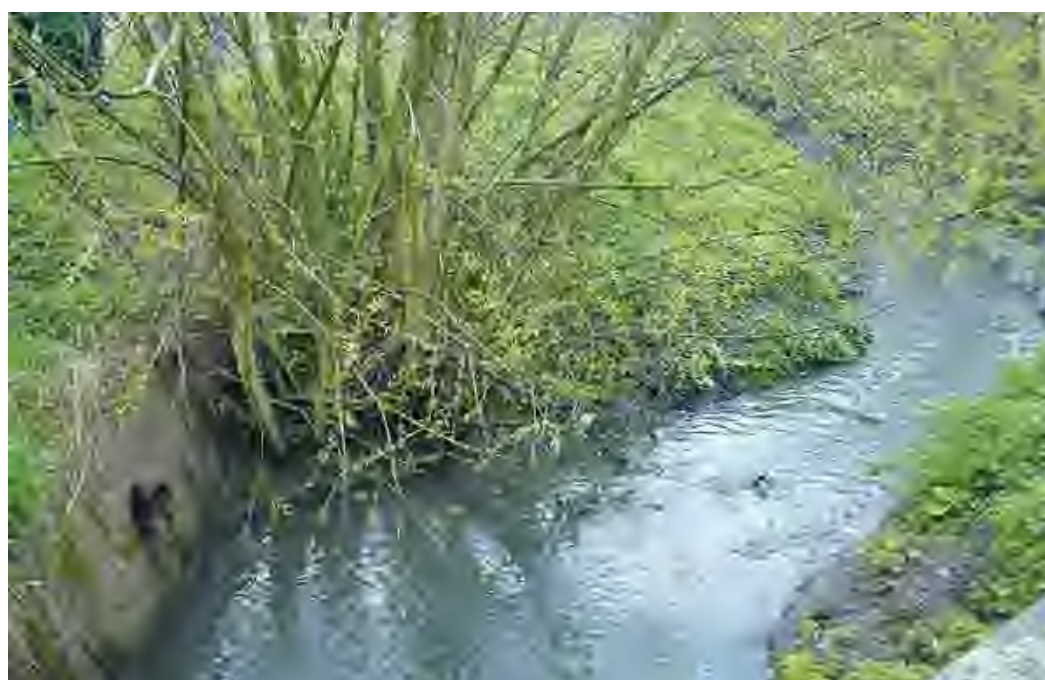
Live willow plug

At the upstream end of the 'new' brook the old course was blocked with rubble then plugged with live willows (*Salix spp.*) laid in during the in-filling process to form a growing plug.

The live willow plug at the upstream end of the brook has continued to be very successful as a bioengineered bank stabilisation method.

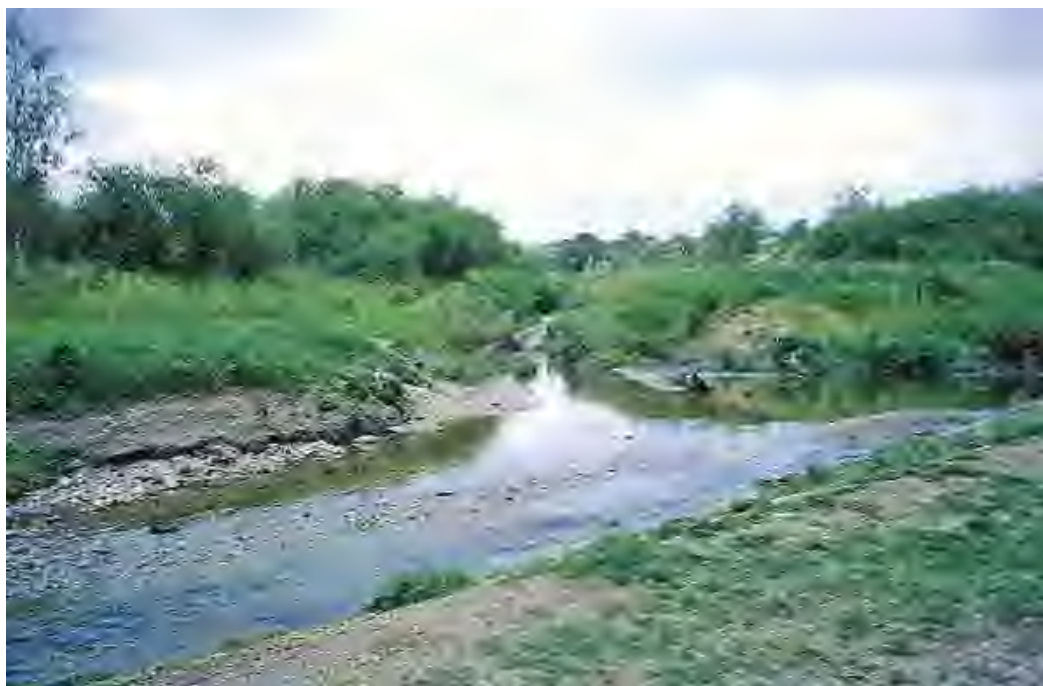
After – the new 'natural' Brook

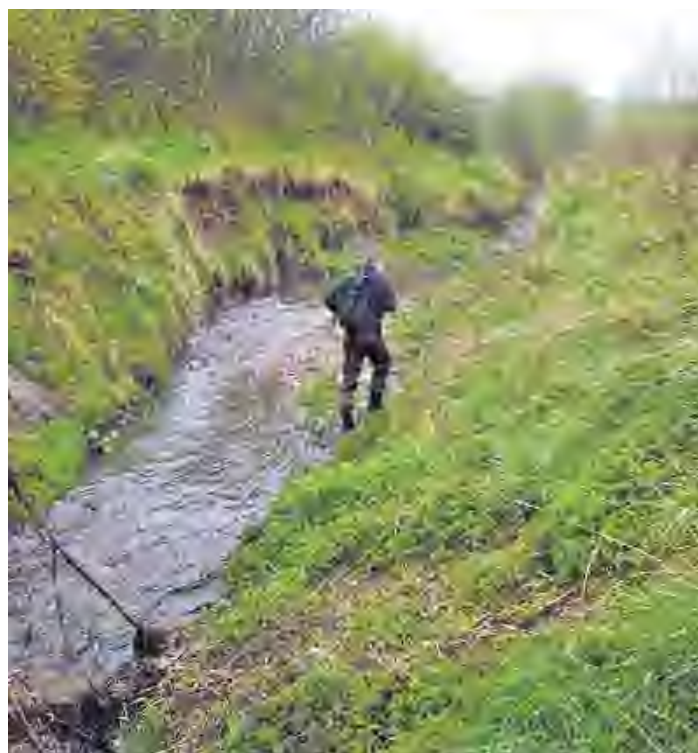
Six years on. Earth cliffs, gravel shoals and a diverse flow regime – April 2001

After completion winter flows quickly began to 'develop' the kinds of natural channel features one would associate with a small brook. The 'V' shape quickly transformed through erosion of the loose fill material into a much more 'natural' channel 2-3m wide. This process has continued as the site matures.

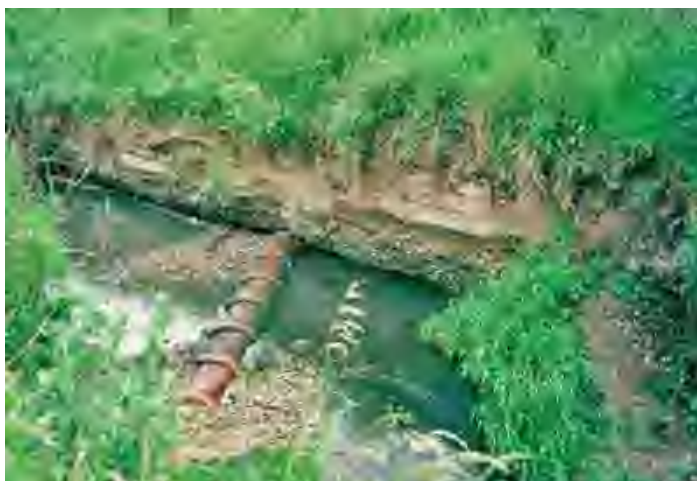
Erosion exposing sewer pipe as nickpoint moves upstream

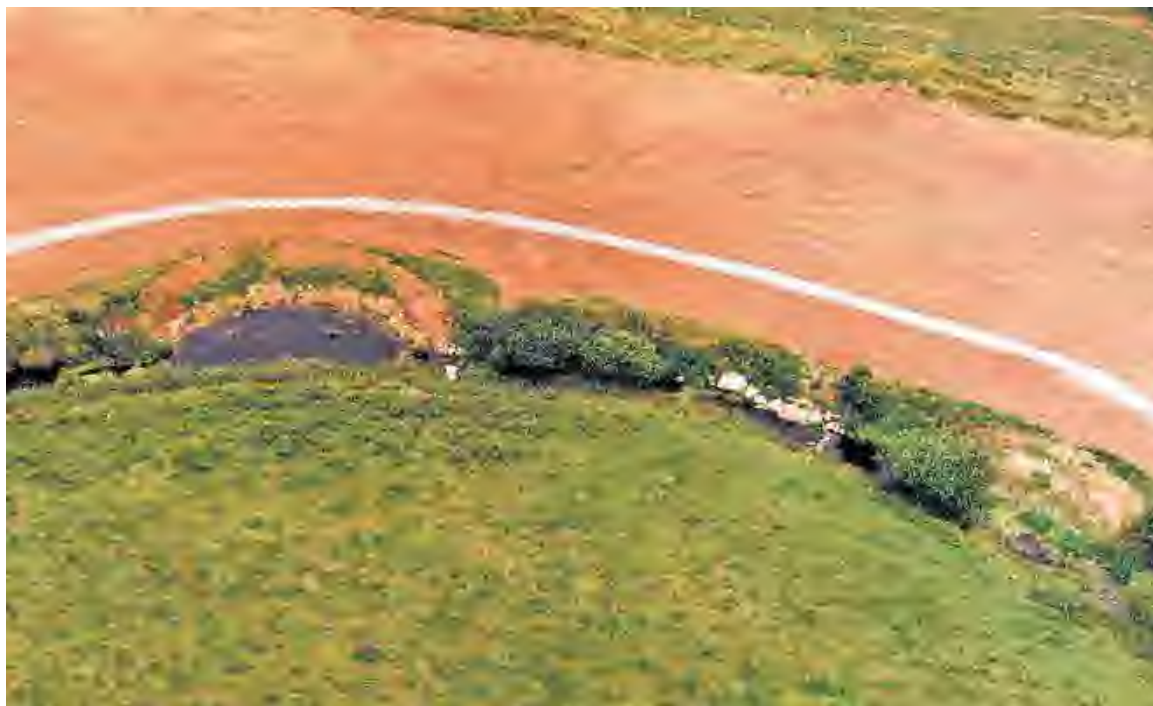
Downstream bays after less than a year.
Note: Bay 2 is already becoming choked with vegetation

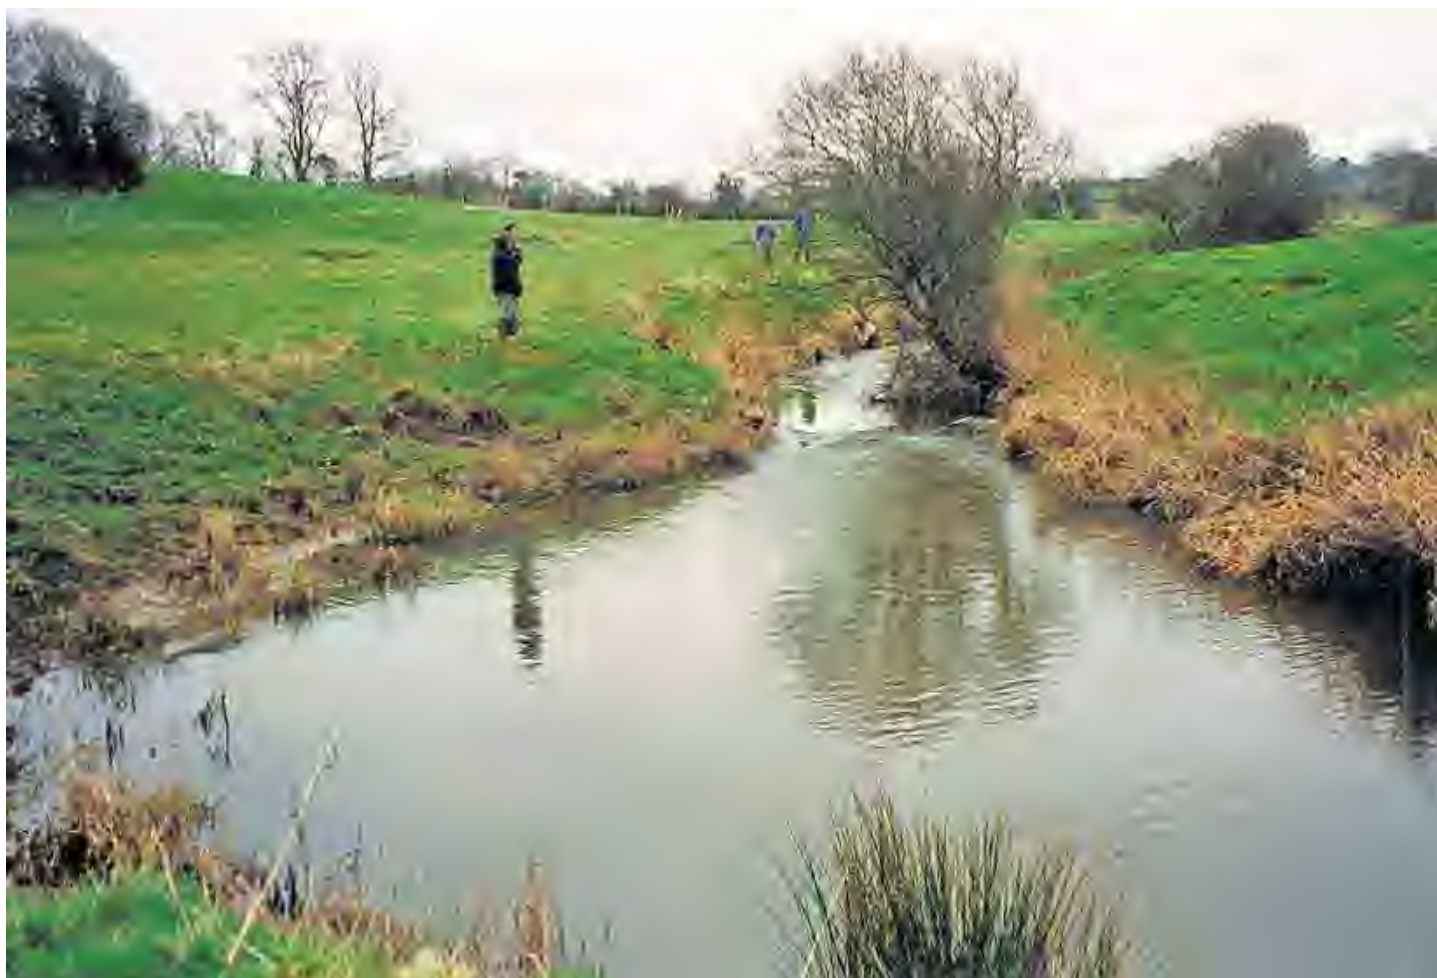
Bay 1 showing the angle of flow keeping the bay 'open'

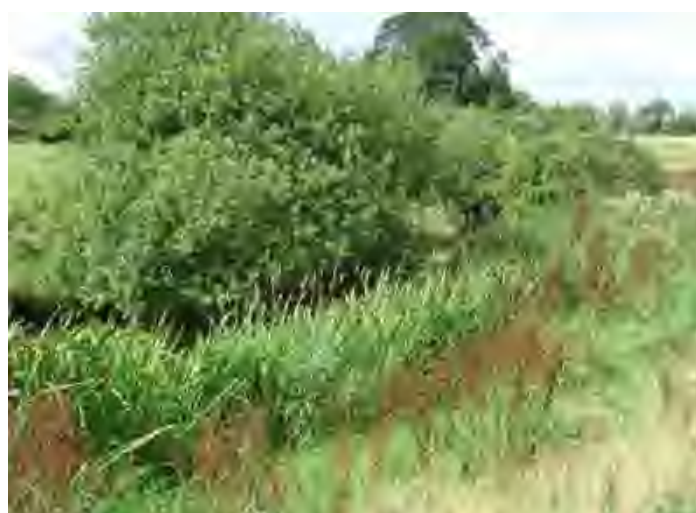
Bay 2, looking downstream.
Heavily vegetated – May 2012

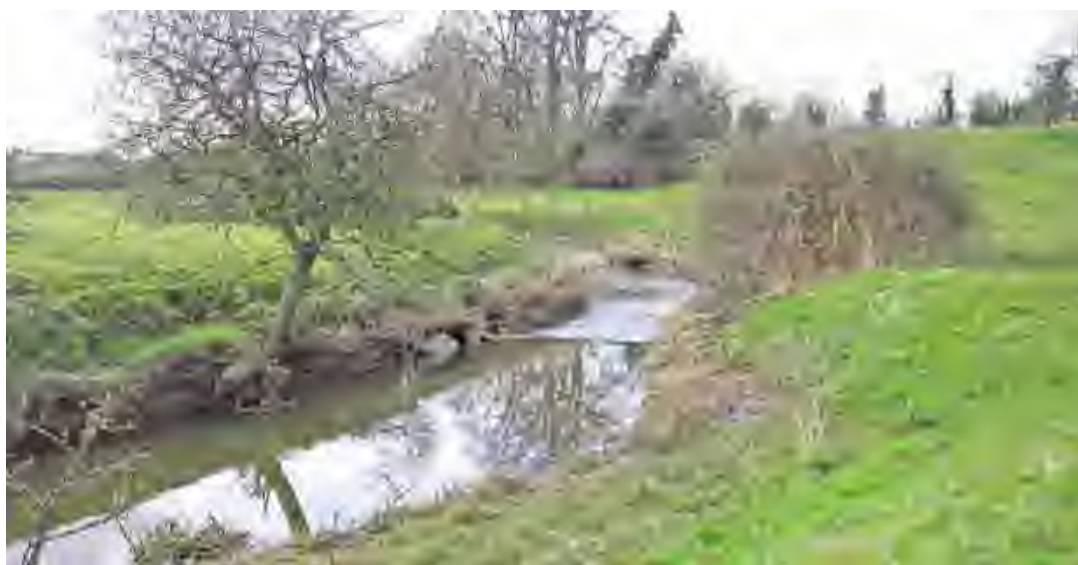
Bay 2, looking downstream
– March 2006

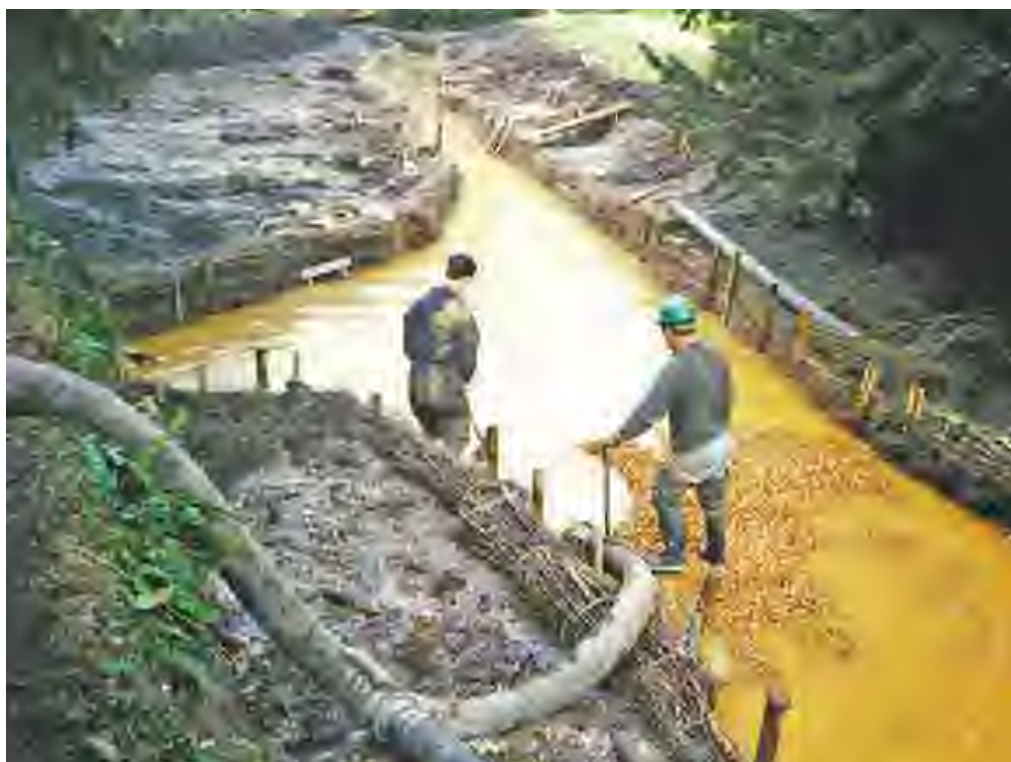
View of the wide dredged section, gravel being placed within the low-flow channel

As a result of the previous management of the river, the Chess had been gradually denuded of its gravel bed. Imported gravels were introduced into the stream by pumping. This method of placement overcame the imposed restrictions associated with conventional plant access to privately owned land and disturbance of woodland and bankside vegetation.

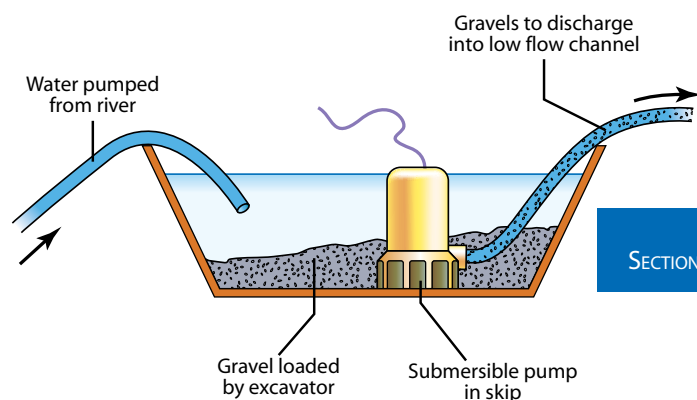
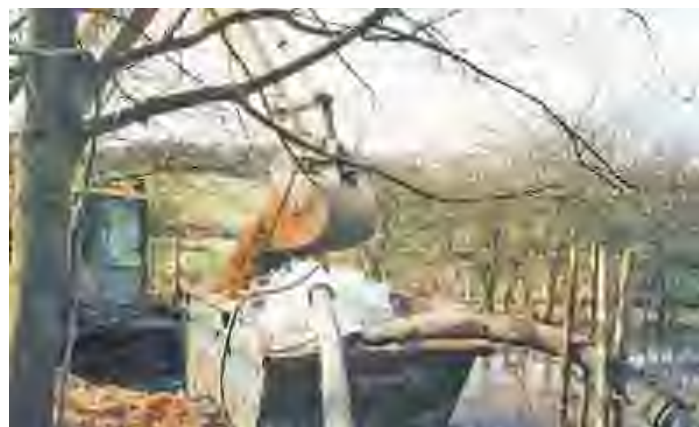
Figure 3.9.2
SECTION THROUGH PUMPING APPARATUS

Pumping apparatus in operation

- At the site compound a submersible pump powered by a diesel generator was placed in a skip located near to the river.

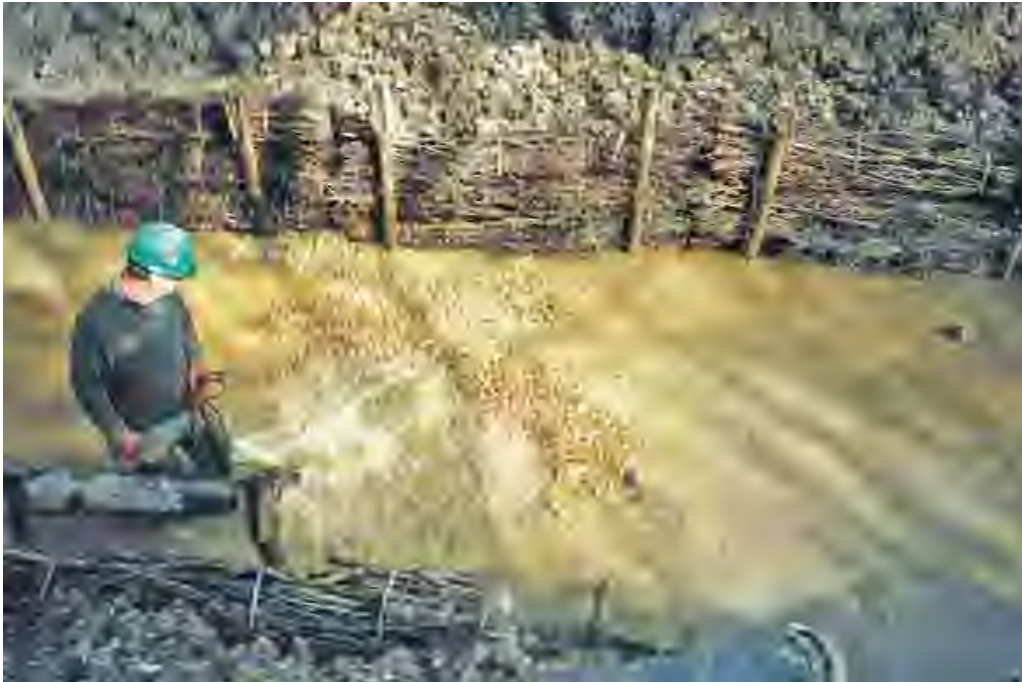
Gravel pumping in operation

The gravel material specified was well-graded 5–25mm gravel, which closely resembled the grading found downstream. The poor accessibility meant a novel approach was used to place the gravel material.

Using this approach the contractor was able to place the gravels economically and without having to remove existing valuable trees and shrubs. By introducing the gravel it was possible to shape the bed, recreating pools on the bends and riffles on the straight sections (*see Technique 5.5* for more detail on bed raising).

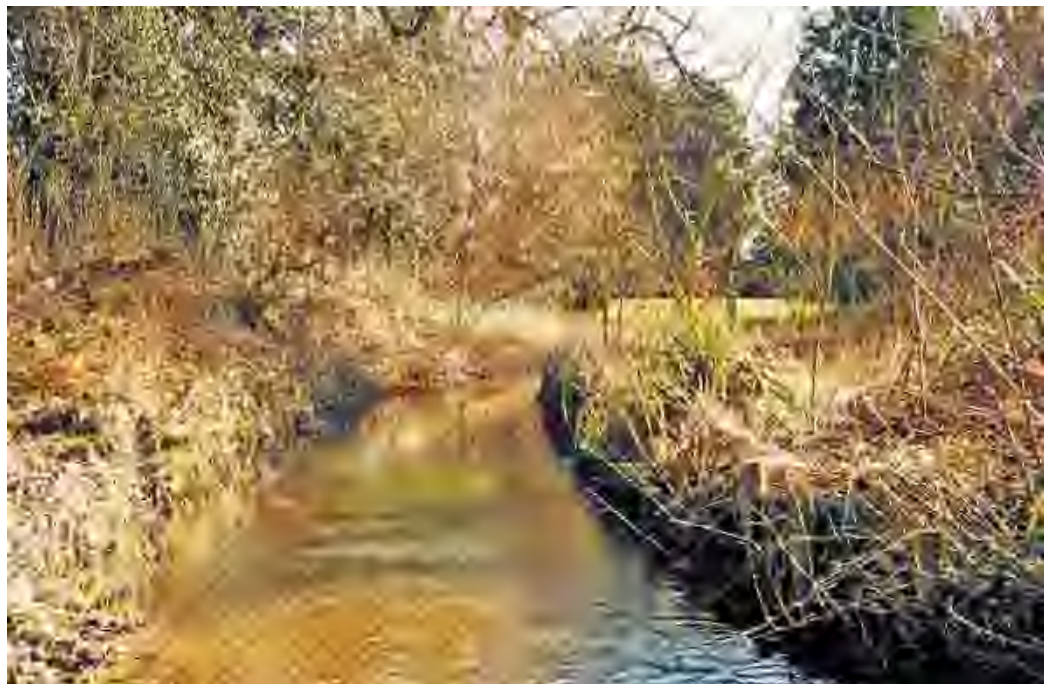
Four years on
– gravel shoals and deeper
hollows remain

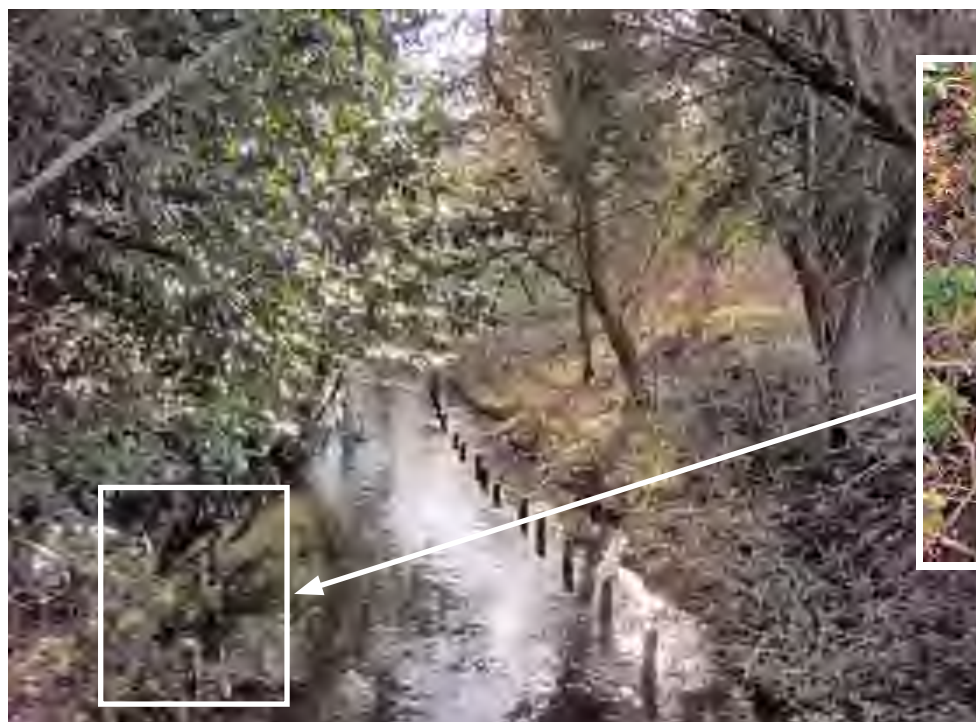
Looking downstream the lines of posts visible with no vegetation behind them – 2013

The works to the 300m dredged section was carried out sympathetically to minimise the need for disturbance to the woodland. However, by not having to carrying out any tree works to these densely shaded parts of the reach, the over-shading has restricted vegetation colonisation and stabilisation of the retained-silt edge. In these reaches the faggots have decayed and in some places the bank edge has eroded (highlighted by the remaining line of posts).

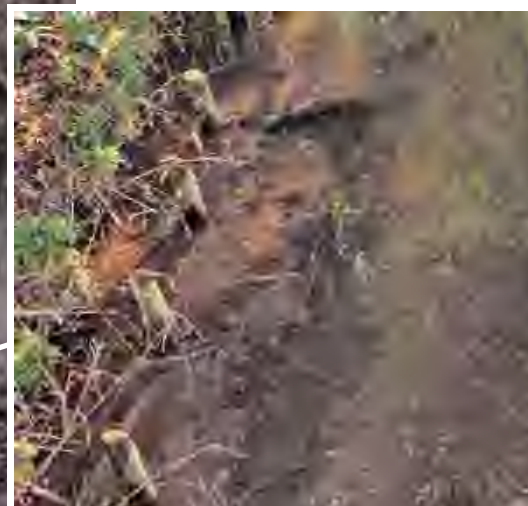
Silt accumulation behind the posts – 2013

The reduced velocities, resulting from the influence of the banks and the posts, are still acting to attract silt towards the stream's edges. Even now, tree work to open up the canopy to allow sufficient light penetration to aid vegetation colonisation of these silty margins, also helping to protect the eroded edge.

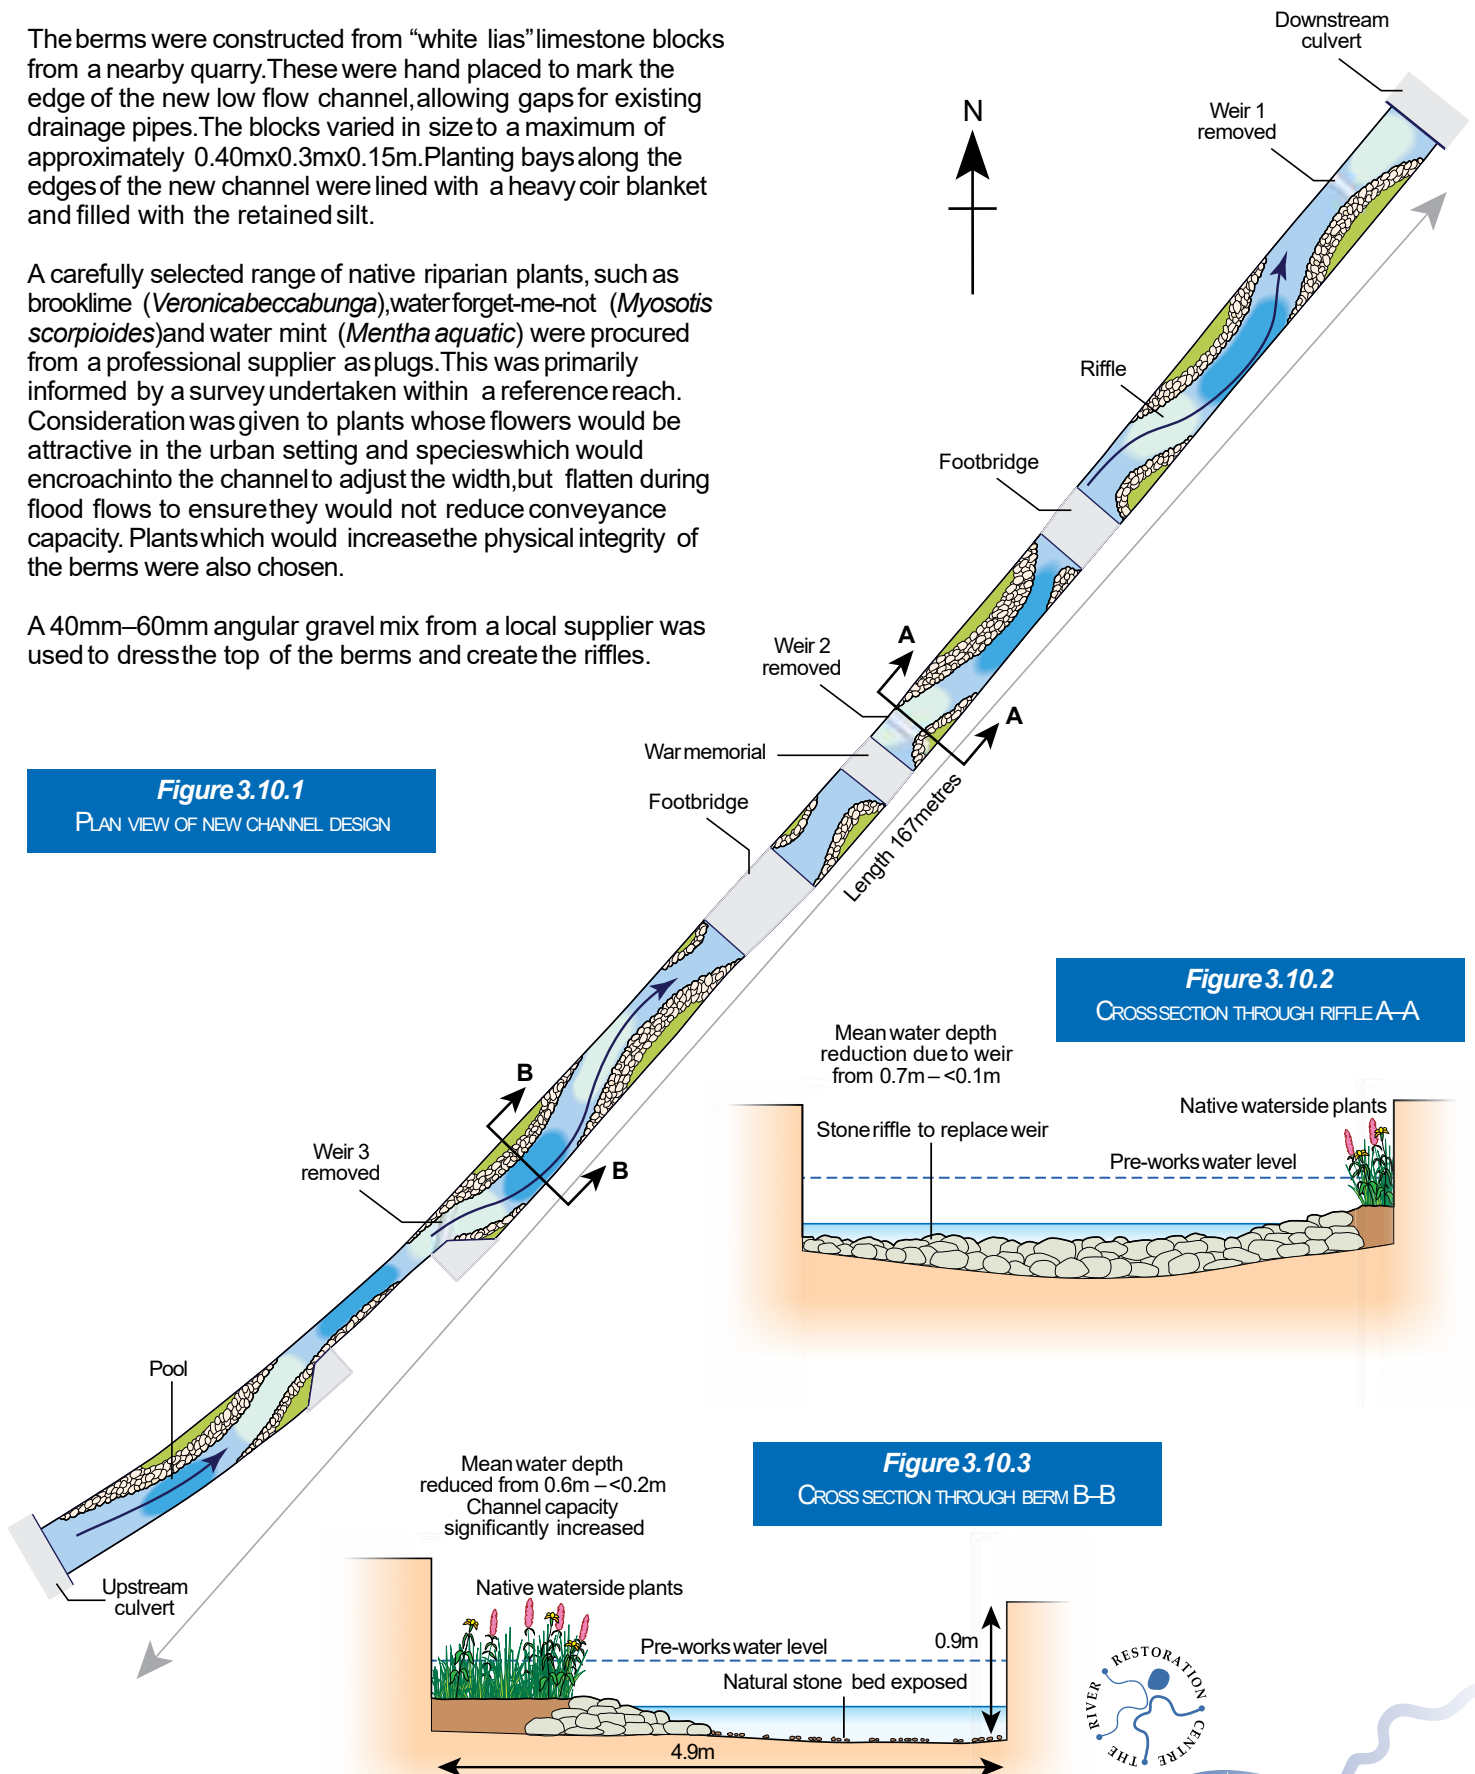
Figure 3.10.1

PLAN VIEW OF NEW CHANNEL DESIGN

Accumulations of silt were removed from the channel and retained on site for use as backfill in the new design. Three weirs were removed, retaining only the two sides of each structure which were incorporated into the channel berms. This was at the request of the council who wanted to be able to install temporary boards across the channel to retain water depth, should severe drought conditions occur.

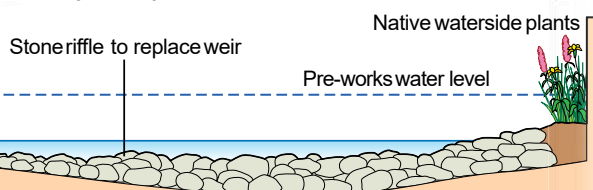
Figure 3.10.2

CROSS SECTION THROUGH RIFFLE A-A

Mean water depth reduction due to weir from 0.7m – <0.1m

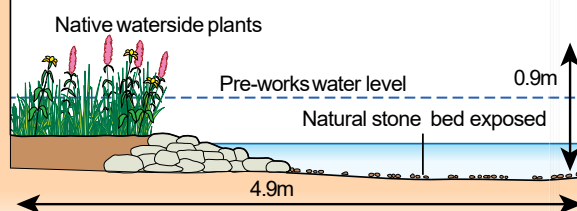
Figure 3.10.3

CROSS SECTION THROUGH BERM B-B

Mean water depth reduced from 0.6m – <0.2m
Channel capacity significantly increased

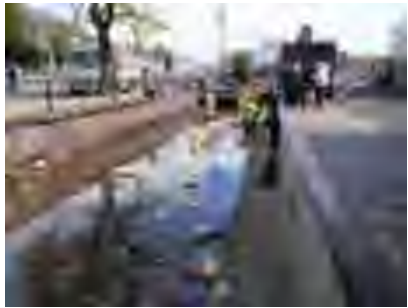
Limestone blocks laid out to delineate berm structure edges – 2011

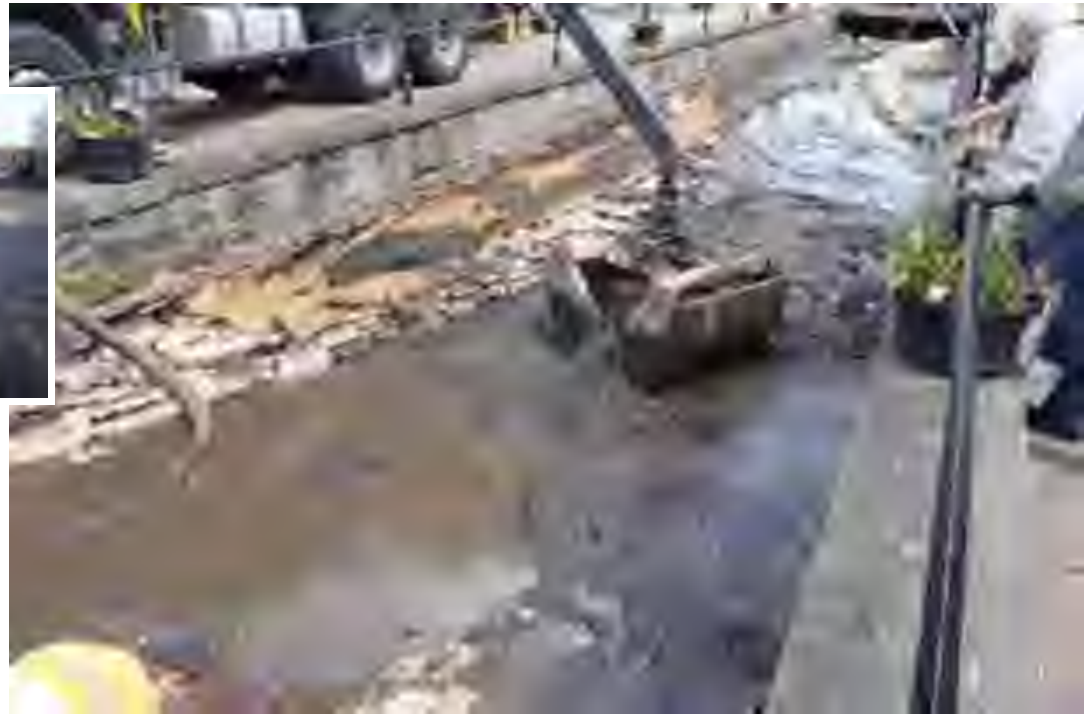
Silt is used to fill the marginal berms ready for planting – 2011

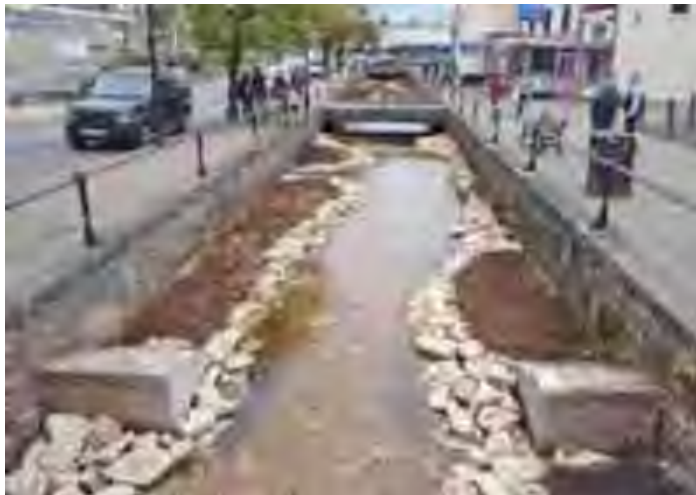
Two sides of the weir have been retained and incorporated into the berms – 2011

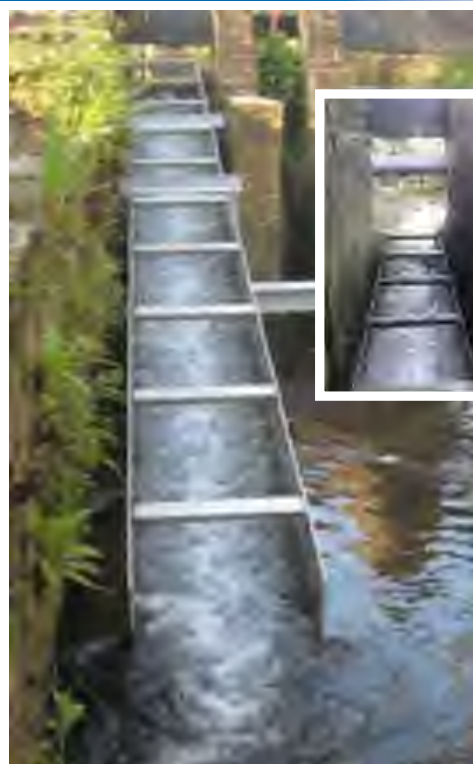
Inset – Weir lowered by 1m and fishpass modified and refitted at 15° gradient. The newly restored channel is visible beyond – 2014
