Enhancing Straightened River Channels

3.1 Current deflectors

RIVER SKERNE

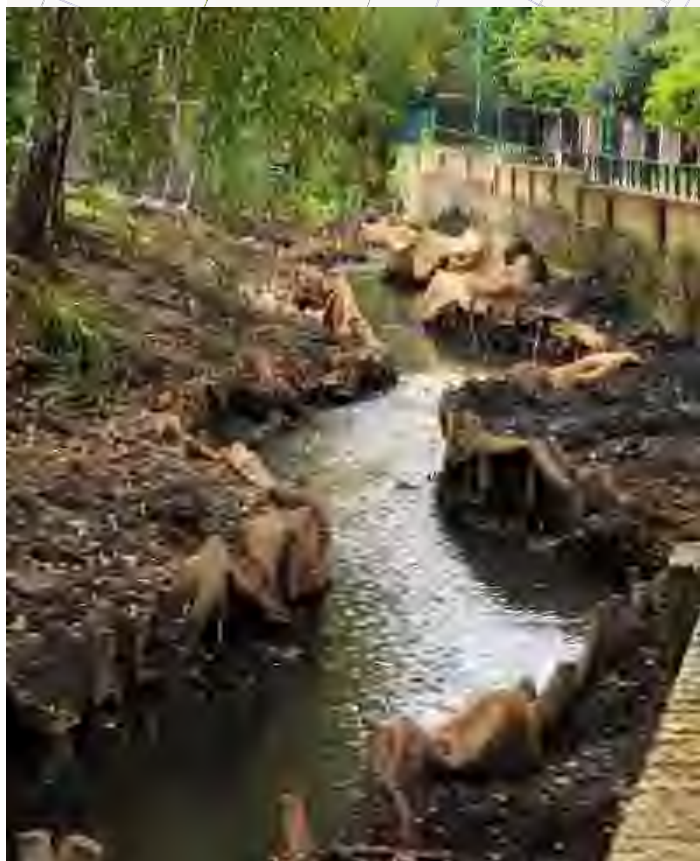
Desilted central channel.
Spoil placed behind the
faggot rows and coir matting
– Sept 2014

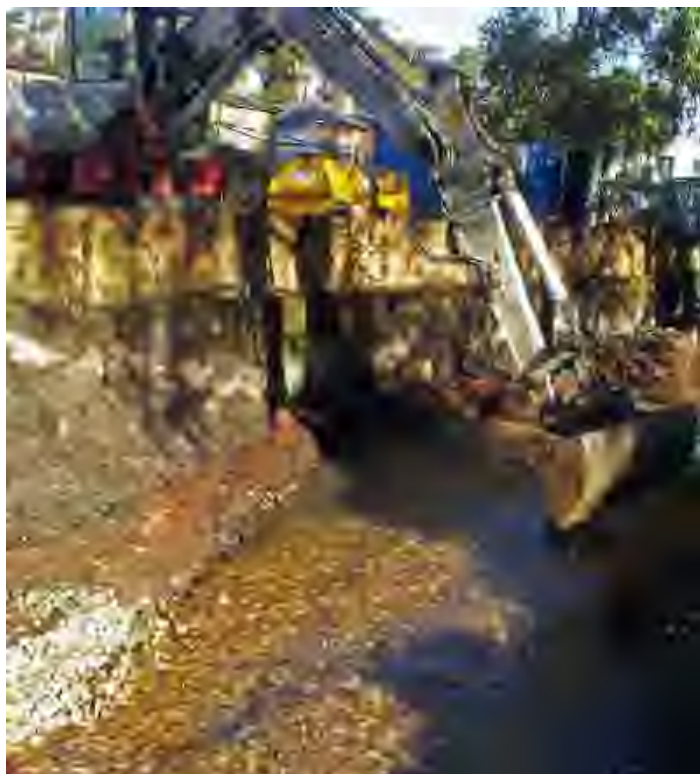
Filling the channel with gravel and pushing down the posts and faggots – Oct 2014

2. 110 tonnes of Thames catchment 40mm+ flint reject gravel was placed into the desilted central channel and sculpted to include pools and point bars.
3. The faggots and posts were pushed down further into the silt to follow the dish profile of the new bed. The gravel was raked up to cover all of the faggots to form a seamless transition between the bed and bank.
4. A number of tree limbs were pinned into the bed to add flow diversity and encourage scour to retain pool habitat.
5. Volunteers planted 2000 plugs of marginal plants on the new berms to help stabilise them further and kick-start colonisation of these wet edges. This was deemed necessary as there was no good upstream source of plants for natural colonisation.

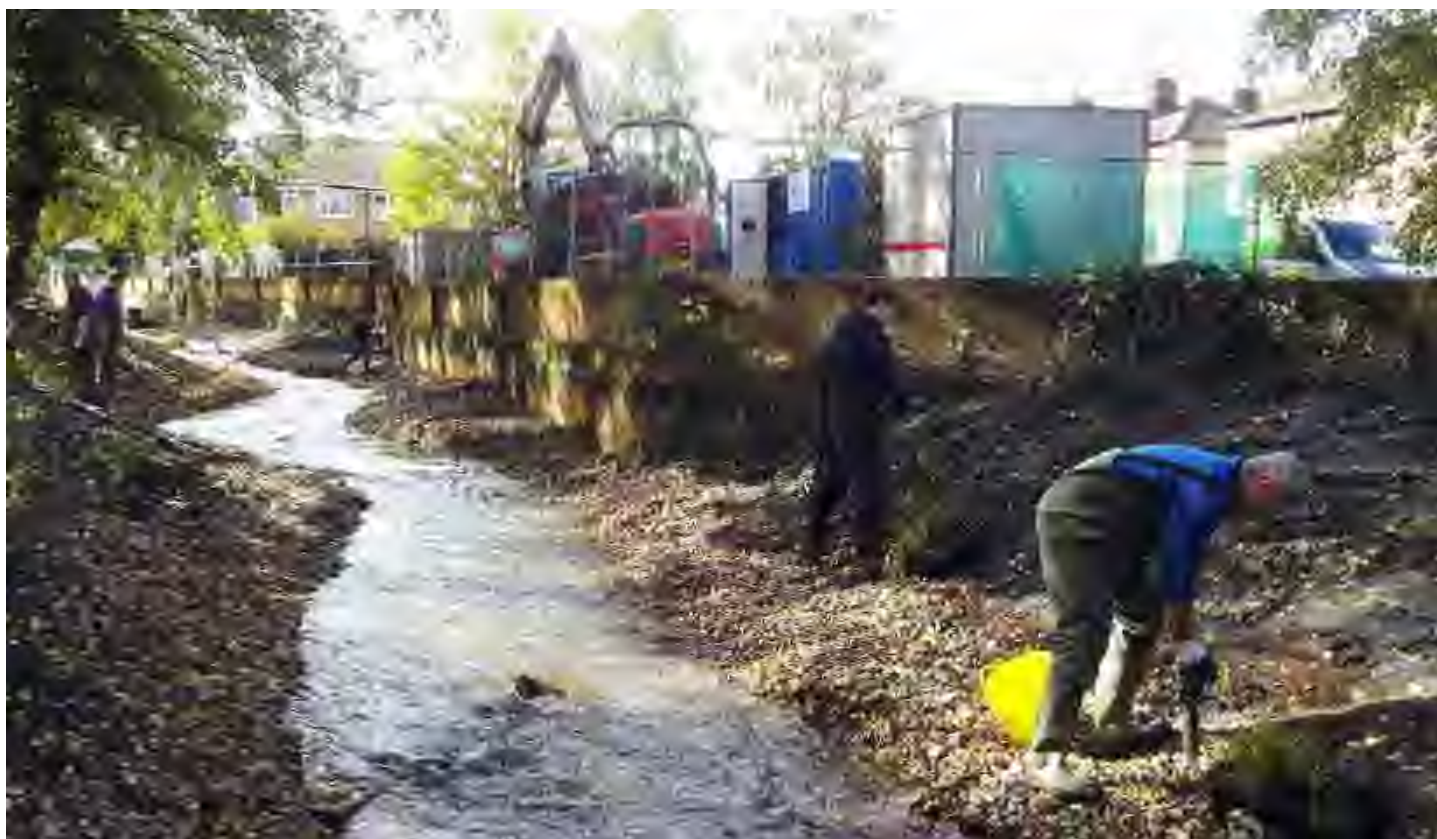
The shaped sinuous gravel bed and berms being planted – Oct 2014

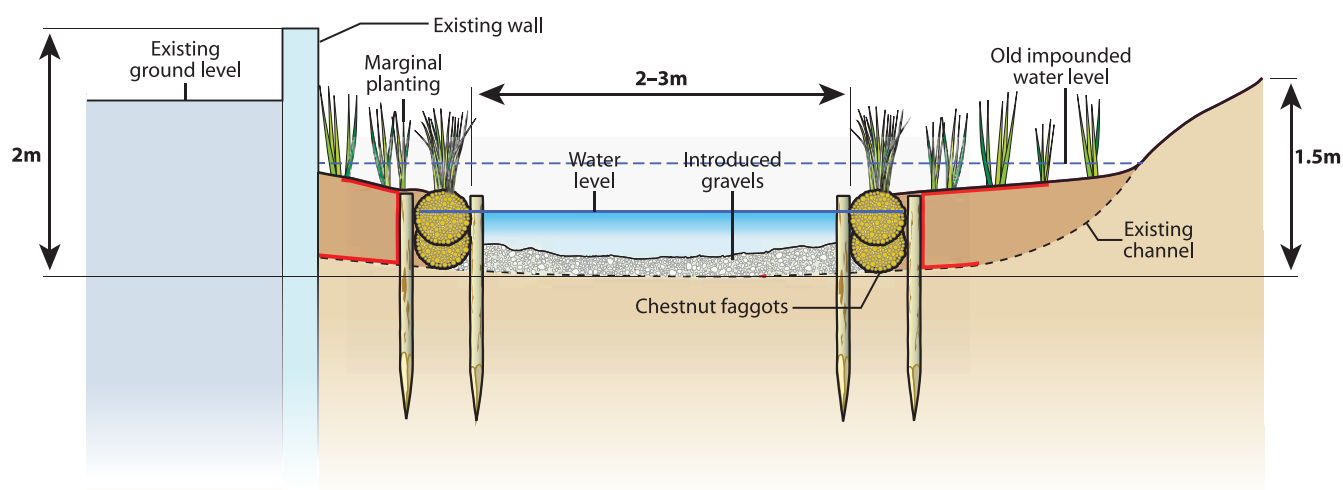
Figure 3.12.2
The initial indicative two-stage design. Main channel and marginal ledge, with a defined faggot edge.

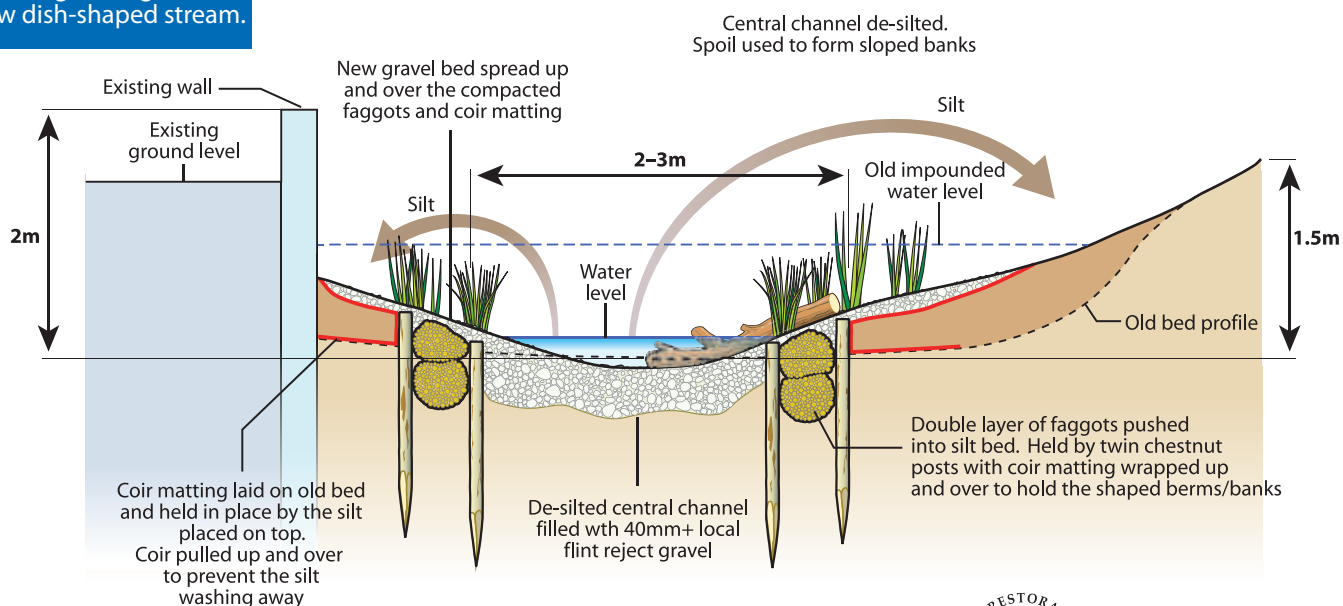
Figure 3.12.3
Indicative as built.
By squashing the faggots and posts into the silt bed and adding more gravel. A shallow dish-shaped stream.

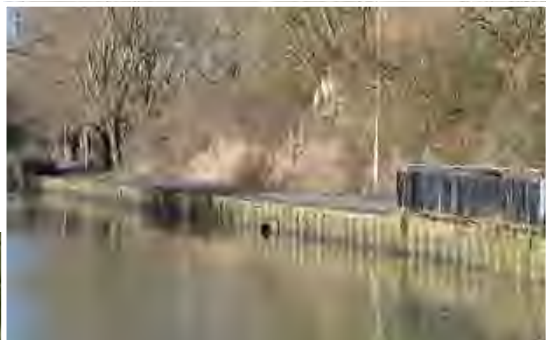
Sheet pile and concrete bank – Feb 2015

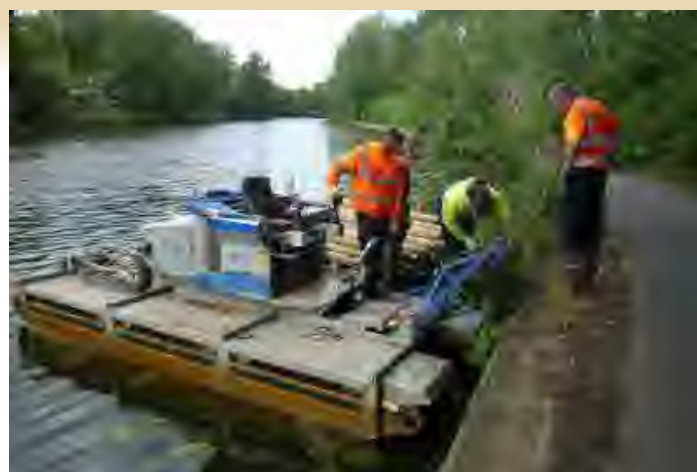
A Truxor provided access from the river – May 2015

1. The Truxor and float units were used to transport materials to the work area. Once the Truxor was anchored in place, a hand held hydraulic rammer was used from the Truxor to drive FSC timber stakes into the bed.
2. The 100mm diameter and 1.5m - 3m long stakes (depending on the river depth) were positioned approximately 300mm into the channel and were driven into the bed at a depth of approximately 50% of the stake. Stakes were positioned 300mm apart in two rows, with 1m centres on the back row and 0.5m centres on the front row. At 2m - 3m centres, the front row was tied to the anchoring back row to provide additional support.
3. The required number (between 1 and 3 depending on depth) of hardwood brushwood faggots (2m x 300mm) were then placed between the two rows of stakes.

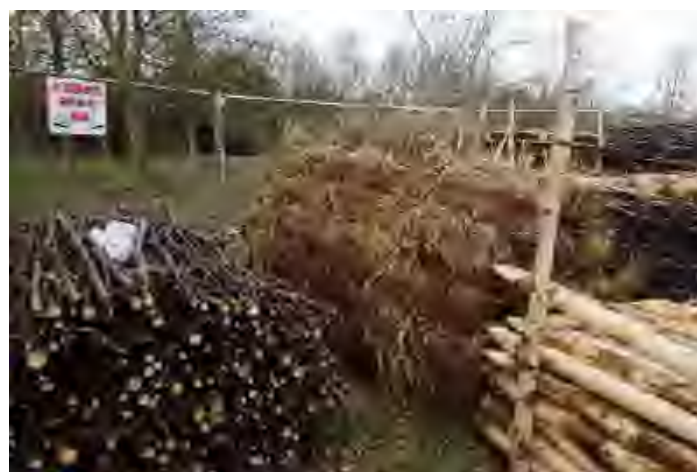
A 'tried and tested' method
using simple components – May 2015

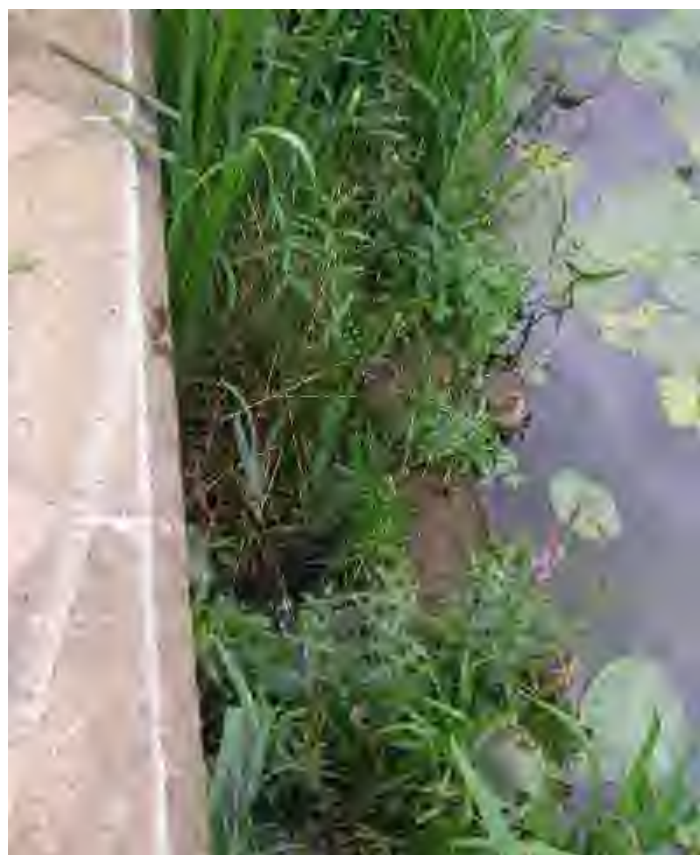
Close-up of the edge, sampled after only 5 months – July 2015

Two macroinvertebrate samples were taken on the 14th July 2015, one within the enhancement area and one in an unenhanced control section, using a standard FBA-pattern pond net.

Even within four months the habitat enhancement had clearly resulted in an increase in the number of supported taxa (23 taxa in the unenhanced control, rising to 37 in the enhanced section). ASPT and BWPM scores rose from 3.93 to 4.24 and 59 to 89 respectively. At this early stage, this did not result in an increase in Community Conservation Index (CCI), as all supported species in both sections are known to be common and widespread. CCI classified both control and enhanced sections as of low conservation value.

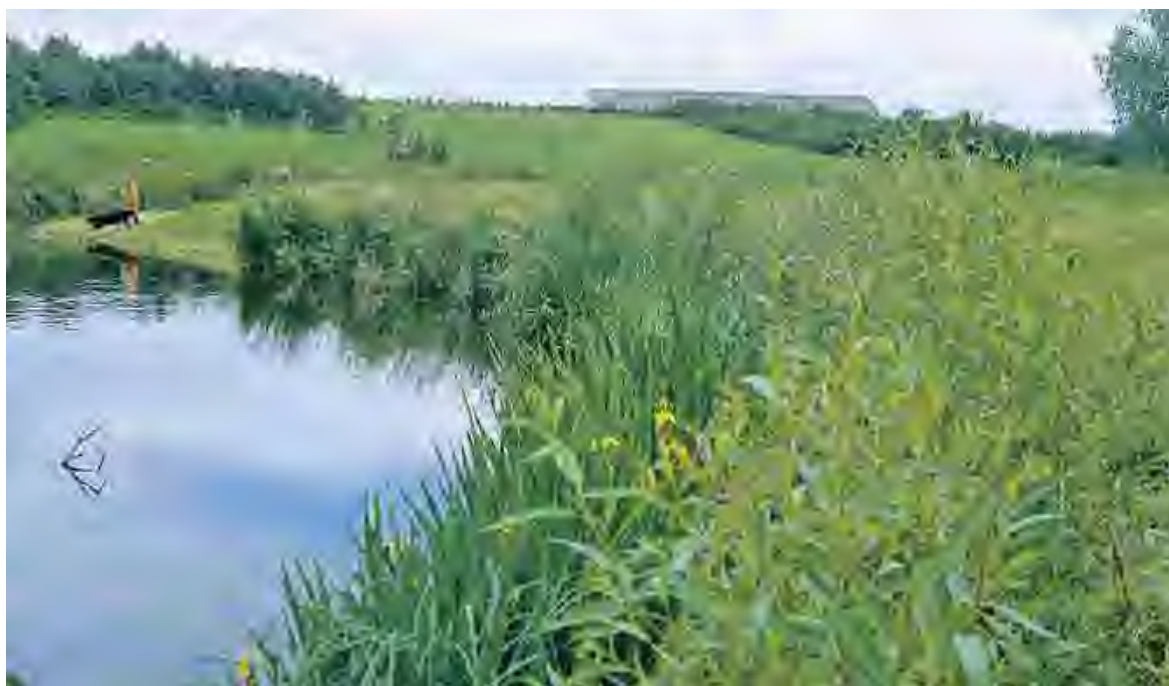
Willow spiling 2 years after construction

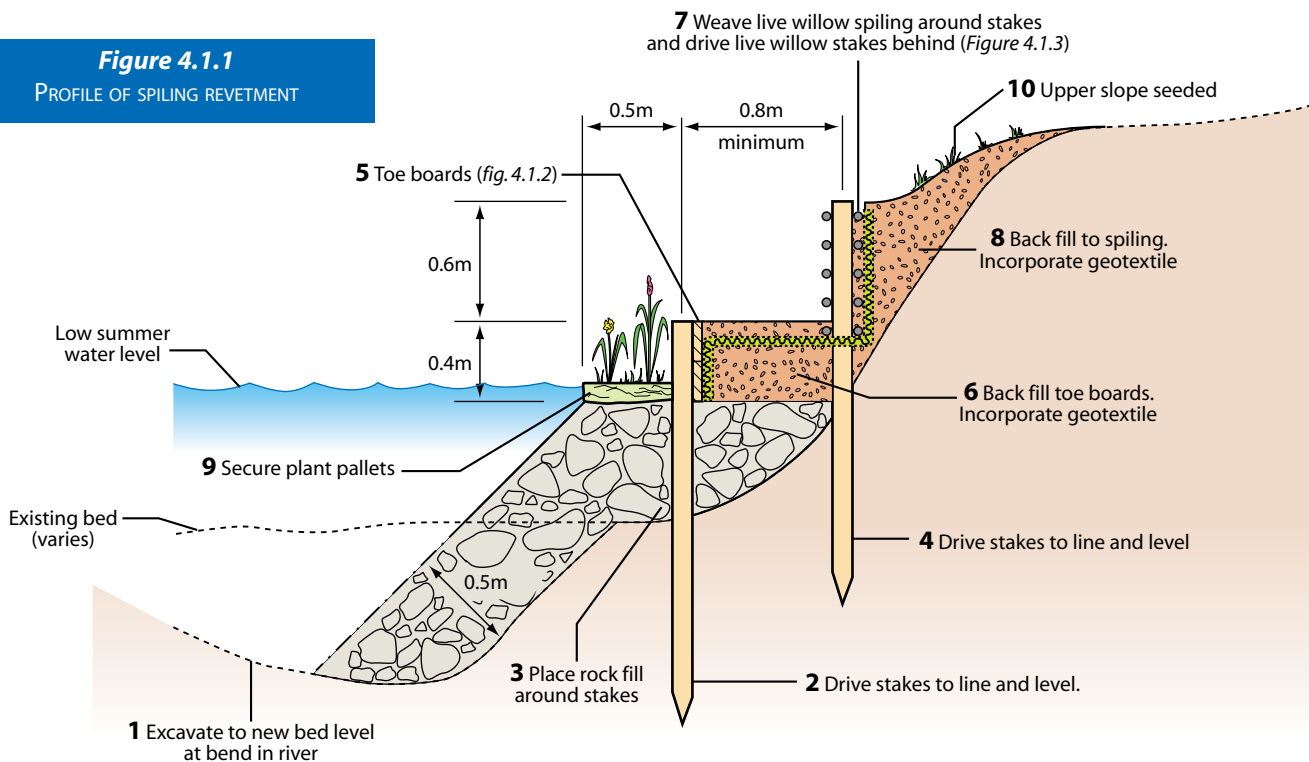
Figure 4.1.1

PROFILE OF SPILING REVETMENT

The basis of this design is to provide a stable underwater environment as a foundation for the spiling which is located just above water level where willows thrive best. The rooted osiers that develop from the woven poles will gradually occupy the underwater rock, and the marginal shelf, as the toe boarding rots away. Pre-planted pallets were placed in front of the toe boards to add to visual amenity and habitat diversity. Over time, the osiers will become dominant and will secure the river bank against further erosion whilst providing valuable habitat. Coppicing of the osiers is planned in line with normal procedure for maintaining the security and integrity of this species.

Commercially available woven willow hurdles can effectively replace the in-situ weaving, but more support posts will be needed. Live willow posts introduced behind the spiling can be allowed to mature into trees (if the osiers are coppiced sufficiently often) and these may be of an indigenous species intended to succeed the osier over time.

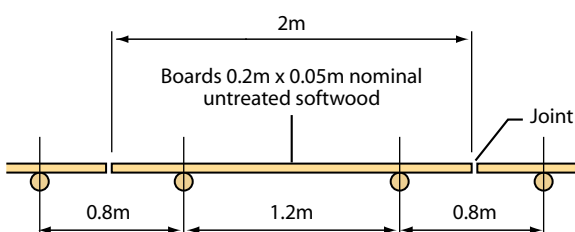
Figure 4.1.2

PLAN OF TOE BOARDS

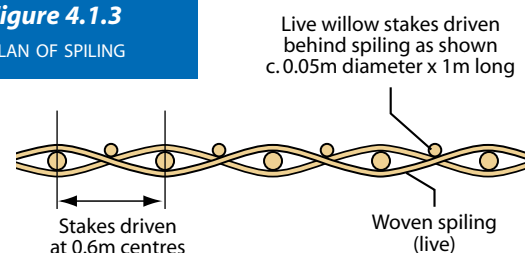
Figure 4.1.3

PLAN OF SPILING

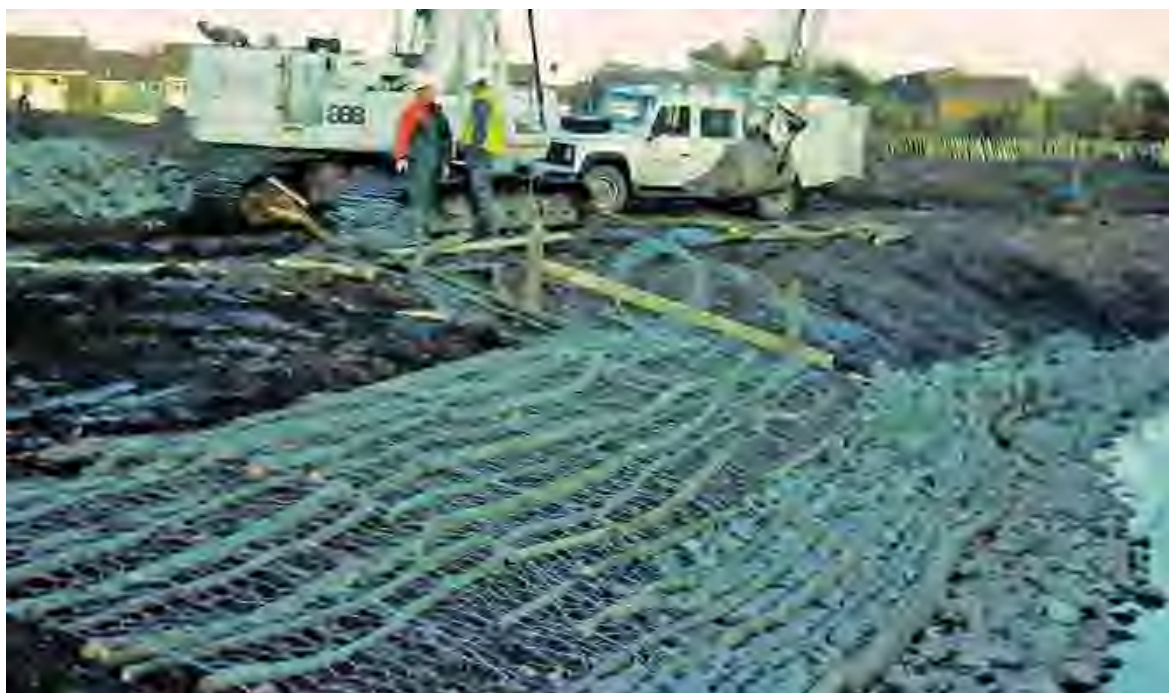
Mattress revetment under construction – October 1995

Note: Additional poles inserted to close up spacing after photo taken

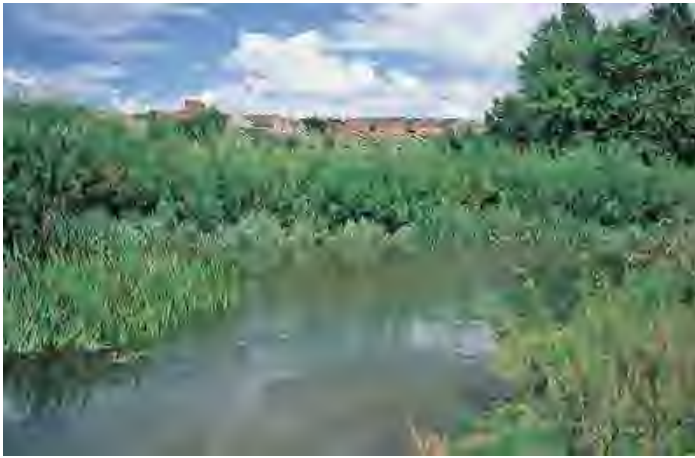
Mattress revetment after 2 years

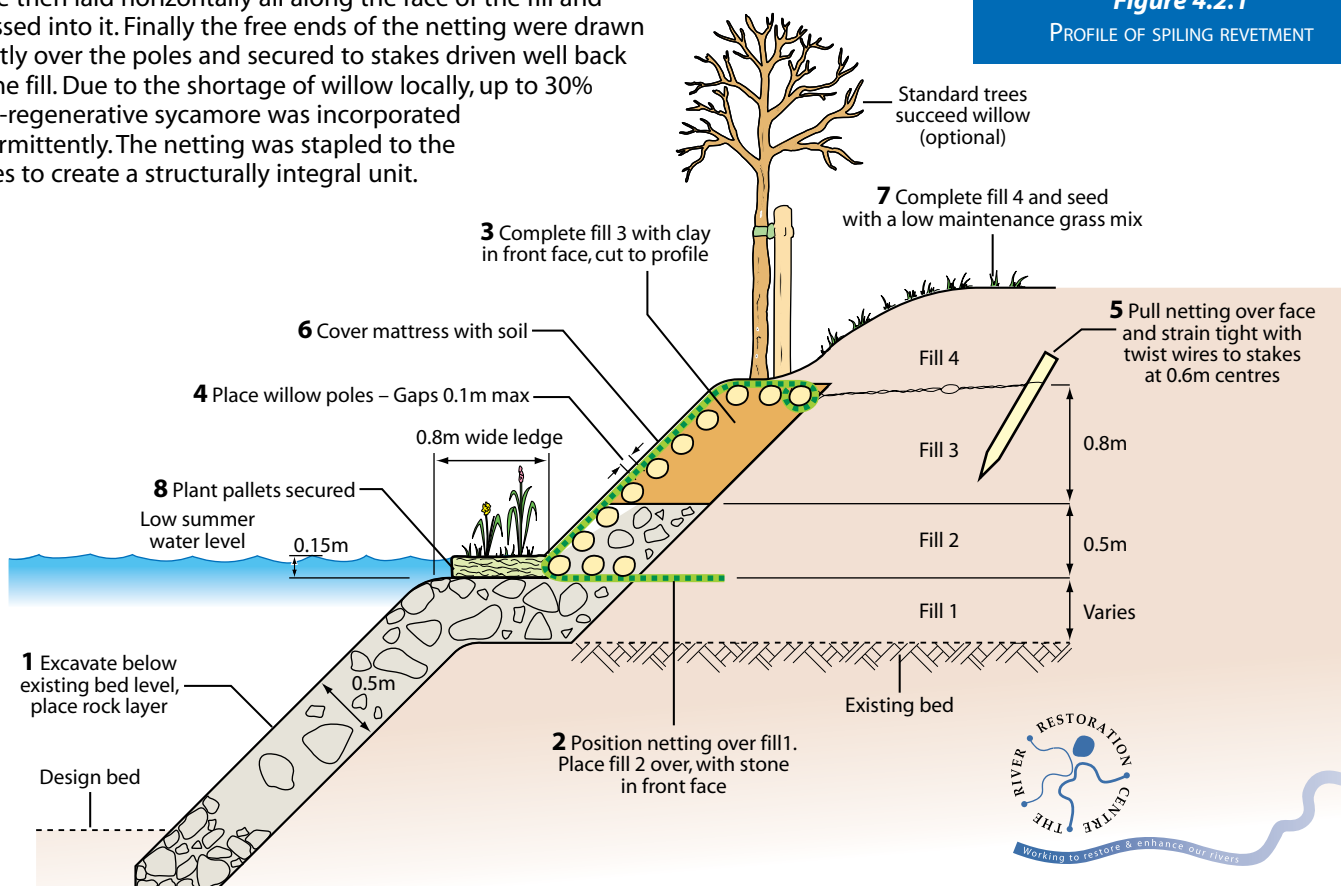
Figure 4.2.1

PROFILE OF SPILING REVETMENT

Selected live crack and white willow poles, 0.05m – 0.1m diameter, were then laid horizontally all along the face of the fill and pressed into it. Finally the free ends of the netting were drawn tightly over the poles and secured to stakes driven well back in the fill. Due to the shortage of willow locally, up to 30% non-regenerative sycamore was incorporated intermittently. The netting was stapled to the poles to create a structurally integral unit.

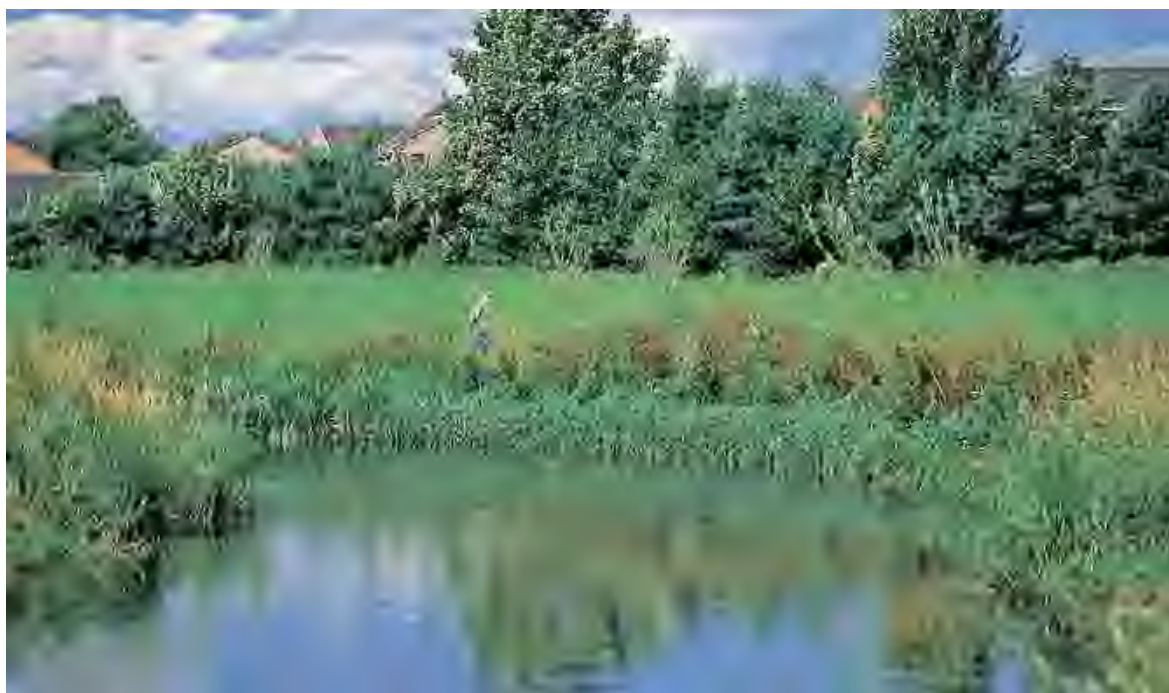
Log toe revetment three years after construction

This technique was used in two locations and both have performed well with dense willow growth up to 2m high along the bank and a thick margin of plants along the water's edge, all of which are accreting river silts in successive floods. Rooted willow plants established much more strongly than unrooted slips, but this is not uncommon with the grey/goat species selected. Other willow varieties are known to strike readily from slips. Species that are indigenous to the site are always preferable. Brushwood containing willow cut locally can be built into the lower banks as an alternative to the geotextile utilised at the Darlington site which was virtually barren of trees.

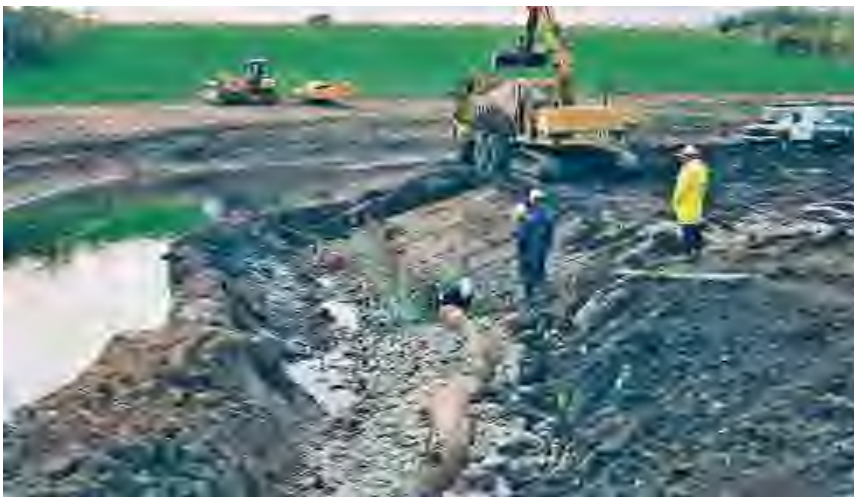
Log toe revetment during construction

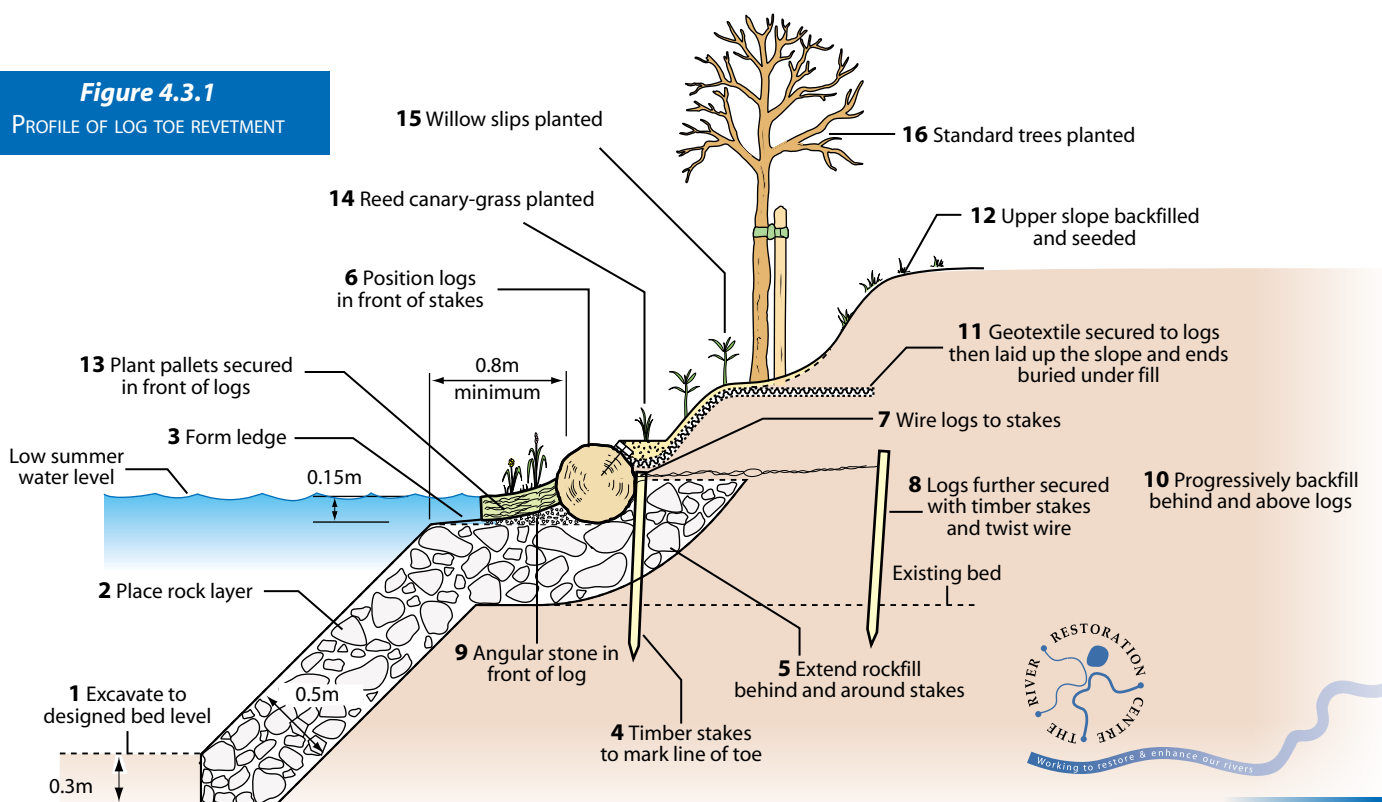
Figure 4.3.1

PROFILE OF LOG TOE REVETMENT

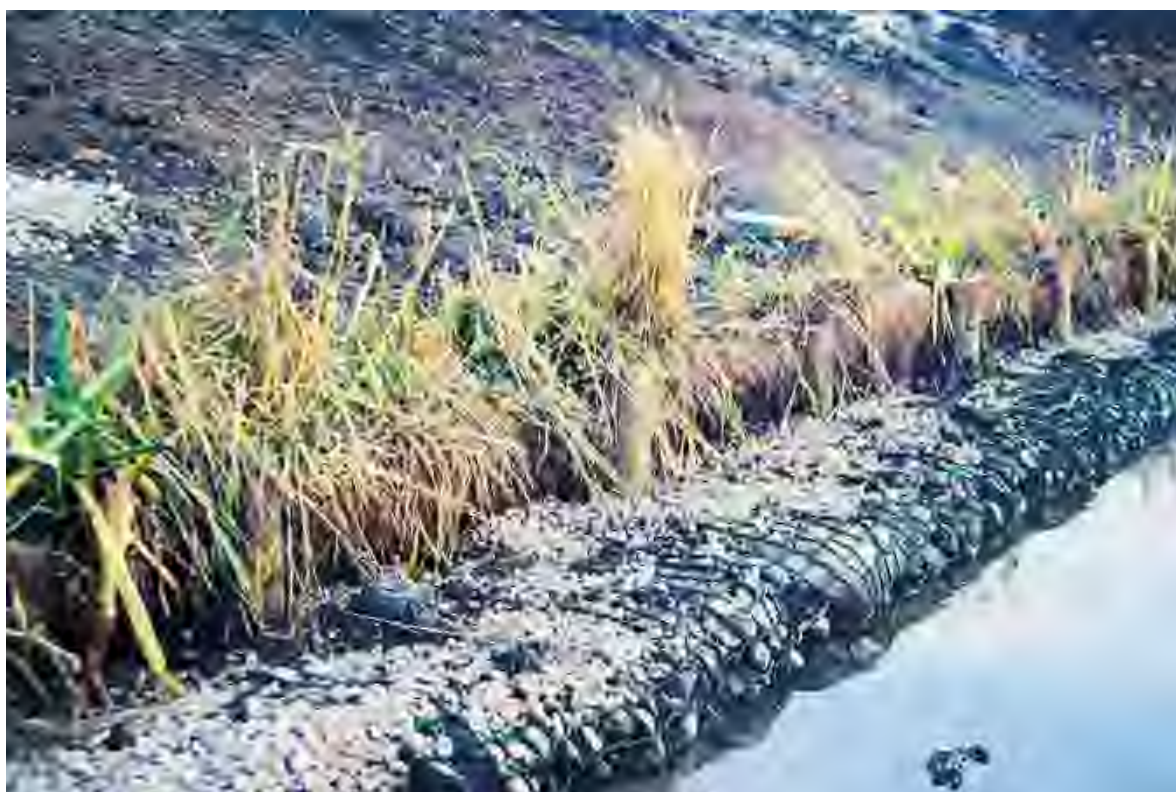
Transitional revetment at installation (water level artificially low in photo)

Rock rolls are flexible 'sausages' of crushed rock contained within nylon netting, whereas plant rolls are of dense coir within which selected marginal aquatic species can be pre-grown. Plant rolls fixed over rock rolls will become homogeneous as roots penetrate downwards into the rock and the adjacent soil. The design provides inbuilt flexibility whilst allowing the plants to develop in stable conditions.

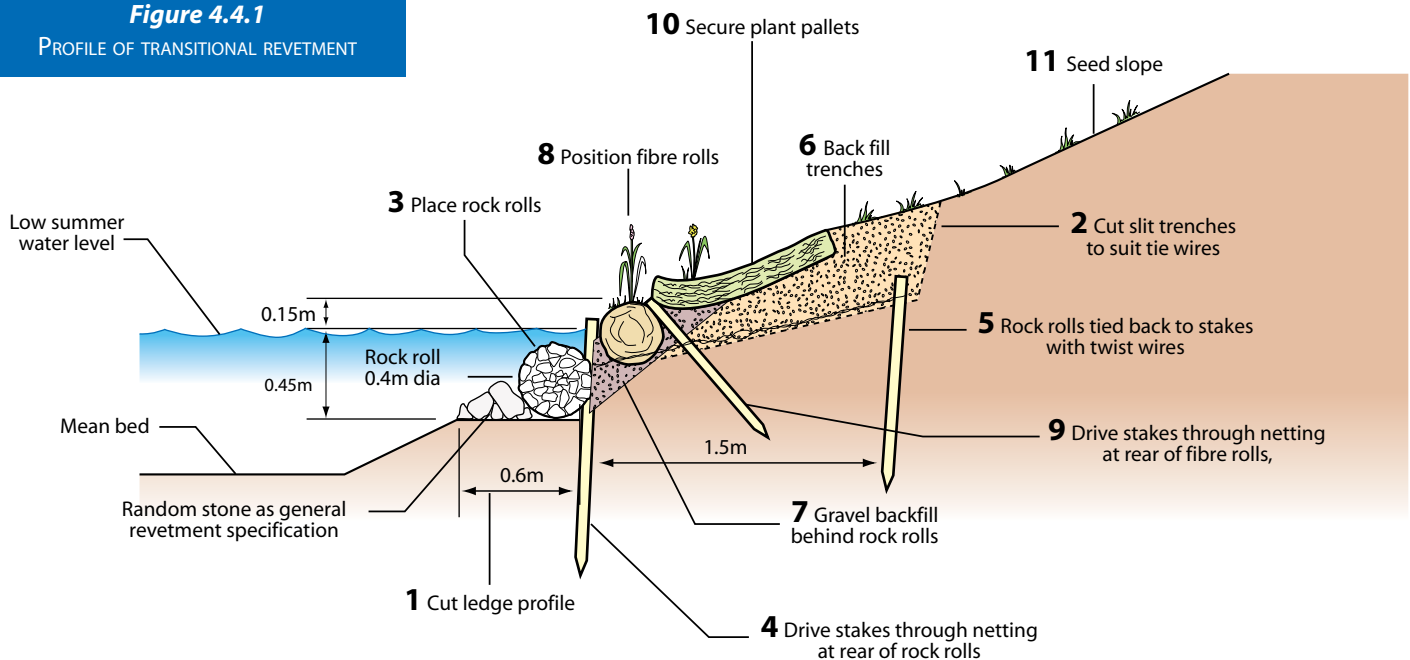
Figure 4.4.1

PROFILE OF TRANSITIONAL REVETMENT

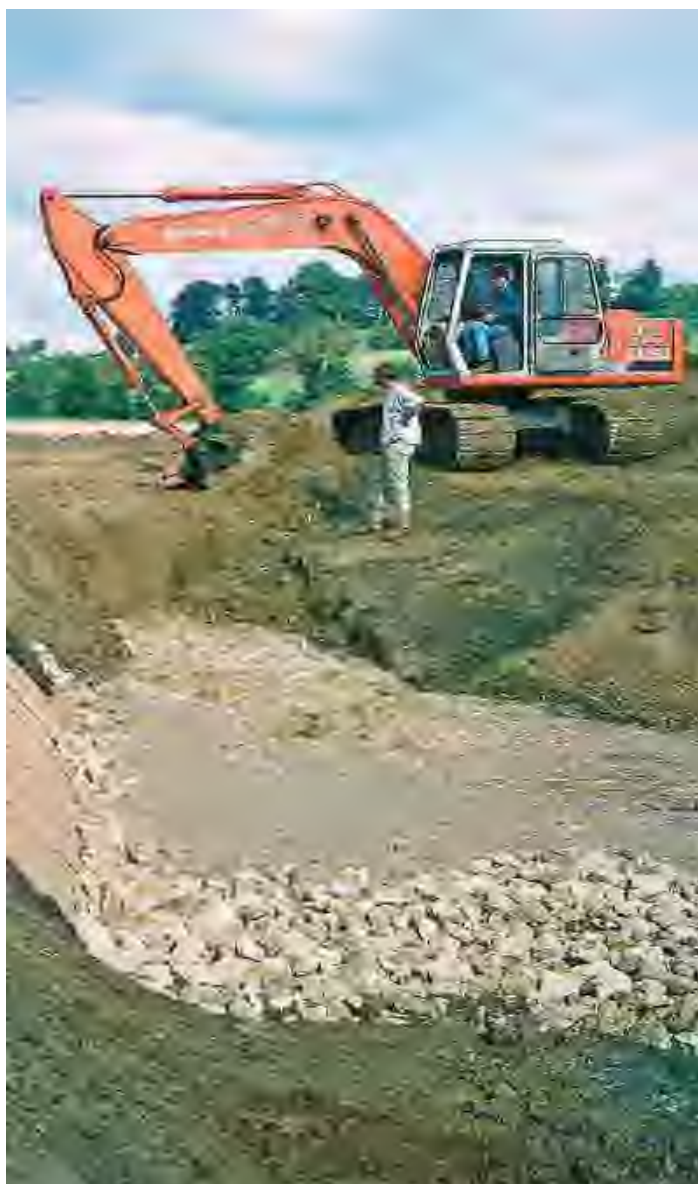
Construction of coir matting revetment
– river being released

The revetments were installed where an old, straight channel is crossed tangentially by a new, smaller, meandering channel at three separate locations. At each crossing point, the old channel was partially infilled and compacted and the new channel then excavated within this fill. As the new river flowed straight across the old, the risk of scour was not great, which suggested that only light revetments were needed, sufficient to protect the bank and bed until soils consolidated and vegetated over. Two bio-degradable materials were selected to line the newly formed banks, coir matting and dead willow hurdles. Stone lines the new bed in both examples.

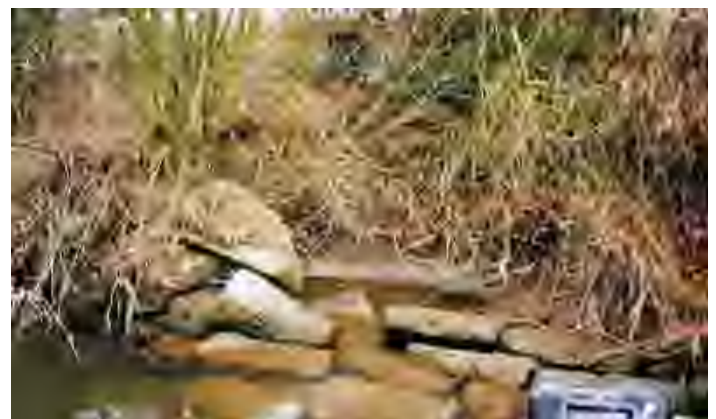
Failed section of bagwork at Clifton Lock Cut

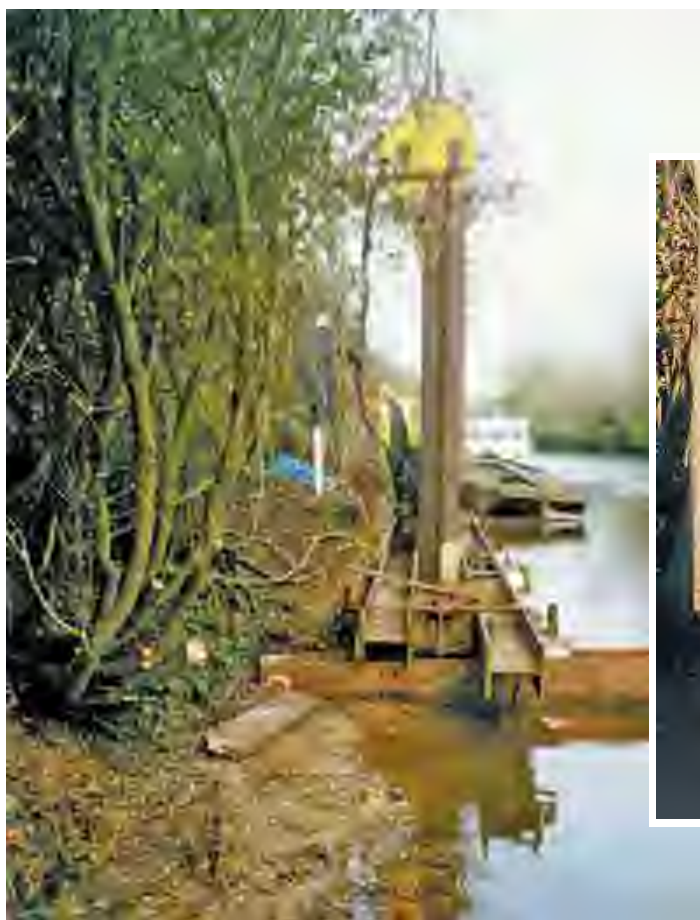
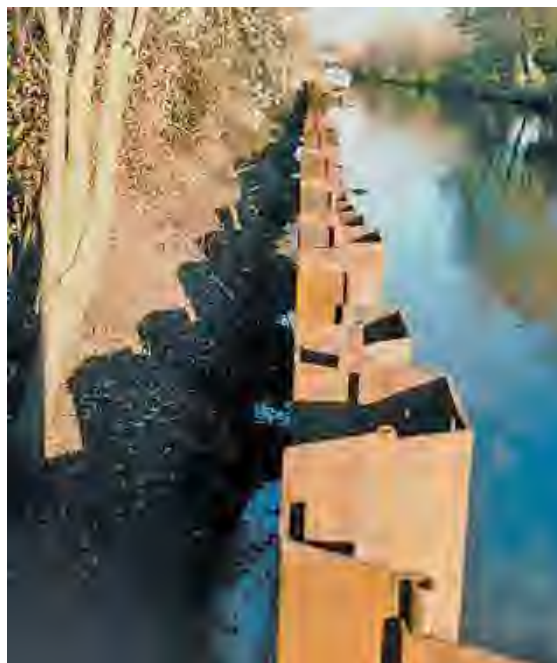
Initial sheet piling after bagwork removal, over existing trees

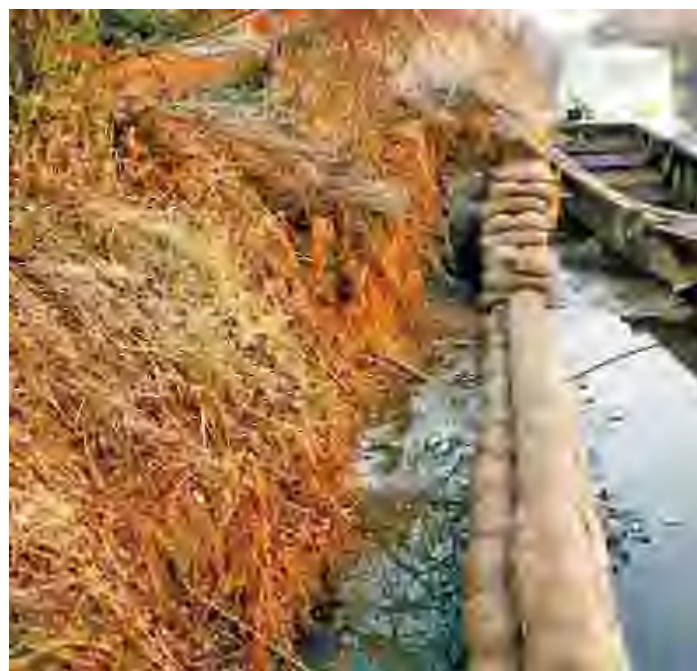
2 layer capping bagwork and tie-in to existing sheet piling

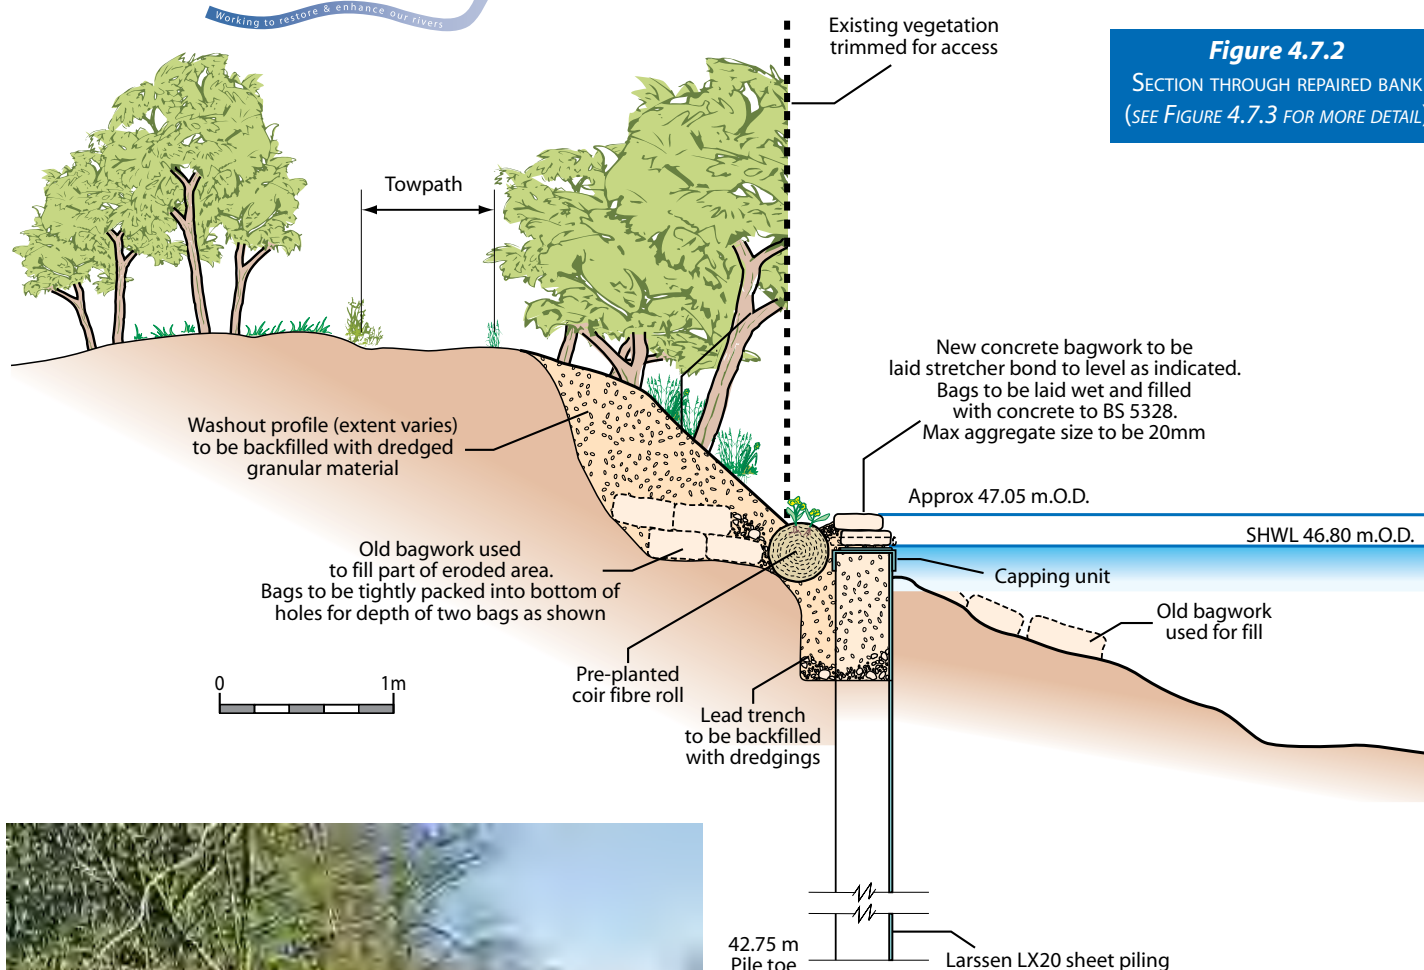
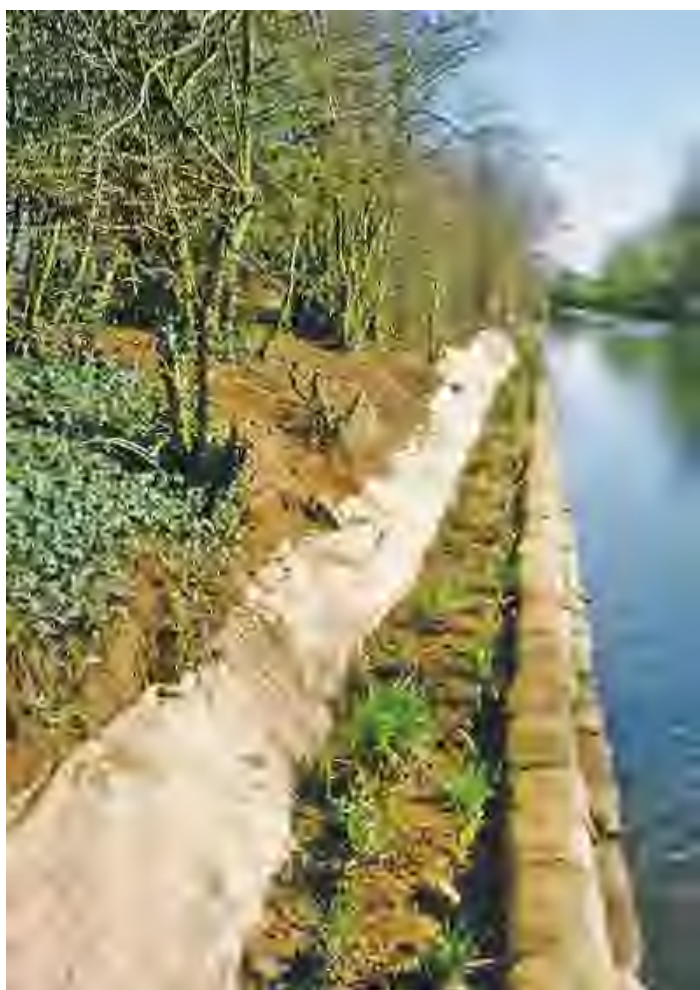
Figure 4.7.2

SECTION THROUGH REPAIRED BANK
(SEE FIGURE 4.7.3 FOR MORE DETAIL)

The sheet piling and bagwork was backfilled with the old bagwork and dredgings from the channel, then capped with a pre-planted (pond sedge, reed canary-grass and iris) coir fibre roll. The dredgings were stockpiled and allowed to de-water before being used as backfill.

The roll provides both retention of the backfill, preventing wash-out, and a medium for reedy marginal vegetation establishment. The vegetation, when established, provides an effective natural defence against boatwash, habitat for bankside wildlife and is visually more pleasing.

In addition, 0.05m diameter UPVC 'mammal' pipes were incorporated between the lower level bagwork at 1.5m intervals.

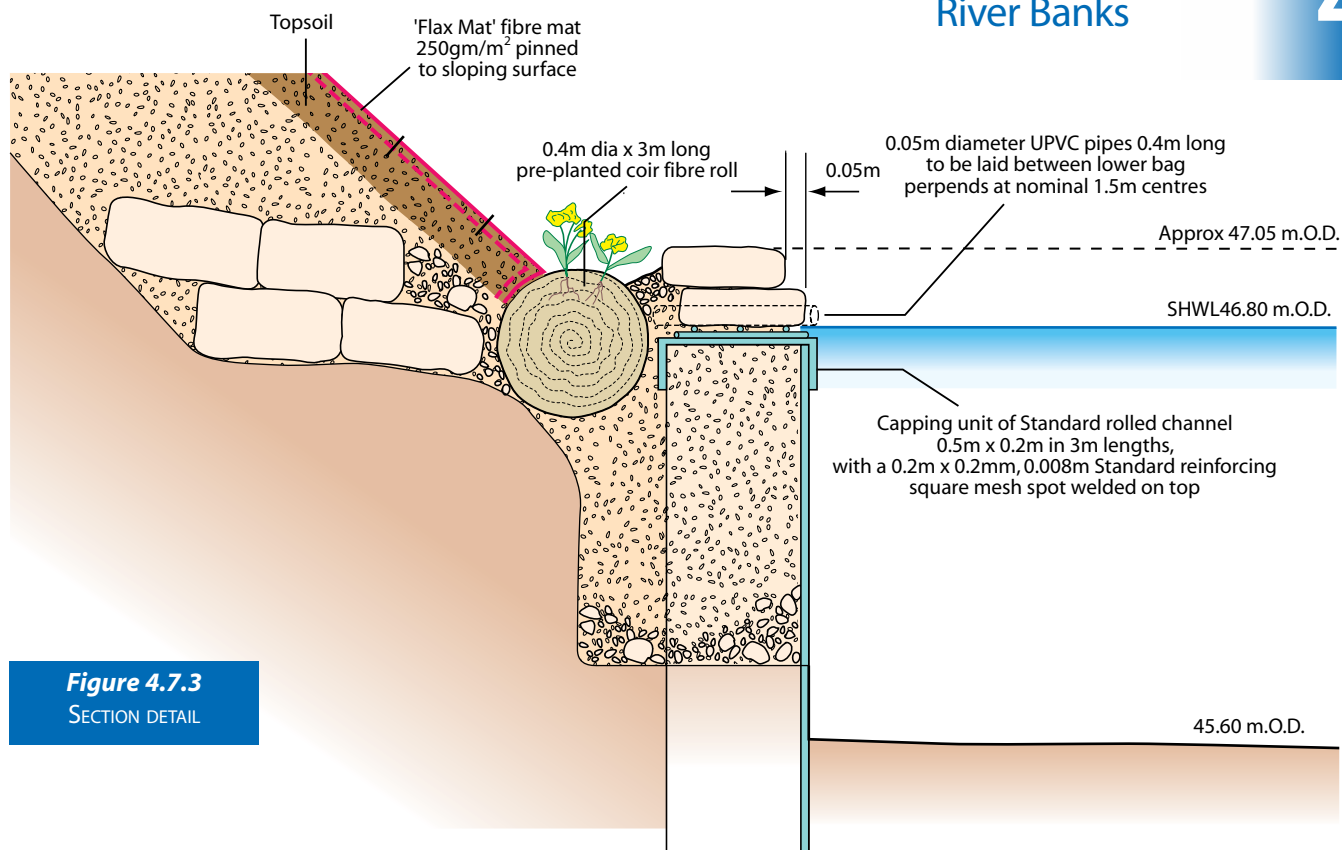
Figure 4.7.3
SECTION DETAIL

The old bagwork was removed to be used as backfill. To ensure stability at the toe of the bank, short sections of sheet piling were driven to below water level. The piling was capped with an inverted steel channel section with mesh welded to the top to prevent movement of the above two courses of new bagwork, ending just below 'standard head' water level (see Figure 4.7.3).
