Enhancing Straightened River Channels

3.1 Current deflectors

RIVER SKERNE

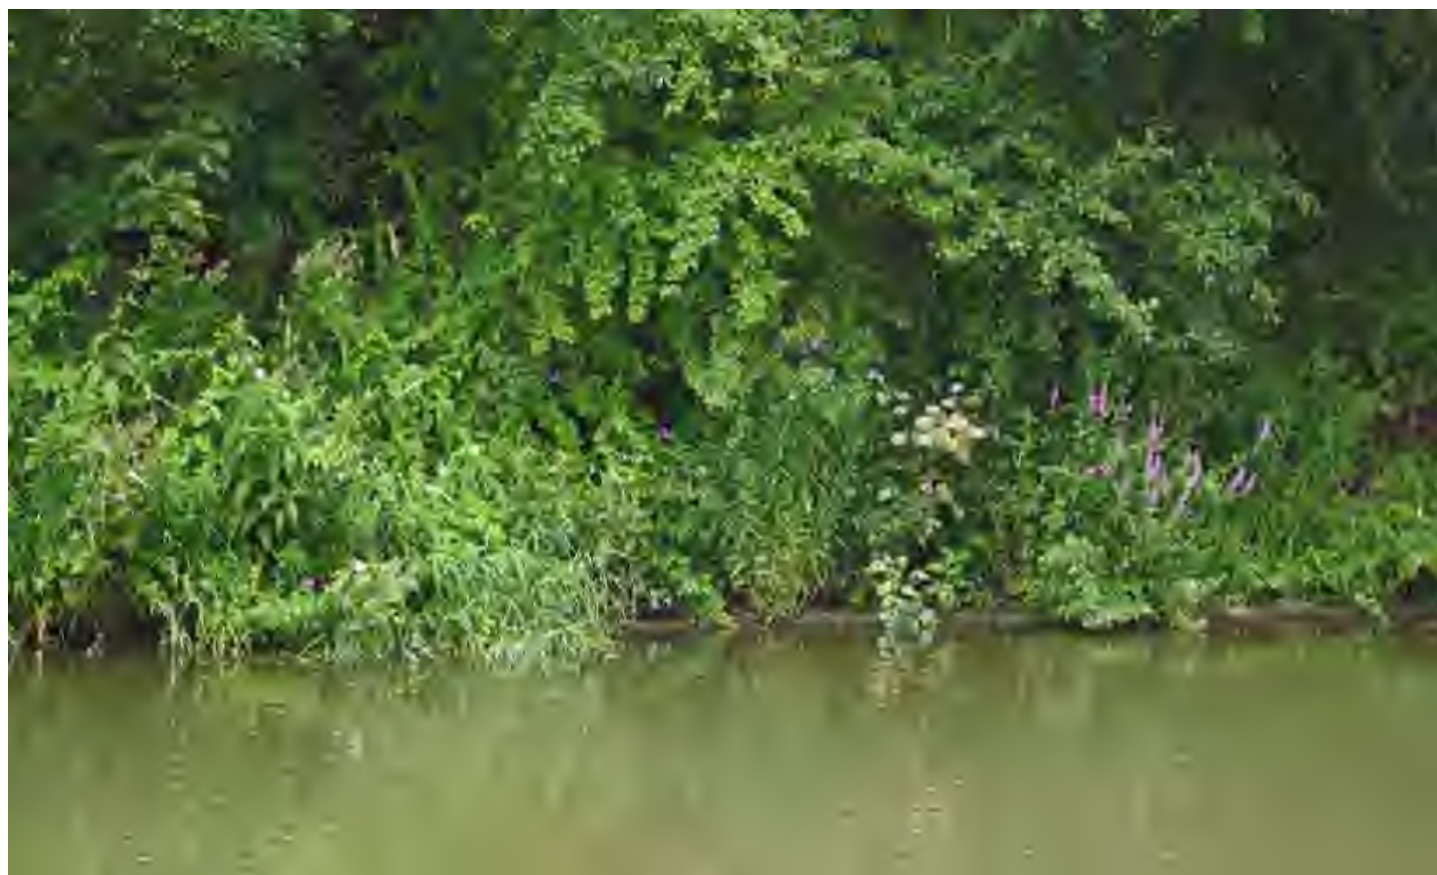
Vegetation growth has established and the bagwork has remained intact – August 2013

The introduced bagwork has settled (soil and silt has solidified) and is standing up well to wash caused by passing boats. Where there is sufficient light there is good vegetation growth and numerous plant species have successfully established. However, in some areas lack of maintenance means riparian vegetation has overgrown, restricting some views of the river from the towpath. The minor tree work carried out along the towpath has since ceased and it is suggested that the scheme may have benefited from a tailored tree maintenance schedule.

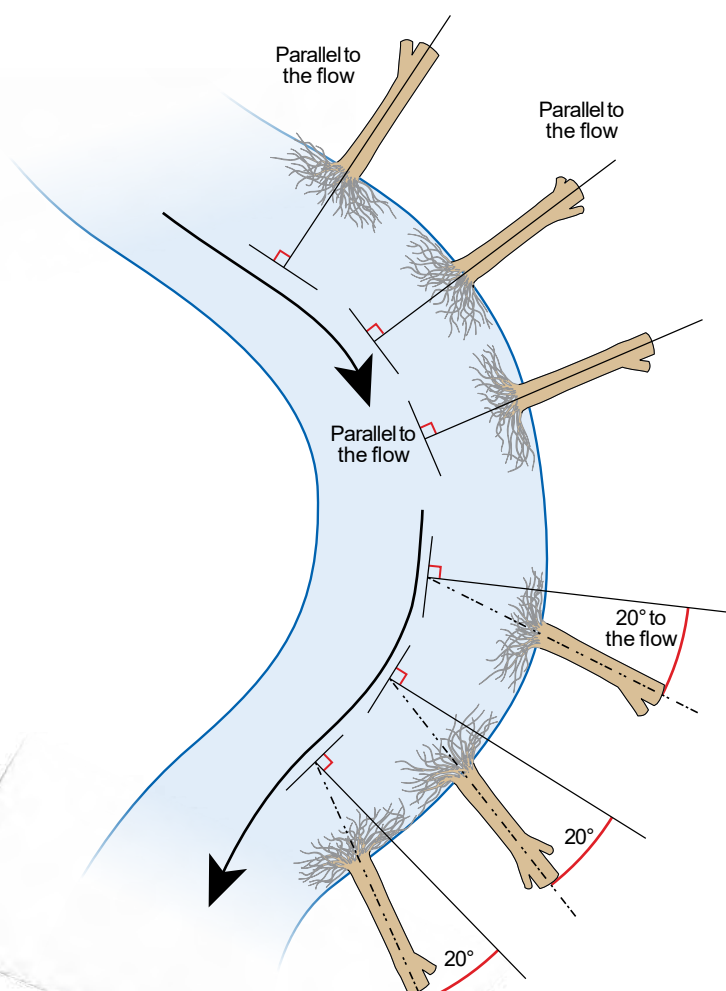
Figure 4.8.1

PLAN SHOWING POSITION
OF ROOT WADS

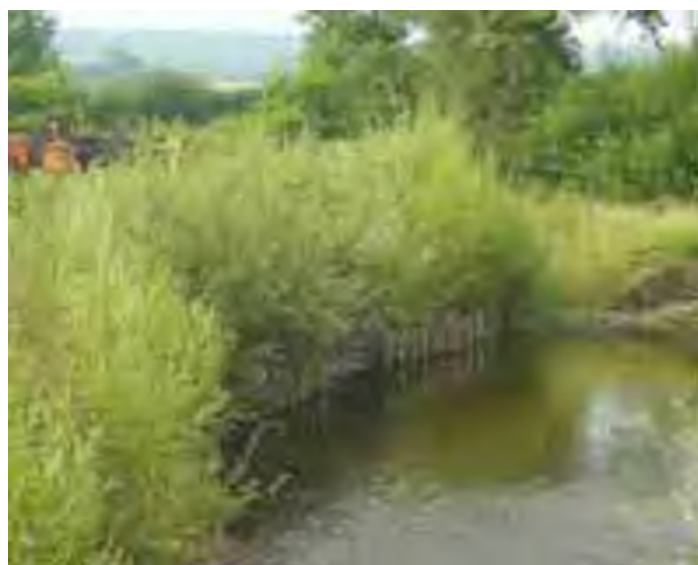
Growth of root wads along bank two years after installation. Brushwood protection can just be seen between root wad growth – 2006

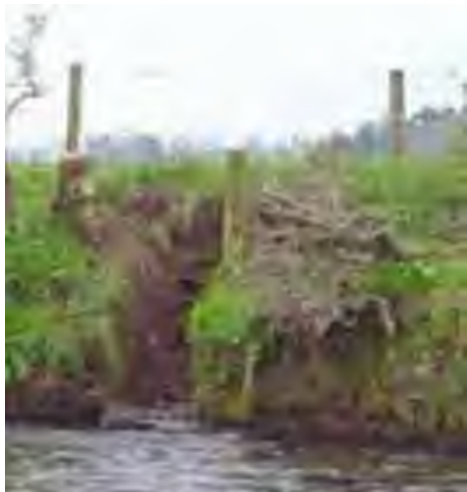
1

Trench excavated in bank – 2004

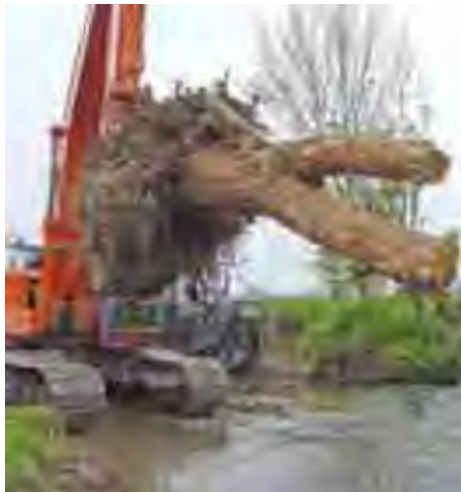
2

Excavator moving root wad into position – 2004

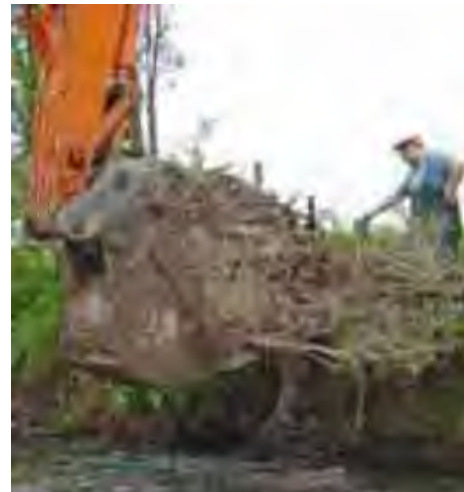
3

Installing root wad in bank – 2004

Forty root wads were installed over eighty metres of bank, with two to three metres of trunk left attached to the root wad. Crack willow (*Salix fragilis*), grey willow (*Salix cinerea*) and white willow (*Salix alba*) with an average trunk diameter of between 0.3m and 0.6m were used. Live willow was chosen as each tree should root and shoot to quickly bind the surrounding bank. All trees were sourced from within the Dulais catchment and two adjacent river valleys.

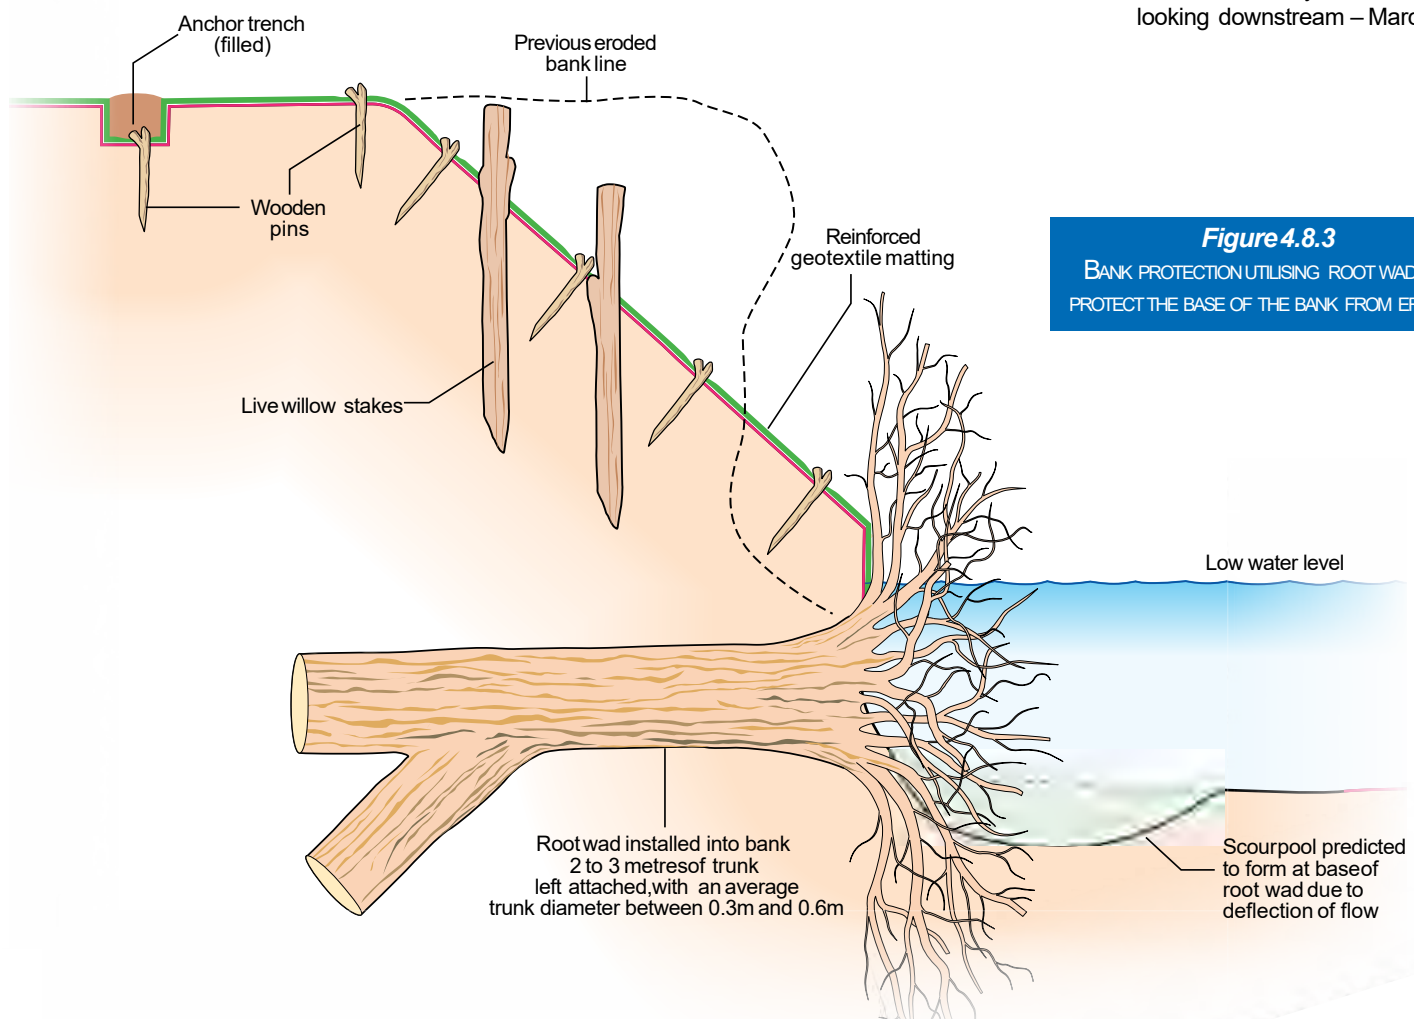
Figure 4.8.3

BANK PROTECTION UTILISING ROOT WADS TO PROTECT THE BASE OF THE BANK FROM EROSION

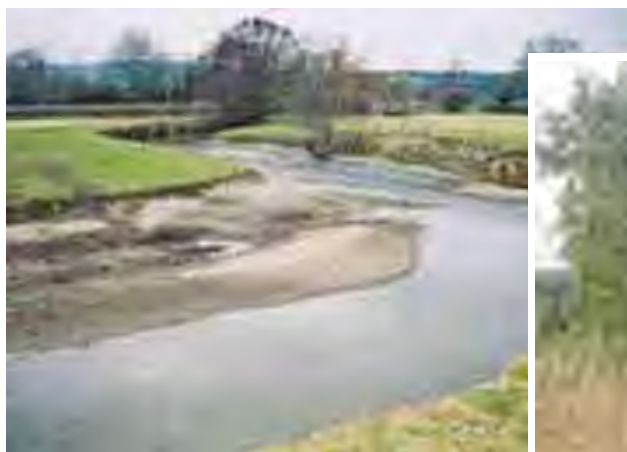
Over-wide eroding channel before restoration – 2003

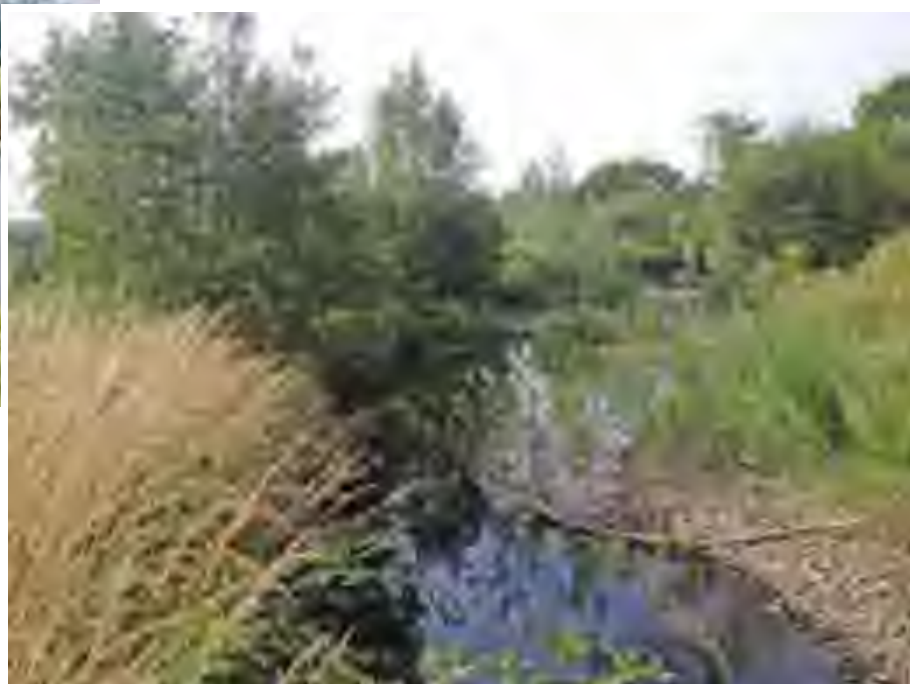
Root wads have become established, stabilising the bank and reducing erosion – August 2013

Diverse bankside cover has established and cleaner gravels are present, with visibly less fine sediment. Overall the channel geometry is now similar to more well vegetated reaches of the river.

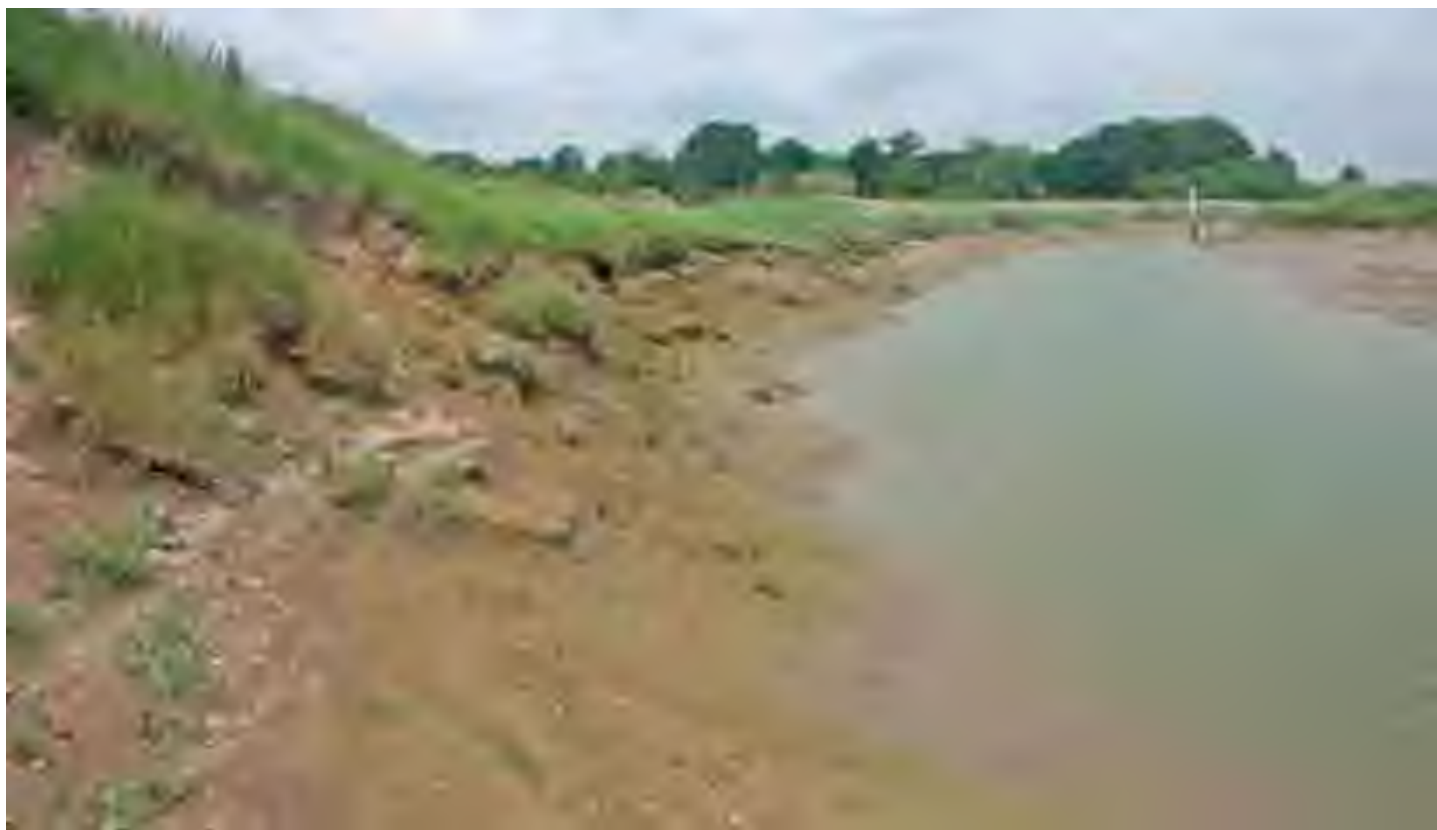
Rother embankment erosion threatening to cause a breach, prior to restoration works – 2004

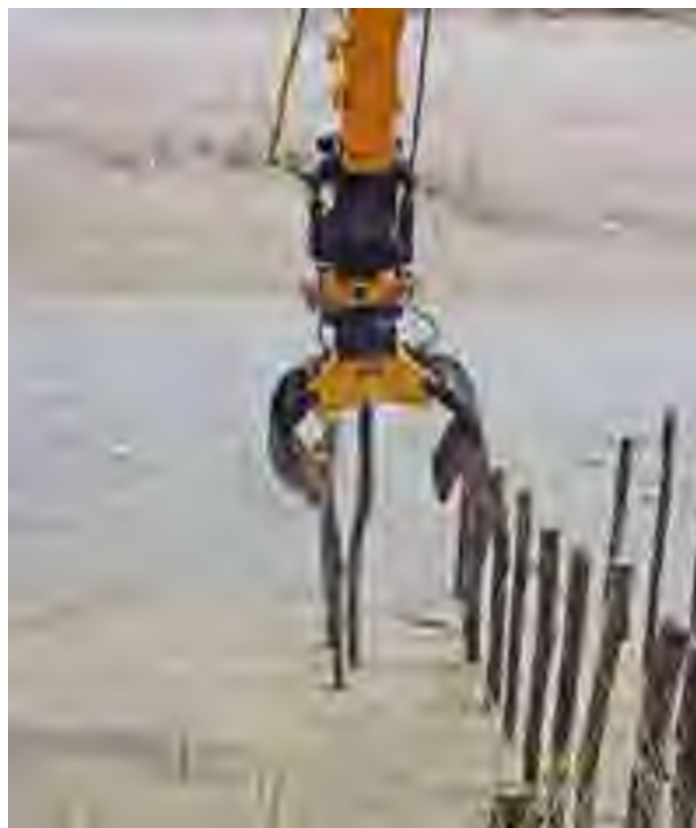
Installation of a matrix of sweet chestnut posts to secure the brushwood mattress – 2005

Hardwood sweet chestnut (*Castanea sativa*) posts were used (minimum diameter of 0.125m). These ranged from 2.1m up to 4.5m in length to allow for the variation of the eroded bank profile and to ensure that at least 1.5m of each post was driven into the bank. The posts were installed in a 1m grid along a 200m section of bank, with an average width of 11m (see Figure 4.9.1) by a long-reach excavator. A hazel (*Corylus avellana*) brushwood mattress was then laid between the posts, using 3m to 4m long brush. Brush was installed to extend slightly beyond the last posts at the toe of the structure, to encourage sedimentation in this critical area by increasing roughness.

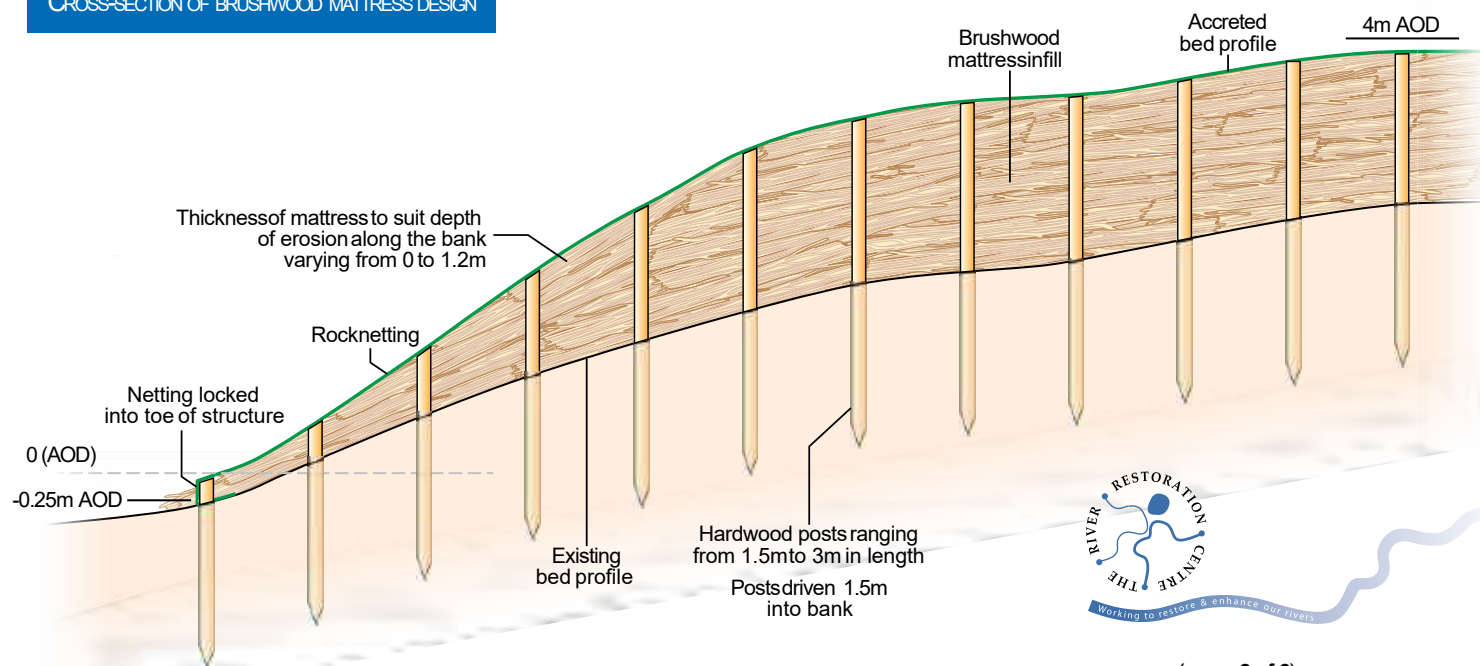
Figure 4.9.1

CROSS-SECTION OF BRUSHWOOD MATTRESS DESIGN

This technique can be used in estuarine environments with high sediment loads where the areas within the normal tidal range. The process of sediment deposition infills the mattress structure. Anaerobic conditions then develop which suspends decomposition of the internal woody skeleton, providing long-term integrity. There is nearby historic evidence from earlier stabilized areas that natural wood has remained intact for some 100 years.

The brushwood created walkways and safe access across the site. Hexagonal galvanised rock netting (generally used on rock and chalk escarpments to prevent rock falls) was stapled to the posts across the whole surface of the structure to prevent any brushwood being lost whilst silt was depositing. Completing this as soon as possible was essential to minimise the risk of the structure failing during construction in the event of an extreme tidal event occurring before the whole structure was stabilised. The final slope of the repaired bank had a design angle averaging 40°.

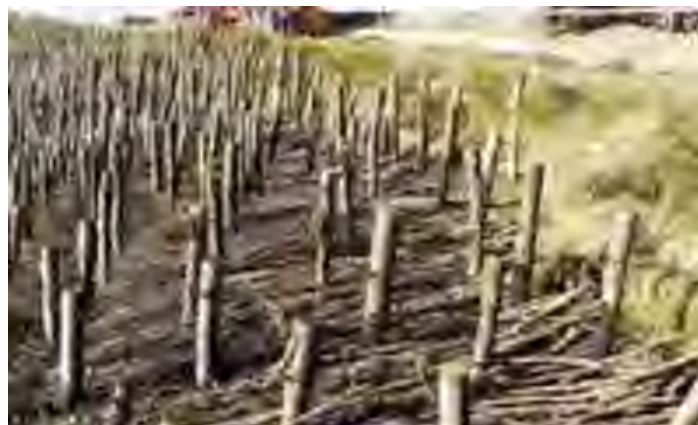
Once brushwood mattress installation is complete, rock netting is secured to the posts to prevent wash out – 2005

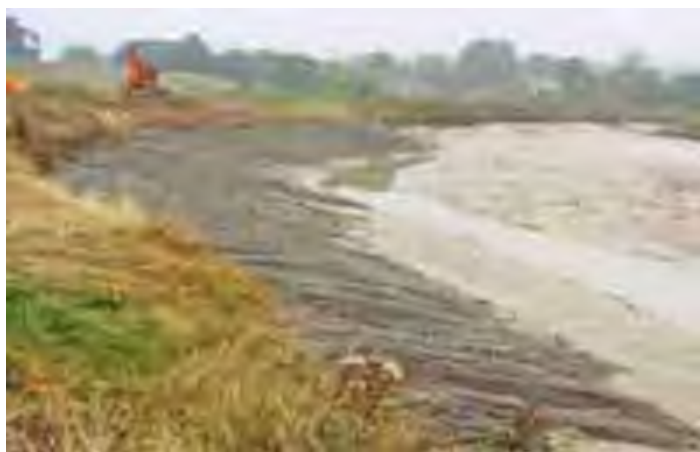
Section of bank post-restoration showing successful accretion of sediments across most of the structure, with some netting still exposed – 2005

Some of the brushwood became compressed by the weight of accreted sediment, leaving the netting standing proud above the brushwood. Cutting holes in the netting around the posts would enable it to settle with the compressed brushwood.

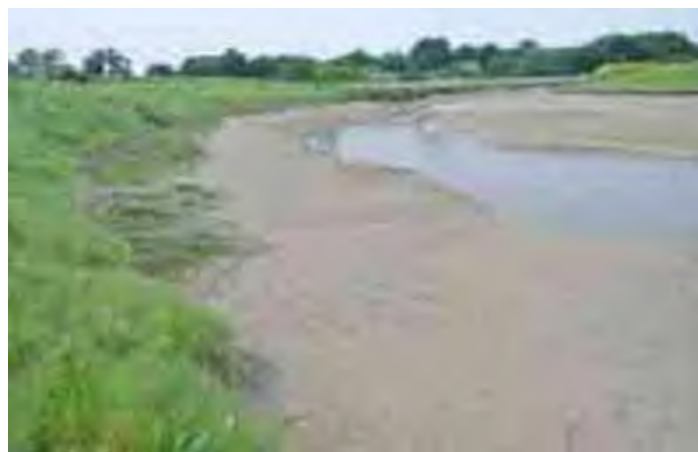
Seven years post-restoration the structure has continued to retain sediments and has been stabilised further by vegetation on the upper bank – June 2012

Fixed point photography has shown that after seven years this technique is continuing to prevent erosion, with vegetation developing well, especially at the top of the bank.
