# Controlling River Bed Levels, Water Levels and Flows

## RIVER COLE

**Figure 5.1.1**

### PLAN OF BIFURCATION WEIR

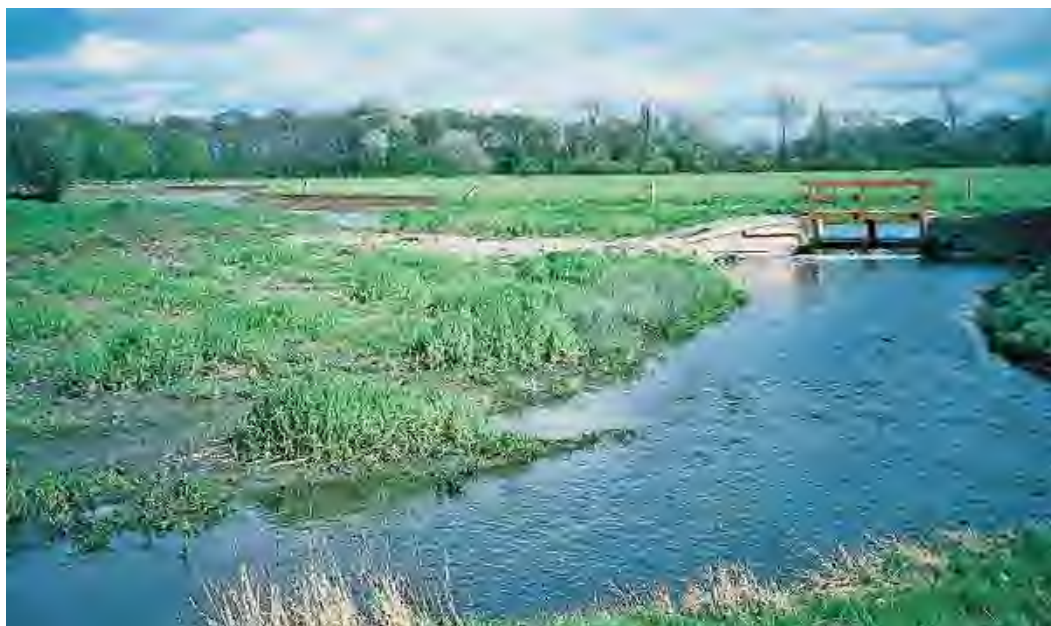
The hydraulic capacity of the flume is small (to suit base flows) so a 10m wide spillway is incorporated alongside to feed sufficient floodwater to fill the new channel. The crest level is only 0.1m above the normal water level in the leat so it operates frequently. Below the spillway, a large area of land is gently graded out towards the new channel which sustains marshy conditions around its inner margins. This low lying area is largely flooded before overspill occurs, ensuring a fairly smooth combining of floodwaters passing downstream. Water in the new channel rises quickly, ensuring the overspill is completely submerged (drowned) at an early stage of a rising flood, thereby further reducing scour potential.

Spillway alongside bifurcation weir – April 1997

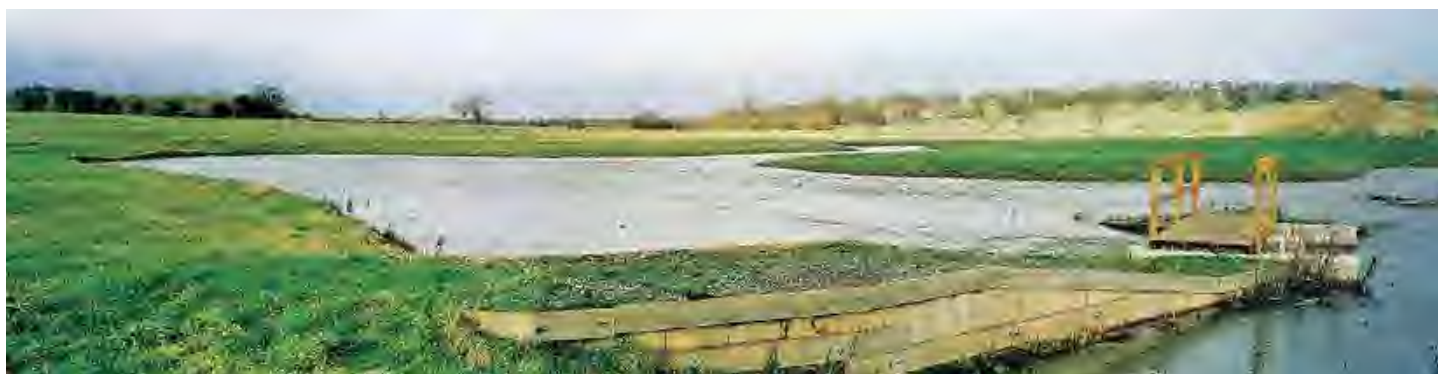
Flood filled channel downstream of bifurcation weir

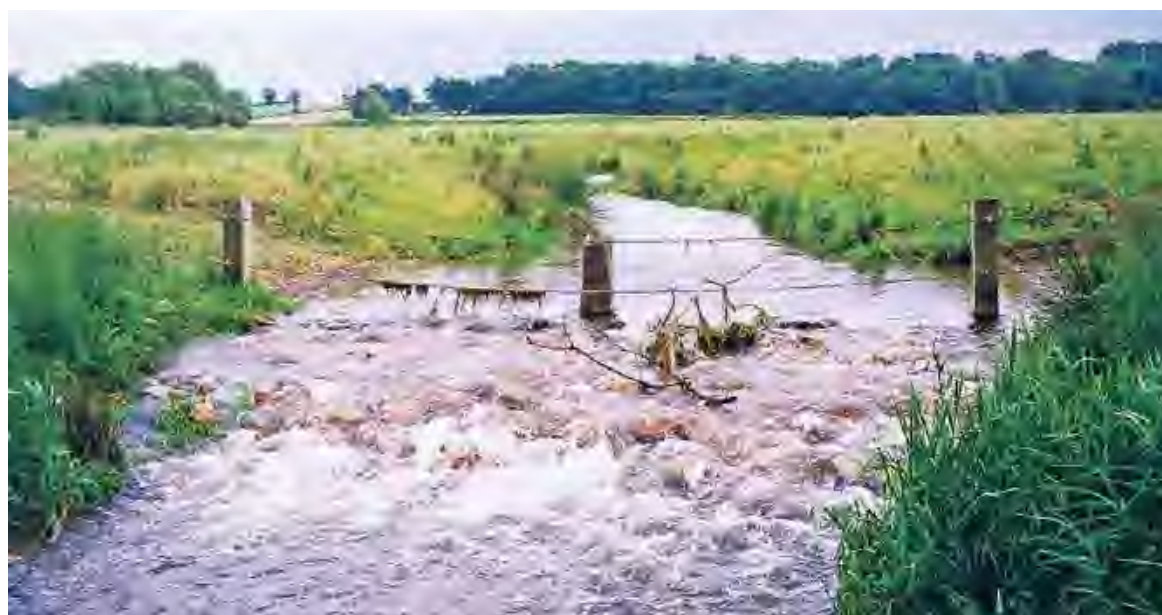
Weir and rock apron

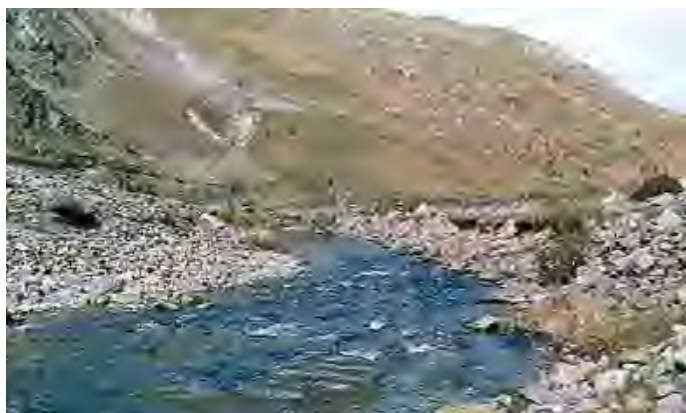
Deep channel and dredgings on bank  
at Blaen-y-Nant confluence

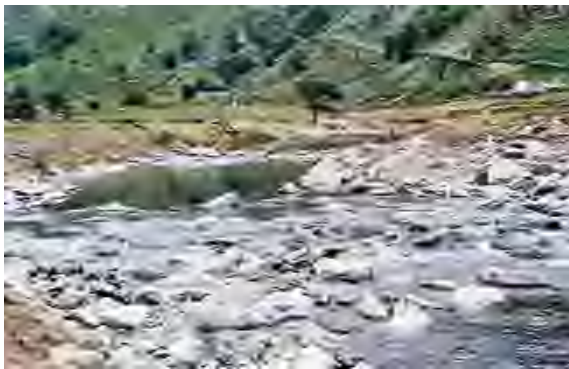
Lower 'stepping stone' cascade

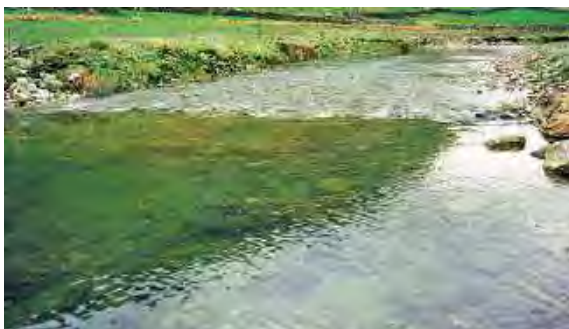
Flatter 'riffle' cascade  
with upstream pool

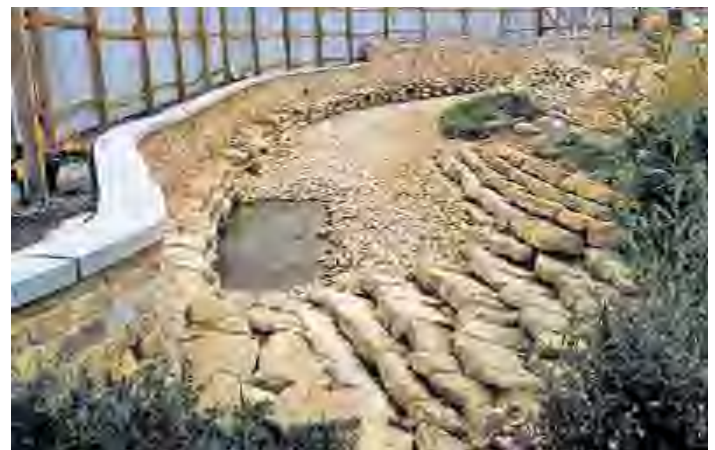
Simulated rock outcrop with downstream pool

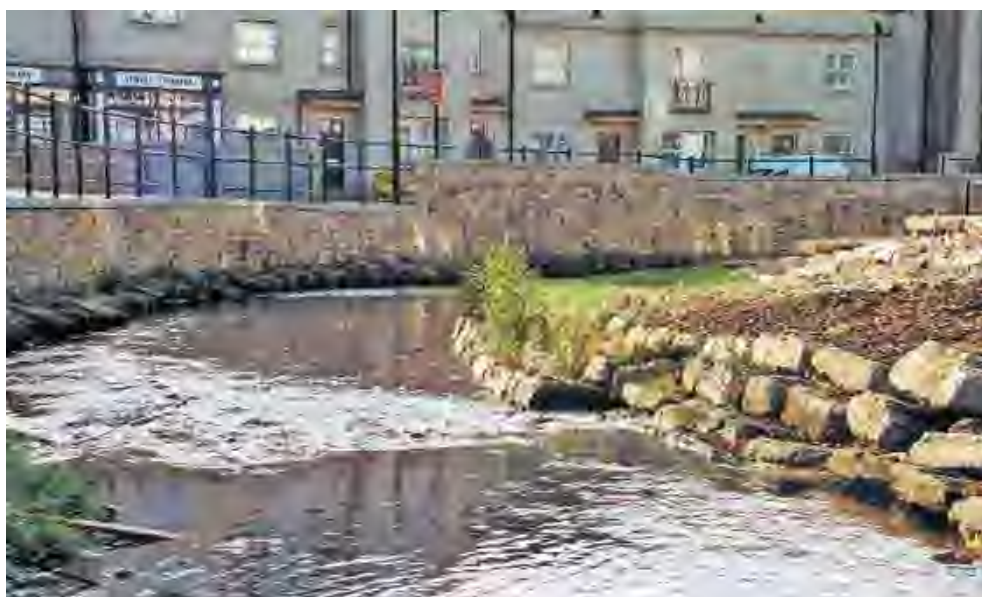
**Figure 5.4.2**

Flat slabs of Purbeck limestone had been selected for a variety of purposes throughout the site and for use in the two outcrops. The slabs needed to be laid with a constant angle of dip and needed to provide a gently sloping face over which the water would tumble down to the lower level. A practical method of arranging the slabs needed to be developed; the outcome is shown in *Figures 5.4.1 and 5.4.2*.

Firstly, the upstream row of slabs was laid carefully to line and level in a bed of concrete. The concrete secures the required crest level along the tips of the slabs and also forms a cut-off wall that prevents water from flowing under the structure which can otherwise cause collapse. The angle of dip and the thickness of individual slabs determine the size of the jagged 'notches' created along the crest. Slab thickness of between 0.1m and 0.15m were found to be best suited. The slabs are extended upwards into each bank to become part of the revetments indicated on the site plan (see *Technique 1.5*).

The effect of the jagged notches created by laying the stones at an angle is to generate an audible tumble of water over the whole structure. The concentration of flow down these irregular notches is likely to prove helpful to the passage of fish.

SECTION B THROUGH CENTRE LINE

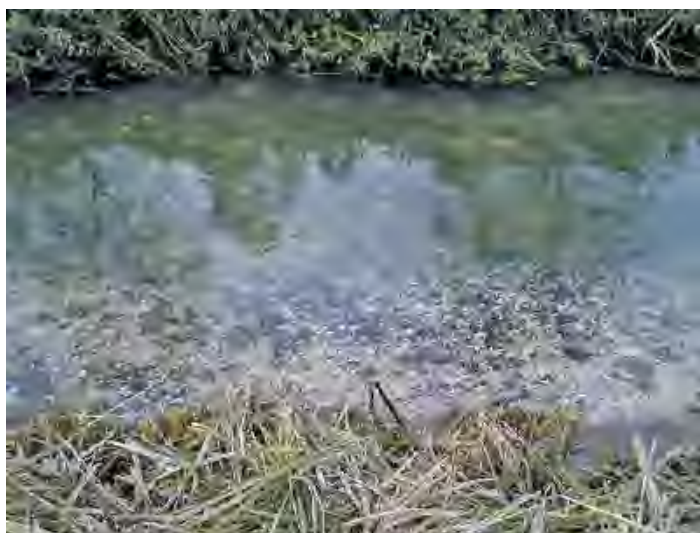
The material used to shallow the channel depth was chalky and gravel flints. Where possible it is advisable to use material from the immediate area to reflect the type of bed that would have been present under natural conditions. Here the gravel fill was excavated from the floodplain by the creation of an adjacent pond on the right bank. The suitability of the material was checked beforehand by the inspection of machine-excavated trial pits. Infill material was predominantly a mixture of gravels and flints varying in size from 0.02m to 0.01m, with <5% coarse sand and minimal silt. A few larger flints were also present.

Flinty gravel used to narrow and raise the river bed

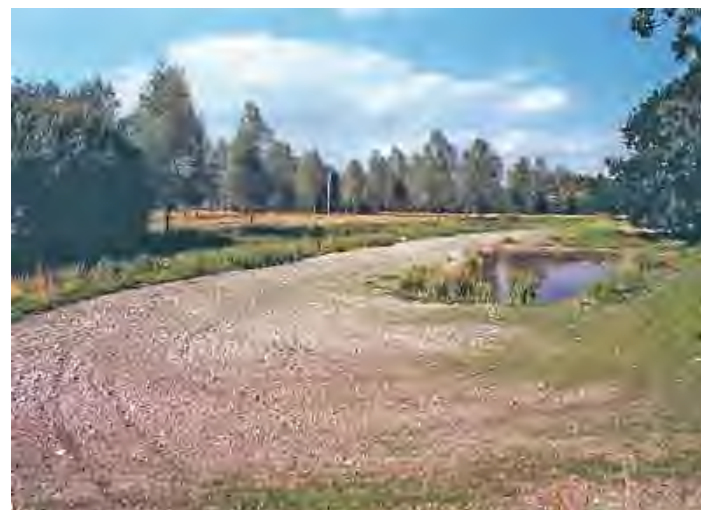
New pond with early growth, showing the gravelly nature of the floodplain material

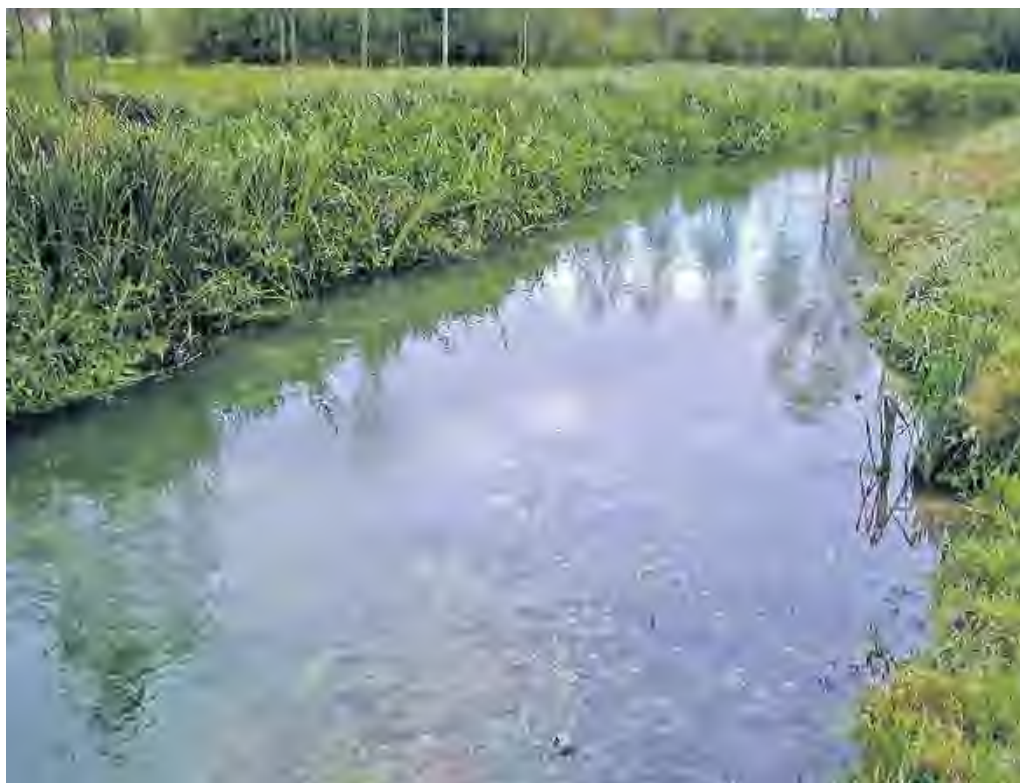
A few months after completion, the raised bed evident

Gravel has been used to shallow and narrow the remaining open water channel by up to a half, with the shallower margins finishing just below the  $Q_{90}$  level. The remaining low flow channel is raised to within 0.5m of the  $Q_{90}$  surface.

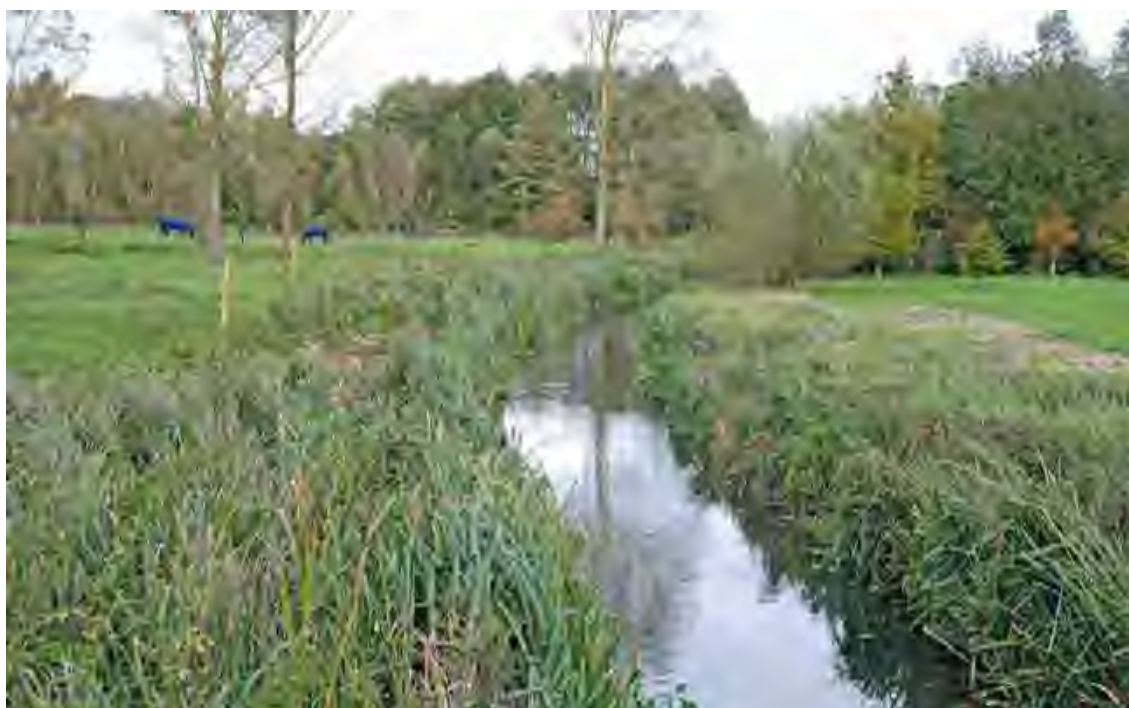
Effective narrowing of the channel and asymmetric shallowing of the bed has occurred following restoration – 2011

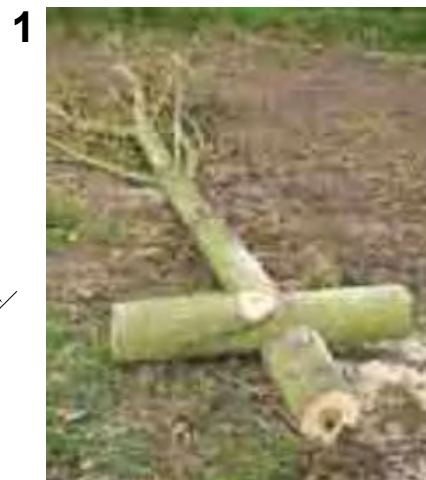
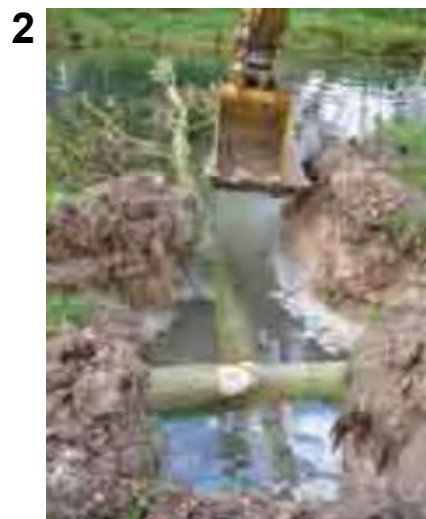
Firstly a cross-shaped trench was excavated. Then the tree to be placed in the stream was attached to another shorter section of timber using a mortise and tenon joint and high tensile wire (see Photograph 1), forming a crucifix shape. Finally the completed structure was lifted, using a long reach excavator, placed into the excavated trench (see Photograph 2) and then backfilled.

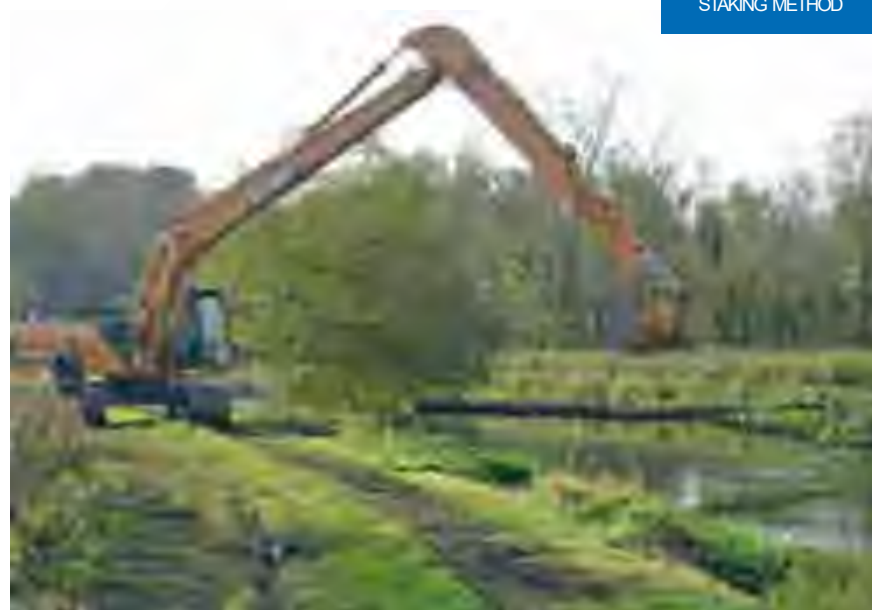
PHOTOGRAPH OF  
STAKING METHOD

Three different fixing techniques were used. Initially a crucifix design was used but, where the bank was very soft, an alternative anchoring technique was utilised. Where there were water vole (*Arvicola amphibius*) colonies, or the riverside path had to be kept intact, a staking technique was used to avoid cutting a slot and disturbing the bank or path.

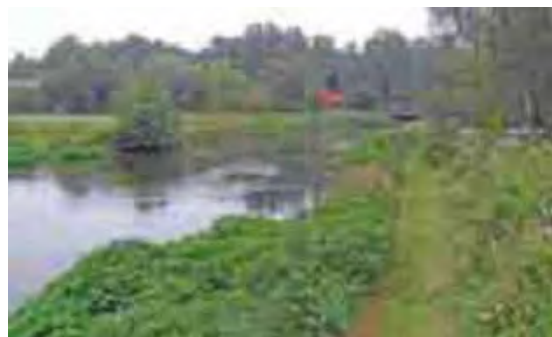
Wide slow flowing channel lacking flow variability – August 2008

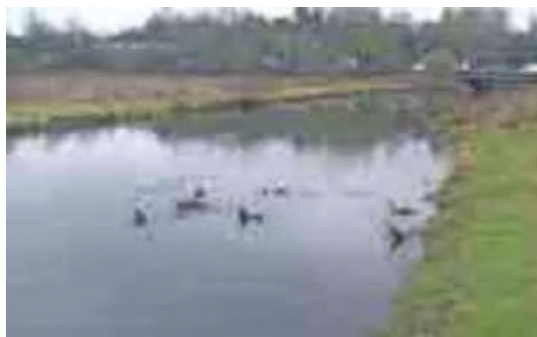
Trees installed on the right bank. Submerged with branches just protruding out of the water – January 2009

Large whole trees were installed on the left and right bank either side of A303 over a distance of 850m (see Figure 5.6.1).

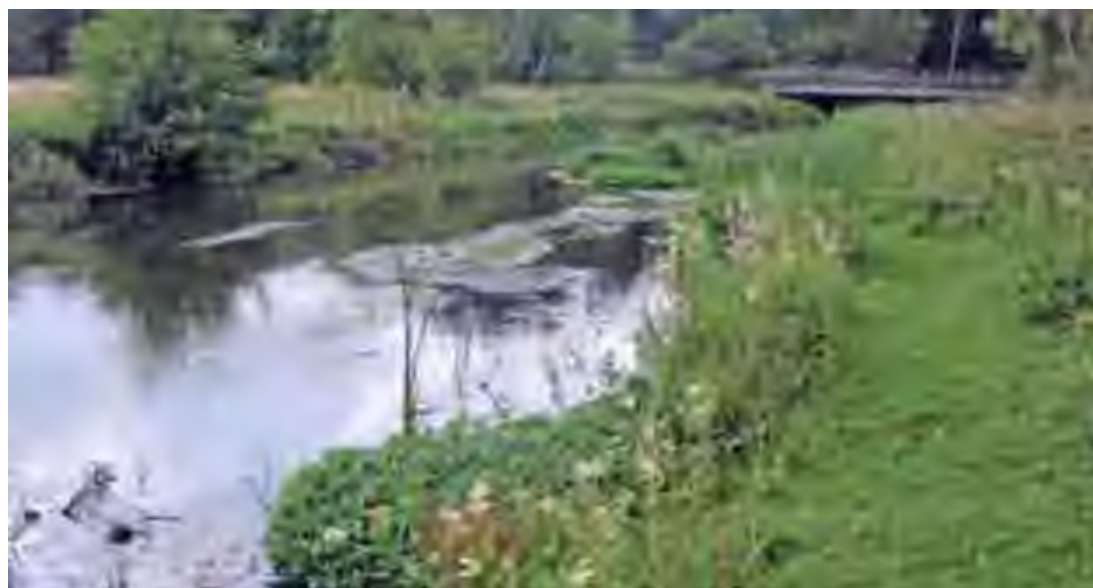
One year later, wood deflectors are collecting rafts of weed and providing shade, cover and habitat. Silt has been deposited between the deflectors.

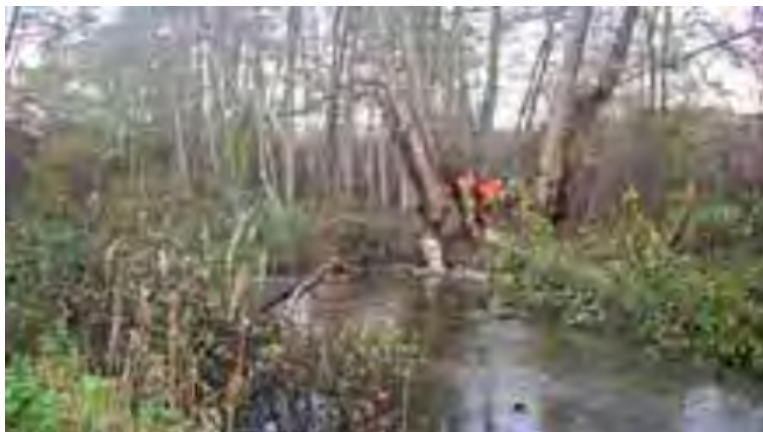
- 1** Select trees which are already leaning over the water and are likely to eventually fall in the river.

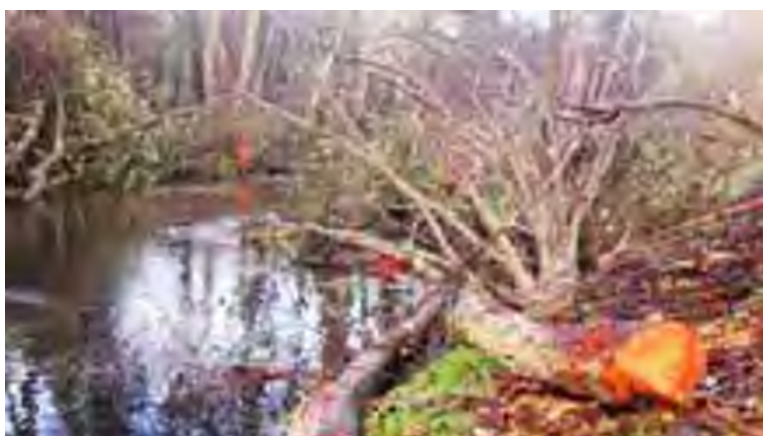
- 2** Fell them so that they remain attached to the stump (often referred to as 'laying' or 'hinging') or so that part of the trunk stays on the bank. Allow branches to penetrate the river bed to increase the stability of the tree and to prevent the tree from rolling or being mobilised by the flow.

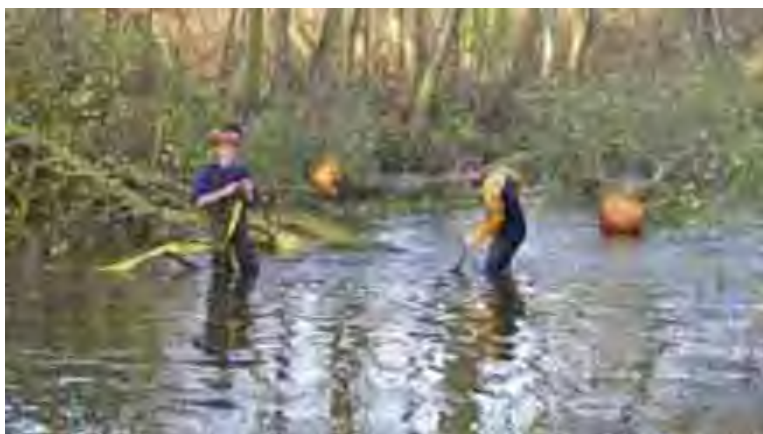
- 3** Modify the position if necessary to maintain an open channel if the felled tree blocks the flow. If absolutely necessary, prevent movement with a 1.5m stake.

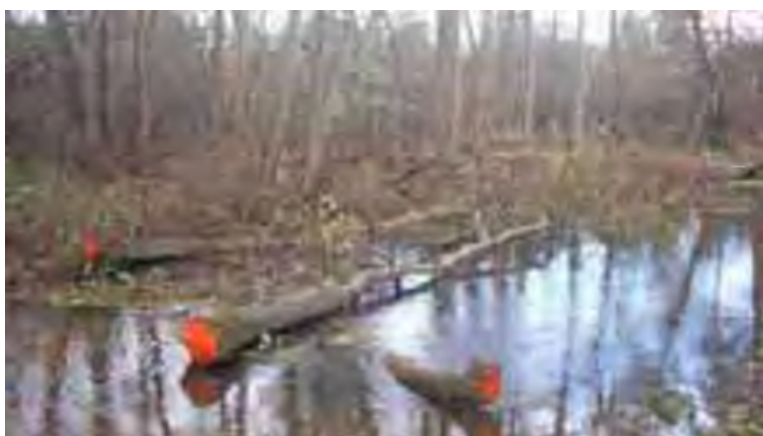
- 4** Fell more than one tree on top of each other to provide a greater mass to the structure and give a dense web of branches.

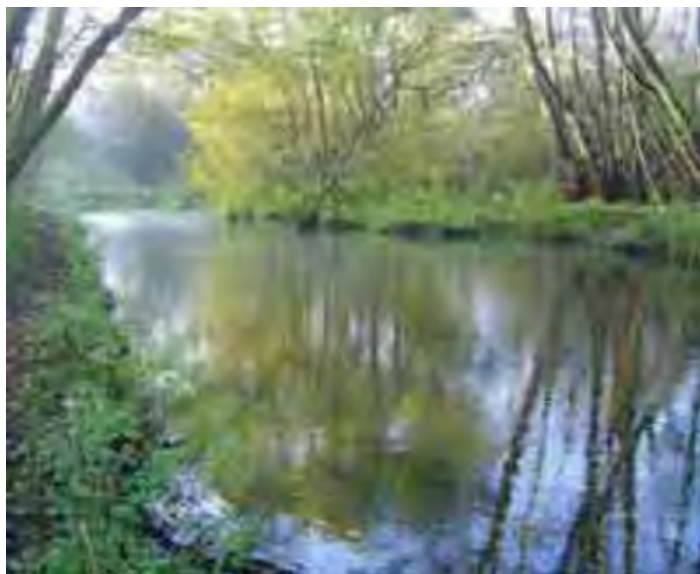
Before – Overwidened silt laden channel

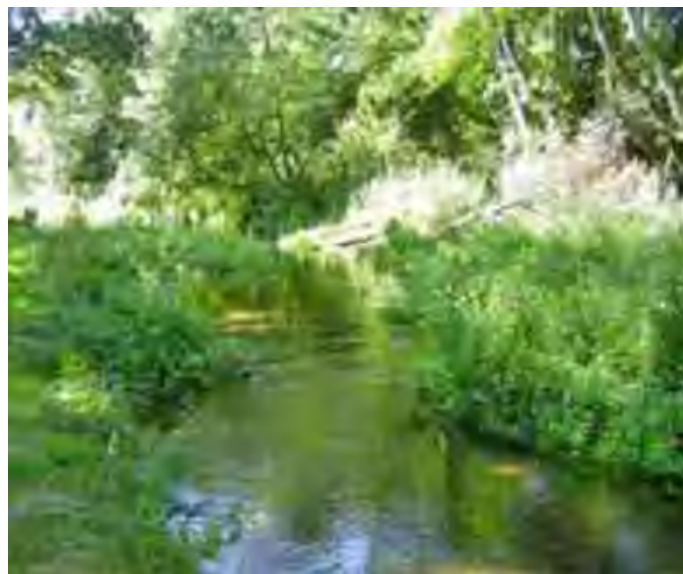
After – With narrowed channel and vegetated berms where silt has built up downstream of the felled trees – 2012

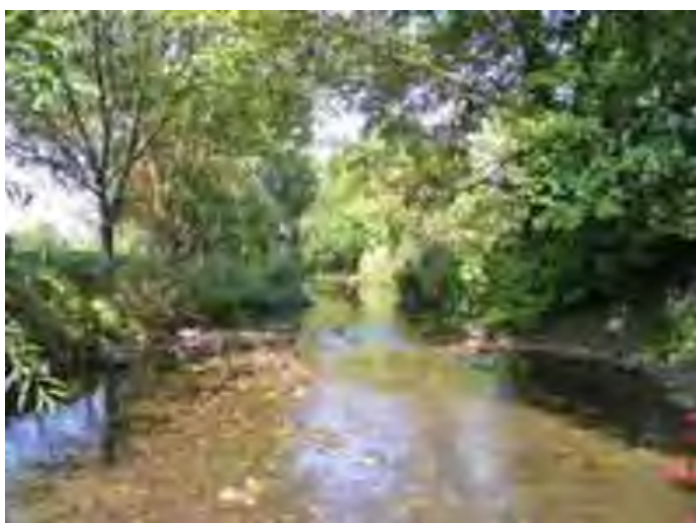
Over-widened channel prone to low flows.  
Little or no marginal or submerged vegetation  
– July 2005

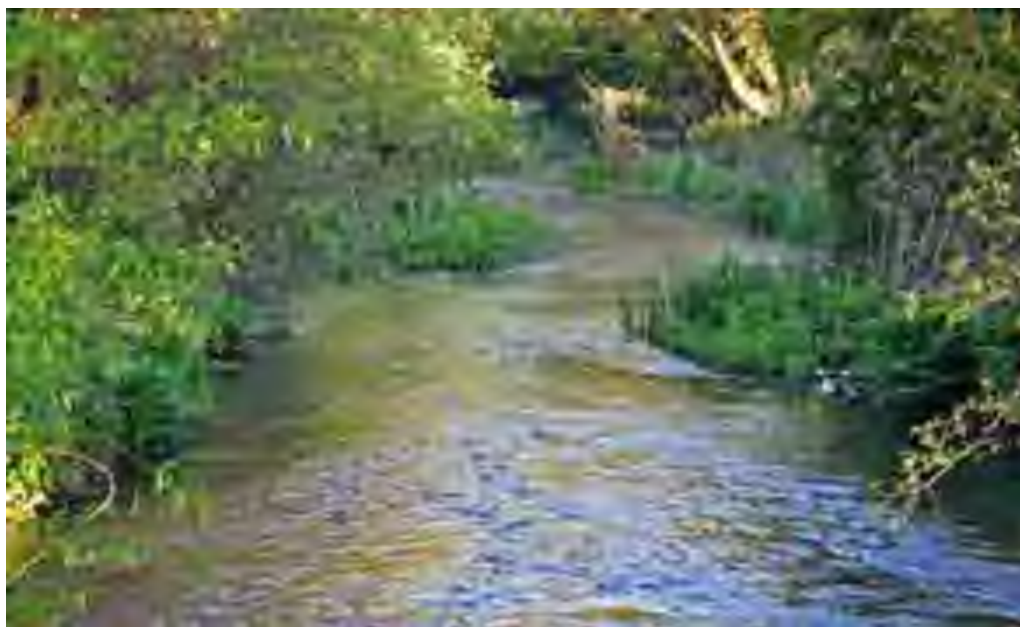
5 years on the channel is narrower and more sinuous. Vegetation, both submerged and riparian, has established well – May 2010

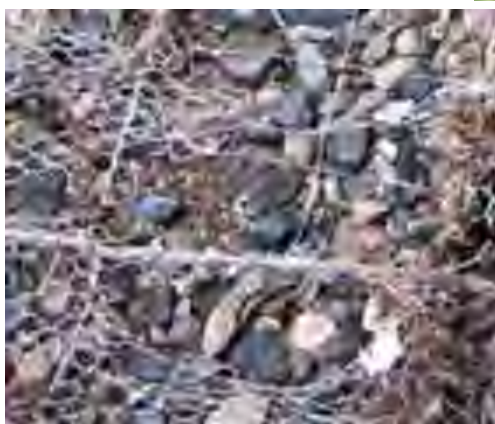
Close up of the degraded  
Reno Mattress base  
– 2007

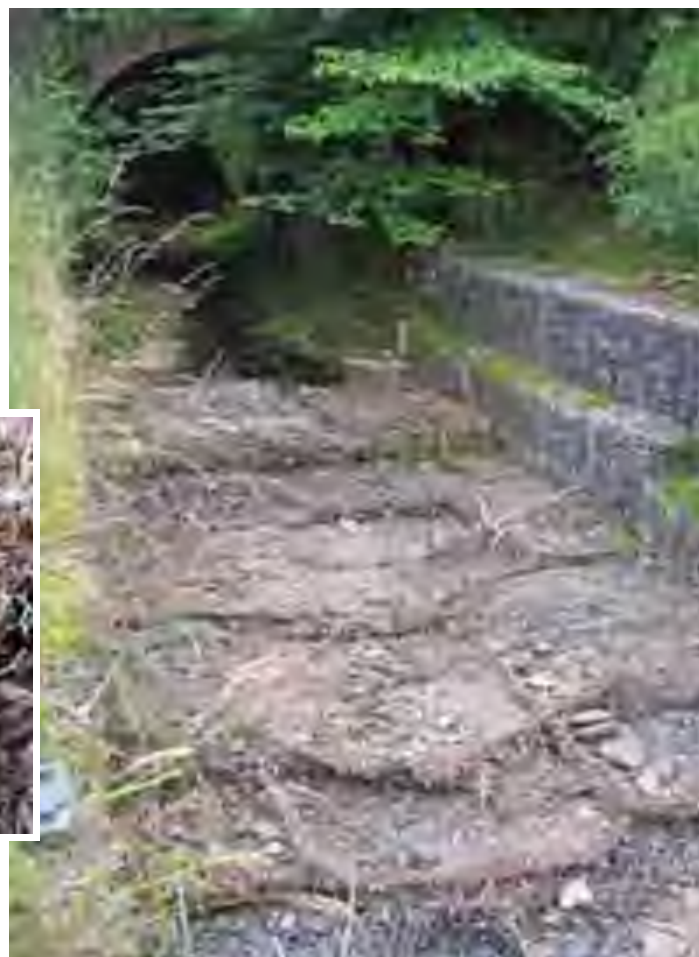
Before restoration works showing complete failure of the wire structure and no surface flow – August 2006

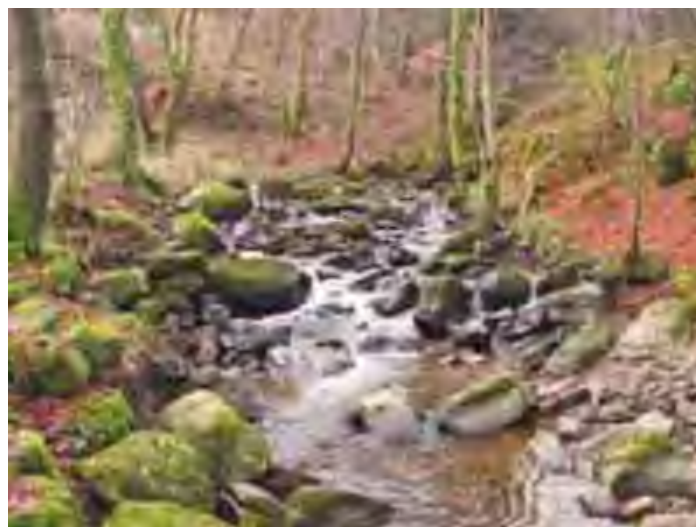
The natural channel, a few hundred metres upstream, showing the variable step-pool configuration formed by large boulders – November 2005

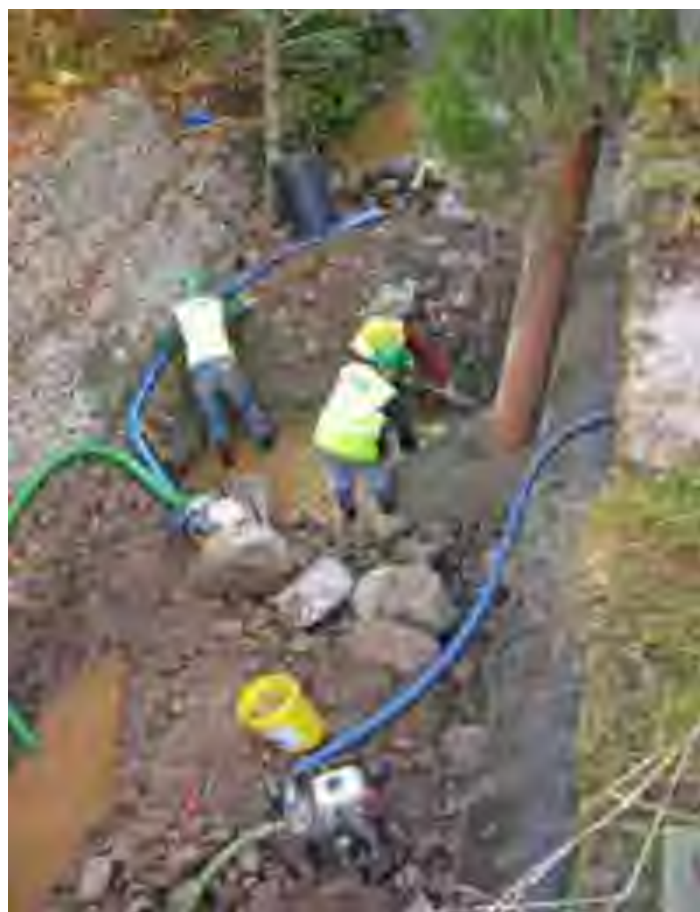
Excavating for the concrete base to bed the larger boulders – October 2007

The high gradient meant that there was a need to ensure that the keystones did not move. For this reason, a buried concrete base and steel pins were used to fix the most critical bed elements. Where concrete was to be used to bed-in the steps, it was specified to be buried at least 0.5m below the stone and cobble base to ensure that it remained unseen (*Figure 5.9.1*).

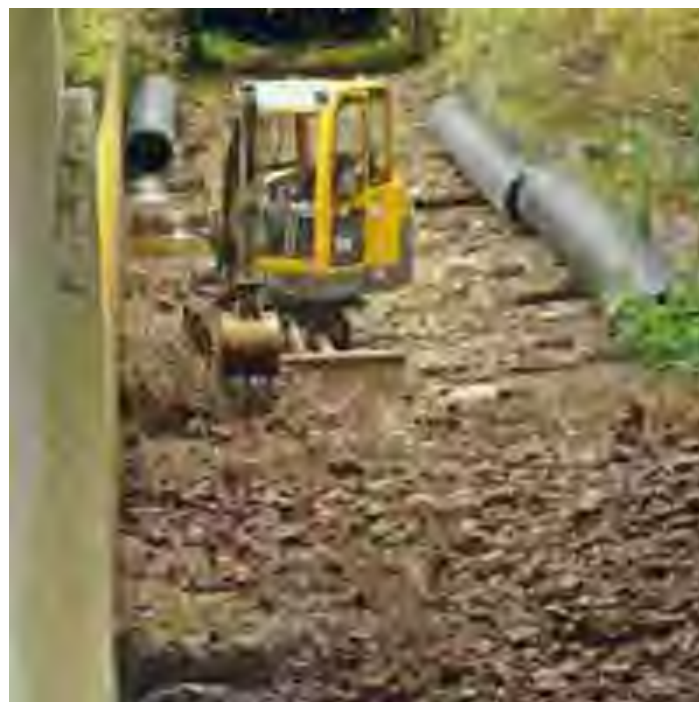
Wire from mattresses in bed removed. The stone was retained to use in the new step-pool system – 2007

First, the wire from the disintegrating mattresses was removed. The cobbles that had been transported downstream were retained for reuse. The work was carried out during a dry period, with all of the low flow in the burn routed through a 0.5m diameter pipe.

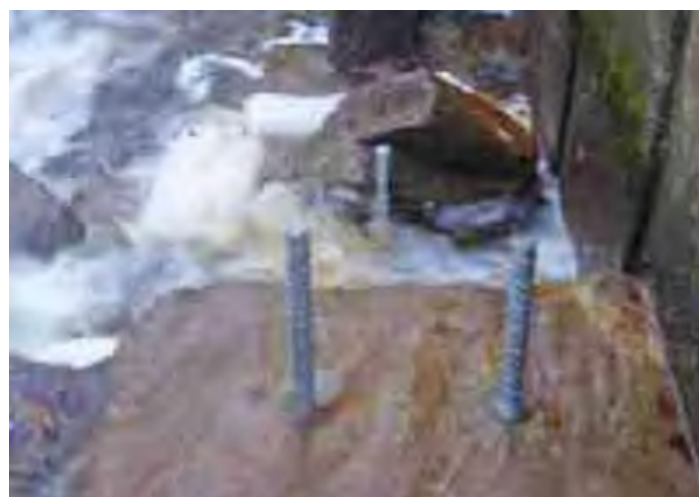
Steel pins in the concrete retaining wall toe awaiting boulder placement – 2007

The vertical concrete right bank (i.e. the road bridge footing) was constructed with a 0.5m wide toe which had previously been hidden beneath the wire mesh bed. This stepped ledge needed to be hidden by the new works (for aesthetic reasons and to prevent undercutting) and therefore provided a secure foundation for locating a number of the keystones. The boulders and concrete ledge were both drilled and the boulders then fixed in place with resin and steel pins.

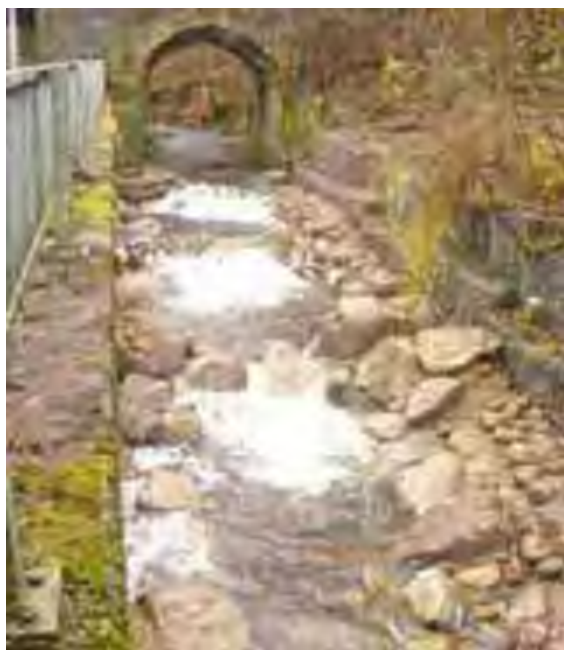
Immediately after completion  
– December 2007

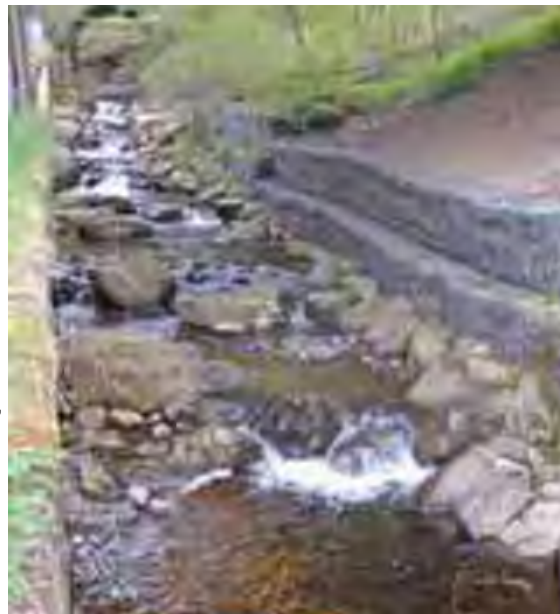
Beneath the A9,  
five years after  
– May 2012

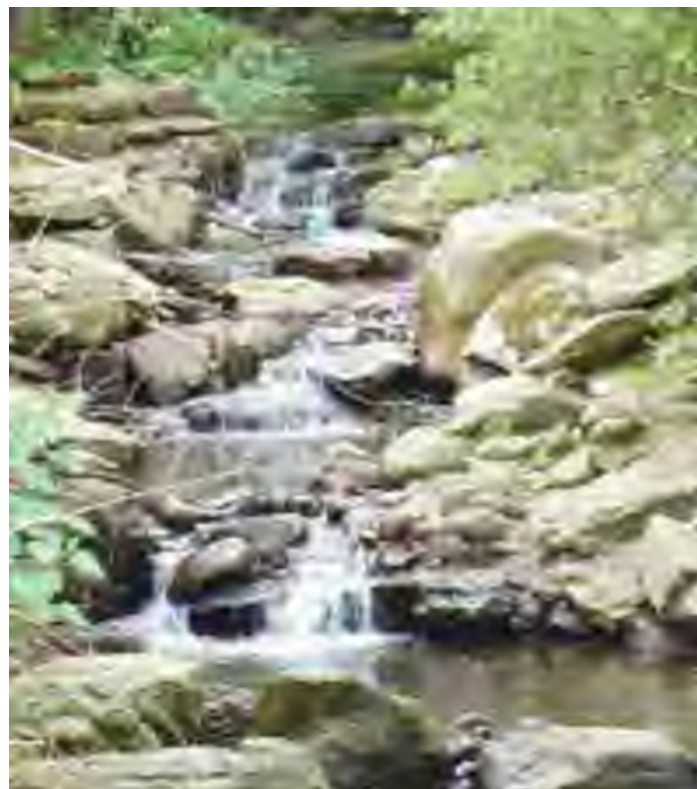
The restored reach mimicking the step pool configuration of the upstream reach – May 2011

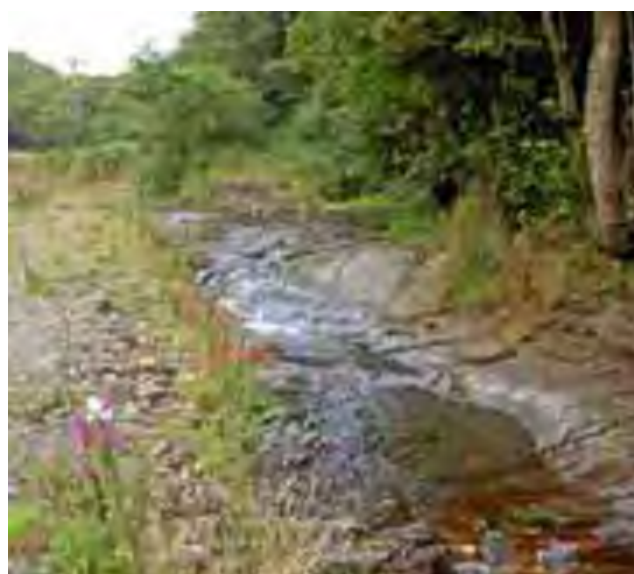
Natural cascade and pool upstream of Boscastle  
- 2006

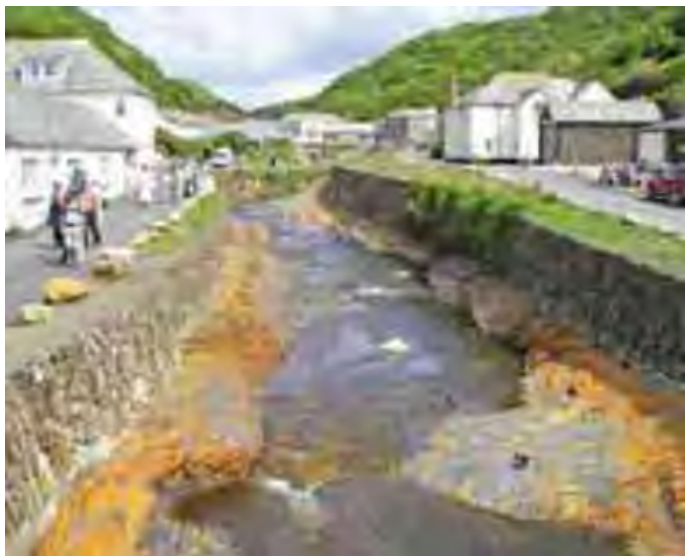
© Halcrow  
The low flow course had to be entirely excavated to best mimic millennia of erosion of a hard rock bed.

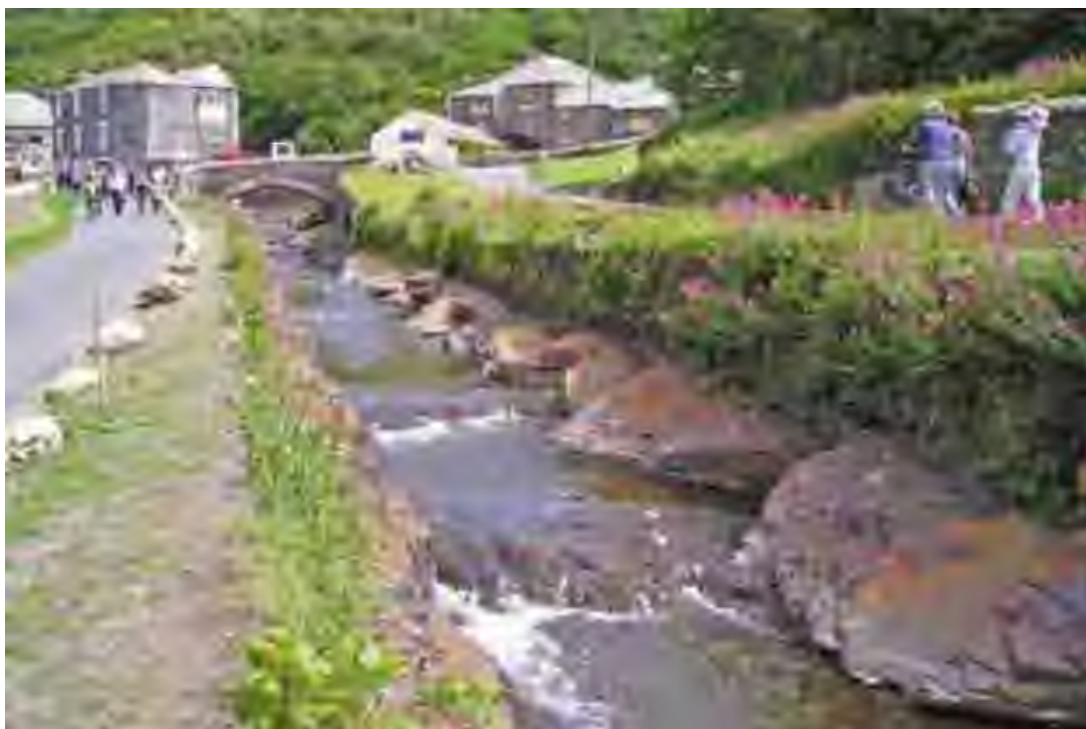
Deepened channel using natural fracture lines within the bedrock. Retaining walls becoming vegetated

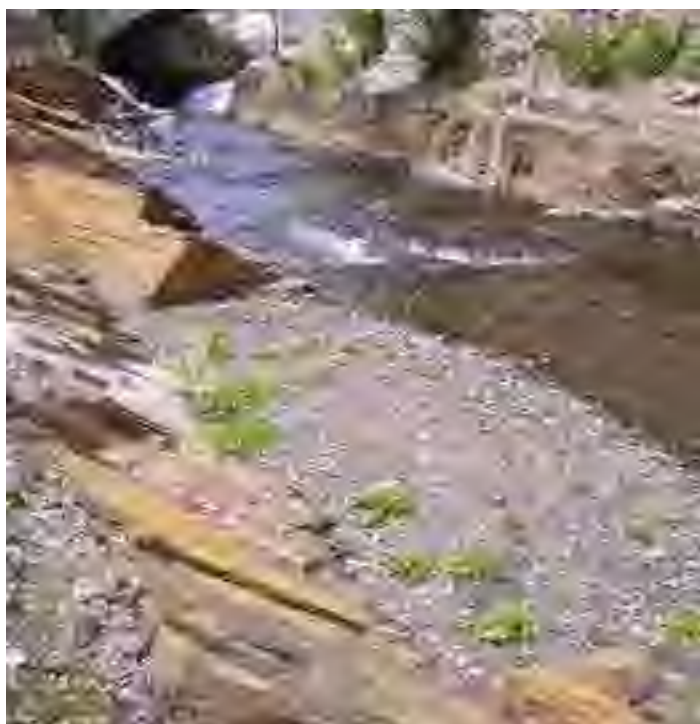
Gravel beaches have formed within the bedrock channel

The re-profiled river has performed well during the years since completion. The excavated profile has remained stable, as have the individually sculpted cascades, pools and embayments. Within the latter a good diversity of flow characteristics provides niche habitats, with some gravel in sheltered eddies as well as small beaches. It is also visually attractive, enhanced by the sound of the cascading water. This contrasts markedly with the flat, featureless river bed that existed before.

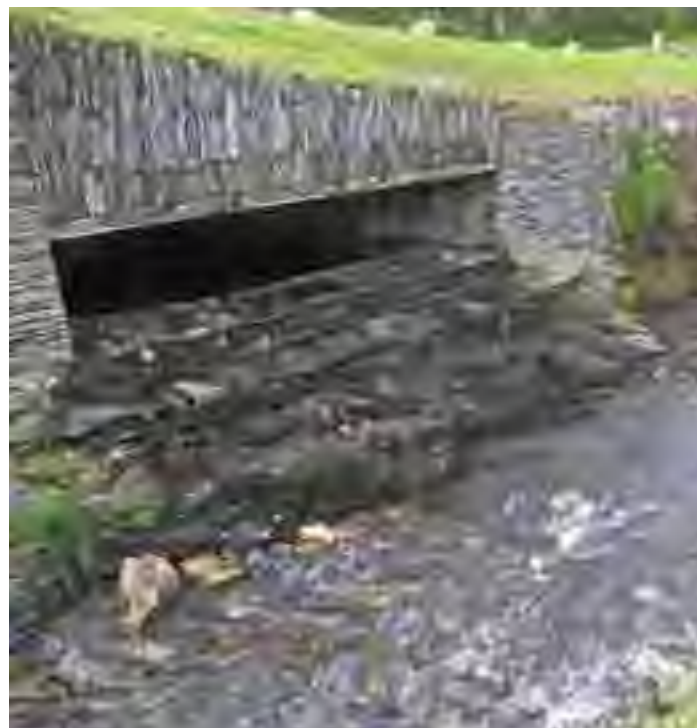
River Jordan outfall. The over-deepened pool has clearly filled with large stone sediment – October 2008

A single negative aspect has been the excessive deposition of stony sediment at one location. This is where the bed was significantly cut down below the optimum mean bed gradient of 1 in 45, to provide greater flow capacity where an overspill culvert of a tributary stream, the River Jordan, enters (See Figure 5.10.2). Bed material has simply filled this over-deepened pool to bring the bed back up to the 1 in 45 mean. Consequently there are no rock features in the bed here. This outcome was foreseen and this 'pool' had been designed such that the excess fine deposits would remobilise during flood flows, thus

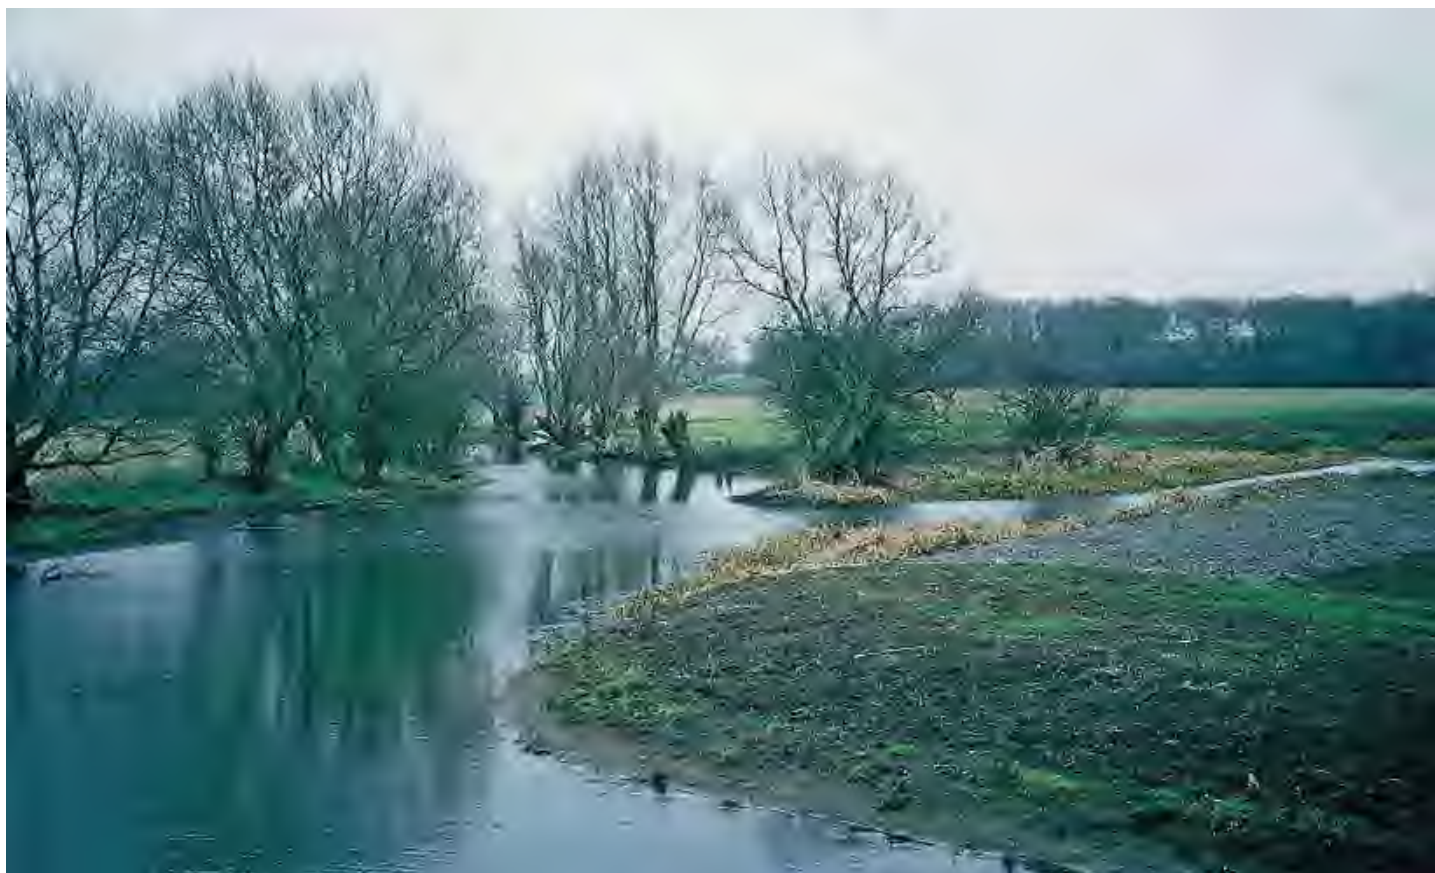
Spillway **S2**. Flood flows indicated by the arrows overtop the spillway, merging with the new channel (not visible) on the Great Eau at Withern

Spillway **S2** begins to operate only after **S1** has filled the new channel with water. Water spilling over **S2** passes directly into the new channel causing it to overflow its banks and initiate field flooding. Scour of the overspill is minimal because this design ensures floodwaters from both **S1** and **S2** merge without excessive turbulence.

The level at which **S2** is set is critical; it is 300mm lower than the floor of the mill further down river, to ensure floodwater is diverted away from the mill. In practice, **S2** replaced an unsightly concrete cascade weir built at the mill to protect it from flooding. The cascade has been boarded off and will be infilled once the performance of **S2** is proven to be satisfactory.

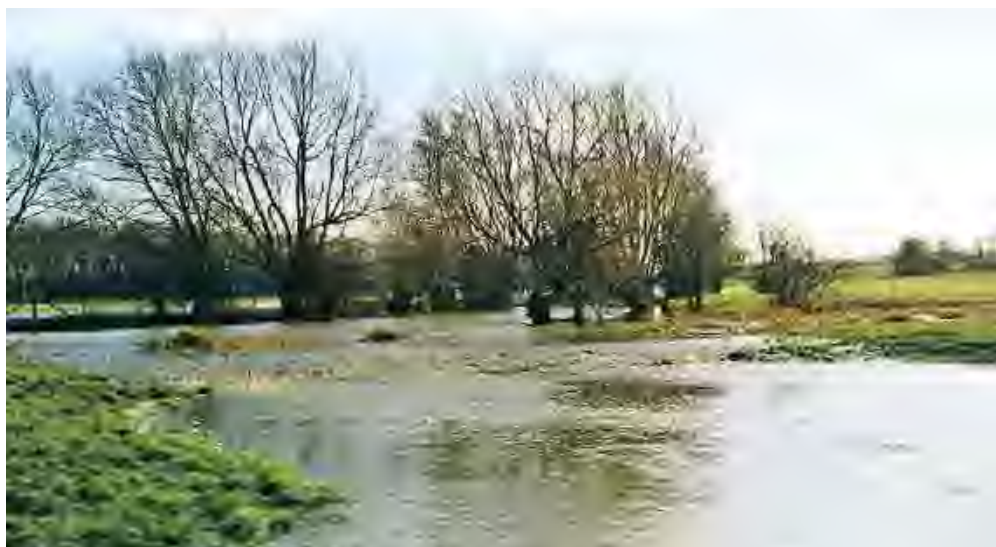
Spillway **S2** in flood

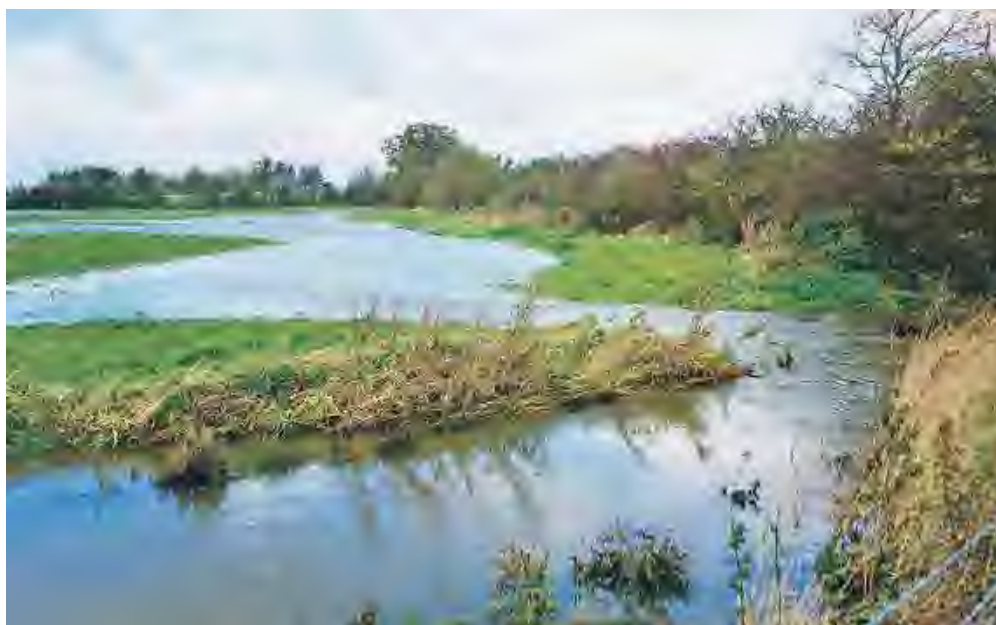
Spillway **S4**. Floodwaters spilling into field gully.

The drain was enlarged to increase its flow capacity and the bank level at the overspill point, lowered to form spillway **S4**. The spillway is located close to a natural gully that meanders down through the floodplain fields and probably marks an ancient river course. The spillway was completed by shallow excavation of the field to extend the gully right up to the bank of the drain.
