# Controlling River Bed Levels, Water Levels and Flows

## RIVER COLE

**Figure 5.1.1**

### PLAN OF BIFURCATION WEIR

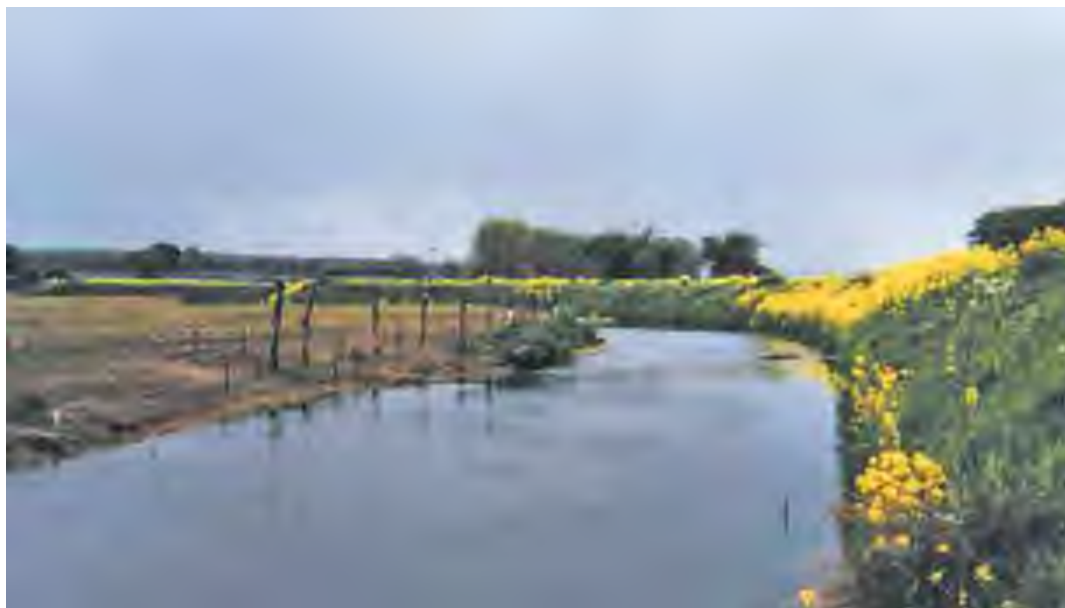
Removal of the left floodbank and marginal berm creation on the Great Eau at Withern

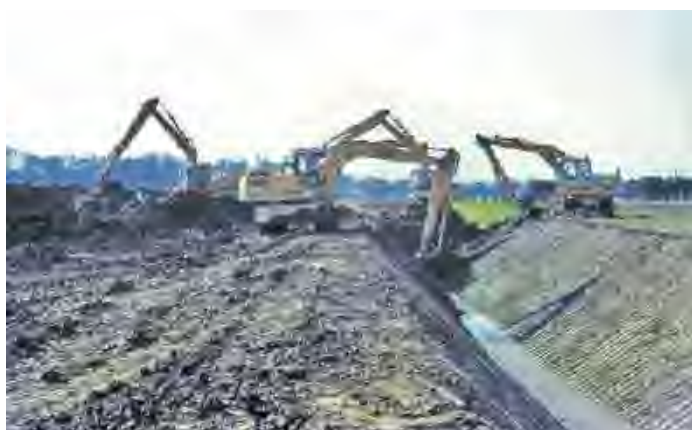
Relocating the IDB drain and set-back floodbank

The 2100m<sup>3</sup> of spoil from the bank removal was used to fill in an Internal Drainage Board drain that ran through the centre of the proposed storage area. This had to be re-routed behind the new 'set-back' floodbank to maintain the integrity of the upland and lowland drainage system. Material excavated from the construction of the new drain was used to form the new floodbank, set back from the river by up to 300m. The new bank is large due to the volume of material that needed to be excavated to re-route the IDB drain. The new embankment is constructed of clay with slopes of 3:1 to a height of 2.5m to 2.7m above the adjacent ground level. This gives a designed crest level of 4.5m above OD with a crest width of 3.5m minimum. The volume of material used for the embankment was 18,500m<sup>3</sup>.

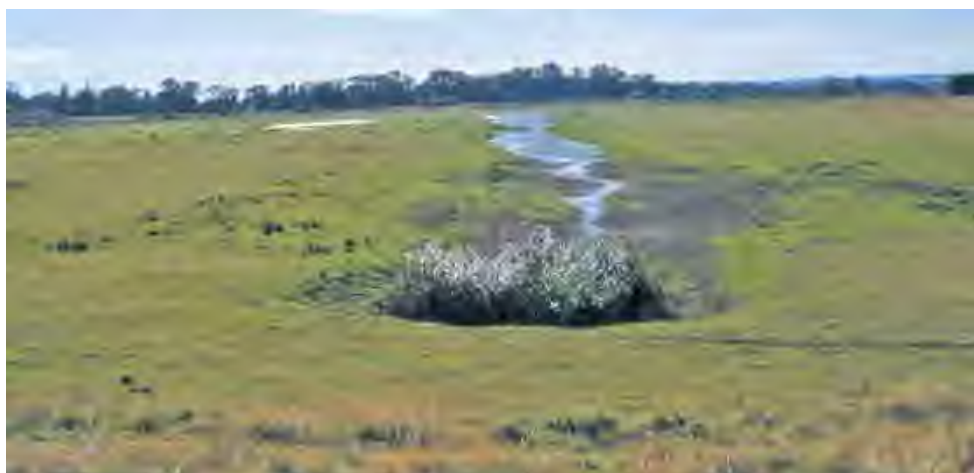
Floodplain, penstock and permanent wetland area  
– October 2001

Water is designed to spill onto the 16ha site from the Long Eau when levels reach 2.6m above OD, just 0.3m over their normal retained level. This floods progressively outwards from the old course of the IDB drain, which represents the lowest levels within the area. This low spot remains damp for much of the year, the downstream end forming a permanent wet scrape/shallow pool.

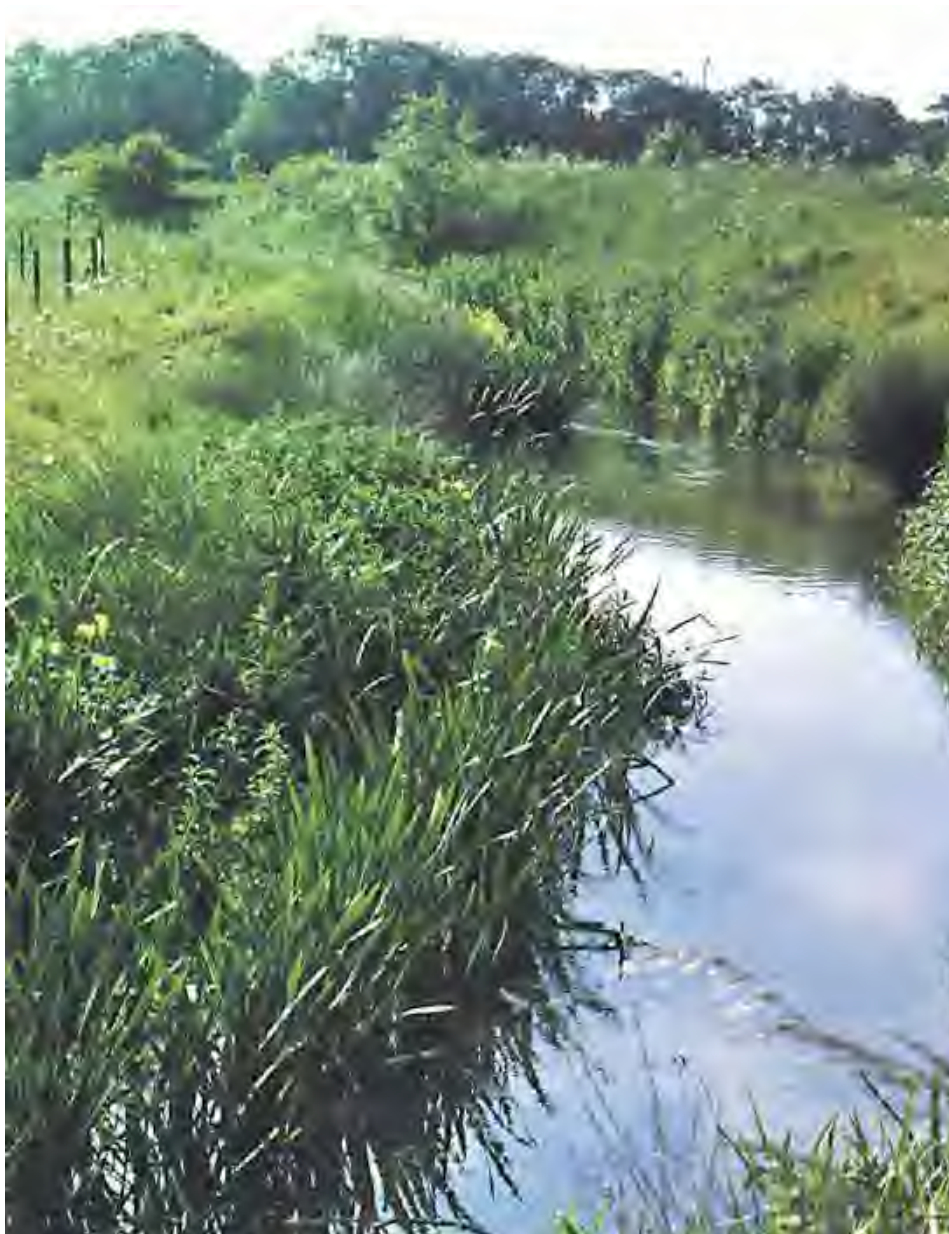
Berm at section A after 4 years

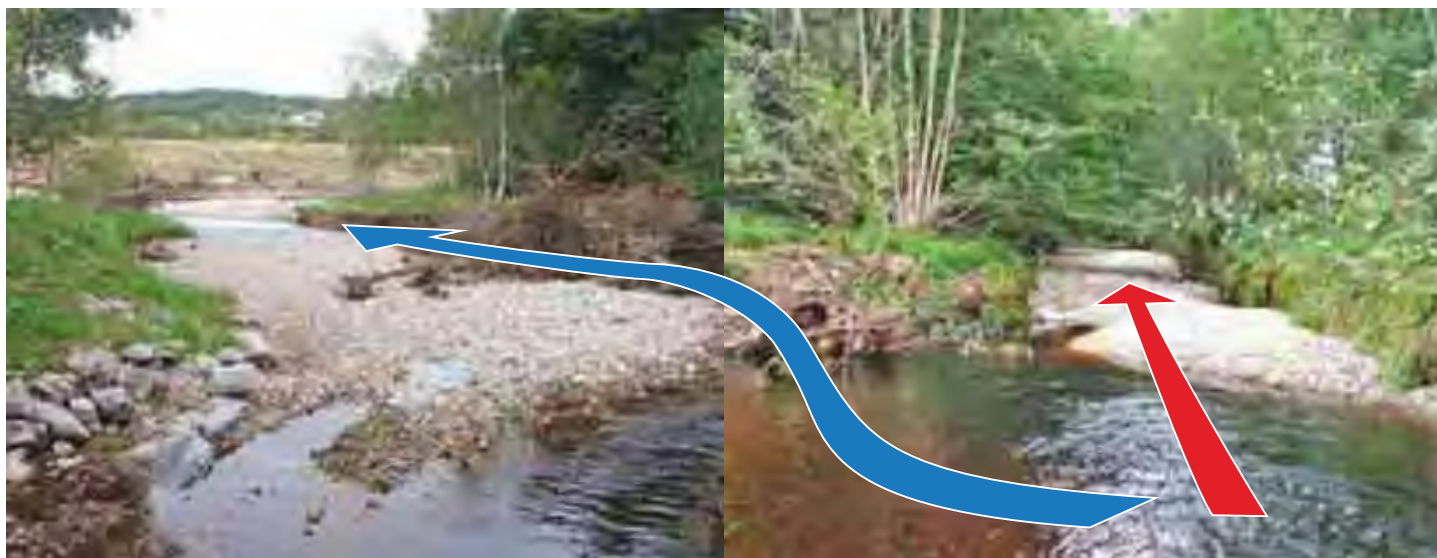
The upstream breach two years post construction: widening of breach and gravel deposit to the left; abandonment of the old course on the right (blue arrow=new route, red arrow=old route) – 2010

Approximately one year after the banks were breached in September 2009 the channel experienced an estimated  $30\text{m}^3/\text{s}$  flood flow (of the order of a 1 in 10 year event). The stone protection at the upstream breach was partially washed out, as anticipated. The breach enlarged such that the majority of the flow was diverted along the new route after the flow subsided. The result was rapid development of river features, including the formation of an outwash fan (see Figure 6.4.1). Some ecological degradation has occurred in the short term, as the old channel is now dry except during very high flow events.

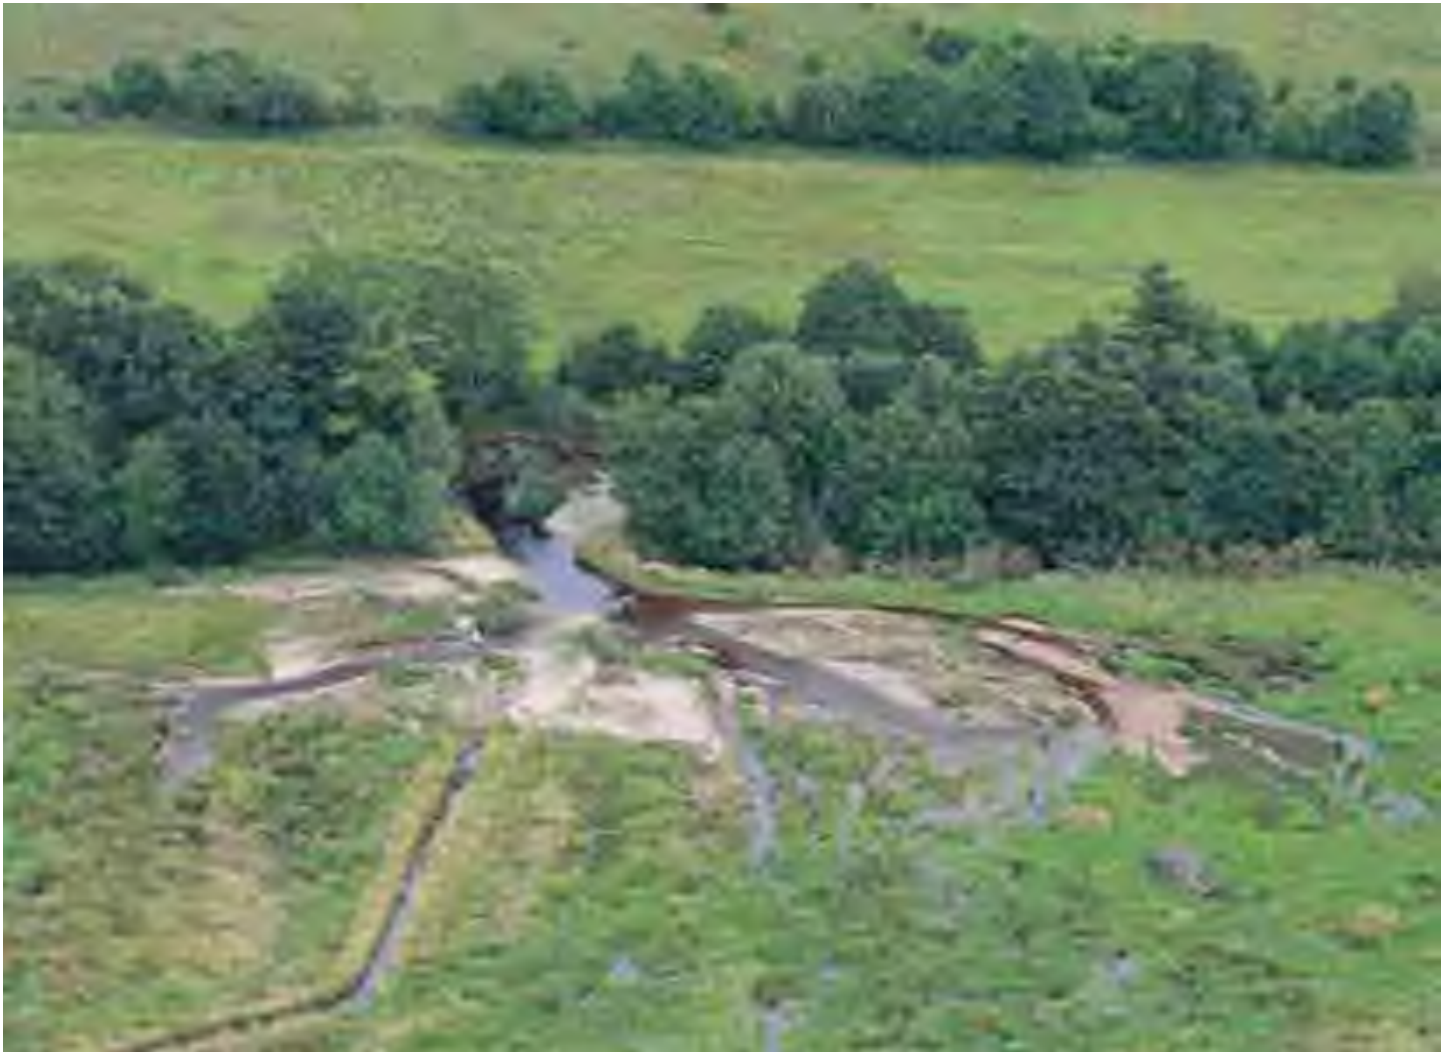
Sediment accretion area/outwash fan has developed  
at the upstream breach – July 2011

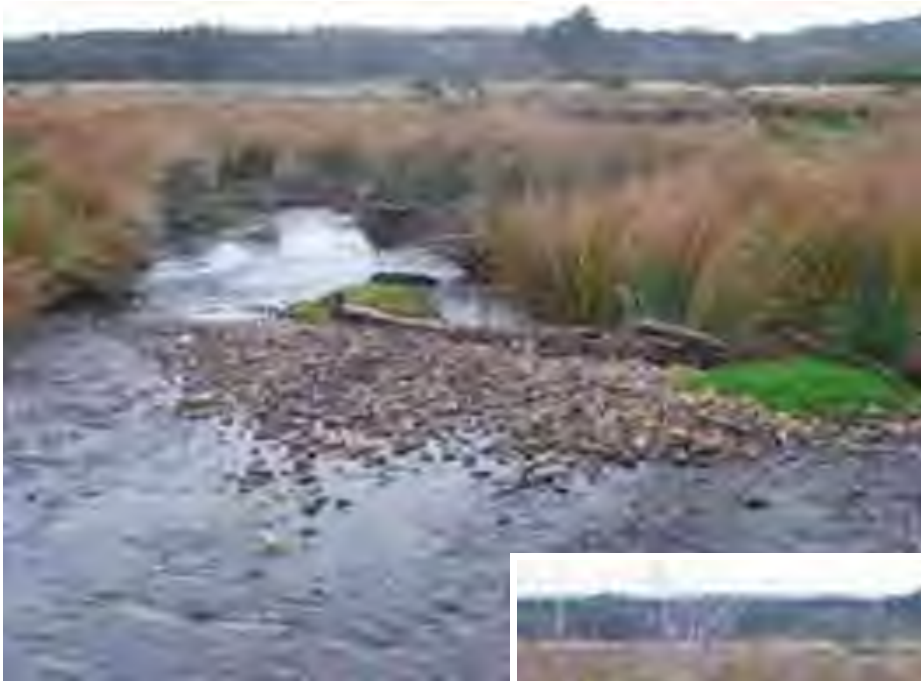
Channel development. The accretion area is storing woody material and river sediments – March 2012

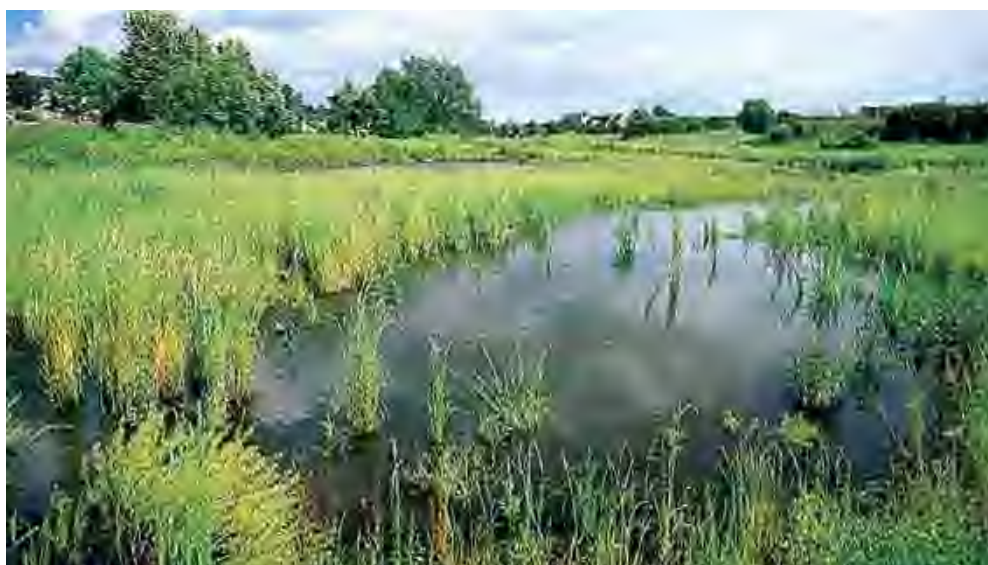
Completed spring-fed scrape

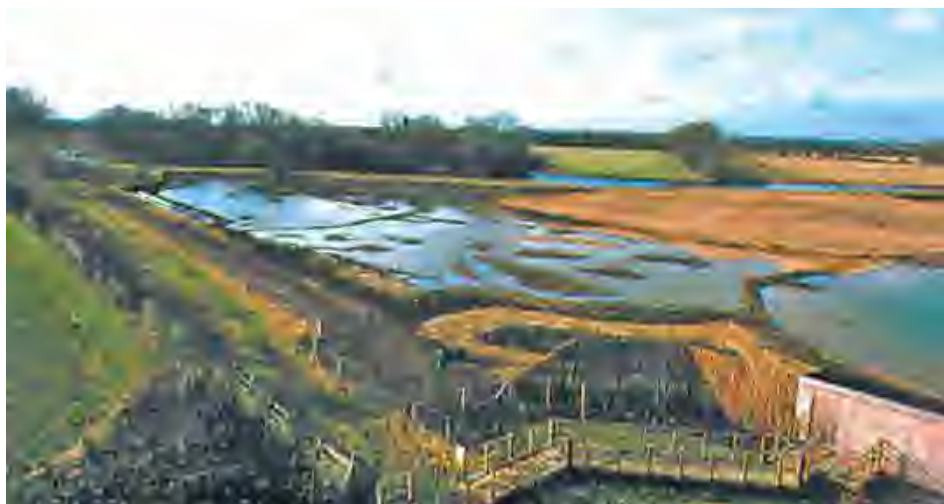
Wader scrapes  
– February 1992

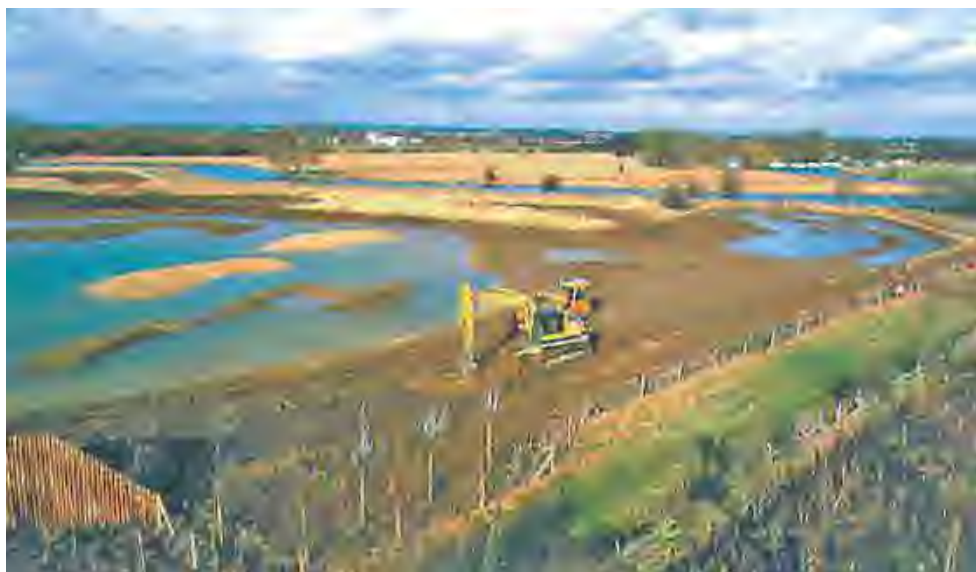
Main pond, pool and reedbed creation  
– February 1992

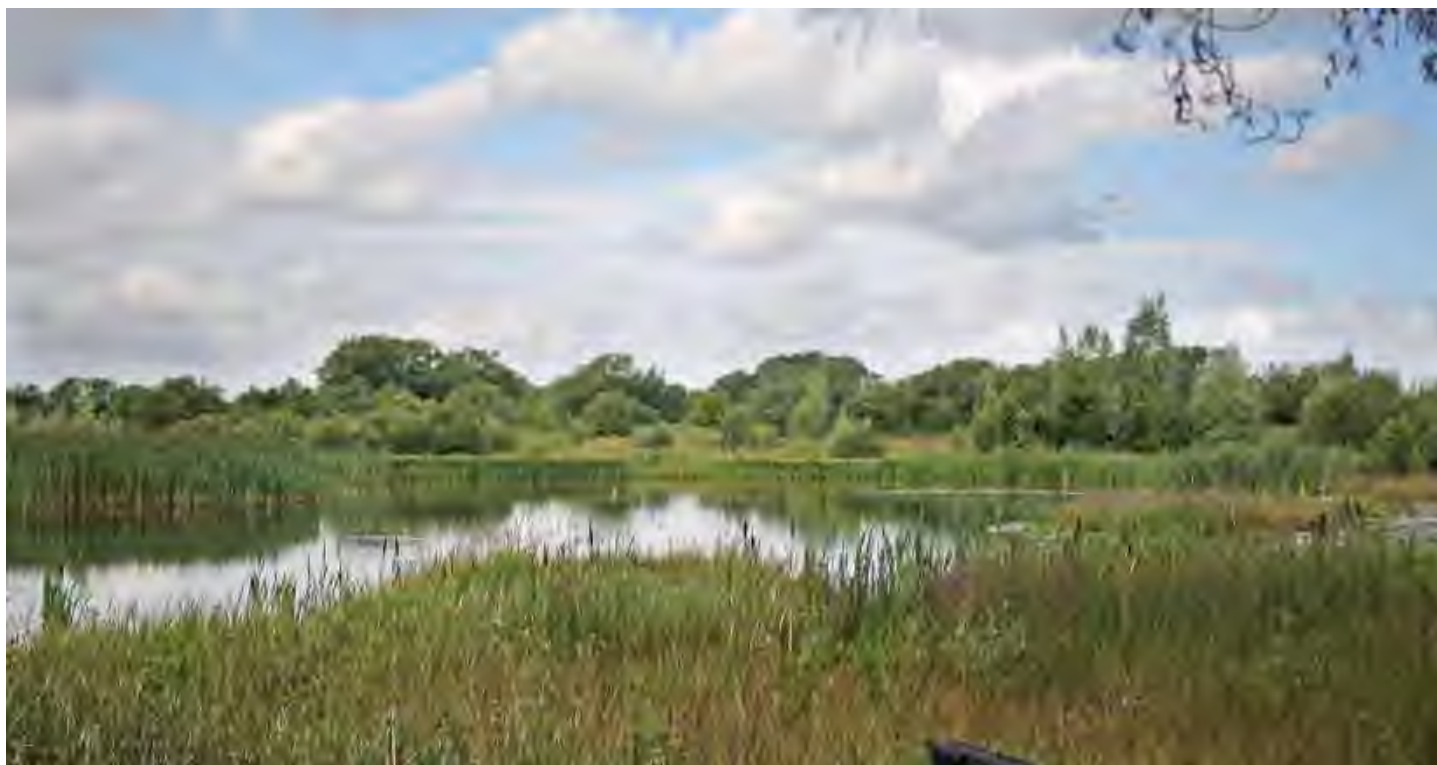
Main pond and gravel island continue to provide favourable habitat for wetland species – August 2013

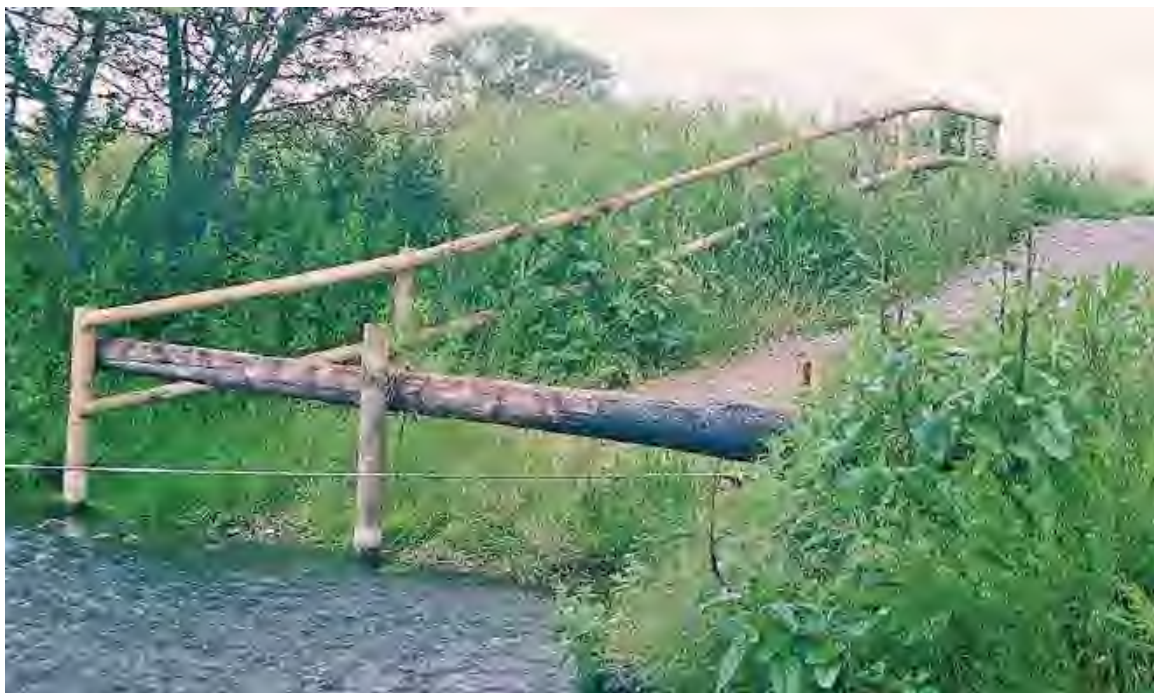
Stock watering point  
at ch. 100m

The river fencing comprises a single heavy wire cable strained tightly across on a diagonal line (see photograph above). The extra length of the diagonal renders the cable less likely to form a complete blockage of the river if floating debris becomes snagged on it. The angle of the diagonal is aligned to direct turbulence caused by its presence towards the mouth of the watering point, further reducing the risk of siltation.

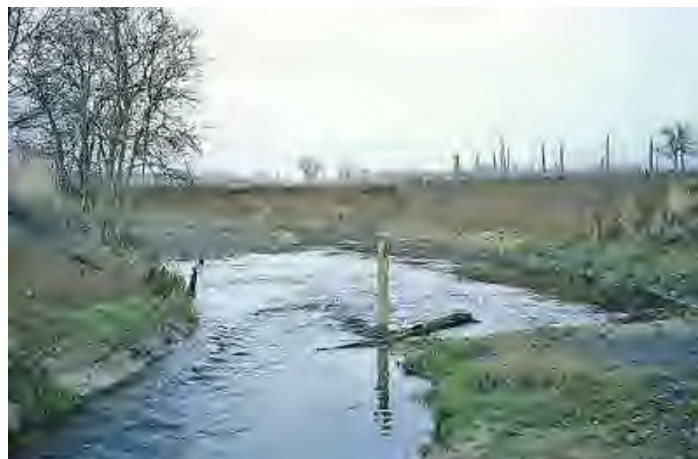
Ford at ch. 280m

Aligned between three mature trees on the old river bank to create an 'S' shaped feature, it crosses the new river bed on a long diagonal (circa 15m compared with the typical bed width of circa 3m). The position of this diagonal approximates to the likely position at which a self-sustainable point bar of gravel would form, because of the sharp bend just upstream.

Most of the ford is formed within the old backfilled river channel, which is carefully contoured to create smooth transitions with undisturbed ground on both sides of the river, as well as with the root levels of the three trees and with the newly excavated channel. The river bed and ramps are surfaced with stone over a filter fabric to suit livestock rather than heavy vehicles.

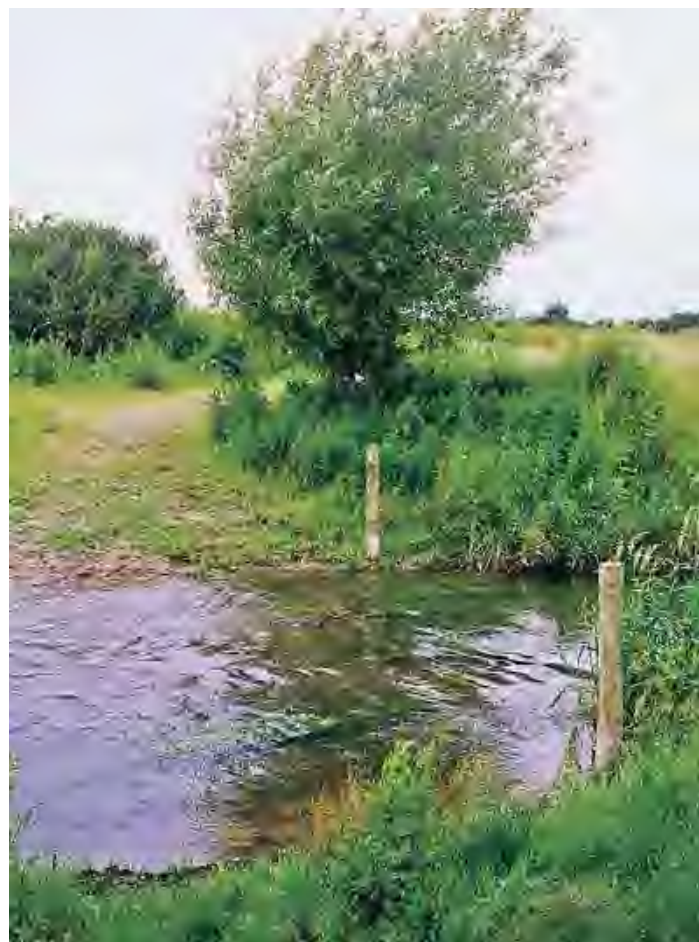
Equestrian ford at ch 620m

Despite the commonality of the design concept, each is individually configured to take advantage of local conditions and this is evident in the variety of visual interest and habitat diversity that has resulted. Of particular note, water crowfoot is thriving in the tailstone of the equestrian ford and ch. 620m.

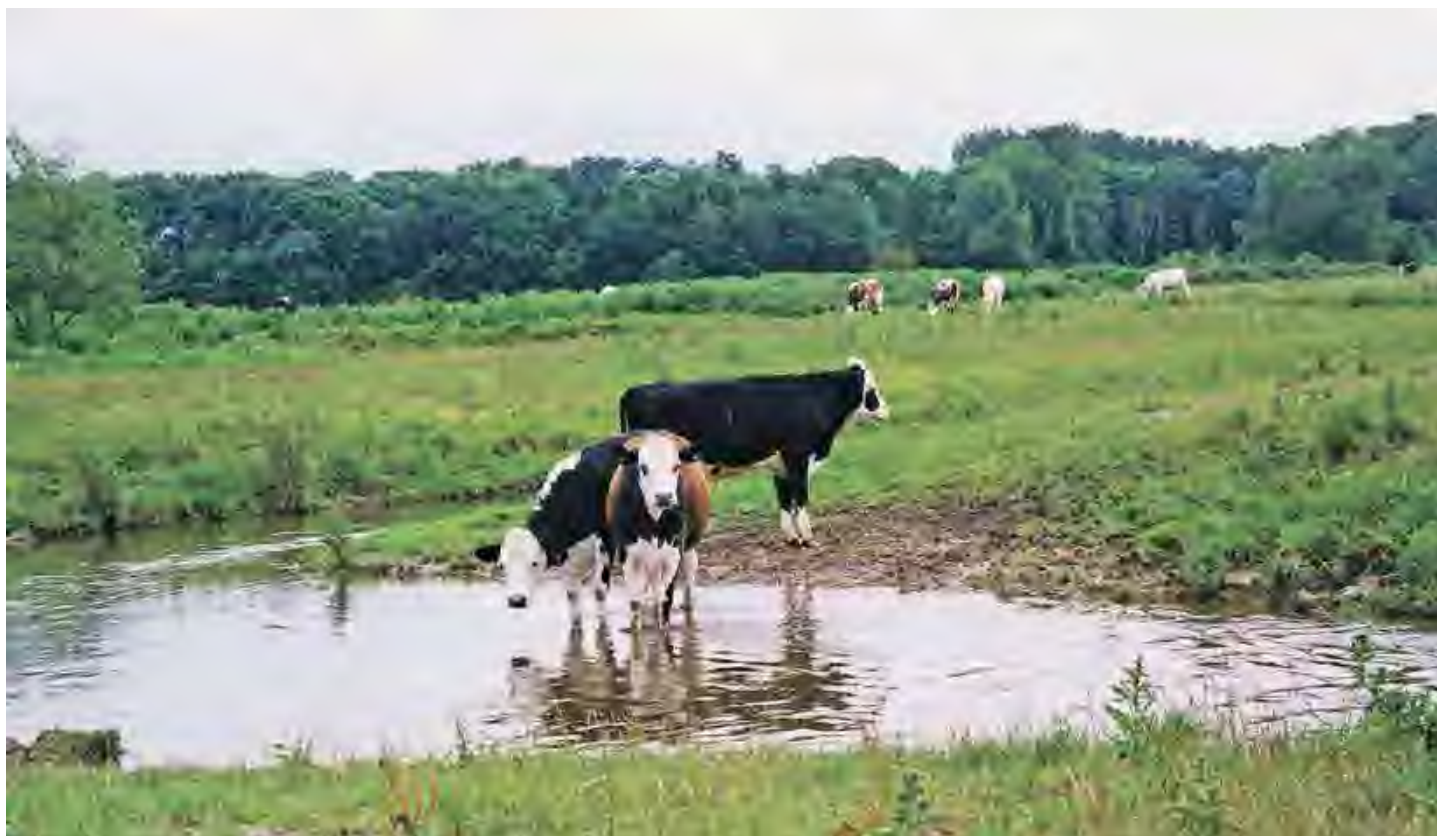
Vehicular ford upstream of mill at ch. 250m

The ford is shown diagrammatically in *Technique 2.2, Figure 2.2.1*. Its purpose is to provide vehicular access across the river in conjunction with the nearby crossing over the mill leat (see *Technique 8.2*). The ford is configured as a point bar located downstream of a sharp bend in the river. It crosses the river diagonally such that the ramp on the inside of the bend could take the form of a natural shoal of gravel that gently rises up to field level, mimicking the geomorphology of upland rivers where point bars and shoals of gravel often serve as crossing points. Because there is no significant bed load of gravel in the River Cole, the bar and shoal had to be artificially created using crushed stone and aggregate.

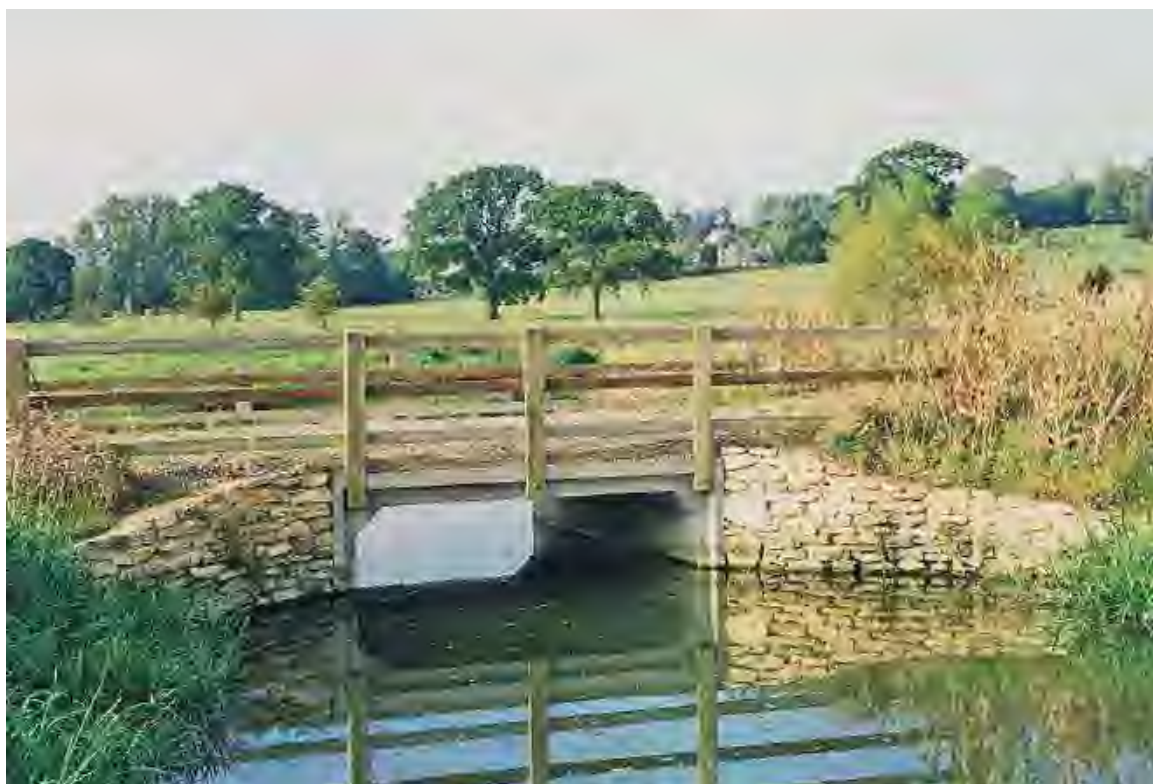
Completed 'bridge'

The upper tier followed a similar curve but was continuously stepped back sufficient to allow a stone wall to be built around the front face - this wall is the only visible element and it is decorative rather than structural. By stepping back the gabions the sloping river banks adjacent could be brought smoothly into line with the gabions and also accommodate an underwater ledge for aquatic marginal plants. The combination of marginal plants and stone walling are intended to draw the eye away from the concrete box which is a relatively minor feature of the overall visual aspect evident in the photo.

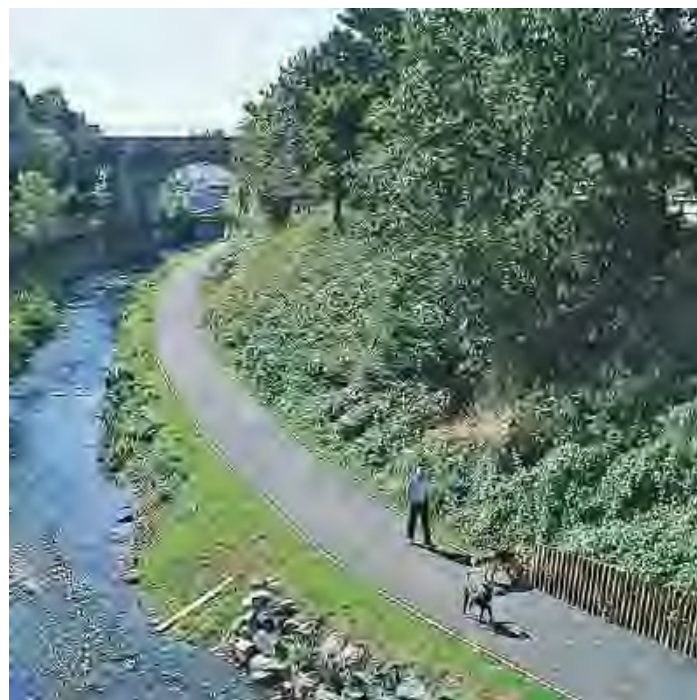
Bitmac footpath towards Skerne Railway Bridge

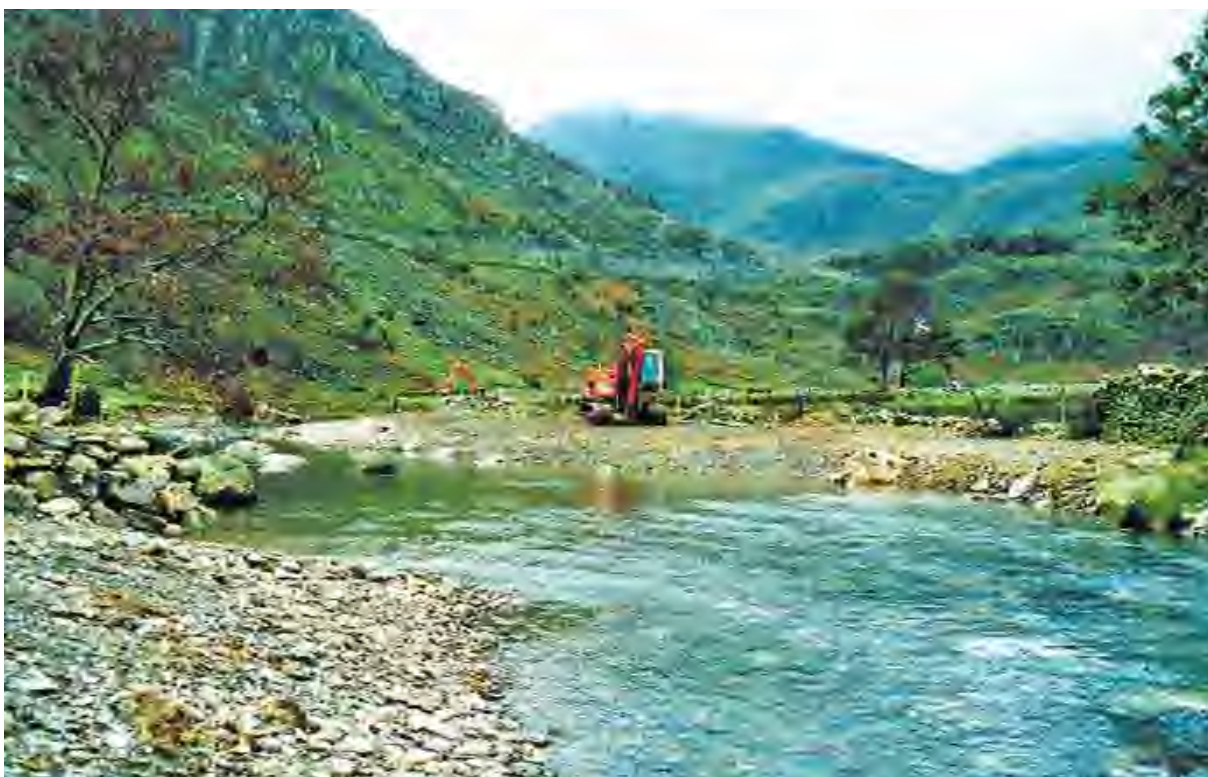
The restored ford, shoals and riverbed

The ford is located between two opposing bends in the river alignment such that shoals of gravel naturally accumulate on the inside of each. The two shoals would typically be joined by an underwater bar of gravel aligned diagonally across the channel. The natural cross-section of the river, drawn across this diagonal bar and up the flat shoal profiles each side, would roughly match the ford profile needed. The sustainability of the shoals and the bar of gravel would depend upon continuing inputs of material to the river. The tributary stream located just upstream (Blaen-y-Nant) was known to be the primary source

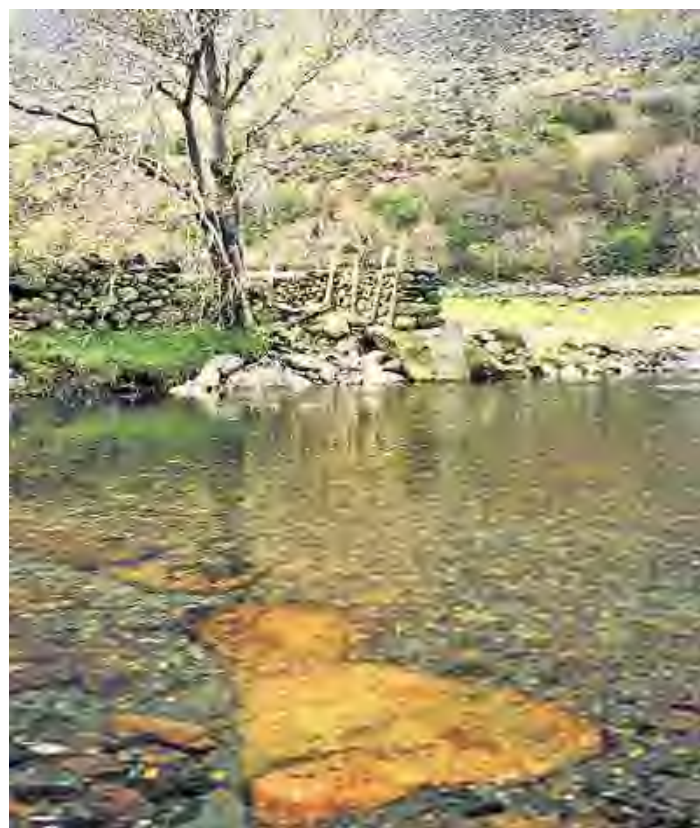
Downstream crest defined by boulders

It was decided to define the downstream edge of the submerged length of ford with a line of glacial boulders as shown on *Figure 8.4.2*. This provided the stable bed level that needed to be defined as part of the overall river bed restoration. It was not possible to completely restore the river bed elevations with gravel due to lack of suitable material (*see Technique 5.3*), so the

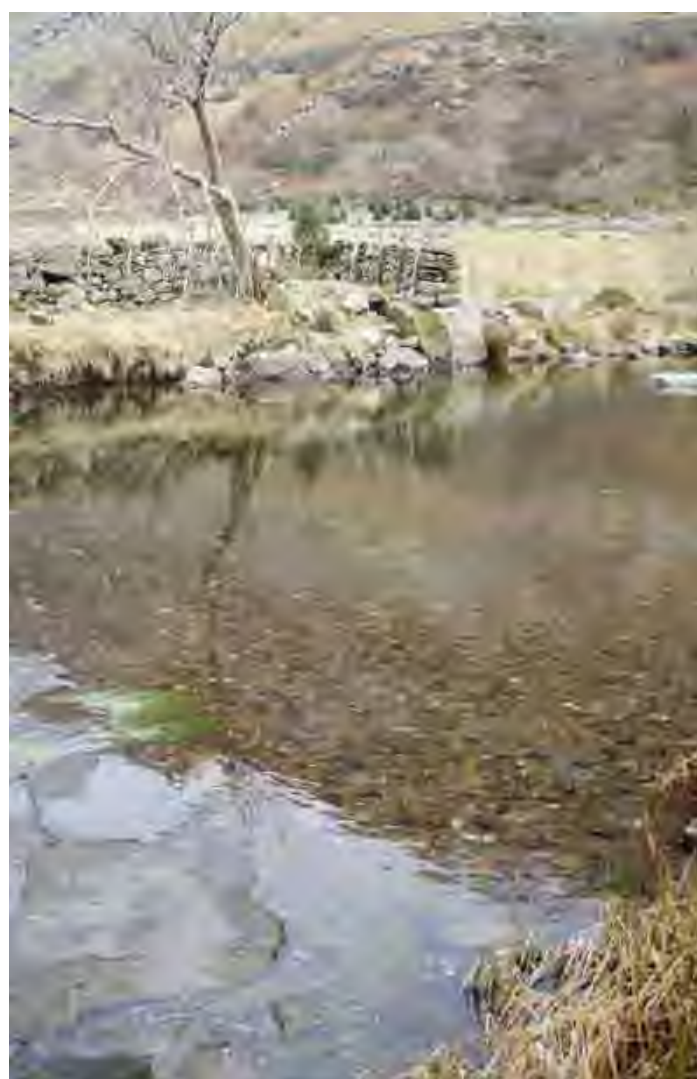
The ford remains stable with the boulders used for the downstream crest remaining in position – February 2013

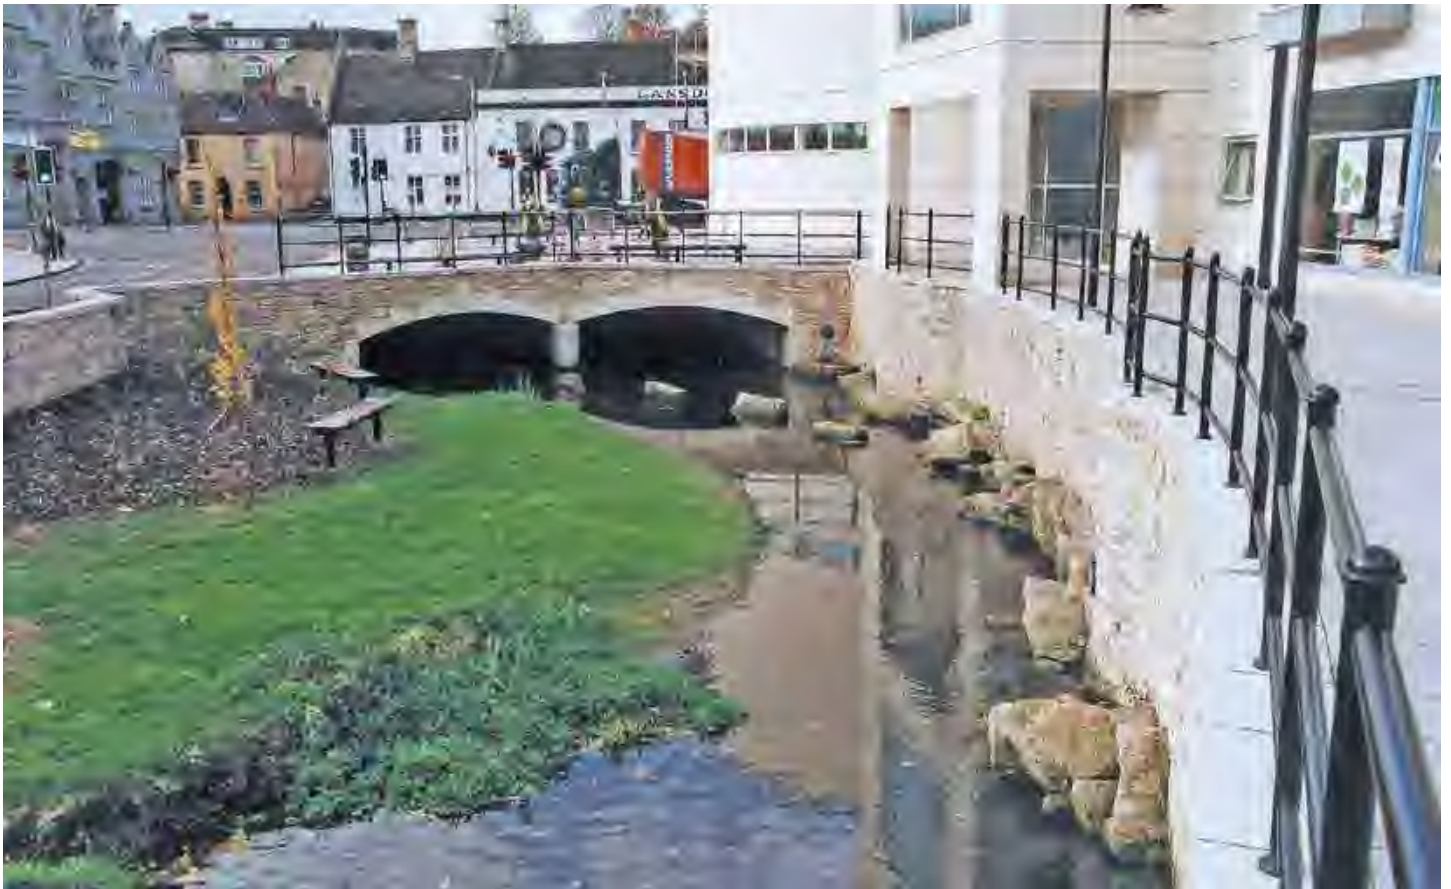
Seating and gentle grass and gravel slope to water's edge

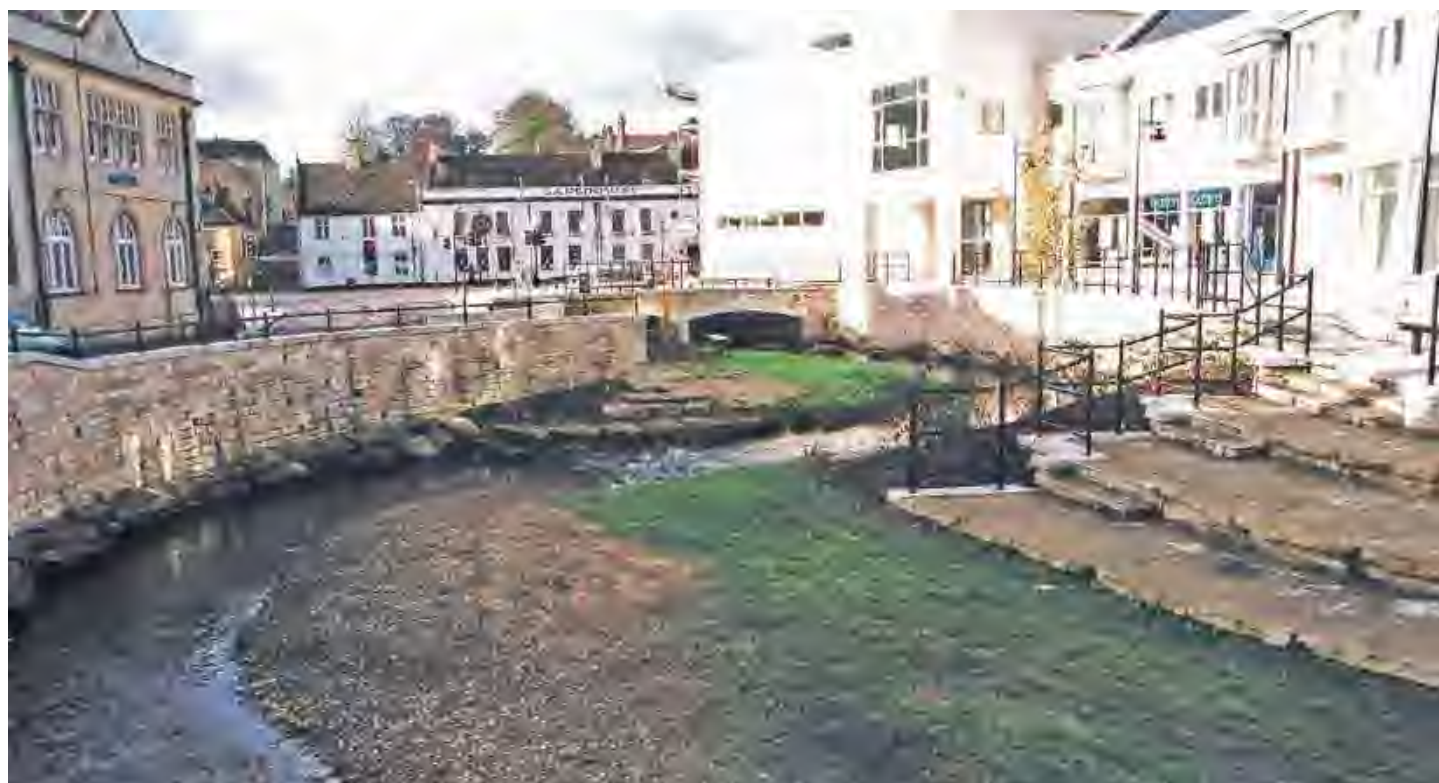
Stone steps leading down to grass and gravel shoal
