Enhancing Outfalls to Rivers

9.1 Surface water outfalls

RIVER SKERNE

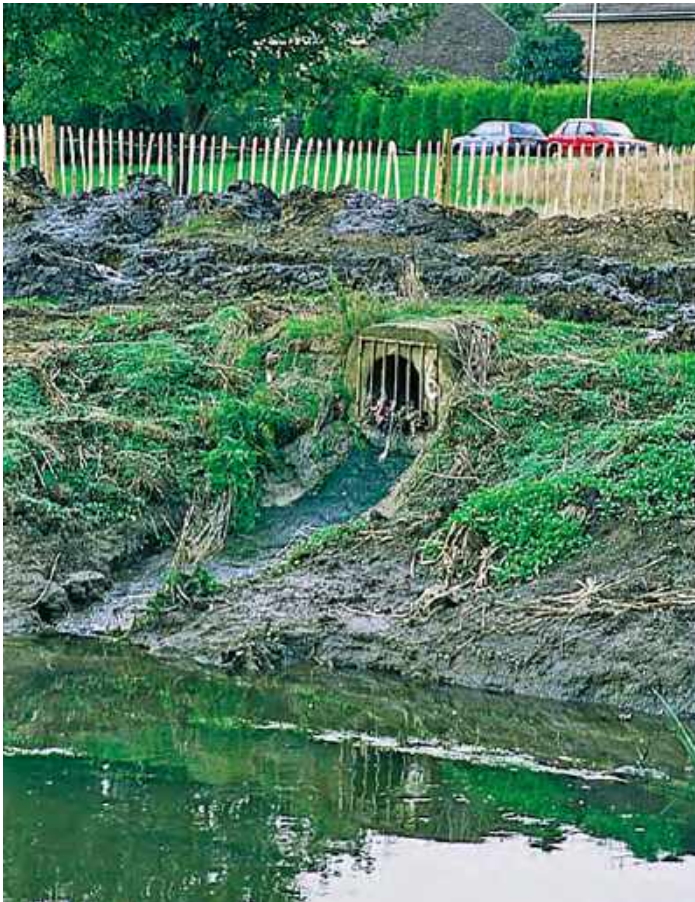
Typical outfall before replacement

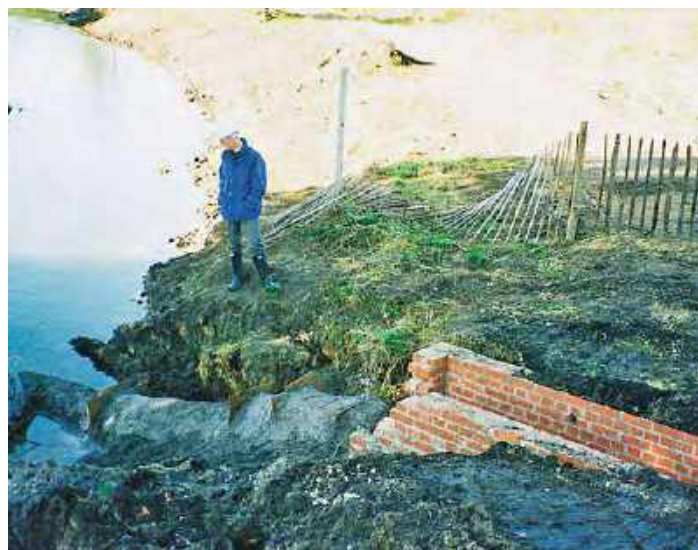
New underground outfall chambers were designed such that the amount of both silt and floating solids discharged into the river would be reduced. Under low surface water flows, silt settles and is trapped in a sump. A dip plate ensures that any oil, petrol and floating sewage items are also retained in the chamber. These can all be removed using a suction unit at regular intervals and disposed of appropriately. Initially this was planned at a frequency of four times per year. Under high flows some effluent will be carried into the river but will be much diluted.

Inspection of the chambers is via recessed covers, incorporating turf, which lie just above ground level and so are visually unobtrusive. These allow sampling and pollution monitoring when needed.

New outfall chamber
under construction

Note: River bank reinstated with soil and toe planting such that no visual evidence of the outfall exists

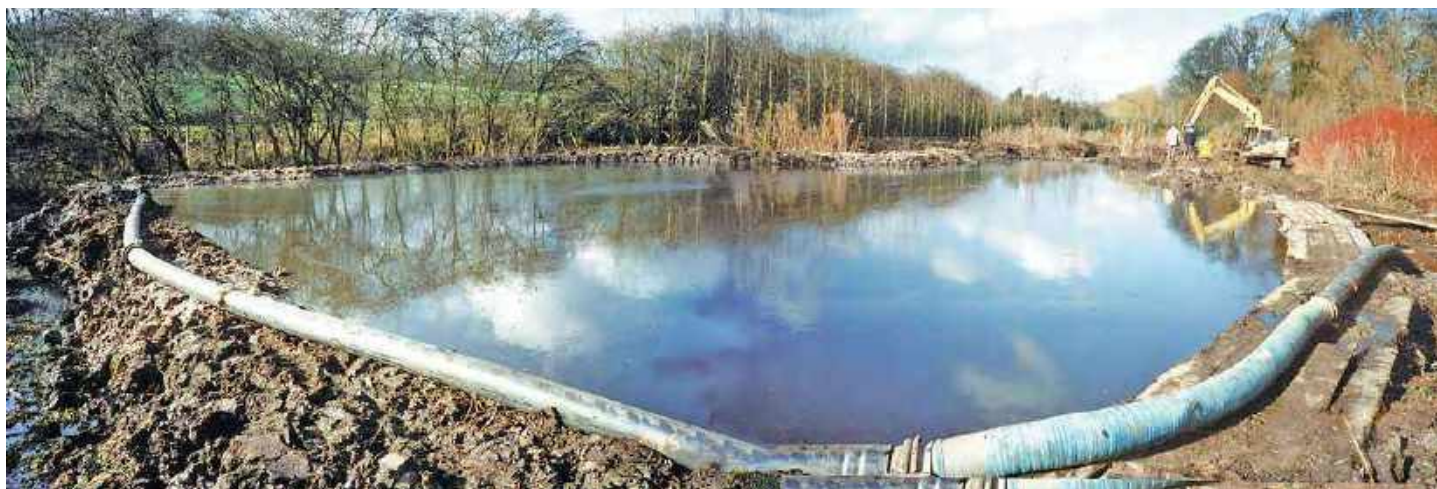
Lagoons and stilling basin – February 1995

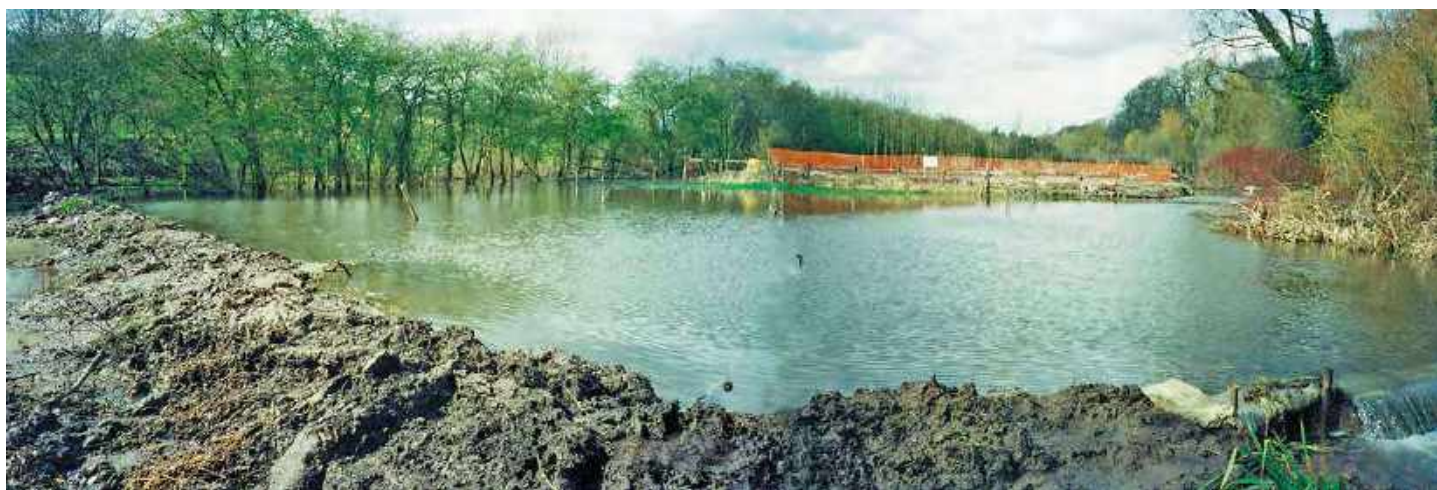
Lagoons, stilling basin and overspill – March 1995

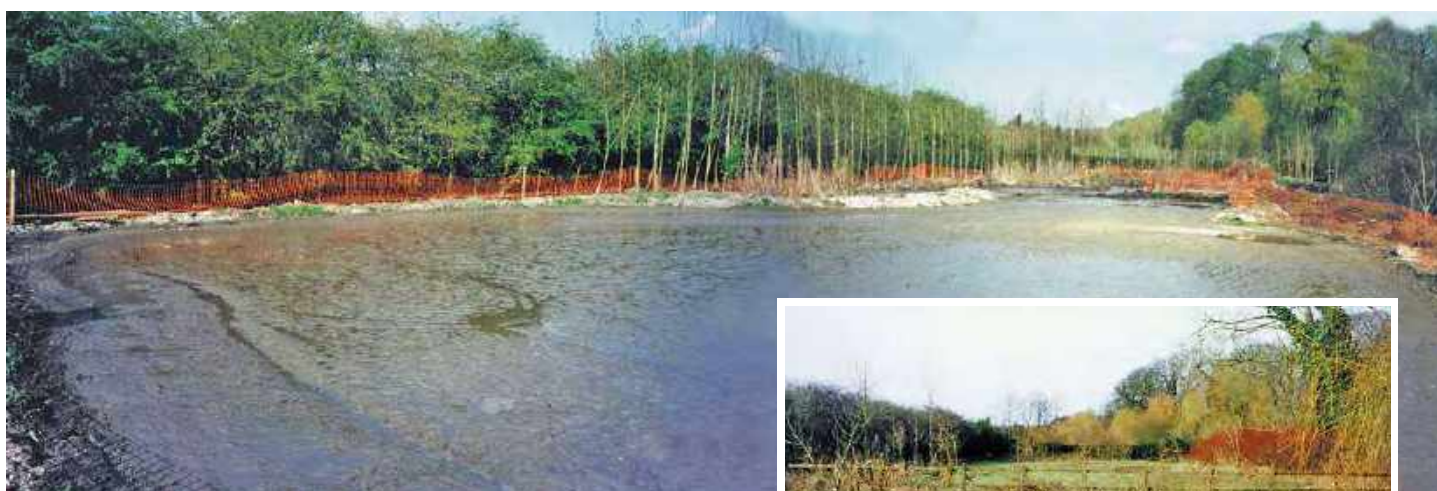
Retained silt load – April 1995

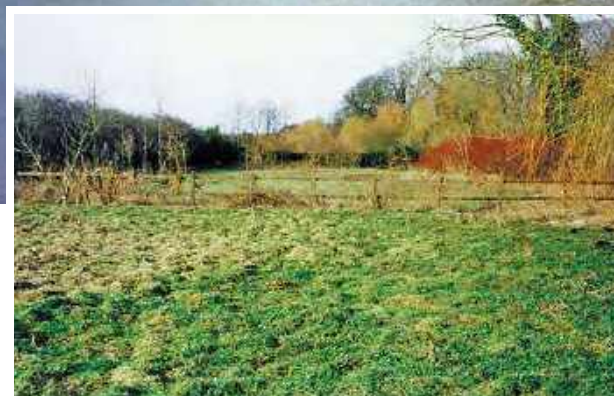
Figure 10.3.2

Using an excavator a series of low bunds were constructed in the adjacent field. The earthworks followed the fall in land levels to allow gravity flow. These bunds formed three shallow lagoons and a stilling basin. The first lagoon incorporated deflectors to ensure an even distribution across the width of the lagoon. The lagoons were separated by low temporary earth weirs (Figures 10.3.2 and 10.3.3).

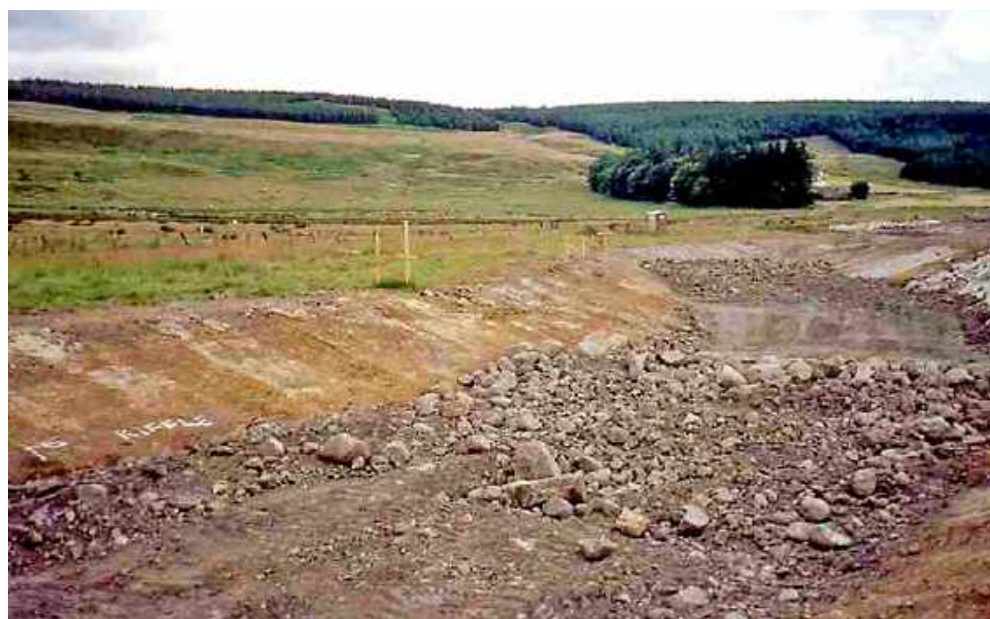
Shaping the new channel within the clay lining

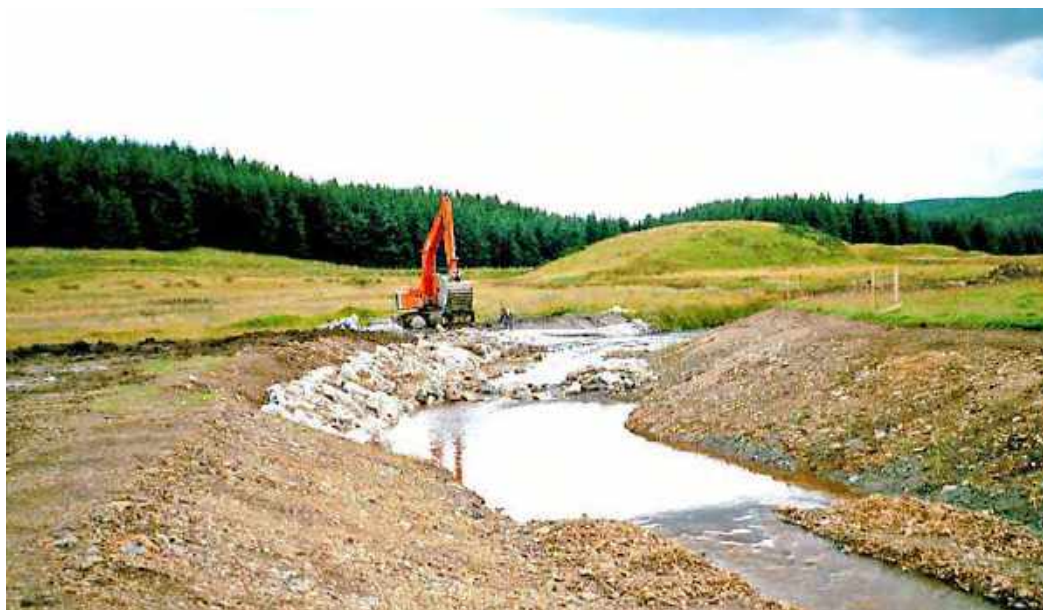
The 'constructed' run-pool-riffle sequence

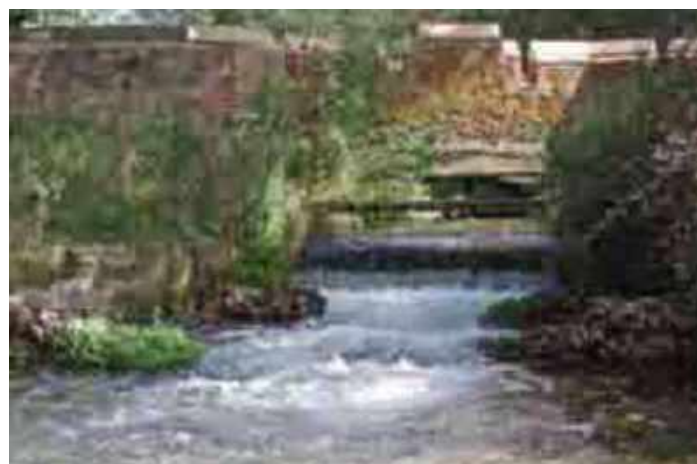
Pool and traverse fish easement after completion. Vegetation has already begun to establish on the rock rolls – August 2007

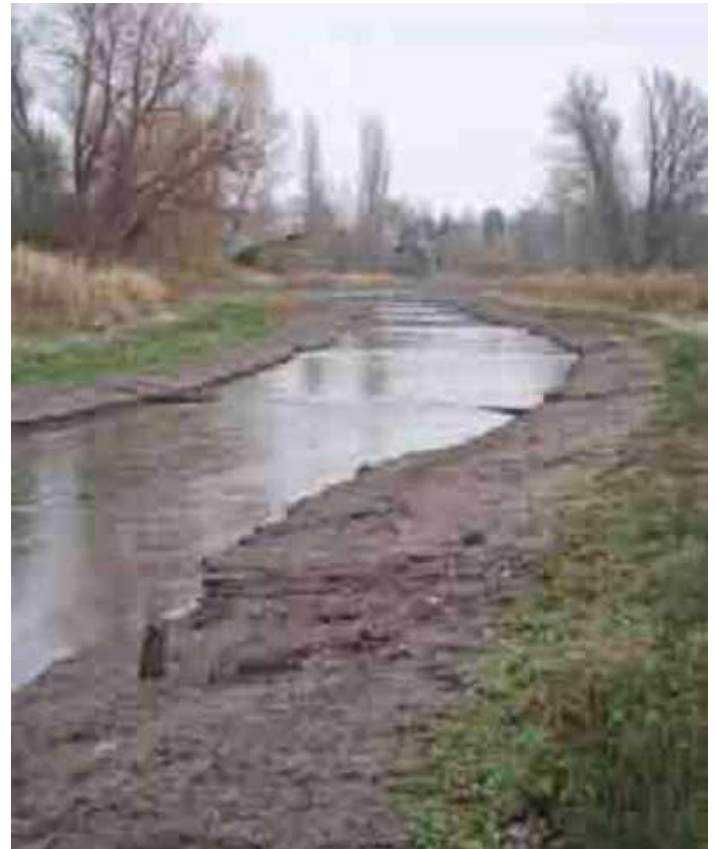
© Environment Agency The newly installed deflectors face upstream and concentrate flow. The old silt bed has formed new banks and has since been colonised by vegetation – February 2007

After the sluice boards were removed and the water level lowered, the river began to cut a new channel into the silt. In the upper reach, where the gradient was steeper, the river was left to naturally continue this process. In the downstream reach the gradient was less and lacked the energy necessary to continue cutting into the remaining silt. The installation of a series of deflectors created pinch points that have concentrated flows sufficiently to cut down to the hard bed and create pool and glide sections. Twenty deflector boards were installed facing in an upstream direction over a 200m stretch.

The deflectors were generally installed in pairs, some opposite each other and some offset. The locations were determined by working with the river. Hillington Fly Fishing Club was responsible for this work so the addition of the deflectors did not contribute to the Environment Agency project cost.

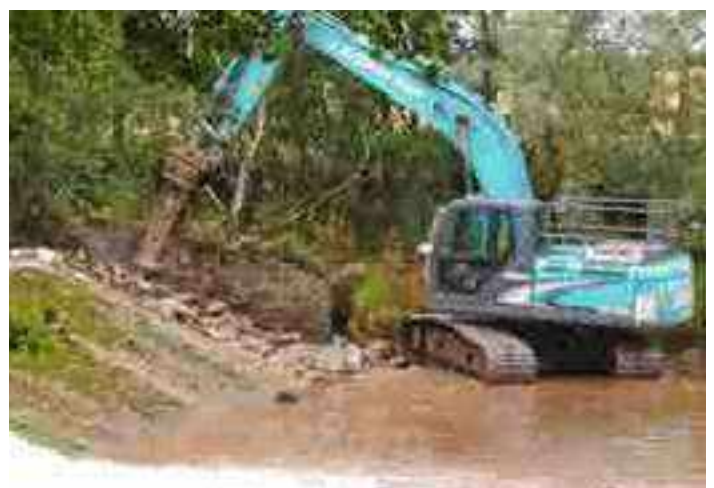
Initial breakout of the weir on the left bank – 2011

To remove the weir a 20 tonne 360° excavator and a 6 tonne swivel skip dumper were used. Demolition started with a 3m width on the left bank which was taken right down to bed level. Once the weir was breached a line of jumbo sand bags was used to channel the flow through this breach. This enabled the contractor to demolish the rest of the weir in the dry as the impoundments had been de-watered.

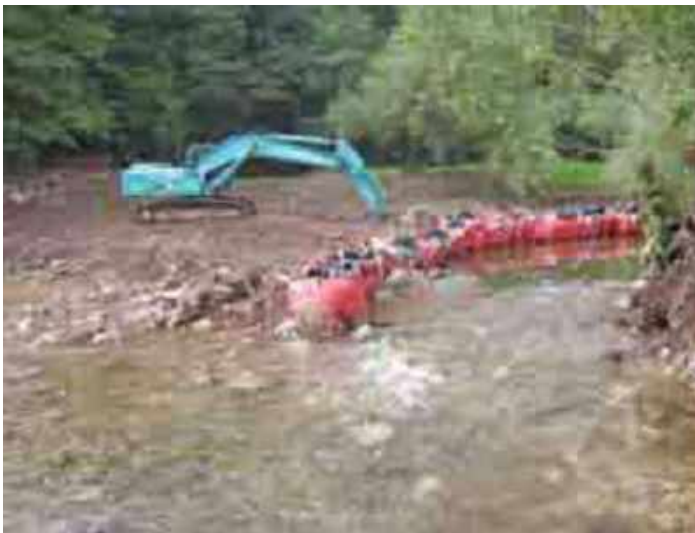
Line of jumbo sandbags channelling the flow through the initial breach allowing the remainder of the weir and material built up behind it to be removed – 2011

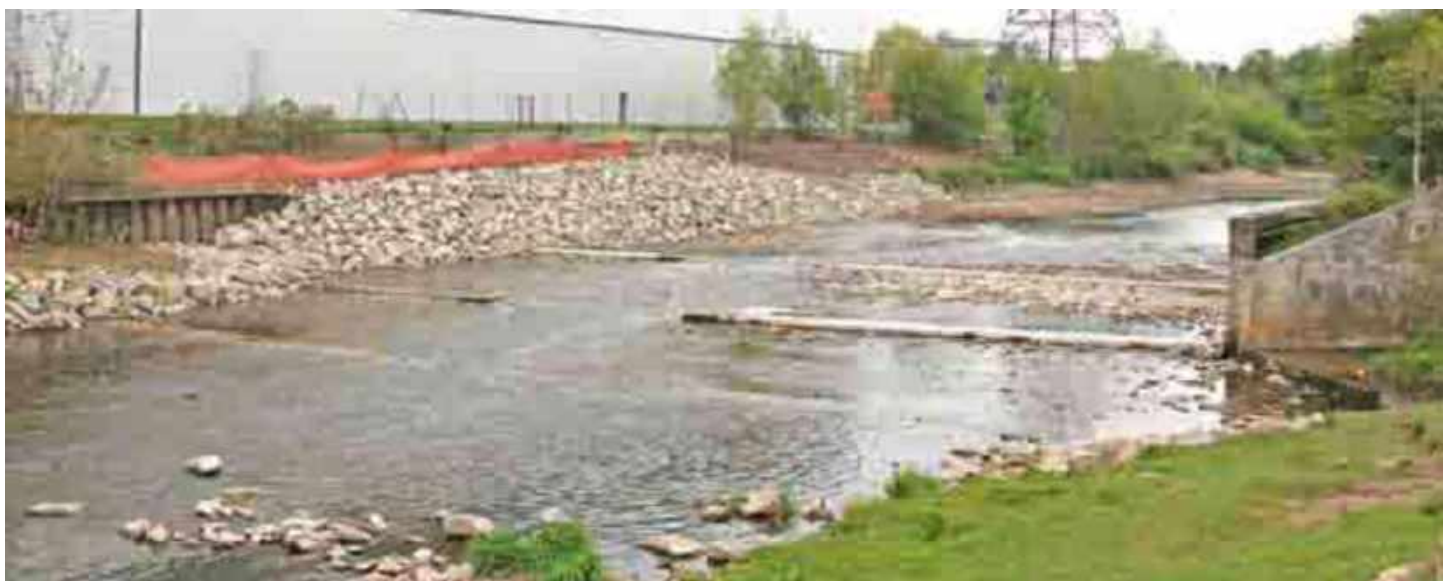
Figure 12.4.2
LONGITUDINAL PROFILE A-A

The site on completion. The low flow channel is visible through the centre of the bed check weirs – October 2010

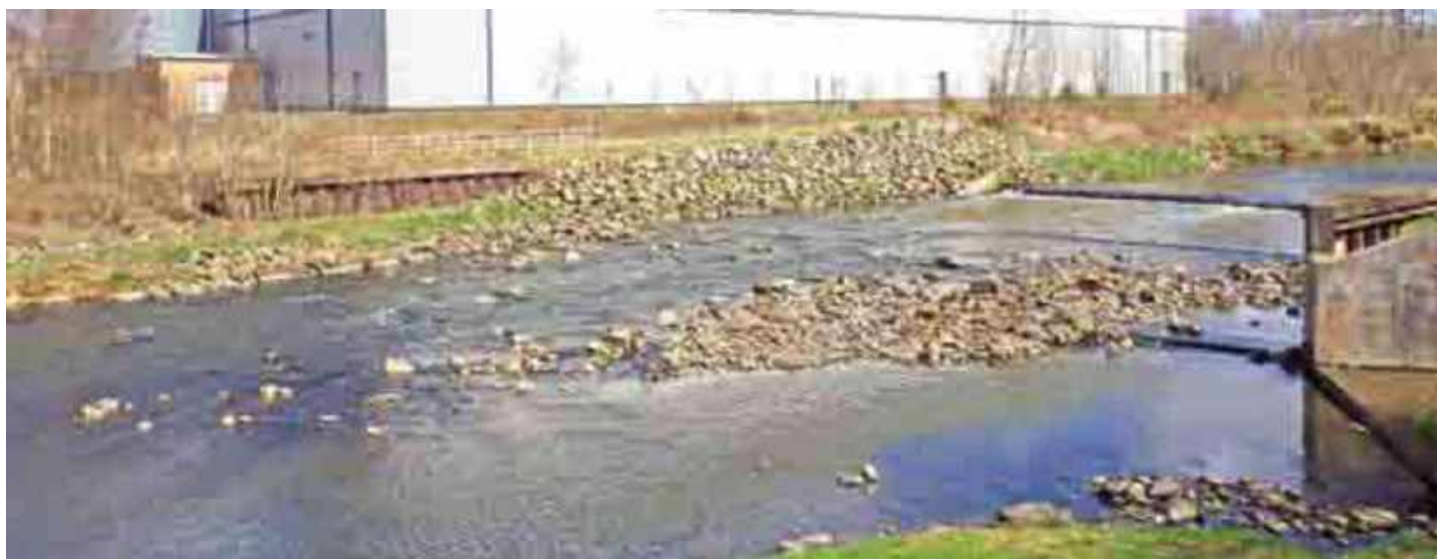
The site after three years. Some of the material entrained during high flood flows has been carried downstream but the majority has remained in the vicinity of the rock ramp and is visible near to the left hand bank – April 2013

The material used in the rock ramp was selected to withstand the expected stream power at the site, however exceptionally high flows over a sustained period during 2012 appears to have caused significant scour and erosion both above and below the weir. Flow volumes experienced during 2012 resulted in velocities capable of entraining the material used for the rock ramp (the 1 in 50 year return period flood event in June had a peak flow of 220m³/s compared to median annual flood flow of 173m³/s).

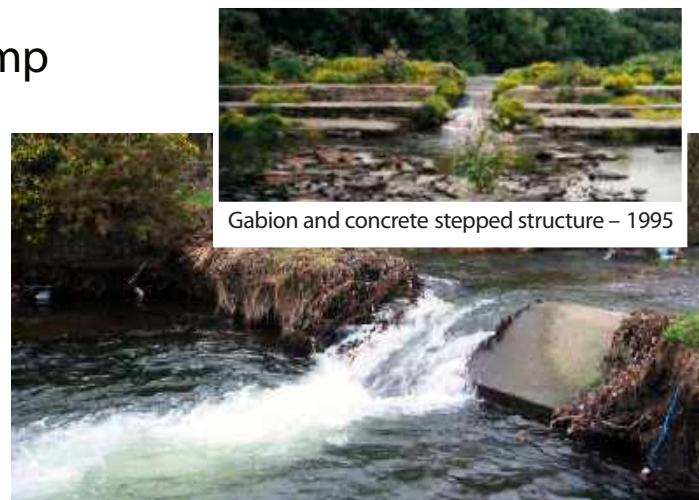
Collapsing weir with deep scour hole used for swimming – January 2004

to be passable by all life stages of Sea Trout. The large deep scour pool was being used as a swimming pool but contained boulders and loose gabion wire that presented a safety issue.

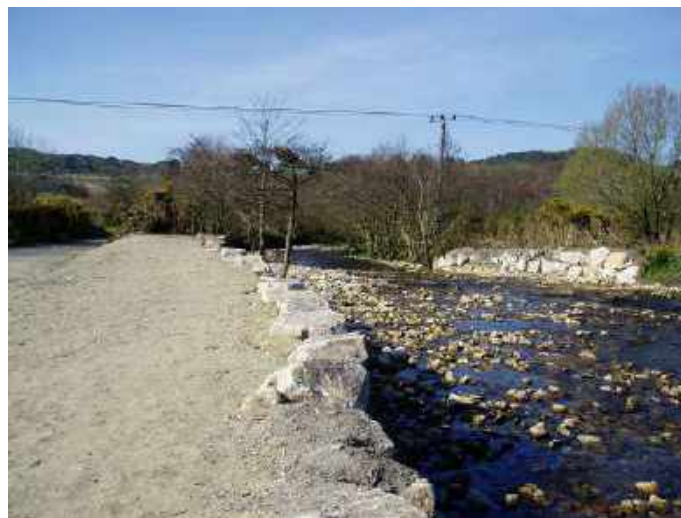
Nearly completed rock ramp, embankment and vertical blockstone edge prior to storm - 2007

At this point, when the works were 80% complete, a large storm event occurred breaching the new left bank embankment and bypassing the rock ramp, flooding the left bank floodplain and scouring and redistributing the rock ramp material.

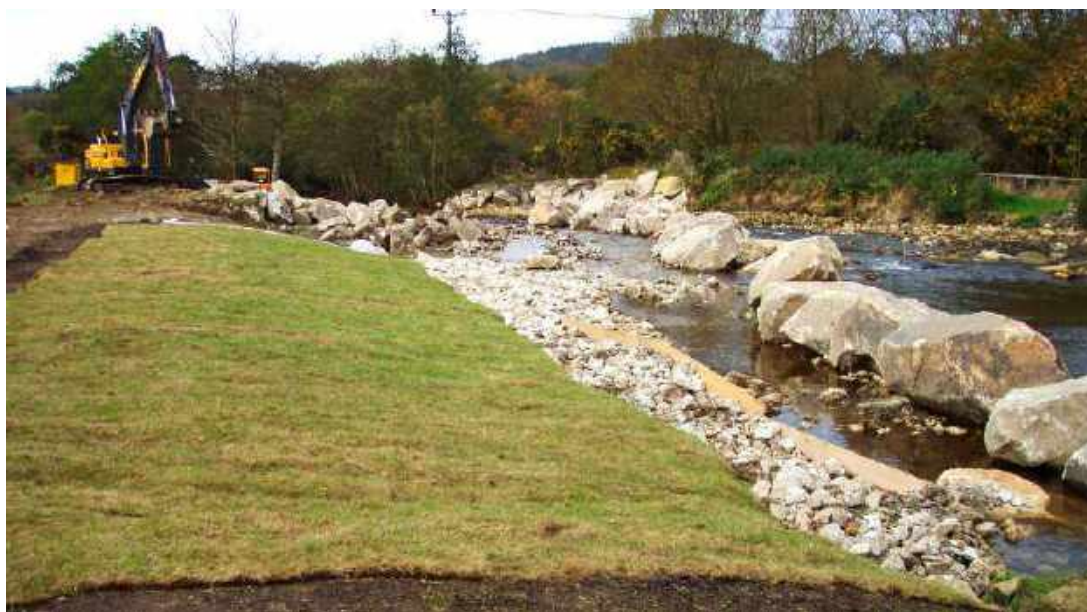
Removal of the vertical edge stones and modified to a shallow slope following the breach event. Stones used to form the ramp extension – Nov 2007

7. The vertical rock face was removed and the embankment was regraded to a slope of 1 in 4 from the 2m footpath top width down to the water's edge, creating a gentle vegetated slope with additional high flow capacity.
8. Turf and coir geotextile provided vegetation cover and initial protection. There was also addition of a Lintobent impermeable clay core liner to solve continued leakage within the narrow upstream end of the embankment.

9. The bankside rock armour was removed to enable the embankment protection matting to be dug in beneath the edge of the rock ramp surface. This spare rock was reused to add four further keystone groynes to lengthen the ramp by a further 35m, incorporating the material redistributed by the storm event, and add further rock groynes to add stability to the ramp. No further smaller rock infill was added. This was left to be filled by ramp redistribution and cobbles from upstream sediment supply.

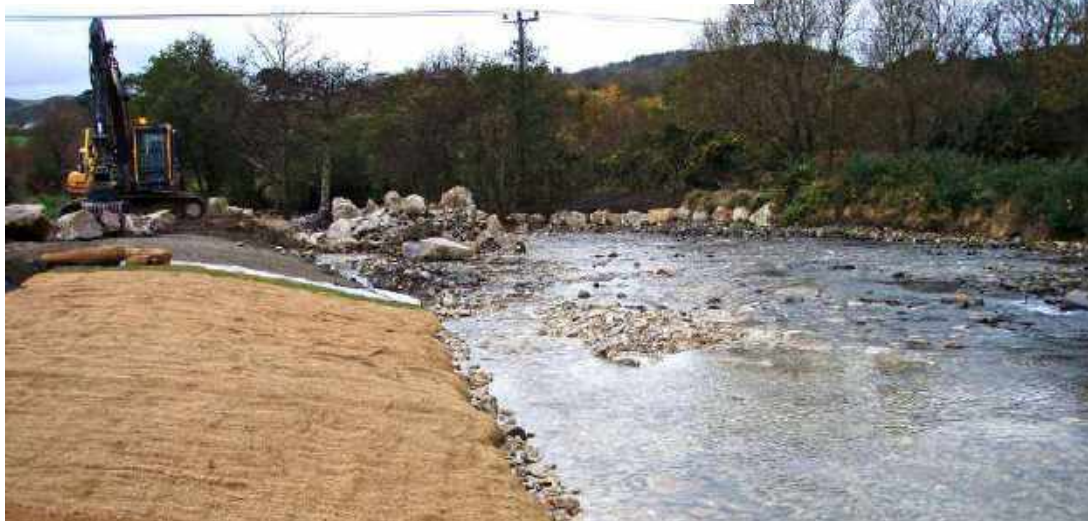
Coir matting laid over the turf to provide initial protection
- Nov 2007

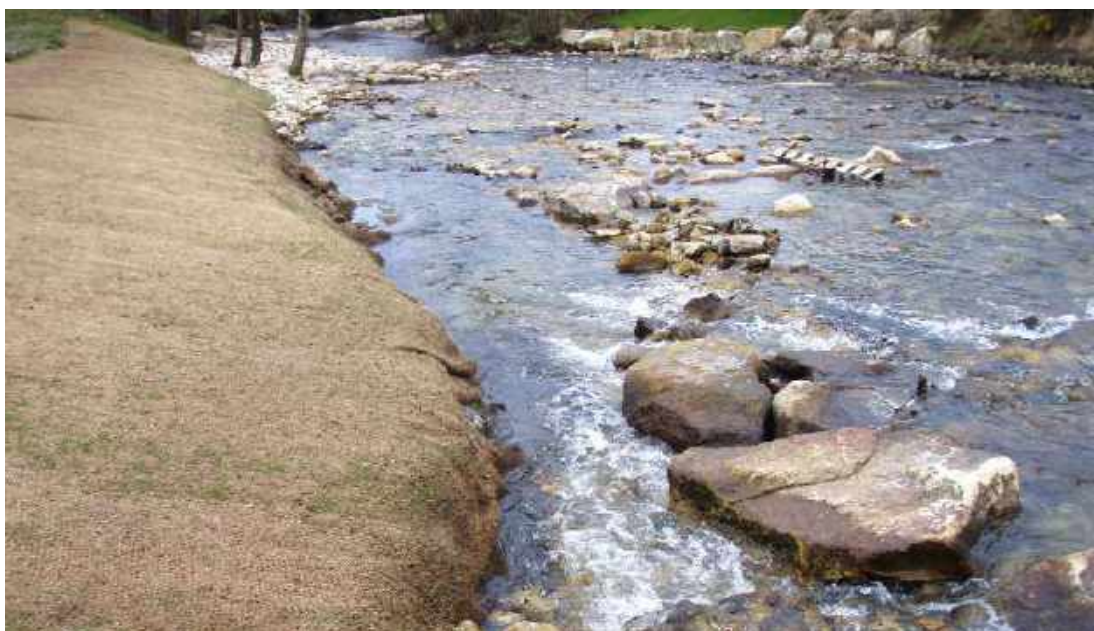
Initial movement of stone at the bank edge, but the turf and coir remained intact. Preferential route then filled. – March 2008

There was movement of the smaller rock (500mm down) as it settled and moved with subsequent flow events. Some adaptive management was required early on to fill in preferential flow routes that developed close to the embankment edge, due to settlement and scour.

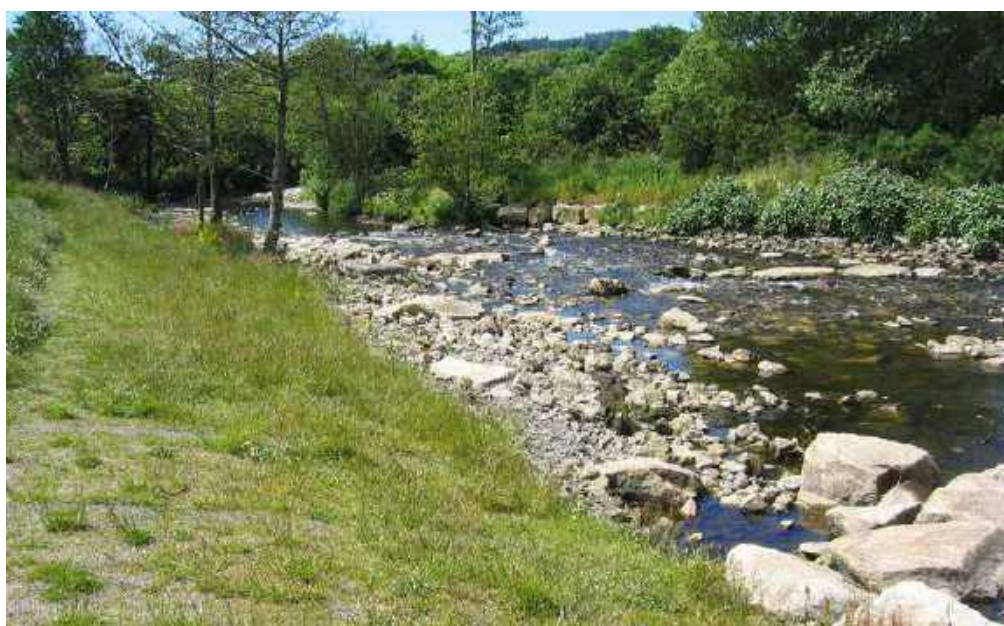
Settlement of the ramp and embankment. – 2009

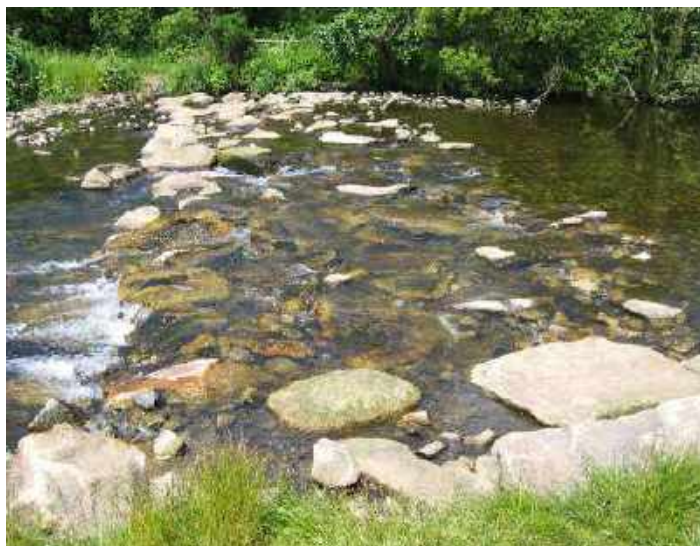
Wide, shallow rock ramp crest also provides fish habitat – 2009

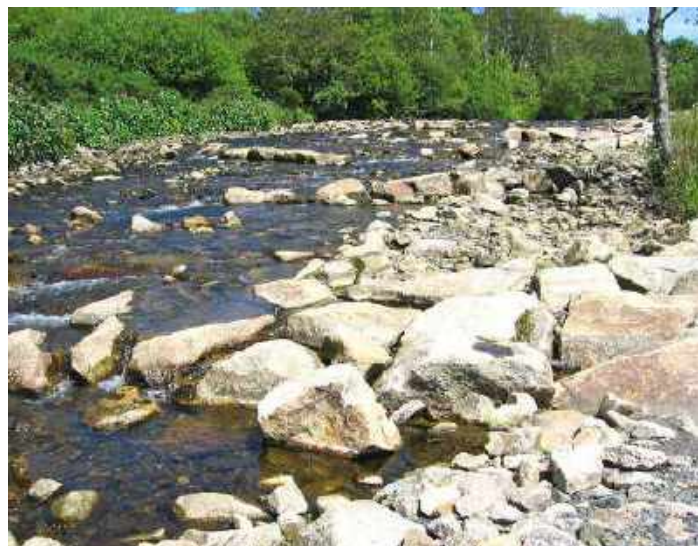
Rock ramp looking upstream towards its crest and showing the extent of habitat available to juvenile fish – 2009

An unexpected benefit of the work, resulting from the doubling of the ramps length, is the very high density of juvenile salmonids occupying the boulder strewn habitat of the ramp. 1000 juvenile salmon and trout were recorded in a 2010 electrofishing survey of the ramp itself.

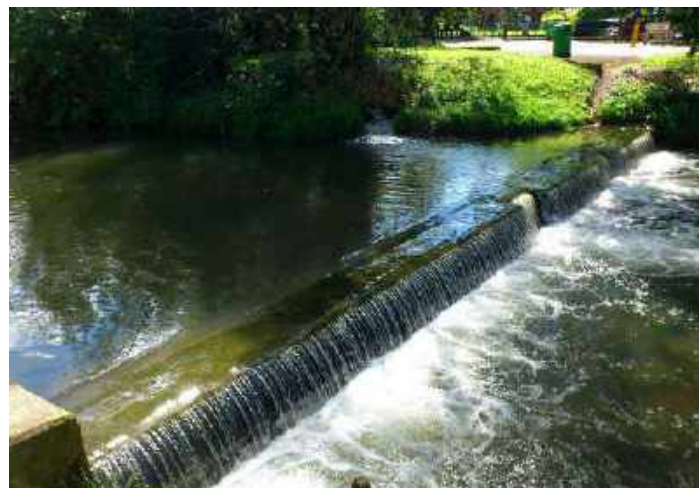
Intact 0.5m concrete weir – 2012

In April 2016, the weir developed a void below the previously extended section, undermining the structure and dewatering the river above. Environment Agency staff removed the two sets of wooden sluice boards to reduce the head of water and to visually assess the implication of removal on the upstream impounded levels (a weir pool, University grounds and residential gardens).

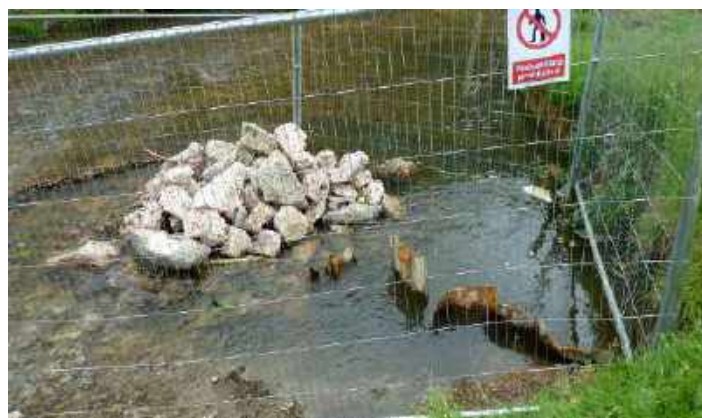
Weir concrete used to fill scour hole – June 2016

5. Remove the identified redundant service pipes associated with the weir.
6. Grade existing bed gravels into voids and use 20-40mm imported gravels to dress the scour hole, concrete fill and to create shallow gravel bars at both bank edges.

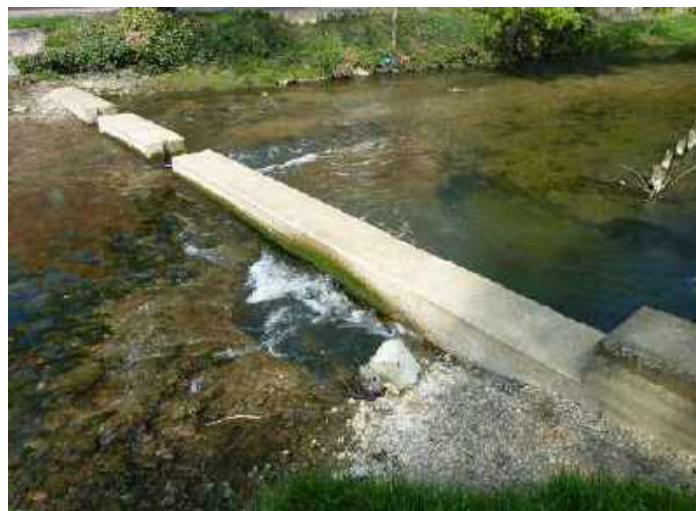
Large scour hole beneath weir – May 2016

Over the next few weeks the void continued to enlarge creating a significant 2m deep scour hole on the downstream side. By May all of the low flow volume was passing under the weir, effectively making it redundant. Removal was deemed to be the most desirable and cost effective solution to restore natural processes, improve fish passage and improve public safety.

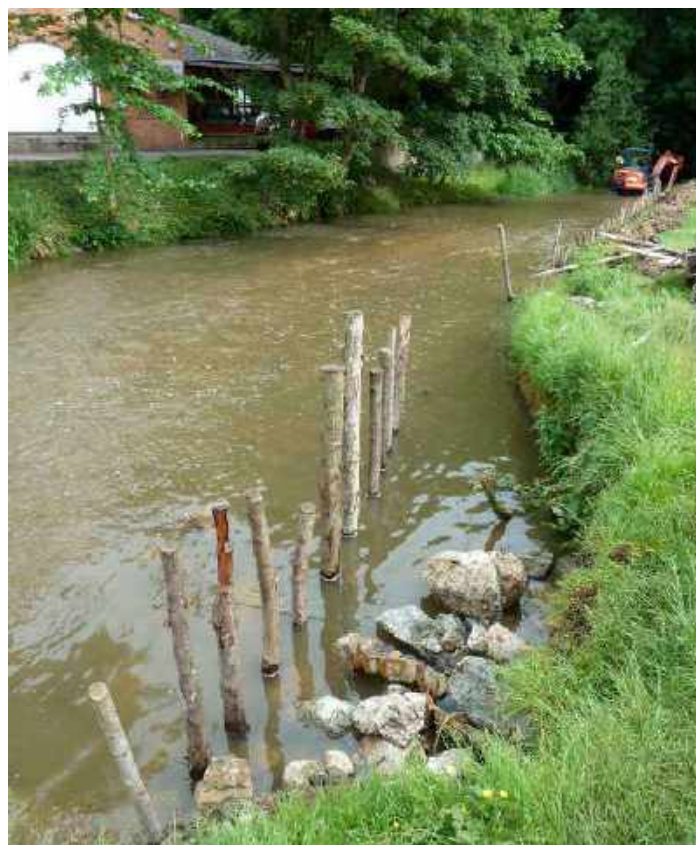
Trench sheeting and concrete fill buried behind bank revetment line – June 2016

3. Trench sheeting found beneath the weir extension. Folded over and buried in the void and bank.
4. Bank toe protected with a post and geotextile retaining line to tie in with the failed toe board replacement and regrading work.

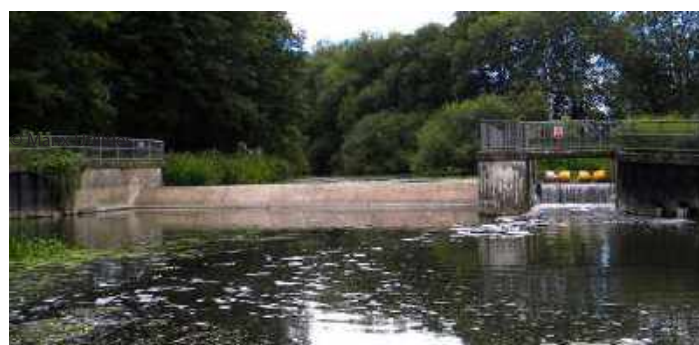
Byrons Pool radial sluice gate and fixed crest weir. The structure is a complete barrier to fish passage upstream and the weir is completely dry in normal flows – May 2011

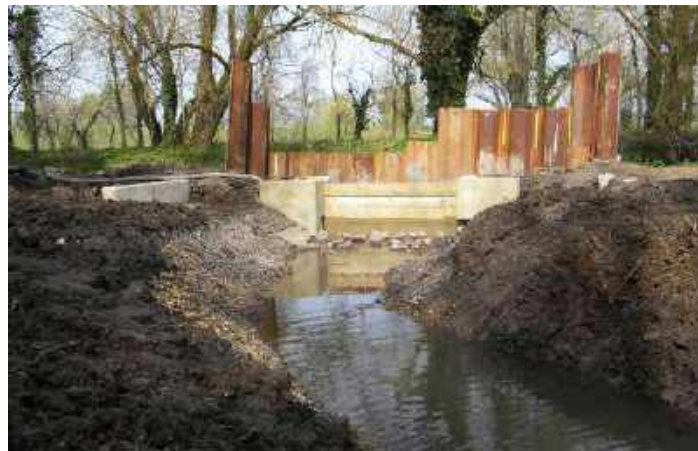
Constructing the upper entry side weir to the bypass channel. – Nov 2010

1. A bypass channel measuring 110m in length with an average width of 2m was created by excavating a heavily silted drainage channel running round the existing weir. The excavated material was spread within the woodland, outside of the floodplain, in an area of low botanical interest.
2. A small concrete side-weir was installed at the upper entry to the pass. Based on flood modelling the weir crest height was set at 7.7mAOD, 300mm below mean water level. This would allow control at times of low flow using stop boards, and for any maintenance operations.

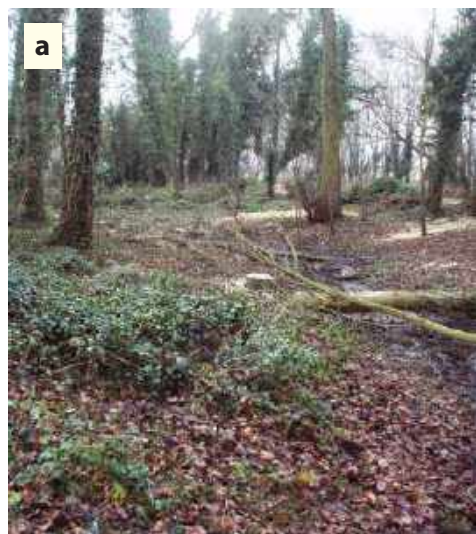
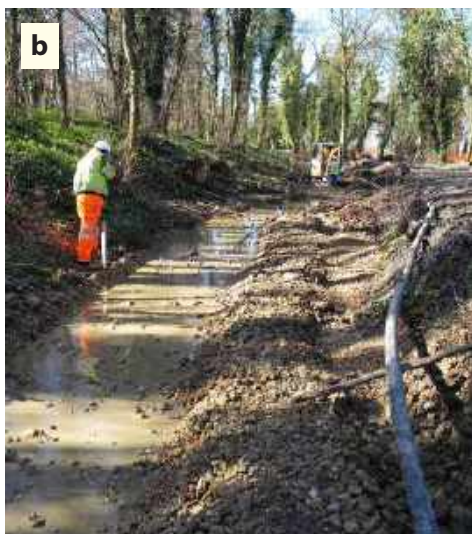
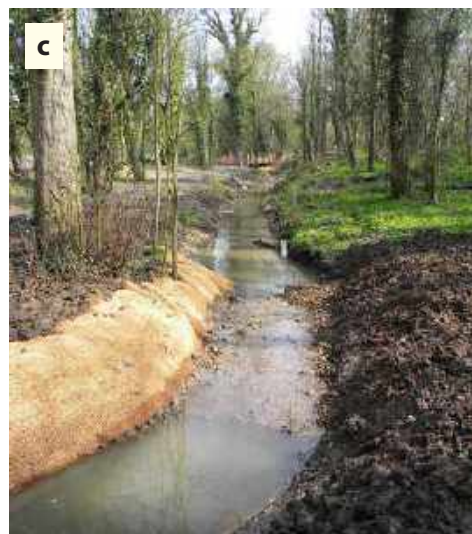
Before (a) during (b) and immediately after (c) construction. The absence of a suitable bed material was overcome by using imported gravels to create a series of pools and riffles along the channel. Jute (hessian) matting was installed to provide erosion protection along the newly created banks – November 2010

A preliminary topographic survey indicated that there might be a hard bed of gravels. However this was not found during excavation with material consisting primarily of river silts. A mixture of coarse gravels was imported to form a variable-width channel with pools and riffles.

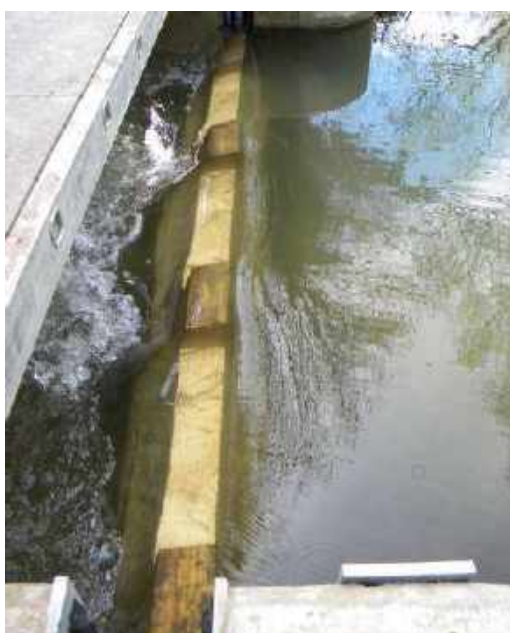
An additional stop log installed on top of the side weir structure and turreted – April 2011

Initial discharge through the channel was excessive, swamping the riffles and producing a highly turbulent flow at the downstream entrance to the pass. An additional board was installed to the side-weir to reduce the flow entering the pass. However, this created a head difference of approximately 300mm between the 'exit pool' and the upstream water level such that minnows (*Phoxinus phoxinus*) were observed failing to swim over. To resolve this, three sections (450mm wide by 100mm deep) were cut out of this board reducing the head difference by 100mm. Even then, the flow through the 'turreted' board was still too high for minnows to negotiate so additional stone was added downstream of the exit pool using 200-300mm angular granite. This successfully raised the water level in the exit pool thereby eliminating the head difference.

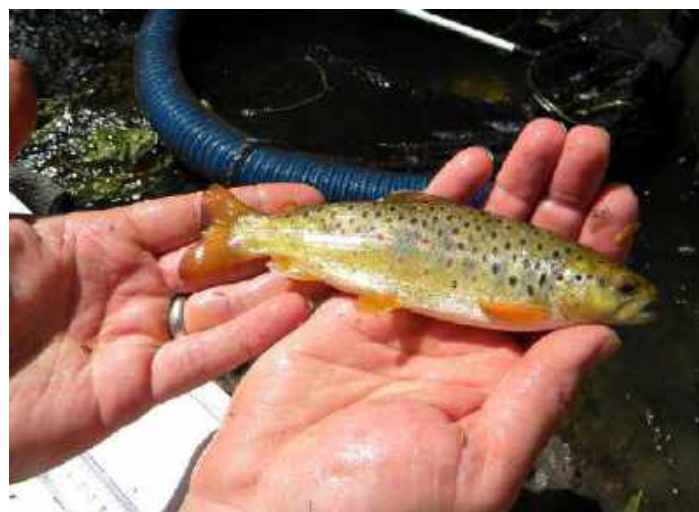
Electrofishing the new bypass – a brown trout already occupying the habitat created. – May 2011

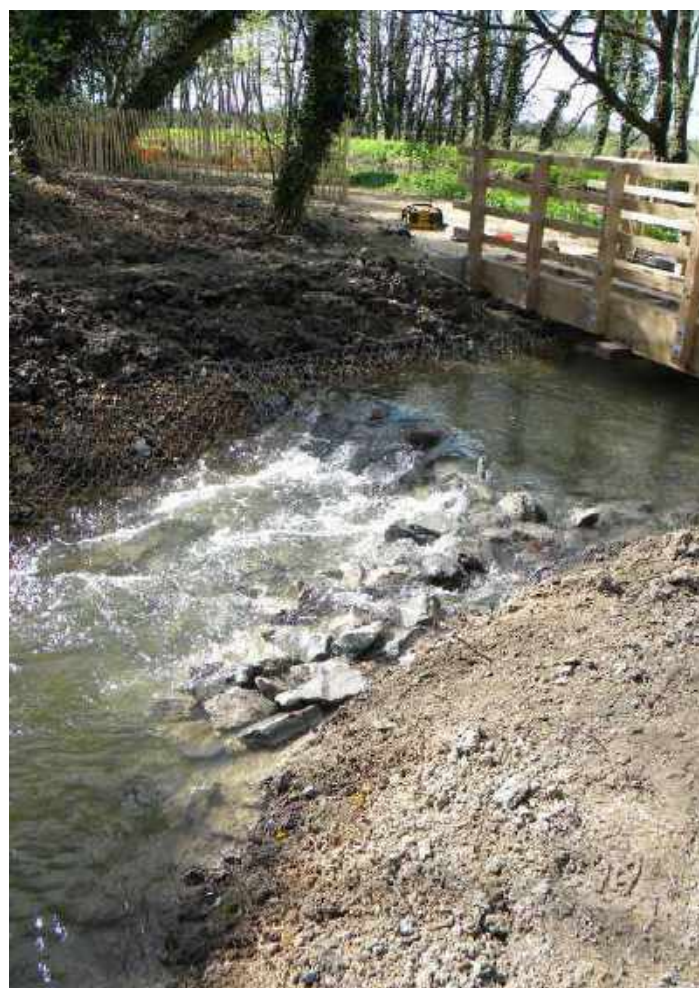
Additional riffle built using granite to allow minnows to exit the pass – April 2011

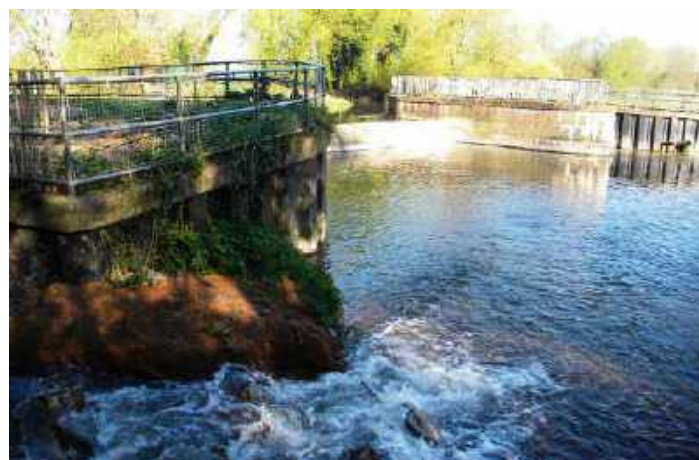
The attractant flow exits as close to the weir as the structure would allow. – April 2011

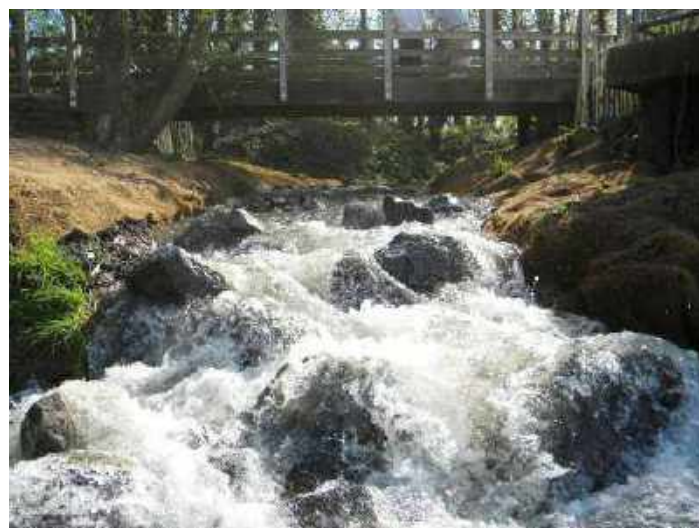
Gabion rocks and perturbation boulders installed at the downstream entrance to the pass, to baffle the flow – April 2011

The water level at the pass outflow was initially very shallow (<100mm) and the water velocity was identified as potentially exceeding the maximum swimming performance of some of the fish species found in the River Cam. So a combination of gabion rocks and larger 300-450mm perturbation boulders were placed between the lower entry to the pass and the first riffle to baffle the flow, producing areas of slack water for fish to rest in whilst ascending into the pass. Flow velocity was later measured and was well within the maximum velocity parameters of 2m/s for the species present in the Cam.

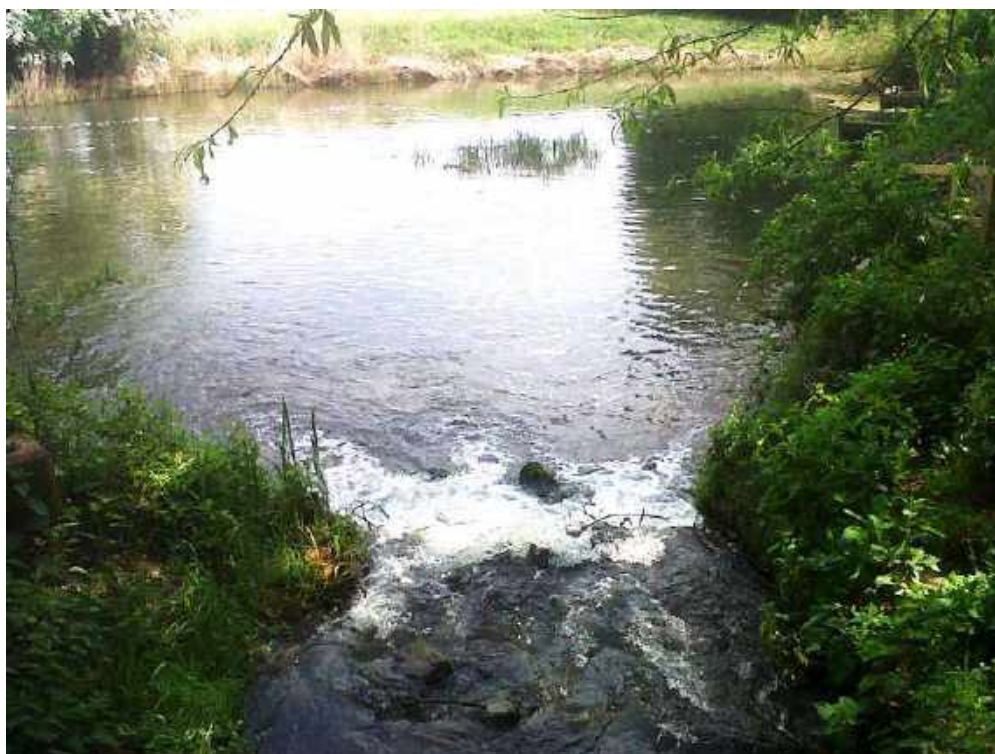
Entrance to the bypass channel, looking downstream towards the weir pool. The perturbation boulders have remained in position and marginal vegetation has colonised the banks – February 2013
