# River Wensum Rehabilitation Project

## Technique: Channel narrowing, riffle creation, cattle crossings, deflectors

Project location: Bintree River: Wensum County: Norfolk Project start date: August 2000 Project end date: October 2000 Length: 1500m Cost: £45,000 Grid reference: TF998242

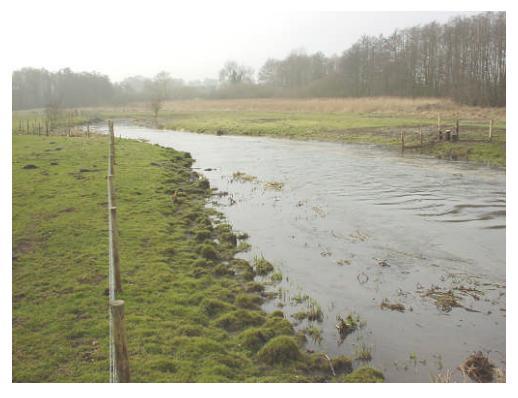
Narrowed section of the Wensum

narrowed using layers of brushwood with stakes in one section and blockstones with gravel and chalk added from the small quarry at Bintree Mill. Finally, a pair of deflectors were created at the downstream end of the 1500m

The installation of gravel, natural narrowing from vegetation growth and narrowing using compacted chalk have, together, resulted in much more variation in channel bedform than was previously present. Whilst the scheme was successful overall, some of the riffles were not ideally designed or positioned; for example, one such riffle was constructed on a meander bend. There appears to have been fairly excessive vegetation

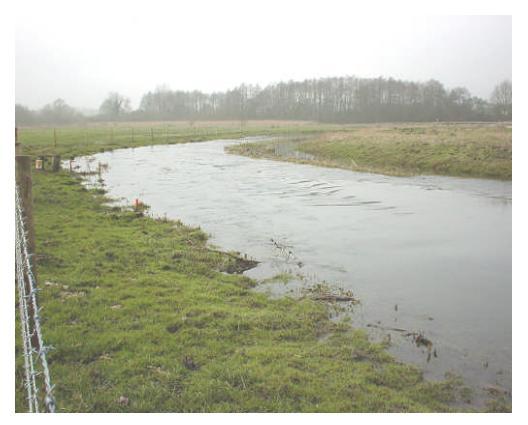
Example of riffle constructed in the channel

Riffles were installed at random intervals, for example one riffle was created by inserting a line of concrete blocks which extended to the midpoint of the river and dumping 15 tonnes of gravel immediately upstream and downstream of the riffle. Fencing and gates were used at selected access points to control cattle access. Gravel was added to the poached banksides and across the river to the exit point on the opposite bank to encourage the cattle not to stray when crossing. The channel was also
