# Modifying River Bed Levels, Water Levels and Flows

## **5.7** Felling trees into a channel to create flow diversity

#### **RIVER BURE**

Location - Blickling Estate, Norfolk. TG161301 Date of construction - Phase 1 - Nov. 2008 - Phase 2 - Nov. 2010

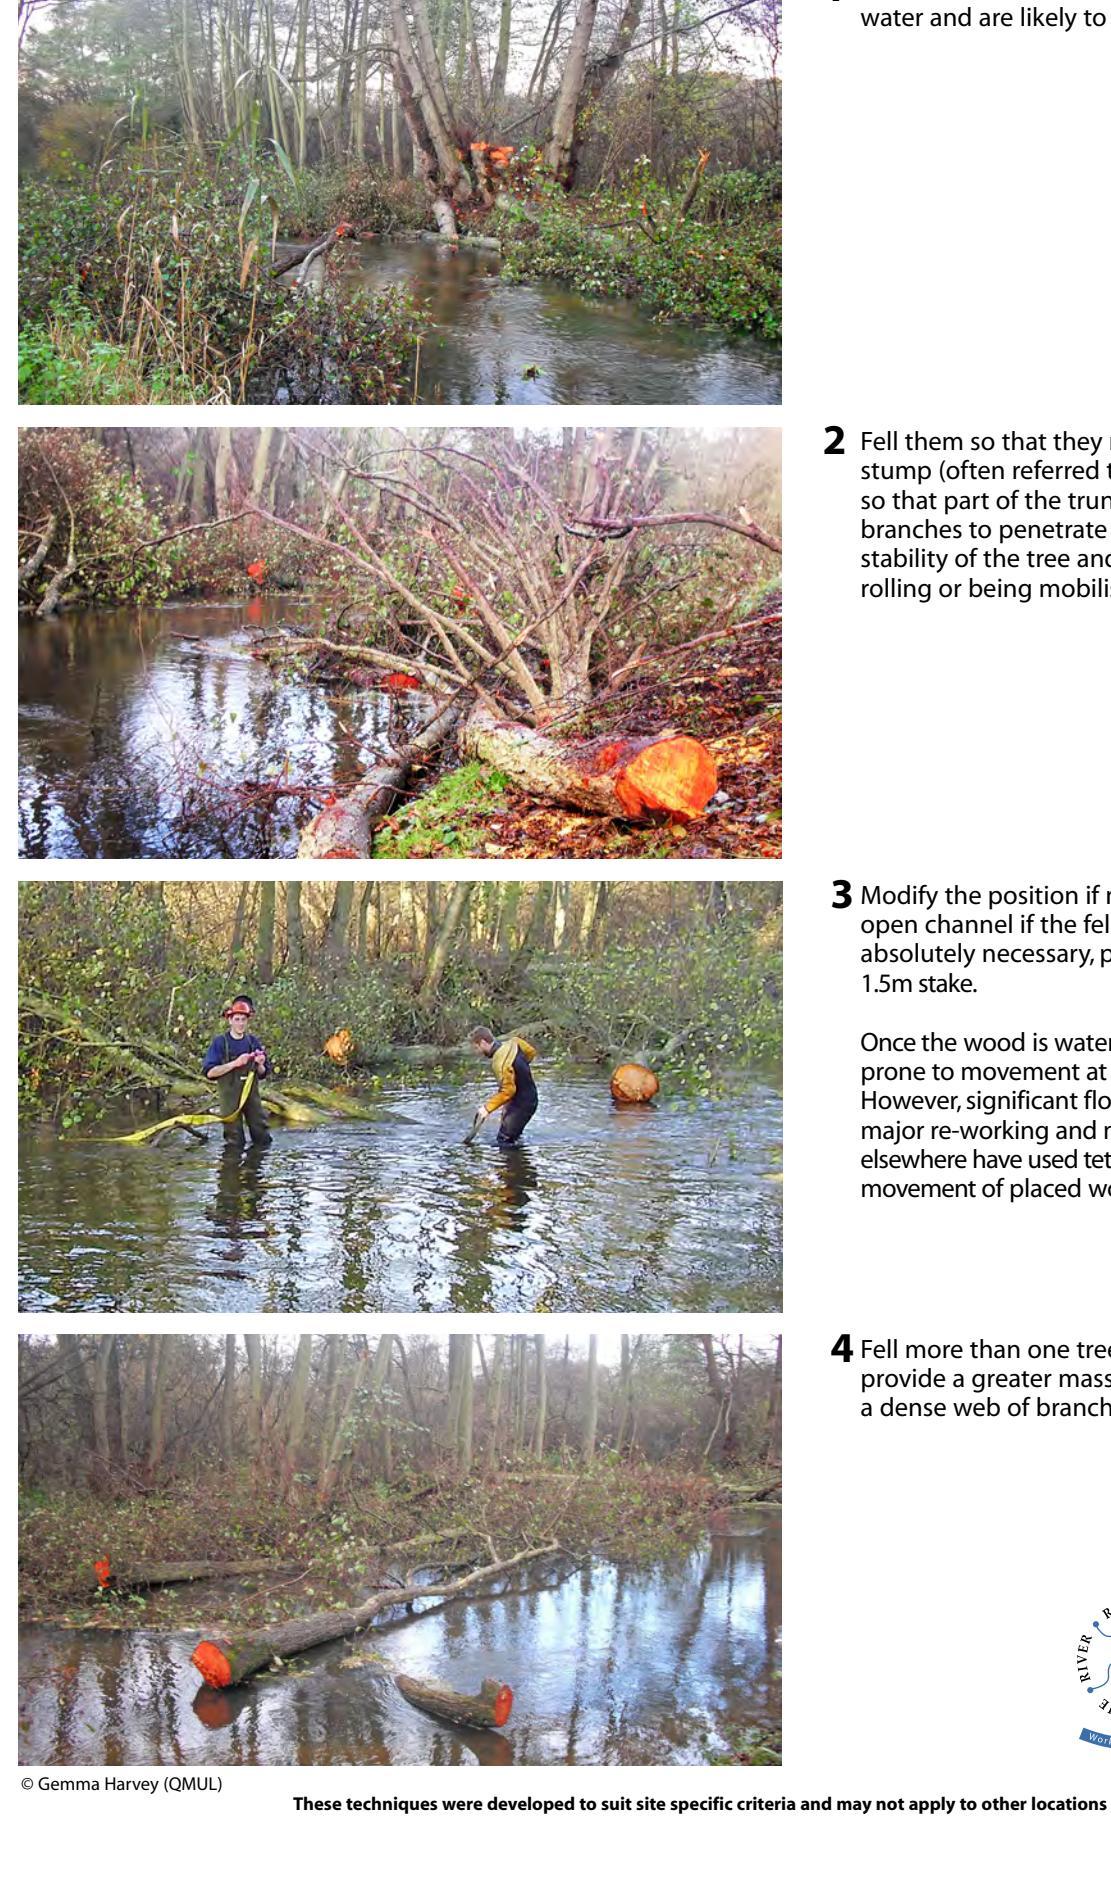
**1** Select trees which are already leaning over the water and are likely to eventually fall in the river.

**2** Fell them so that they remain attached to the stump (often referred to as 'laying' or 'hinging') or so that part of the trunk stays on the bank. Allow branches to penetrate the river bed to increase the stability of the tree and to prevent the tree from rolling or being mobilised by the flow.

**3** Modify the position if necessary to maintain an open channel if the felled tree blocks the flow. If absolutely necessary, prevent movement with a 1.5m stake.

**4** Fell more than one tree on top of each other to provide a greater mass to the structure and give a dense web of branches.

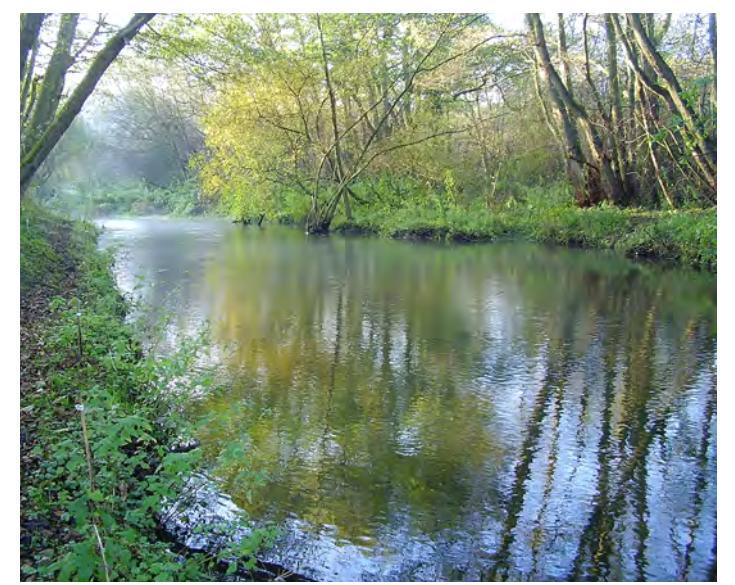
Before - Over widened silt laden channel

There is scouring of fine sediment and exposure of gravel in areas where the structures have concentrated flow. The movement of sediment and the colonisation by marginal plant species around the wood structures can be seen. These observations appear to support effective narrowing of the over-widened channel and an increase in physical habitat complexity.

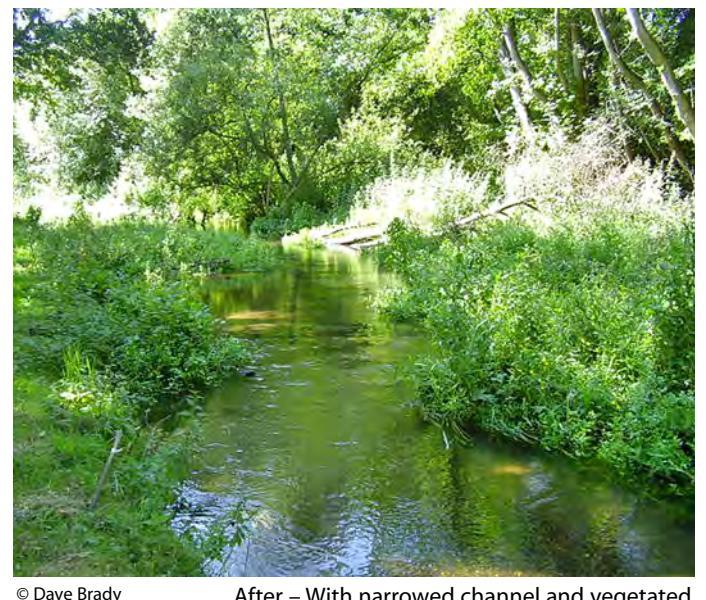
After – With narrowed channel and vegetated berms where silt has built up downstream of the felled trees - 2012
