8.1 Fords and stock watering point

RIVER COLE

LOCATION - COLESHILL, OXON/WILTS BORDER, SU234935

DATE OF CONSTRUCTION - AUTUMN 1995

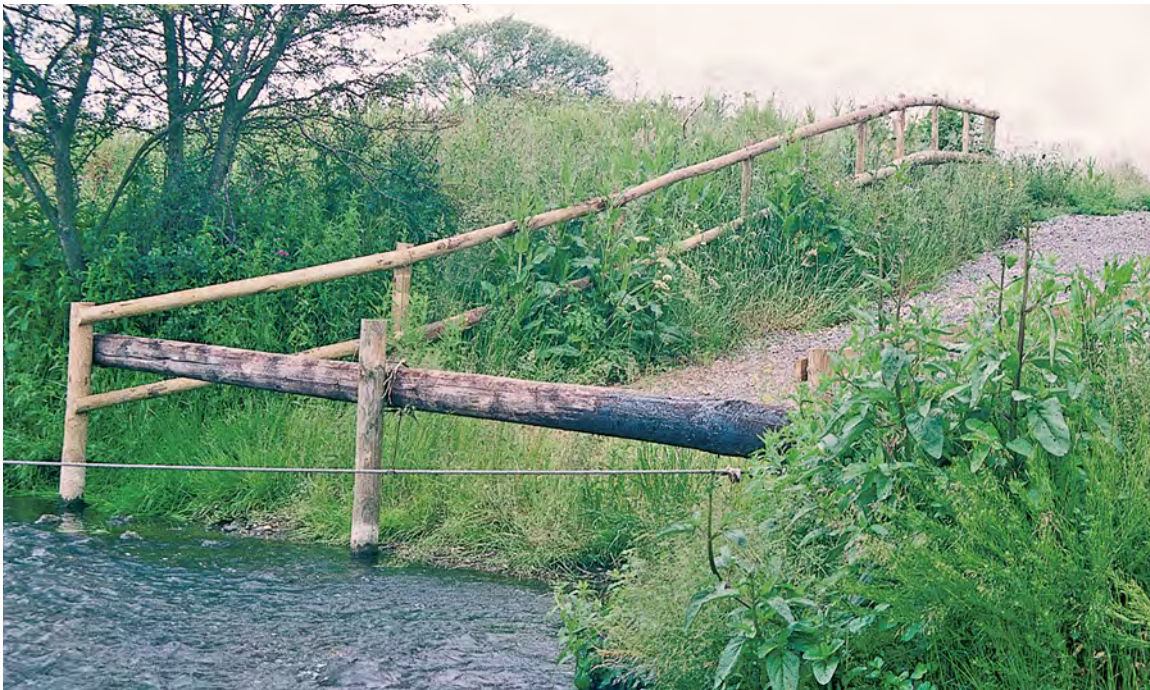
Stock watering point at ch. 100m

The river fencing comprises a single heavy wire cable strained tightly across on a diagonal line (see photograph above). The extra length of the diagonal renders the cable less likely to form a complete blockage of the river if floating debris becomes snagged on it. The angle of the diagonal is aligned to direct turbulence caused by its presence towards the mouth of the watering point, further reducing the risk of siltation.

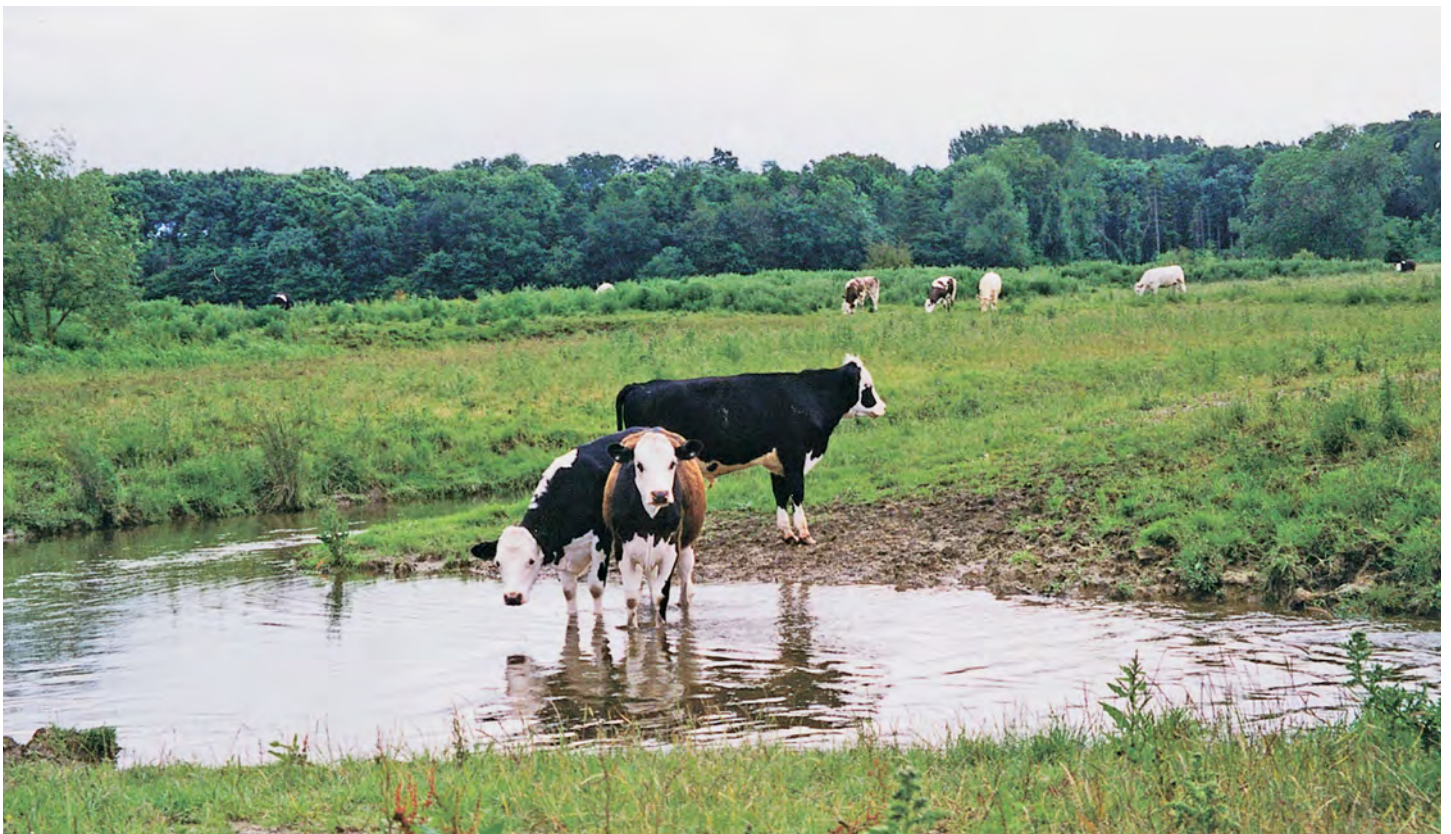
Vehicular ford upstream of mill at ch. 250m

Ford at ch. 250m

The ford is shown diagrammatically in *Technique 2.2, Figure 2.2.1*. Its purpose is to provide vehicular access across the river in conjunction with the nearby crossing over the mill leat (see *Technique 8.2*). The ford is configured as a point bar located downstream of a sharp bend in the river. It crosses the river diagonally such that the ramp on the inside of the bend could take the form of a natural shoal of gravel that gently rises up to field level, mimicking the geomorphology of upland rivers where point bars and shoals of gravel often serve as crossing points. Because there is no significant bed load of gravel in the River Cole, the bar and shoal had to be artificially created using crushed stone and aggregate.

The ramp on the outside of the bend was simply graded up to the new crossing over the leat and its flanks were contoured to form smooth transitions with the river banks on both sides. A flood spillway on the side of the mill leat is located near to the ford (spillway **S2** see *Technique 6.1*) so the hydraulics at the location are fairly complex. The bank contouring needed to reflect this by ensuring that all slopes were flatly graded and rounded off to minimise the risk of scour damage from turbulence during high flows.
