ENHANCING STRAIGHTENED RIVER CHANNELS

3.3 Stone riffle

RIVER SKERNE

LOCATION – Darlington, co Durham, NZ 301 160

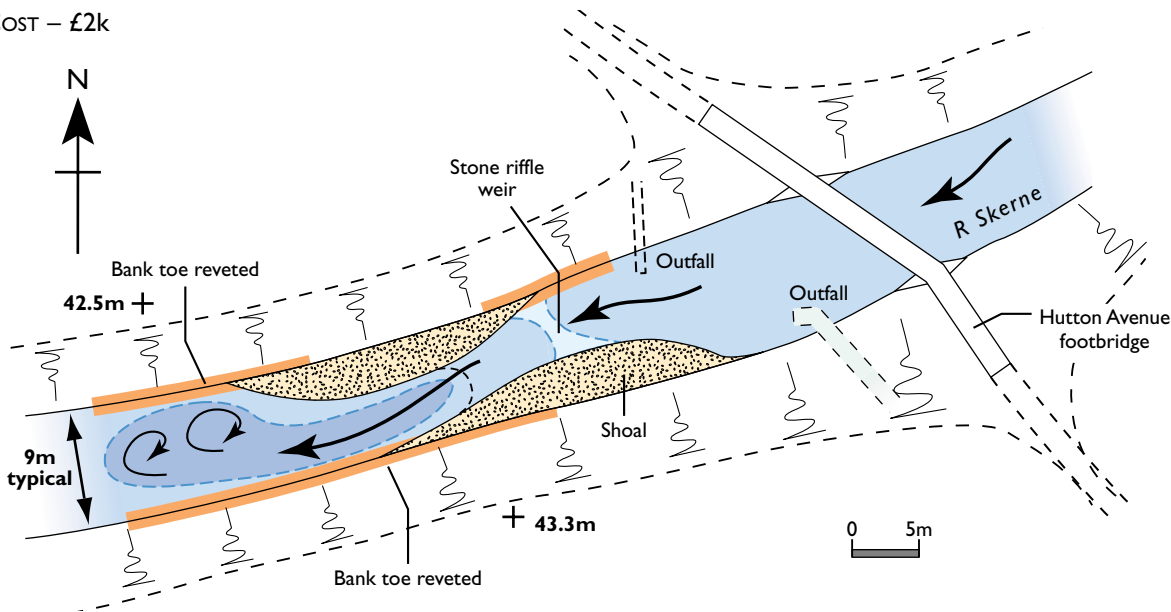
Figure 3.3.1
PLAN OF STONE RIFFLE

The riffle is configured as two semi-elliptical shoals, diagonally opposite each other, that are linked by a shallow sloping weir, such that the whole is a single, homogeneous structure. During low flows, only the weir is submerged but the shoals quickly drown as flows increase. The configuration sustains a deep,

Although described as a riffle, the structure was designed as a low weir. Scour of the structure, as well as the river bed and banks downstream, were primary considerations.

faster flow of water around the downstream shoal that noticeably eddies as the currents merge with the lower river. These variations in the speed, depth and direction of flow all sustain habitat diversity. The river banks alongside each shoal are graded as flat as practical to make access to the water's edge easy and safe. The toes of the river banks are reveted with stone where river flows are accelerated during passage over the structure and beyond.

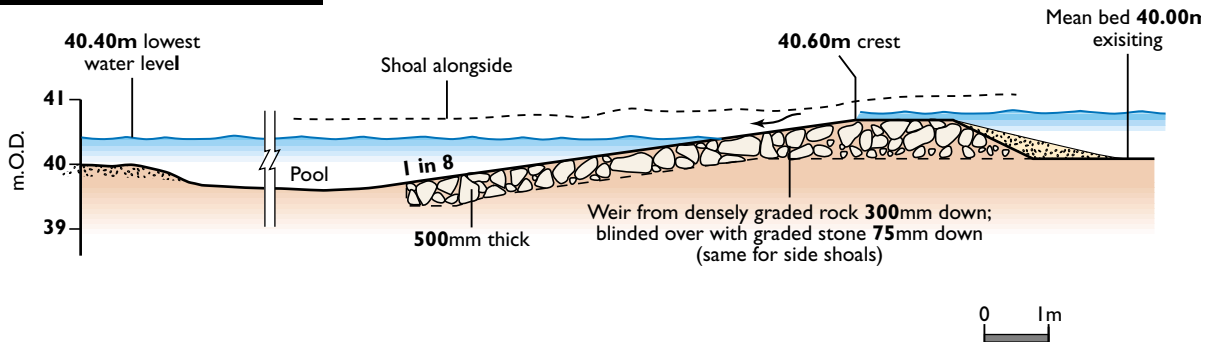
Figure 3.3.2
SECTION THROUGH WEIR

The stone used for construction was a densely graded crushed rock mixture sized 300mm down to 5mm. The dominant size (at least 50%) was in the range 125-300mm to ensure that the structure would not wash away during floods, albeit some adjustment to form would inevitably occur. As a final measure, the entire structure was covered in a layer of smaller crushed stone to simulate gravel. This mixture was

sized 75mm down. Its purpose was to smooth out the irregularities in the core rock surfaces improving appearance. Much of this material would be washed away by floods, but was expected to settle out in desirable niches close downstream.

At normal water levels the new structure is free-flowing, but spates of floodwater cause downstream levels to rise more quickly than those upstream such that the structure is 'drowned out' at an early stage; an important flood defence and fishery requirement. Weed growth downstream of the structure also causes seasonal rises in normal water level that partially submerge the structure.

The new riffle/weir has performed well and adds greatly to the amenity of this well visited location. The river has scoured away much of the smaller sized stone, as anticipated, but a stable structure has evolved in the form required. The slope of the weir has steepened significantly (from 1 in 8 built to perhaps 1 in 4).
