MANAGING OVERLAND FLOODWATERS

6.3 Removing and setting back floodbanks

LONG EAU

LOCATION - Manby, Lincolnshire TF 407863

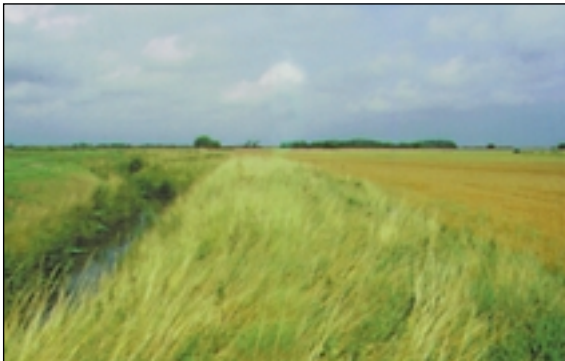
View along the trapezoidal right bank of the Long Eau

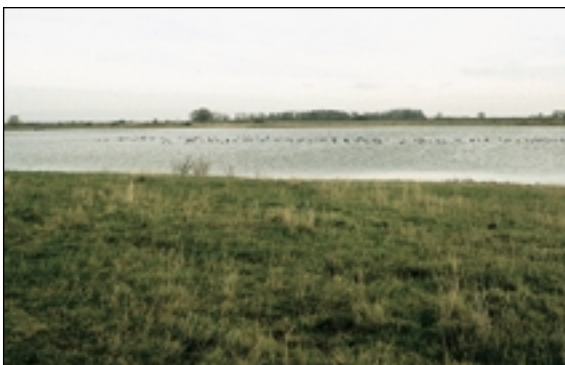
View from the new embankment across the restored floodplain. Showing wintering wildfowl, January 1999

Water is designed to spill onto the 16ha site from the Long Eau when levels reach 2.6m above OD, just 0.3m over their normal retained level. This floods progressively outwards from the old course of the IDB drain, which represents the lowest levels within the area. This low spot remains damp for much of the year, the downstream end forming a permanent wet scrape/shallow pool.

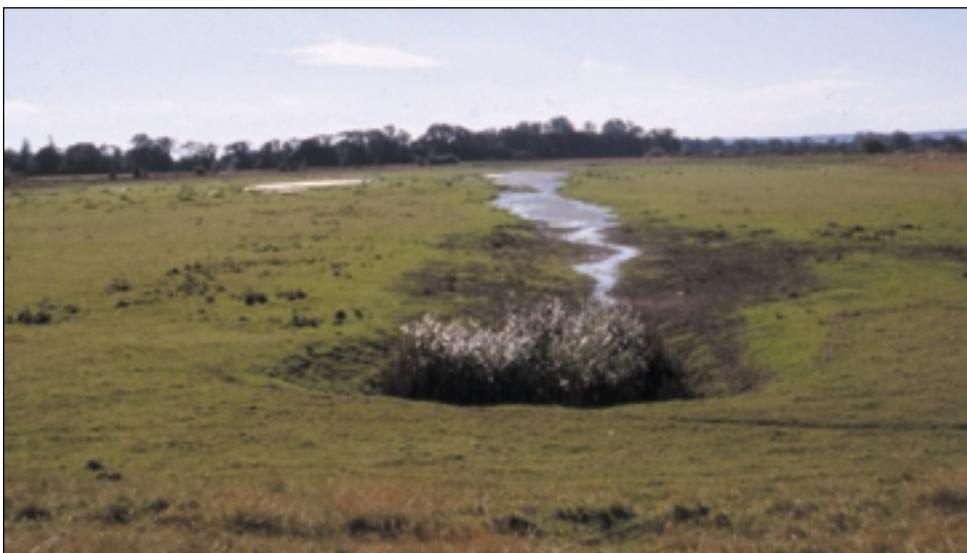
Floodplain, penstock and permanent wetland area, October 2001

Water will spill onto the site from the Long Eau when levels reach 2.6m above OD and has reached a maximum of 4m above OD. Levels are then reliant on conditions in the Eau subsiding and, depending on the intensity of the event, have been retained for two or three days. Below the Eau level of 2.6m, 75% of the washland will retain water to a depth of up to about 0.5m. This can remain for 3-4 months providing ideal conditions over the winter months for dabbling and grazing ducks such as widgeon, teal, gadwall and mallard.

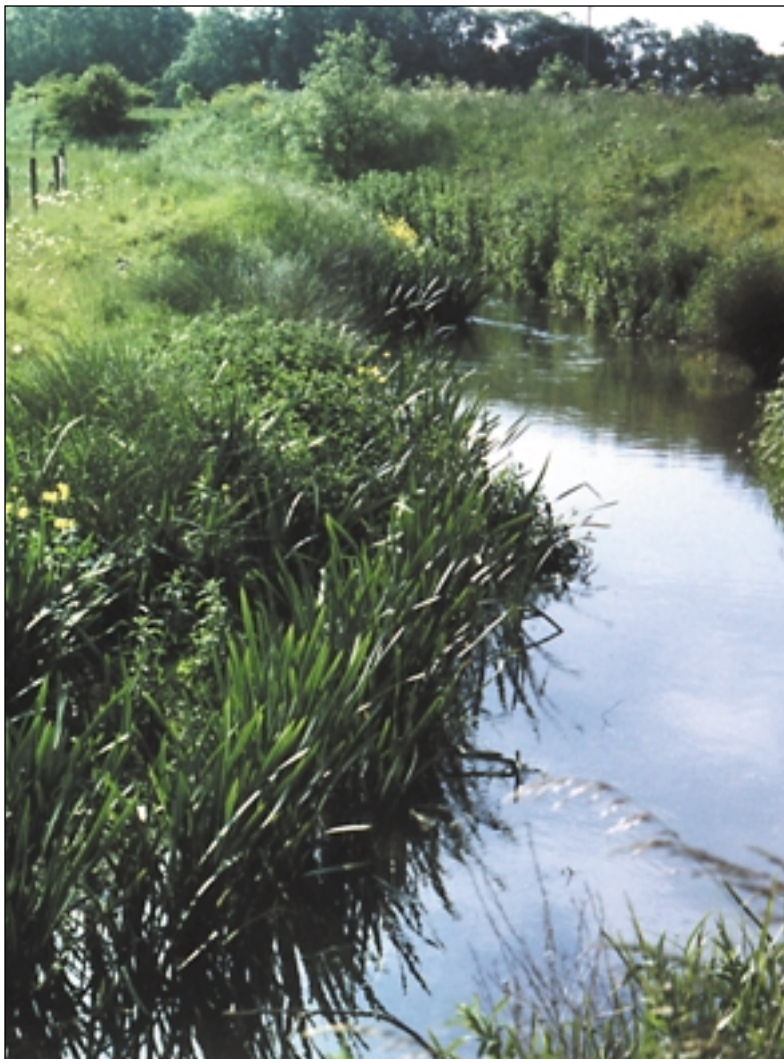
Berm at section A after 4 years
