The River Cole Restoration Project

LOCATION - Coleshill, (Oxon/Wilts border) SU 234935
 DATE OF CONSTRUCTION - Autumn 1995
 LENGTH - 2km
 FLOODPLAIN AREA - 50ha
 COST - £140k

The River Skerne Restoration Project

LOCATION – Darlington, Co Durham, NZ 301160
 DATE OF CONSTRUCTION – Autumn 1995 to Spring 1996
 LENGTH – 500m
 COST – £300k

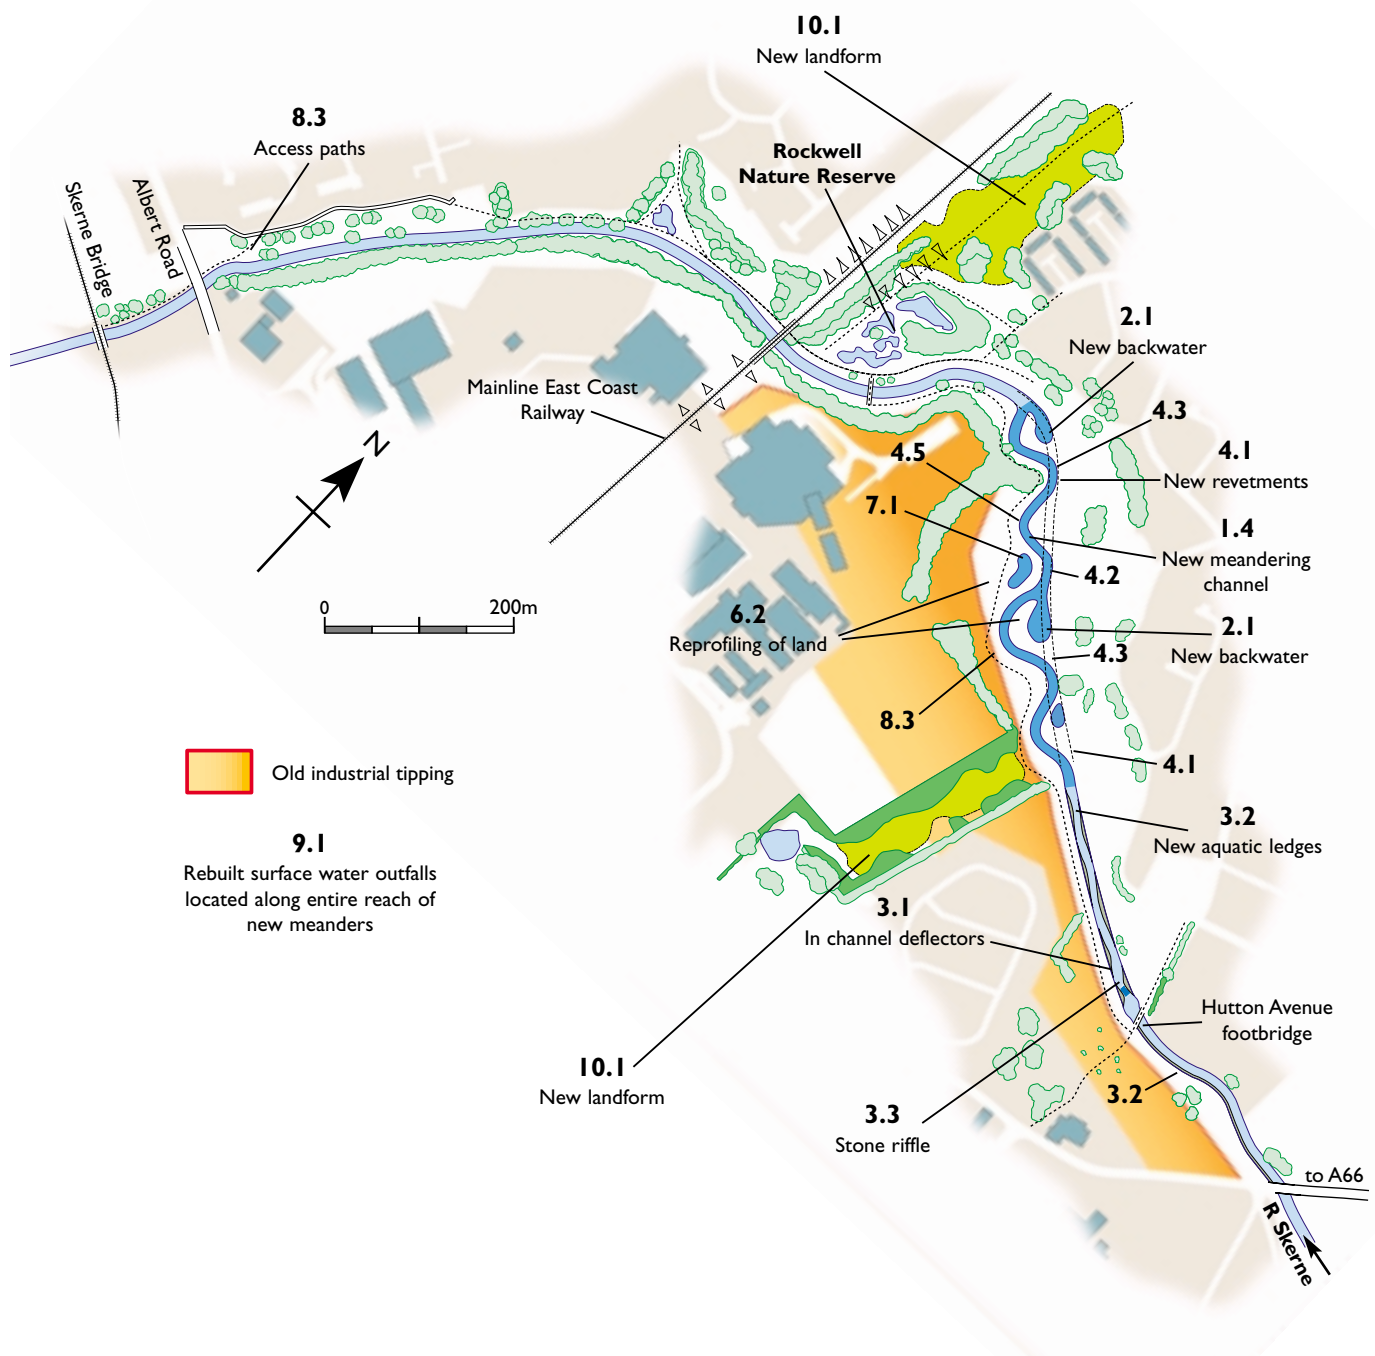
Restoration works are shown on the accompanying figure. The principle achievements are the creation of new meanders on the south side of the old, straight course, and the enhancement of the existing course, both upstream and downstream of the new meanders, where it proved impossible to re-route the river. A reach of 2 km in all was either restored or enhanced. Extensive public amenities were incorporated including new paths and landscape planting.

- 1.4 New meandering channel
- 2.1 New backwaters
- 3.1 In-channel deflectors
- 3.2 New aquatic ledges
- 3.3 Stone riffle
- 4.1 - 4.4 New revetments
- 4.5 Supporting river banks
- 6.2 Re-profiling of land within meanders
- 7.1 Floodplain scrapes
- 8.3 Access paths
- 9.1 Rebuilt surface water outfalls
- 10.1 New landforms

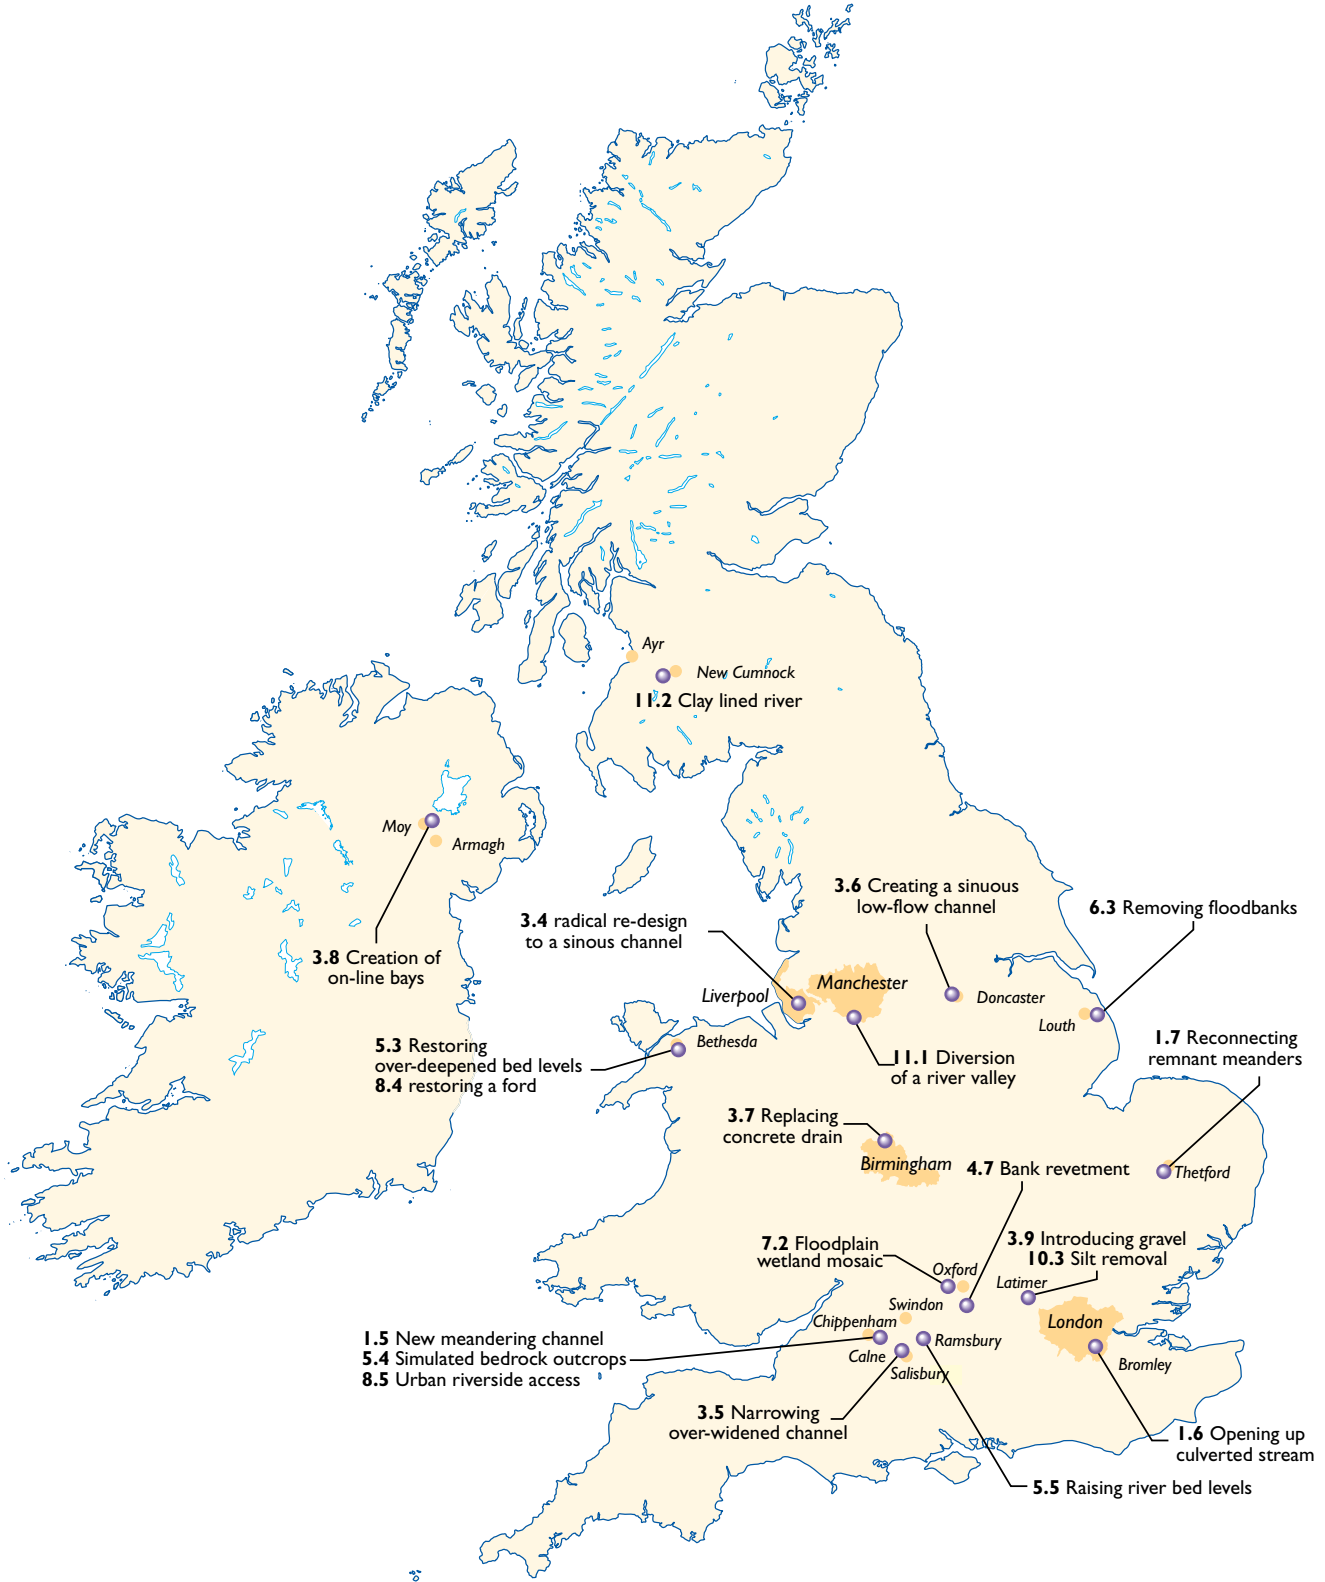
Project Locations – 2002 Update

This update of Edition 1, 'Restoring the River Cole and River Skerne', introduces fifteen further projects where rivers have been enhanced, rehabilitated or restored by a variety of organisations and partnerships. Each entry is accompanied by a contacts list should further information be required.
