River Mel Enhancement Project, Meldreth

Technique: Faggots & coir rolls, importing gravel, flow deflectors

the River Restoration Centre Case Study Series

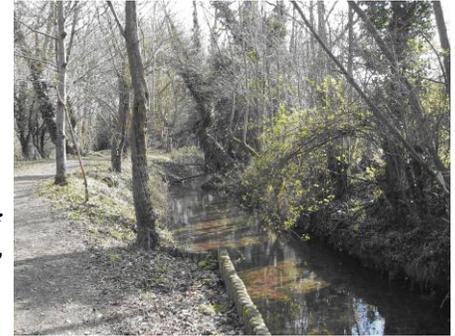
A slow flowing, straight section of the river Mel prior to restoration

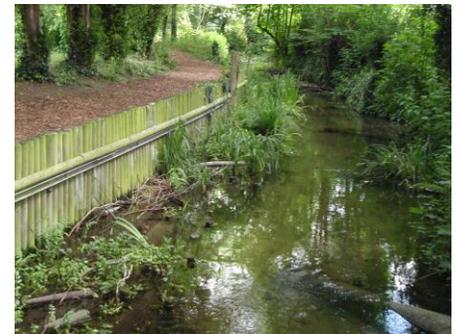
Narrowed section, showing marginal vegetation colonisation

- Willow brushings were installed along sections of the river, including the reach where wooden bank revetments were constructed in 2000.
- Upstream of the bridge, the river was narrowed using faggot bundles and planted with sedge.
- Vegetation clearing took place to reduce shade and enable more natural light to enter the channel, encouraging in-channel vegetation growth.
- A V-groyne flow deflector was installed, to create flow variation and encourage scour and deposition of silt. Further works are planned.

The work undertaken has helped restore the river to a more natural width. However, the willow has begun to degrade, perhaps due to the presence of freshwater shrimp. Due to difficulties in agreeing sufficient tree management, some sections of the river are over-shaded, and vegetation colonisation has been limited. Some marginal vegetation has colonised well in the narrowed reaches. This project is an example of what can be achieved by working with the community with a limited budget. The RMRG were awarded winners of the Amateur category at the Wild Trout Trust Awards in 2009.

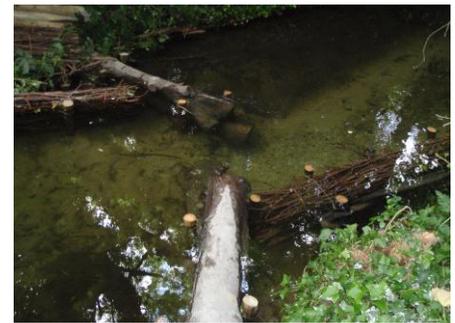
V-groyne constructed to create flow variation within the channel
