River Pool Linear Park Enhancement Project, Lewisham

Techniques: Berm creation, tree felling, invasive vegetation management

the River Restoration Centre Case Study Series

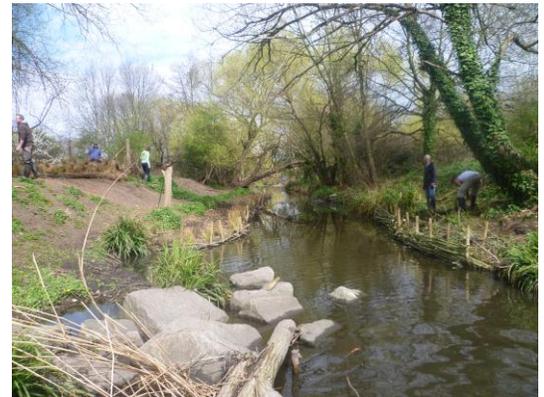
Facing downstream, looking towards the bottom end of the restored section. Wood from trees felled on the right bank was used to construct the berms in the photo

A team of volunteers led by Vic Richardson (Thames 21) have helped to implement the works, which comprise a series of berms on alternating banks along a section of 300m constructed from site-won wood felled along this section; and spoil from an Environment Agency project near Catford. The positions of the berms have been carefully thought about to create a more sinuous channel, and to encourage a riffle-pool sequence to diversify flow. Watercress flowers in the summer months so particular care was taken when deciding how much to narrow the river to ensure that works make a difference, but to avoid choking the river when watercress is in bloom. Japanese Knotweed, Himalayan Balsam and Giant Hogweed are all present in this section, and volunteers have, and will continue to manage this in an appropriate manner to allow native vegetation to grow and mature.

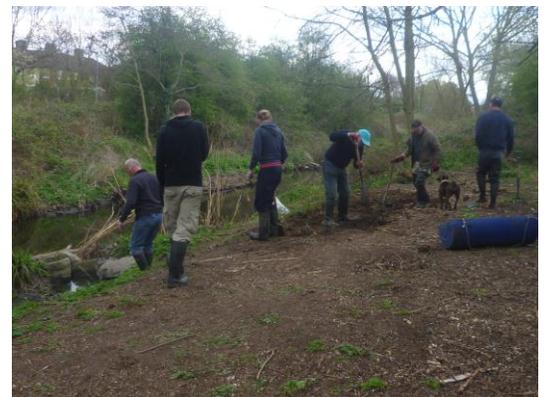
Thames 21 volunteers helping to backfill a side berm on the left bank of the River Pool
