River Shep, RSPB Fowlmere Nature Reserve

Techniques: Faggoting, bed raising, riffle creation, hand weed cutting.

Project location: Fowlmere Nature Reserve

the River Restoration Centre Case Study Series

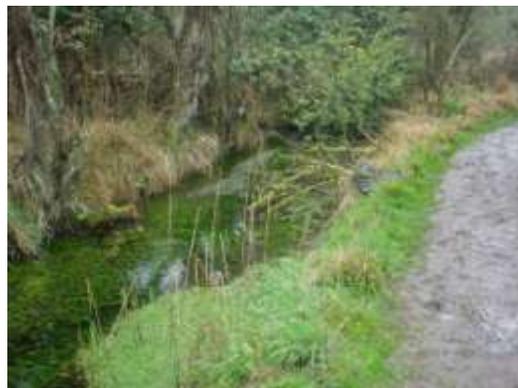
Straight and overgrown section pre-restoration

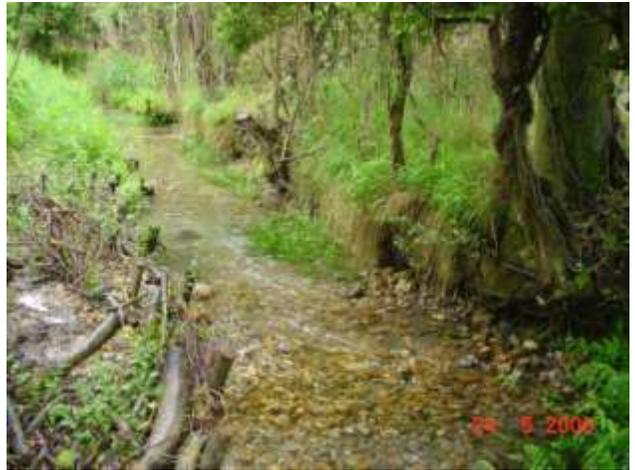
A restored section of the River Shep, showing riffle creation with marginal vegetation developing.

- 2006 - a length of river had been identified with a gradient that enable bed raising by ~0.7m to form a riffle. The bed level was raised by the placement of 10 tonne of flint and gravel hoggin in an asymmetric undulating manner (rather than the usual smooth riffle). The material was then top-dressed with locally sourced 5-30mm graded gravel to give a natural appearance. The gravel was donated free of charge by a local quarry.

The faggot bundles have successfully created a habitat ledge and reduced the channel to a more natural width. The gravel appears to have been well placed with minimum silt settling during 2010. The habitat has improved significantly, with water-crowfoot and water-starwort slowly increasing in the first year, but it is too early to detect any improvement in macroinvertebrate diversity or abundance. The firm and shallow bed enables the channel to be safely maintained by hand cutting. Trout are frequently observed within the channel.

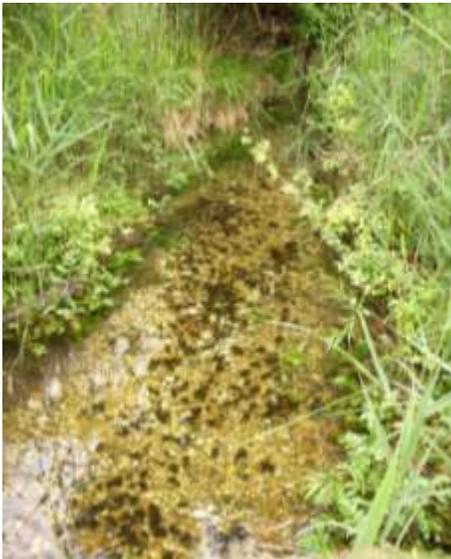
River bed six months after work. The dark patches on the gravel are clumps of Simulium larvae.

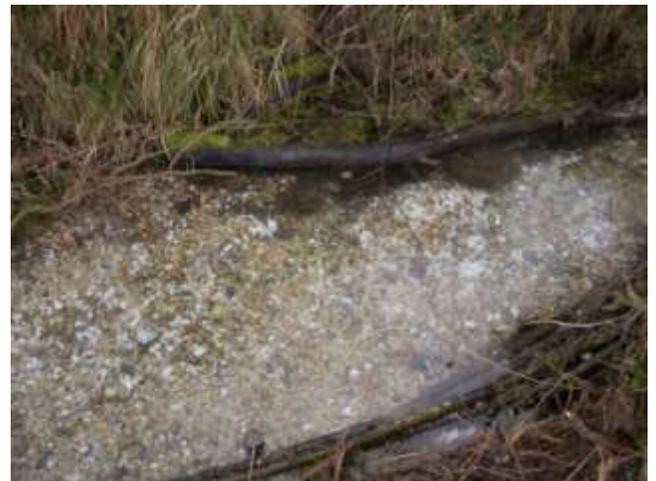
Freshly placed gravel and chalk mix. Faggots are partially hidden and large woody debris is placed to give a more natural appearance.

- 2009 - deeper reaches of the river were filled using clay-bound reject stone which was then covered with a suitable mix of 0.5-40mm gravel, flint and chalk. The material was placed in a controlled manner to restore the bed to the level prior to the 1980's dredging. Where required, a double layer of faggots with a hessian membrane was used to hold dredged silt.
