4.3 Log toe and geotextile revetment with willow slips

RIVER SKERNE

LOCATION – DARLINGTON, Co DURHAM, NZ301160

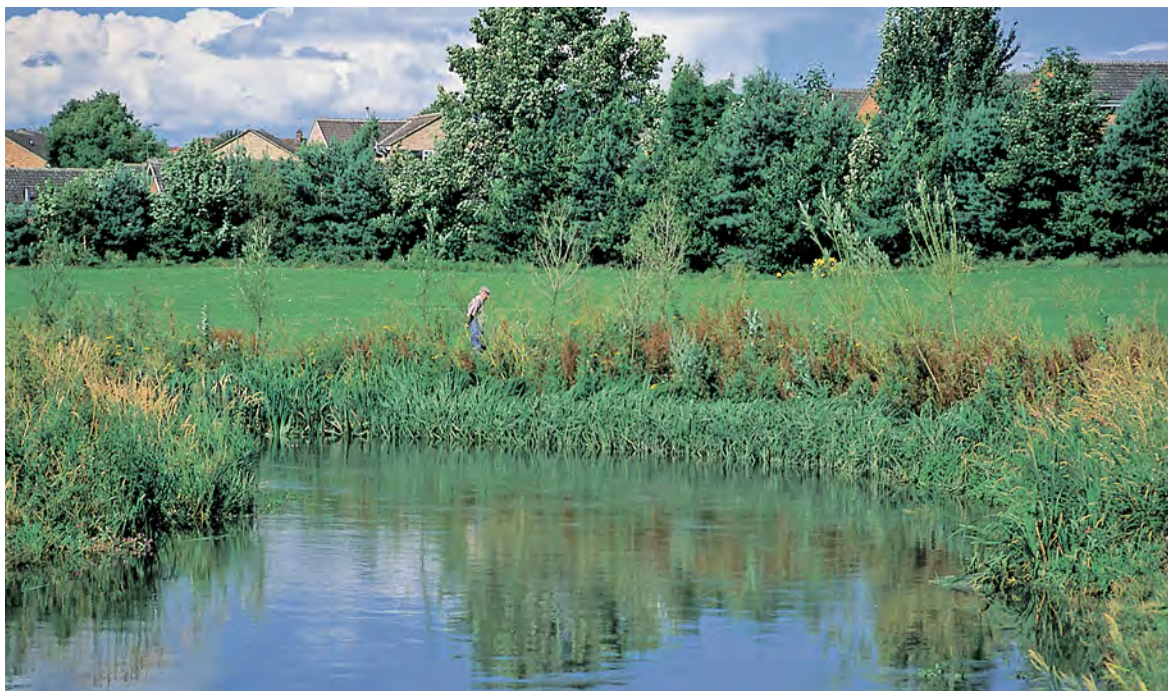
Log toe revetment three years after construction

This technique was used in two locations and both have performed well with dense willow growth up to 2m high along the bank and a thick margin of plants along the water's edge, all of which are accreting river silts in successive floods. Rooted willow plants established much more strongly than unrooted slips, but this is not uncommon with the grey/goat species selected. Other willow varieties are known to strike readily from slips. Species that are indigenous to the site are always preferable. Brushwood containing willow cut locally can be built into the lower banks as an alternative to the geotextile utilised at the Darlington site which was virtually barren of trees.

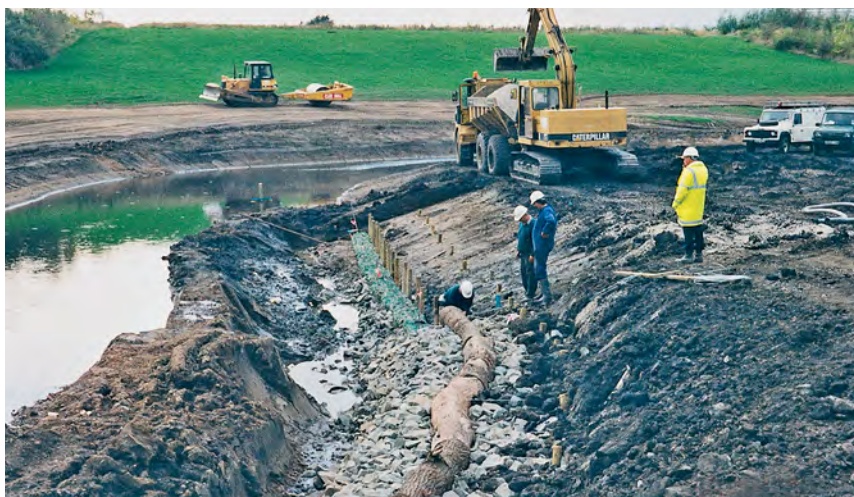
Log toe revetment during construction

Logs were laid out along the top of the rock and lightly wired to the fencing posts to prevent flotation. Logs were then strained tight against the posts using twist wires anchored to stakes set well back into the fill. These ensure that the logs can never float away even if major settlement or scour of the river bank arises.
