River Quaggy, Chinbrook Meadows

Technique: Re-meander channelised section and floodplain storage

the River Restoration Centre Case Study Series

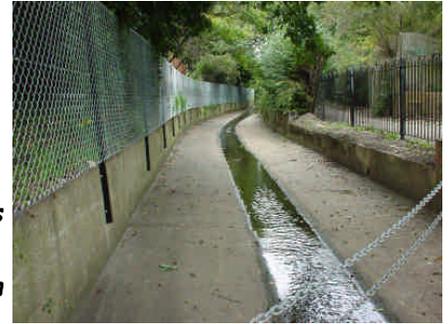
The River Quaggy, d/s of Chinbrook Meadows, prior to restoration

This section of the River Quaggy, with a flashy flow regime, was channelised and straightened between 1960-1970 as part of a flood alleviation scheme. Prior to restoration it was encased in concrete with fences and high privet hedges near to each bank. It could neither be accessed nor viewed by the public and was devoid of natural fauna and flora.

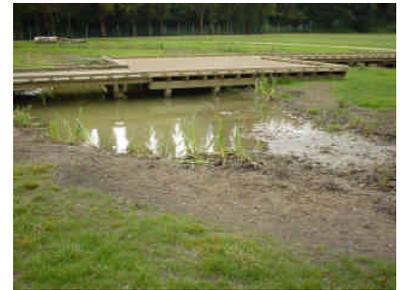
Marginal planting around the pond & along edge of river (2002)

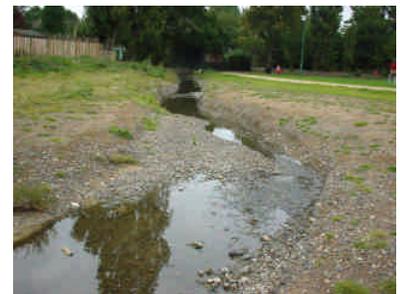
Rapid natural changes in the river planform (2002)

This project is an excellent example of a partnership initiative that has not only restored the river and floodplain, but has also paid careful attention to improving the park amenities. The channel work was completed in spring 2002 and by September that year there had already been considerable movement of gravels. Natural geomorphological features including a pool/riffle sequence, gravel bars and steeper banks had formed. The pond has been colonised by invertebrates and the vegetation planted along the banks is now providing good cover in both the planted and unplanted sections.

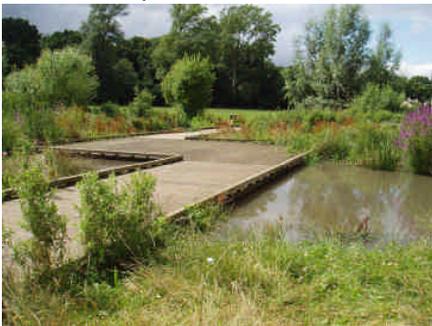
Vegetation development at the pond (2008)

This scheme continues to be successful. Some desilting of the dipping pond (not linked to the main channel due to the location of a drain) may be necessary in the future together with some vegetation management.
