# River restoration of a historical site

R.J.Bull was contracted to restore Southington, a 300m stretch of the River Test. Working with the Environment Agency and Natural England who were funding contributors, and input from the Test & Itchen Restoration Strategy, the objective was to improve the stretch of river that was in very poor condition due to the impounding effect of a mill/turbine structure preventing fish passage and impounding the river for 300m upstream.

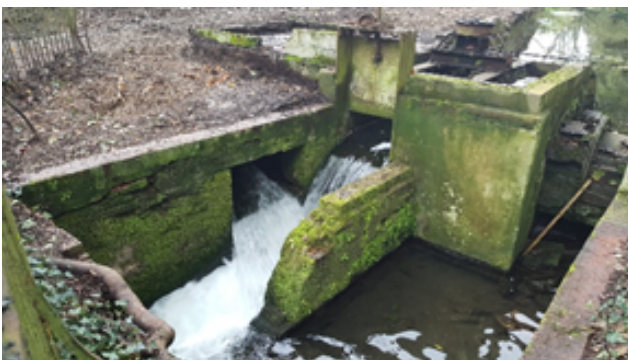
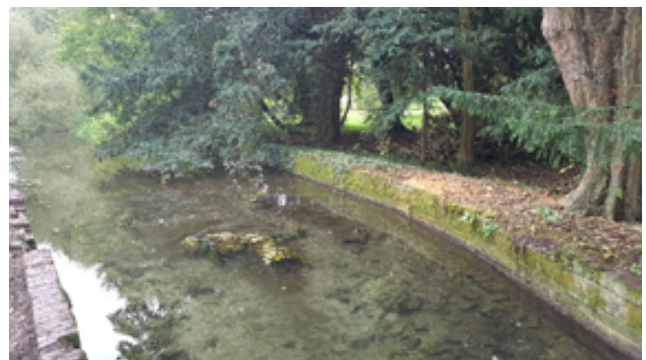
Before: impounding structure and silt deposits

- Removed the existing 1.5m high impounding structure of the mill/turbine
- Linked this area to 4km of river upstream where previous restoration works have resulted in improved habitat and spawning

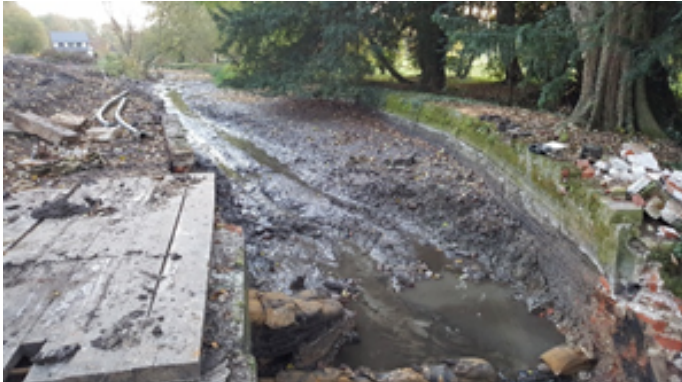
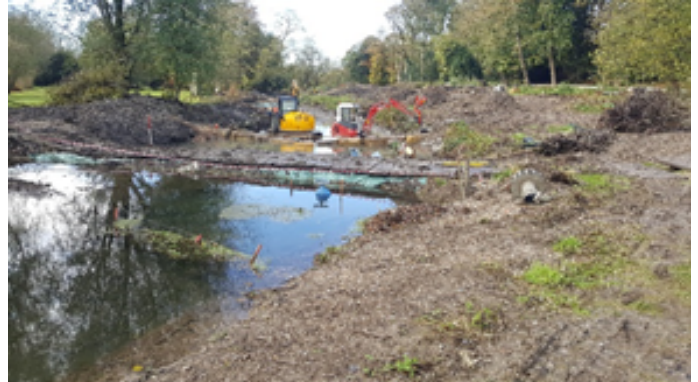
During: silt deposits drying down and coffer dam in place allowing dry working on rock ramp

- Managing multiple levels with rock ramps to ensure fish passage as well as the lift required
- Retaining the flow to the section of river downstream for the 4 weeks of the dry down stage
- Accommodating the historic nature of the site, refurbishing the mill area to keep its character once project completed, and supporting full scale archaeological dig around the site during work

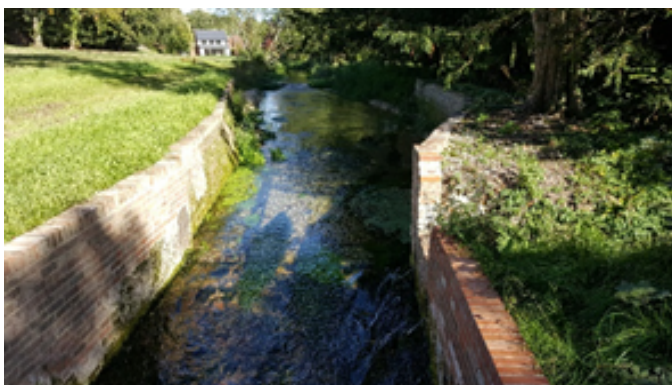
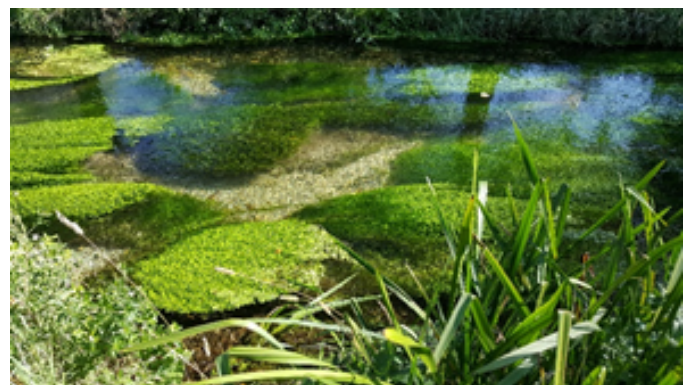
After: clean clear beds, good weed growth and fish passage

The restoration has resulted in a much improved section of the river which now looks like a chalk stream and allows free fish passage. We have created a resilient environment. A simple self-sustaining solution is now in place which requires no input to deal with a range of water flows and heights.
