River Cam Habitat and Access Enhancement Project at Trumpington, Cambridgeshire

Techniques: Gravel shoals, Bank re-grading, Ditch and Sluice restoration, Bank revetments, Flow deflectors and Backwater habitat creation

Project location: Trumpington Meadows, south of Cambridge

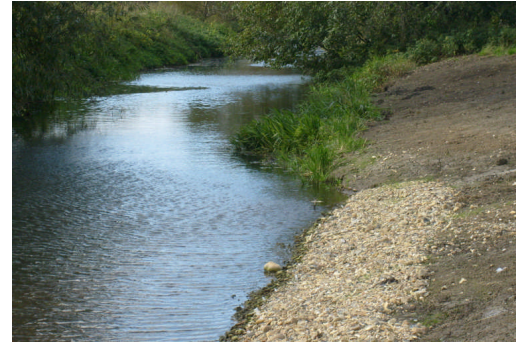
Restored bank gravels, marginal vegetation and in-stream gravel shoals.

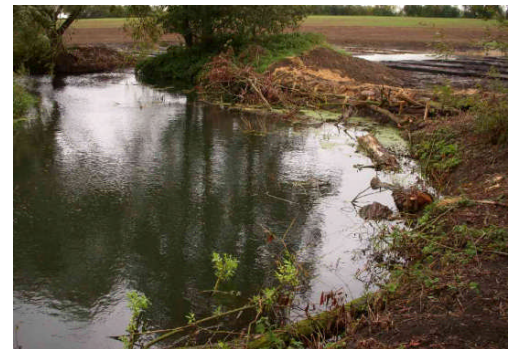
Log jam revetment with the flood storage area behind

Public safety has been increased in a manner which should provide new recreational areas away from sensitive wildlife area. By leaving marginal vegetation where beneficial, it is hoped that the banks will naturalise within a year. Some erosion control matting has been used and in places extra gravel has been placed to protect against bed scour. Flow diversity has increased and there are new habitat opportunities appropriate to the river's character (e.g. backwater ditch system and rootball deflectors). Bank revetments have been well designed and constructed.
