River Ravensbourne at Cornmill Gardens

Techniques: Removing concrete channel, bank re-profiling

Project location: Lewisham, South East London
River: Ravensbourne
London Borough: Lewisham
Project end date: 2007
Length: Approx 100m
Upstream grid reference: TQ381757
Partners: Building Design Partnership (BDP), Lewisham Borough, Environment Agency

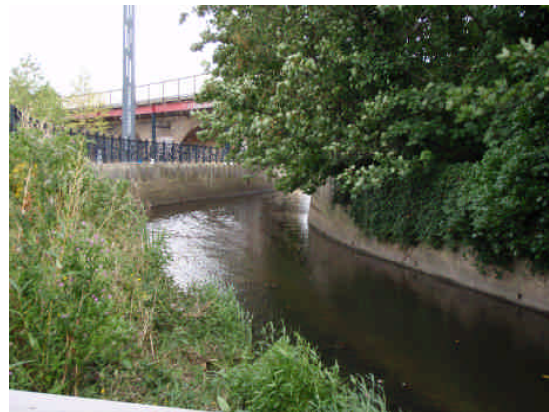
Concrete channel upstream of Cornmill Gardens

Before the regeneration of this site, this section of the Ravensbourne flowed through an area known as the Sundermead Estate. The river had been constrained within a narrow concrete channel as part of an historic flood defence scheme. This, together with high steel railings and overgrown vegetation had resulted in a neglected river possessing little ecological or local community interest. The river restoration scheme formed part of the 'Urban Renaissance in Lewisham' programme which aimed to create a new public open space within the Town Centre.

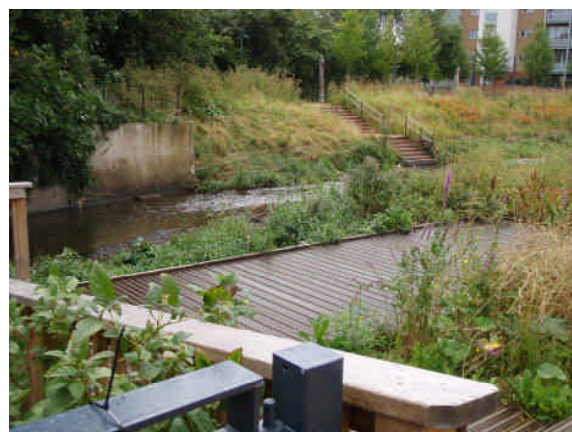
River Ravensbourne following removal of concrete channel and provision of board walks

Following the preparation of design proposals and a full public consultation, a masterplan was developed for the whole site. The concrete walls of the river were removed and replaced with more natural re-graded banks interspersed with steps and wooden platforms to improve river bank access. A puddle-clay liner was constructed to help restore flows. Gravels were introduced into the bed of the river. These were sized to ensure that they could move in the channel with respect to the flow conditions, thus creating natural habitat features for wildlife. Marginal areas were planted with native species such as Rush (*Juncus effusus*) and Yellow flag Iris (*Iris pseudacorus*) whilst a wildflower mix was sown along the banks. An overflow storage area which retains water during high flows was designed into the scheme by lowering an open space alongside the river.

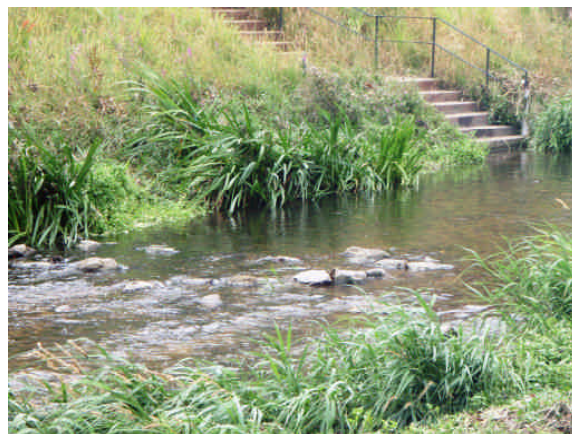
Provision of gravel/rock riffles within the channel
