Day Brook Water Meadow Project

Technique: Small-scale urban river restoration – re-meandering

Project location: Nottingham

River: Day Brook

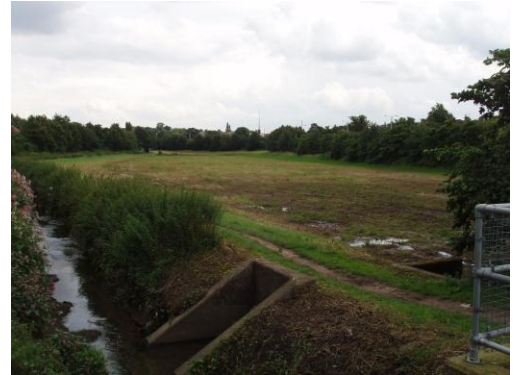
The trapezoidal channel of the Day Brook and adjacent flood storage area prior to restoration

A partnership between the Environment Agency and Nottingham City Council (landowner) delivered the restoration scheme in Summer 2007. Working within the confines of the existing infrastructure, the channel was re-meandered through the adjacent flood storage area, increasing the channel length from approximately 250m to 320m. The channel design incorporated natural features such as pools and riffles, shallow berms and an online reedbed. Permanently wet and ephemeral scrapes were created alongside the new channel and a low-lying area was seeded with an appropriate seed mix with the aim of establishing wet grassland over time.
