A River Glaven Restoration Project

**Techniques: Introducing variation in river depth, width & flow;
& re-connection of a flood plain**

Project location: Holt

River: Glaven

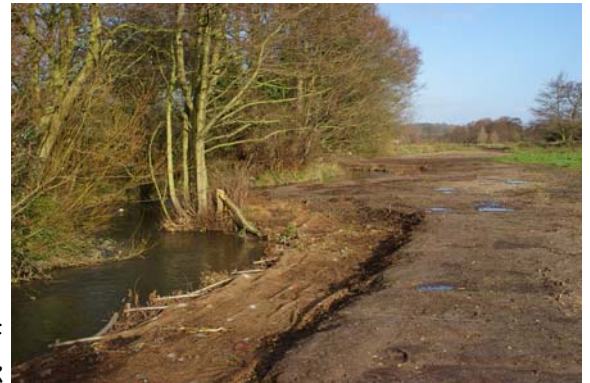
Protection of
re-profiled bank

- In addition 700-1,000 tonnes of spoil was removed along 130 m of a meadow. The re-profiled bank was protected from erosion by use of hazel revetment & coir matting.

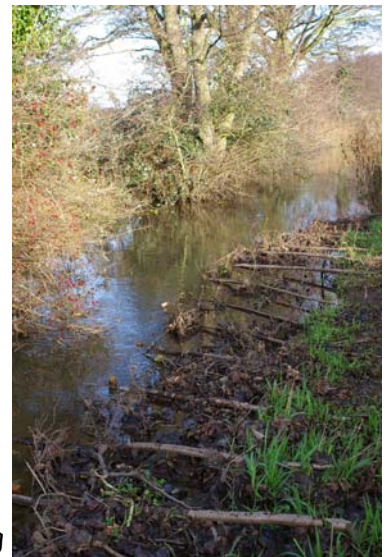
River narrowing

- The main works carried out in the river were the introduction of 6 riffle areas (total length 65m), two of which were dual function as cattle crossings; two lengths of river narrowing (10m and 13m); the creation of 3 mid-stream islands; and 9 lengths of tree trunk as large woody debris flow deflectors at a spread of points.

- The 6 sycamore trees felled on site provided the large woody debris requirements. The posts, faggots, batons and brash used for river narrowing, island construction, and the bank protection work were produced by coppicing hazel trees on site or nearby. The stone and gravel came from local sources, both less than 3 miles from the site, as did the gravel. Large stone was recovered by hand from the spoil, which was later spread over an arable field.
